The New Normal – Planning for Sediment Project Water Management Considering Climate Change

Cannon Silver, PE

**CDM
Smith**

OCTOBER 26-28, 2020

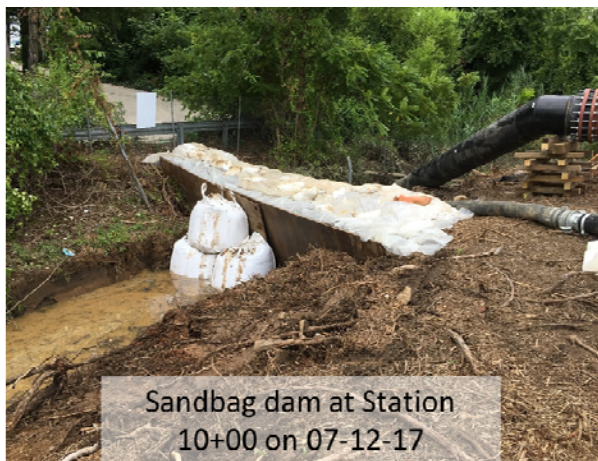
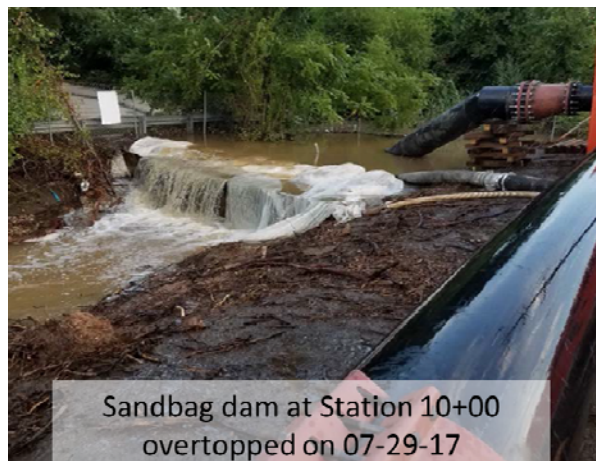
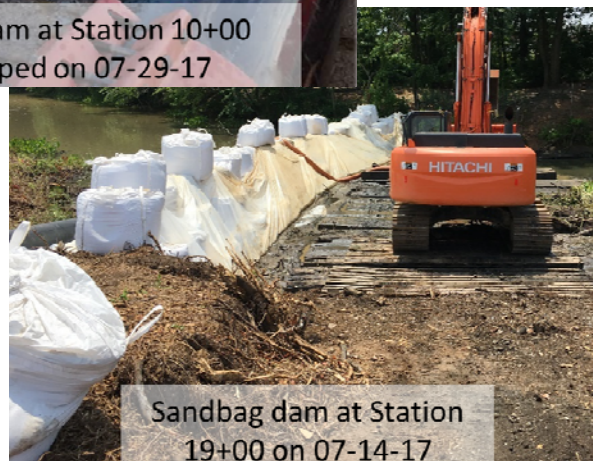
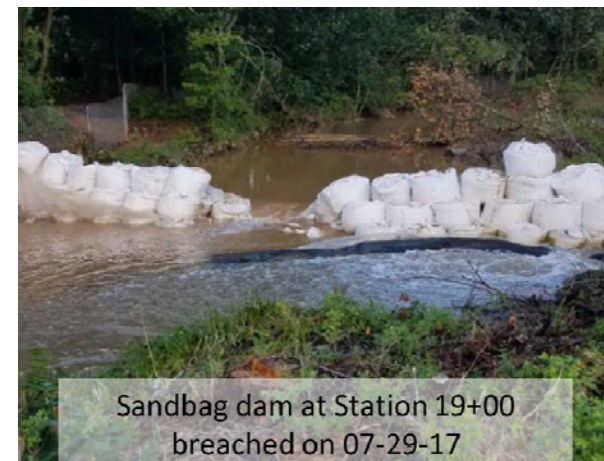
Dam Overtopping and Breaches

- July 28 and 29, 2017
 - 5.7 inches of rain overnight
 - Storm approached and possibly exceeded 24-hour, 25-year flow event
 - Dam at station 10+00 overtopped and dam at station 19+00 breached
- August 18, 2017
 - 1.5 inches of rain in 1-hour
 - Storm exceeded 60-minute, 2-year flow event
 - Dam at station 10+00 overtopped
- August 21, 2017
 - 1.75 inches of rain in 2-hours
 - Storm exceeded 2-hour, 2-year flow event
 - Dam at station 10+00 overtopped
- Design (with safety factor)
 - 10-year flow event (24-hours)
 - equivalent to 5.1 inches of precipitation in 24-hours
 - ~0.2 inches/hr

- Released untreated contact water downstream of the work area
- Schedule delayed due to inundation of the work areas
- Overwhelmed the water treatment system due to the need to treat significantly more contact water than planned

- Constructed additional dams and impoundments
- Reinforced by installing sheet piles
- Optimized the water treatment system

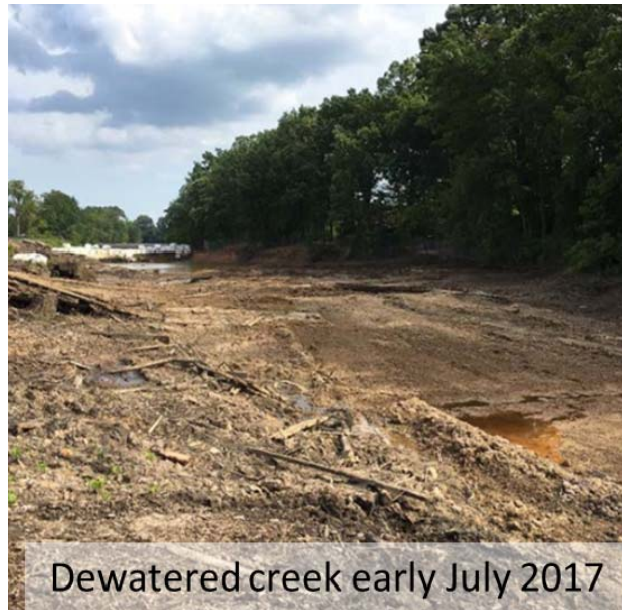
Dewatered creek early July 2017

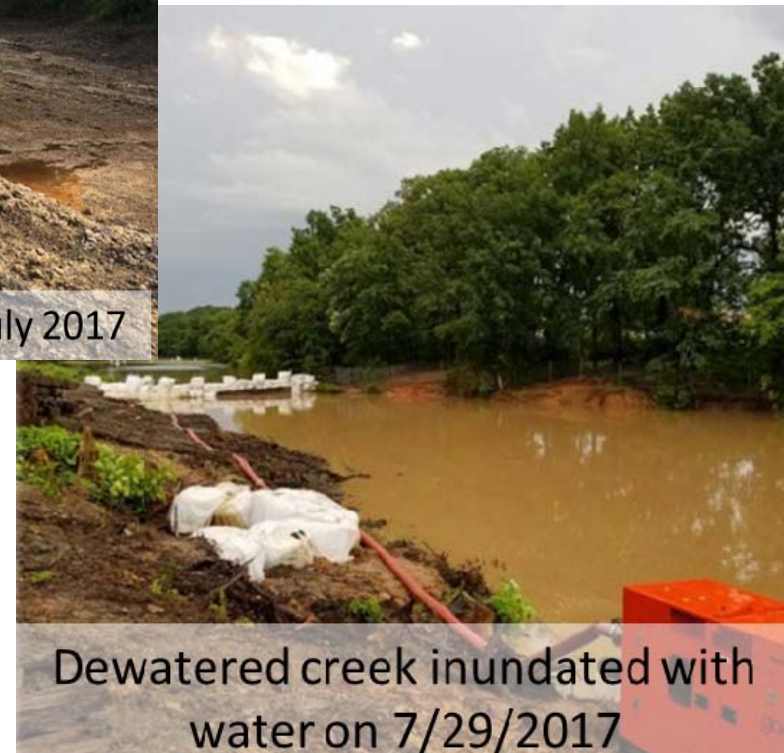
Dewatered creek inundated with water on 7/29/2017

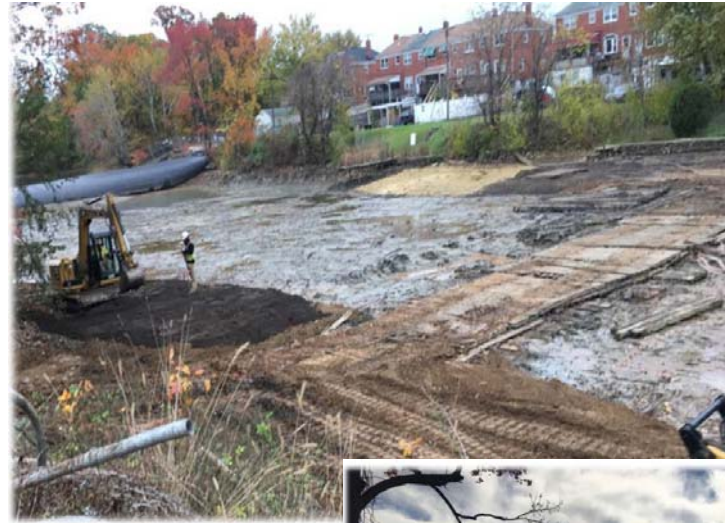
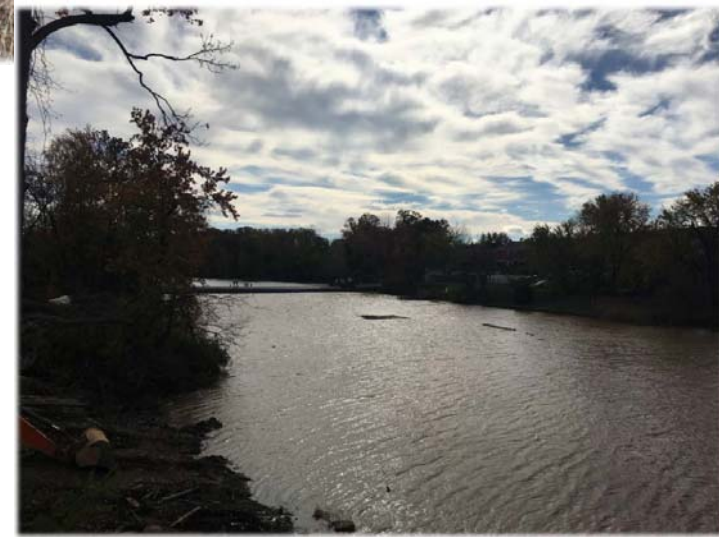
Bladder Dam Failure

- Bladder dam installed August 25, 2017
- Bladder dam breached on November 10, 2017 by creek water channeling under the dam from the downstream side, flooding the upstream segment

- Schedule delays due to inundation of the work areas
- Operation of the water treatment system problematic due to need to treat significantly more contact water than planned
- Release of untreated contact water downstream of the work area

- Multiple repair attempts
- Repair completed by placing an impermeable liner and 800 tons of sand upstream and downstream of the dam
- Large volume of contact water in excavation area treated prior to completing excavation activities
