American Cyanamid Superfund Site

Climate Change Adaptation Webinar 4/1/2015 cluin.org

Hurricane Irene Summary

Impacts on Impoundments 1 & 2

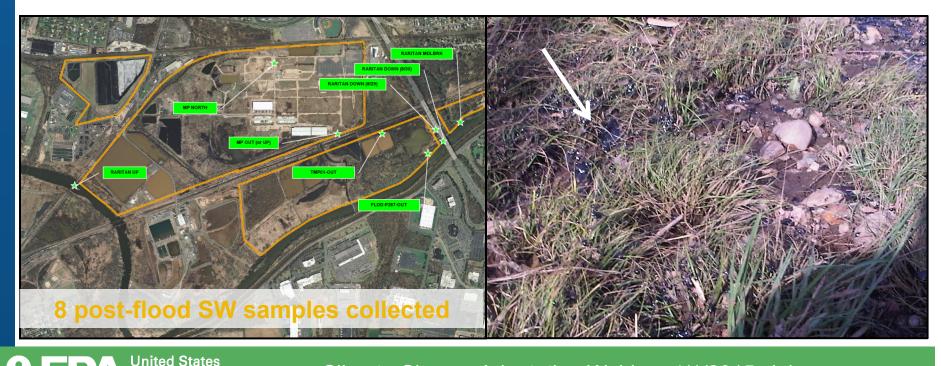
- Post-flood surface water sampling conducted from Aug 29 to Sep 2
- Post-flood berm inspection completed after flood waters receded
- No significant release occurred
 - Some minor tar splatters observed on berm walls

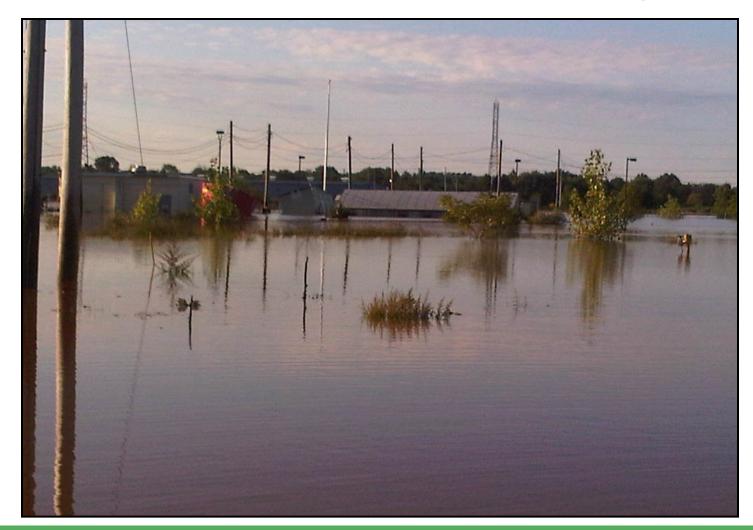
Site Trailers and Records Destroyed

- 214 M gallons of standing water within North Area (5 ft high)
- Sluice gate for drainage of flood water concreted and dismantled
- Flood control berm, office trailers and records damaged
- No electrical power
- Groundwater extraction system to maintain hydraulic control in North Area did not operate for 30 days (no electricity or submersible pumps)

- Office trailers relocated out of the floodplain
- Flood control berm repaired and armored
- All electrical instrumentation re-constructed 5 feet higher than Hurricane Irene levels
- Submersible pumps installed in the two bedrock groundwater extraction wells so that hydraulic control can be maintained throughout a flood event.

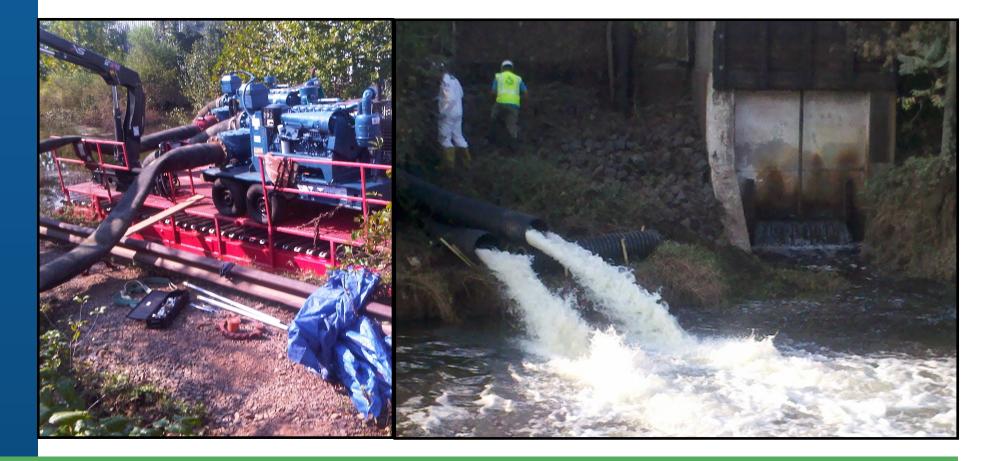
Generator-powered pumps used to controllably discharge 152M gallons of flood water to Cuckel's Brook by Sept 28

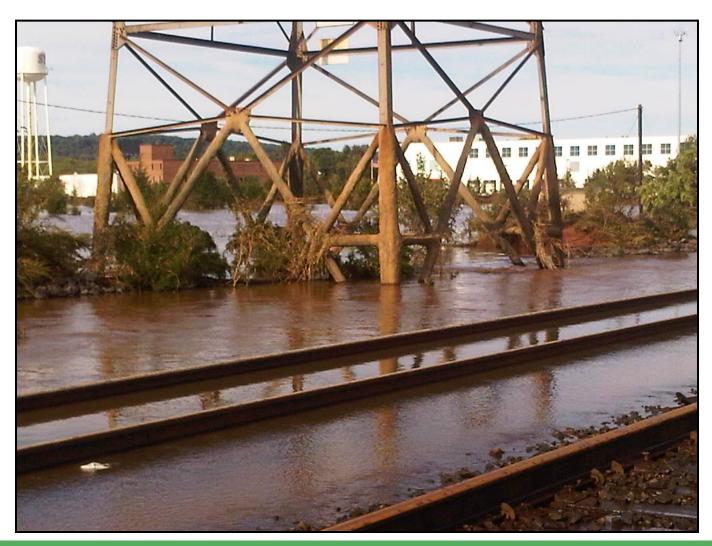
Damaged Portion of Site's Flood Control Berm
