EPA-540-R-013-018

**Optimization Review**  
**Valley Park TCE Superfund Site**  
**Valley Park, Missouri**

Report of the Optimization Review  
Site Visit Conducted at the Valley Park TCE Superfund Site on  
24 January 2013

Final  
4 June 2013

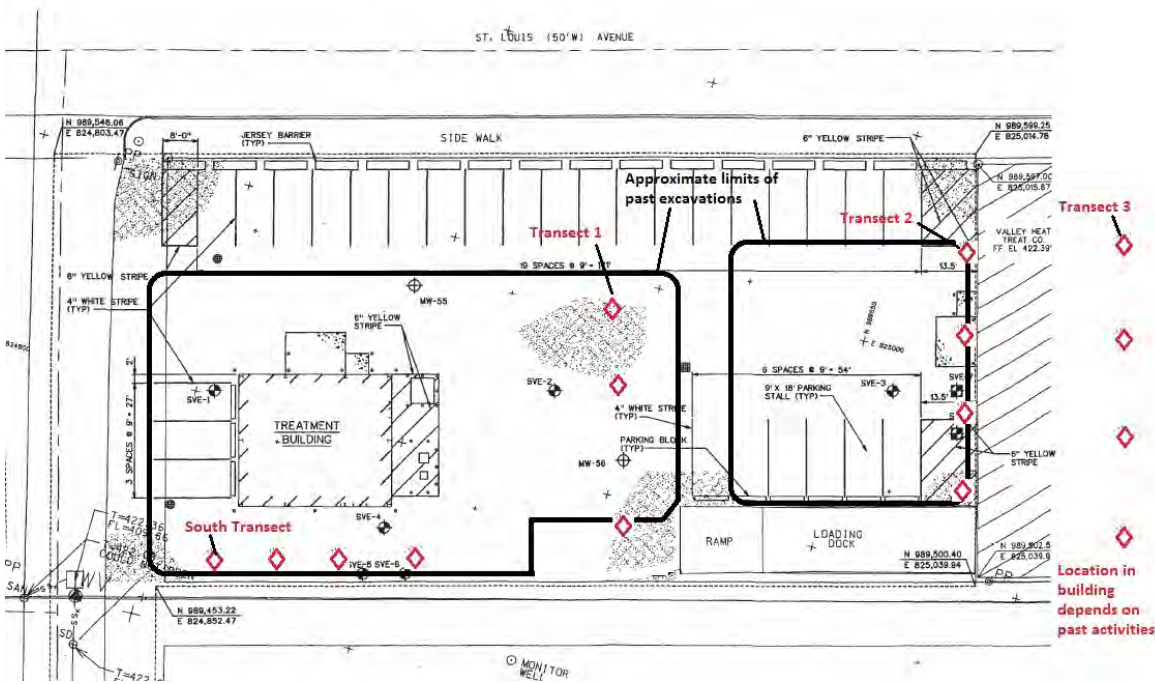
Figure 9. Suggested Ground Water Sampling Transects on Valley Technologies Site

The primary recommendations for progressing toward site closure involve identification and remediation of additional source materials on the Valley Technologies site itself. The persistent concentrations in MW-56 suggest an on-going release, perhaps under and near the water table. The TCE concentrations near MW-56 are around 1000 ug/L and the influent TCE concentrations are near 25-28 ug/L, indicating a roughly 35-40X dilution. Assuming that all of the mass coming into the extraction well is from a source area affecting MW-56, and assuming roughly radial flow, this would suggest that the mass is coming into the well in flowlines over 360°/40 or roughly 10-20° arc. This means that, at most, the contamination is migrating along a 15- to 30-foot-wide zone at MW-56 (90 feet from the extraction well; width = distance \* tan10°). Thus, finding the source may be quite difficult. The goal will be to work upgradient (assuming westward flow toward the extraction well) from known contamination to determine the source.

It is recommended that several ground water sampling transects be conducted to the east-northeast of the treatment plant building and within the Valley Technologies building (if possible). These profiles should consist of 4-5 sampling points separated laterally by as little as 10 feet that obtain grab samples for either on-site or expedited off-site analysis. Samples should be obtained from at least two depths; one near the low water table (say, 28-30 feet below ground surface [bgs]), and other sample 20 feet below that (to be within the MW-56 screened interval). The profiles should be conducted along north-northwest to south-southeast lines; one extending north and south from MW-56, another parallel to the west side of the Valley Technologies building, and another within the Valley Technologies building (if possible). If contamination substantially over the cleanup goals is found under the building, another line on the east side of the Valley Technologies building would be needed to confirm the extent of the contamination. Soil samples should be obtained above the water table for any boreholes within the Valley Technologies building and the location of the profile in the building should be based, to the extent possible, on the locations of equipment and piping for past vapor degreasing activities (and possibly floor drain locations). New monitoring wells would be installed in select boreholes to provide the ability to monitor the high concentrations and to possibly be used to facilitate future treatment.
