## **PERIODIC REVIEW**

**Dexter Horton Building,  
Facility Site ID#: 68766933**

**710 2<sup>nd</sup> Avenue,  
Seattle, Washington**

**February 2011**

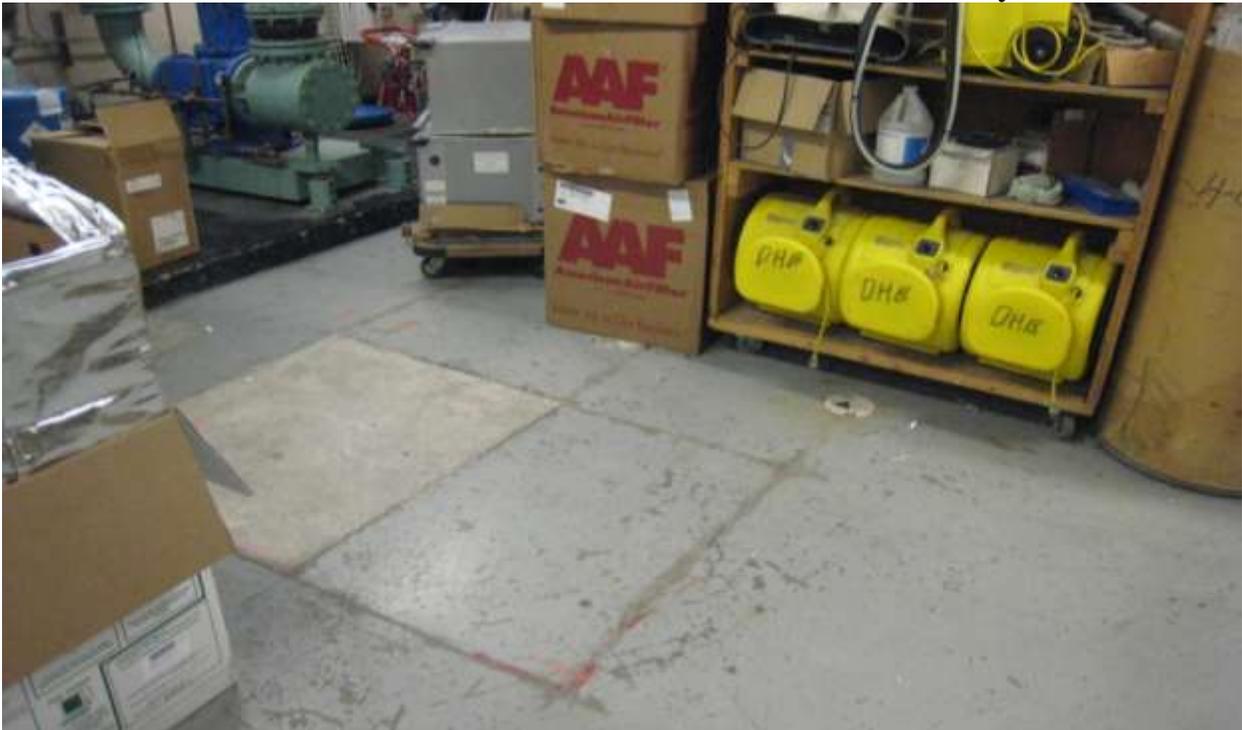
**Photo 2: Ground floor area where tank access was cut – weel visible near yellow items**

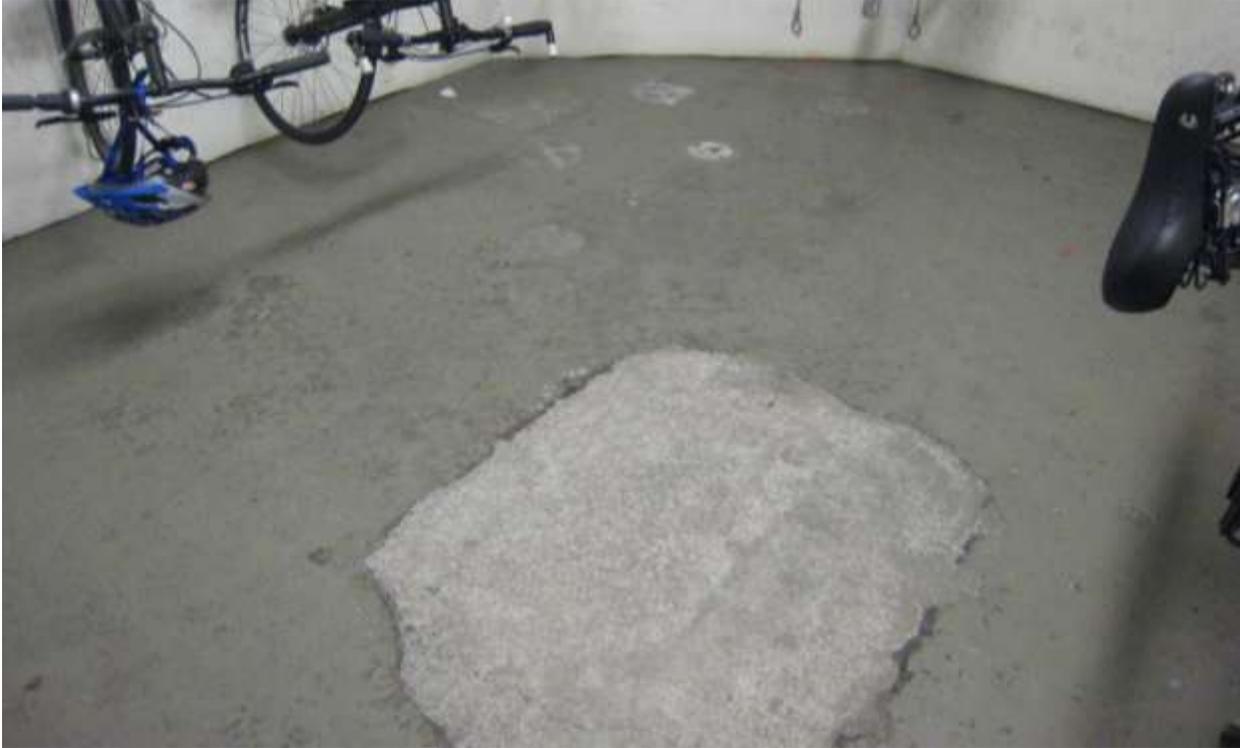
**Photo 3: Another tank access cutting in bike storage room – well at top middle of picture**

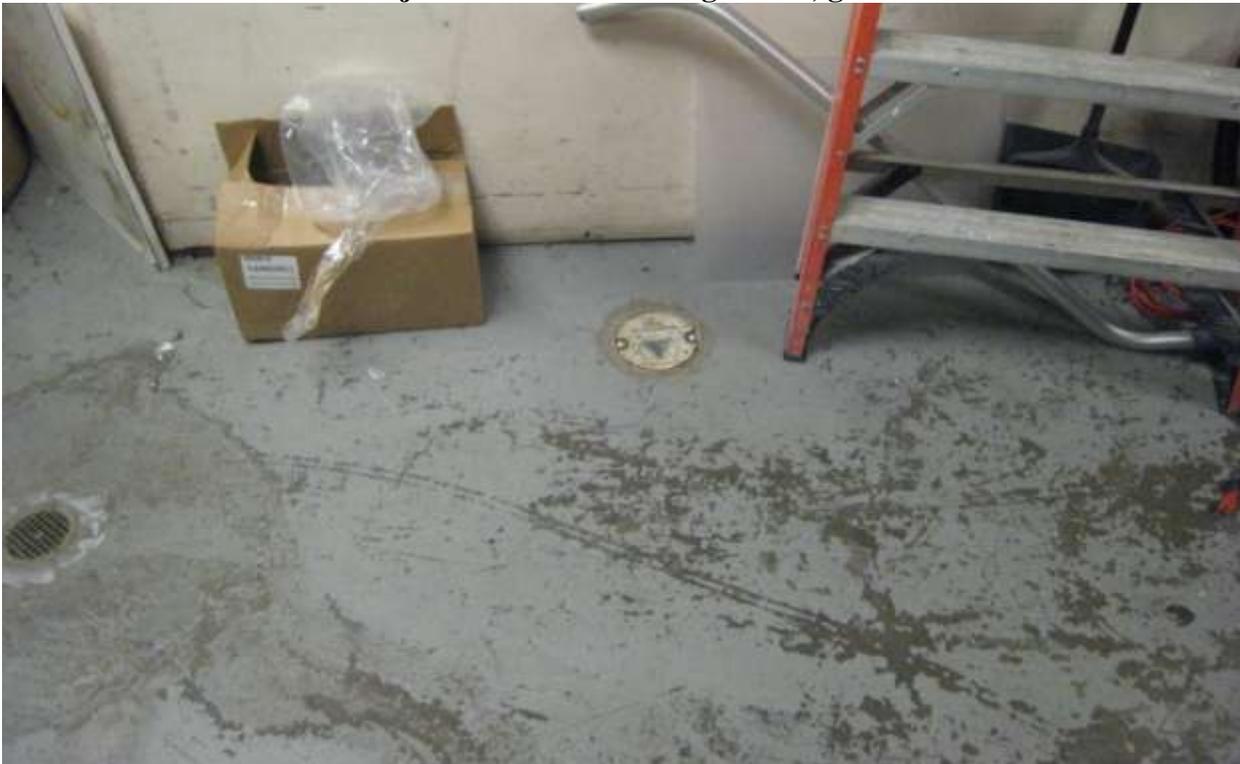
**Photo 4: Another well visible just outside bike storage room, ground floor**
