Third Five-Year Review Report for Distler Brickyard

West Point Hardin County, Kentucky

September 2008

Prepared By: E² Inc. Charlottesville, Virginia 2417 Northfield Road Charlottesville, VA 22901

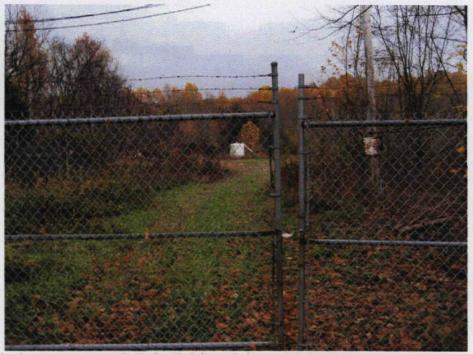
Locked entrance gate of Distler Brickyard site on Dixie Highway at mile marker 36.

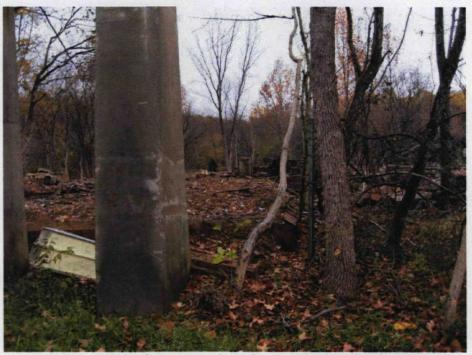
End of fence north of entrance where fence ends along Dixie Highway.

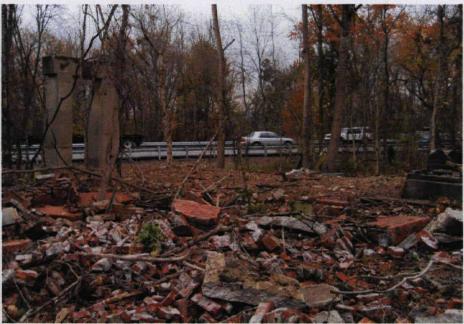
Debris, including bricks and concrete, from the brick kiln and warehouse demolition along Dixie Highway at the Distler Brickyard site.

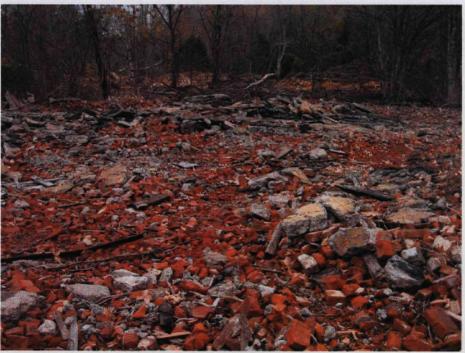
Remains of brick kiln demolitions.

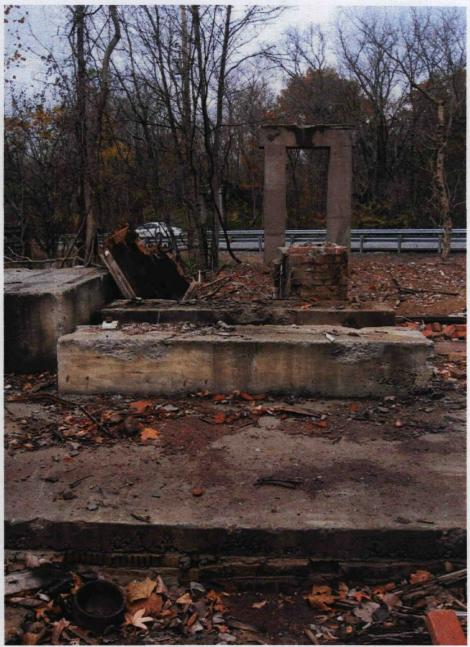
Remnants of warehouse foundation and bridge over Dixie Highway.

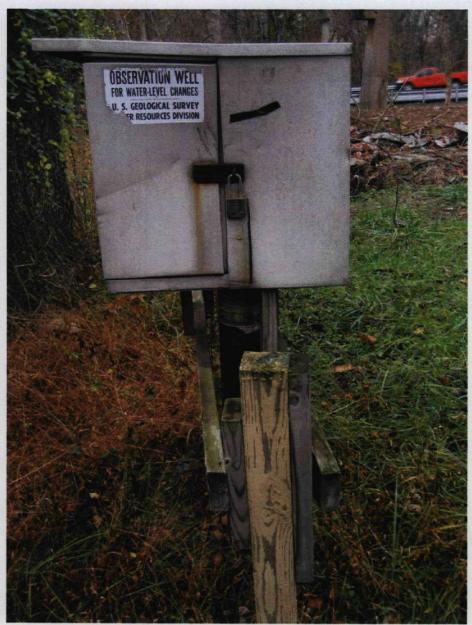
USGS observation well UDBP-7.

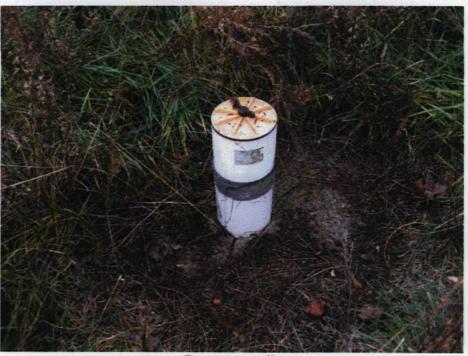
Recovery well.

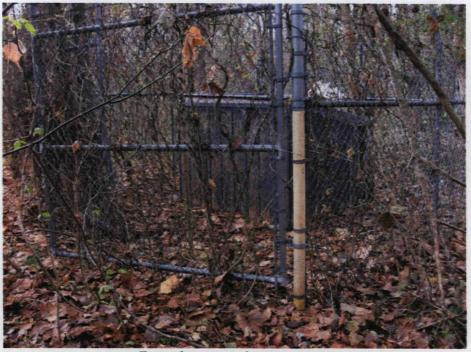
Fenced pump and treat system.

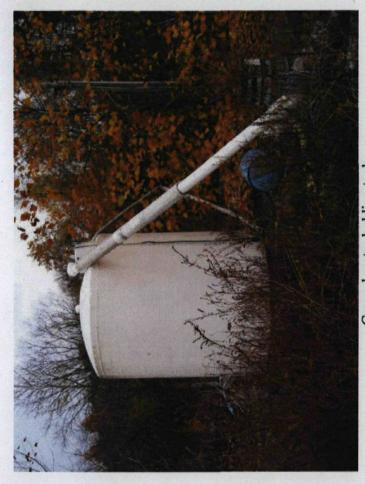
Ground water holding tank.

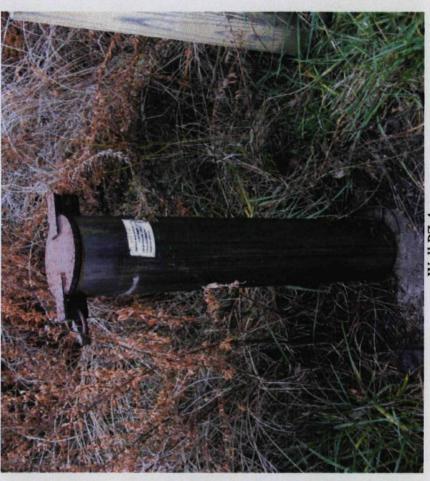
Well PZ-4.

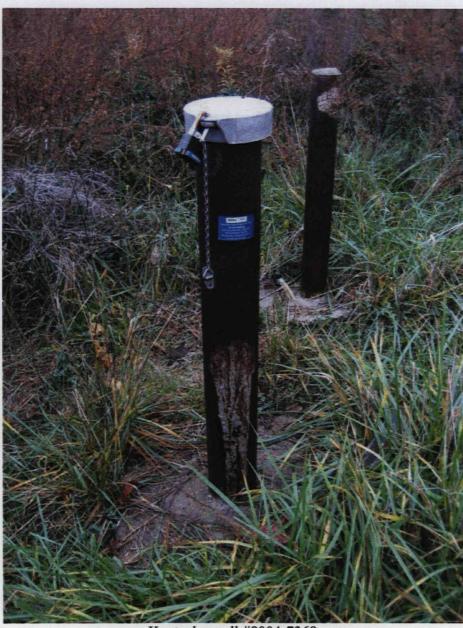
Kentucky well #8004-7368.

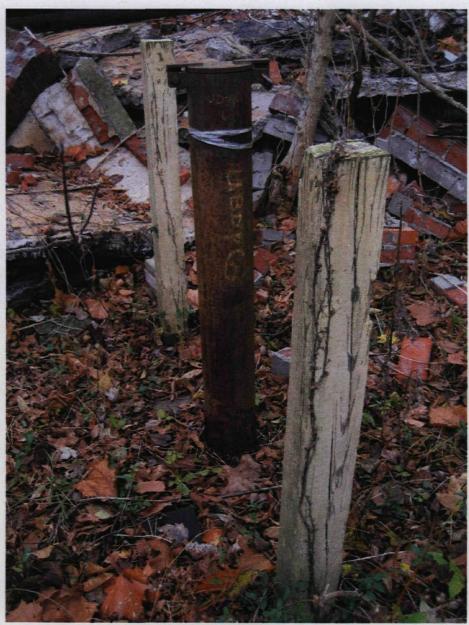
Well UDBP-6.

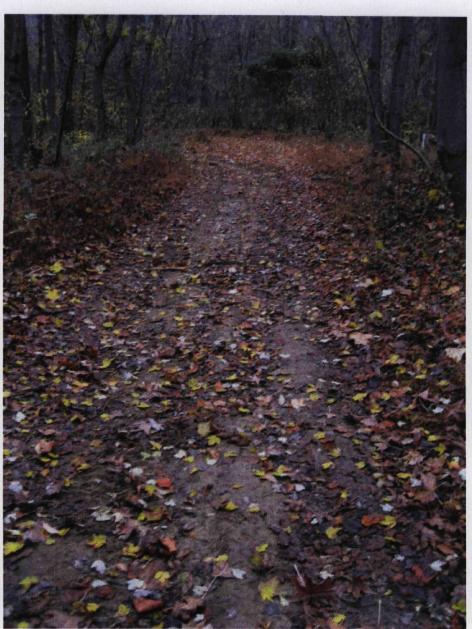
3. 01	ther Site Conditions	A aver from 1				
	Remarks: There is a path that vehicles are taking	through the s	ite, tracks	are clearly	<u>y visible.</u>	
	Roads damaged			ds adequat] N/A
4, Ro	oads 🛛 Applicable 🗌 N/A					
	VI. GENERAL SI	TE CONDI	TIONS		· ·	
	Remarks:

Dirt road running through site.
