**FIRST FIVE-YEAR REVIEW
FOR THE
MOUNTAIN PINE PRESSURE TREATING SUPERFUND SITE
PLAINVIEW, YELL COUNTY, TEXAS**

September 2010

FIRST FIVE-YEAR REVIEW REPORT
Mountain Pine Pressure Treating Superfund Site
EPA ID No. ARD049658628
Plainview, Yell County, Arkansas

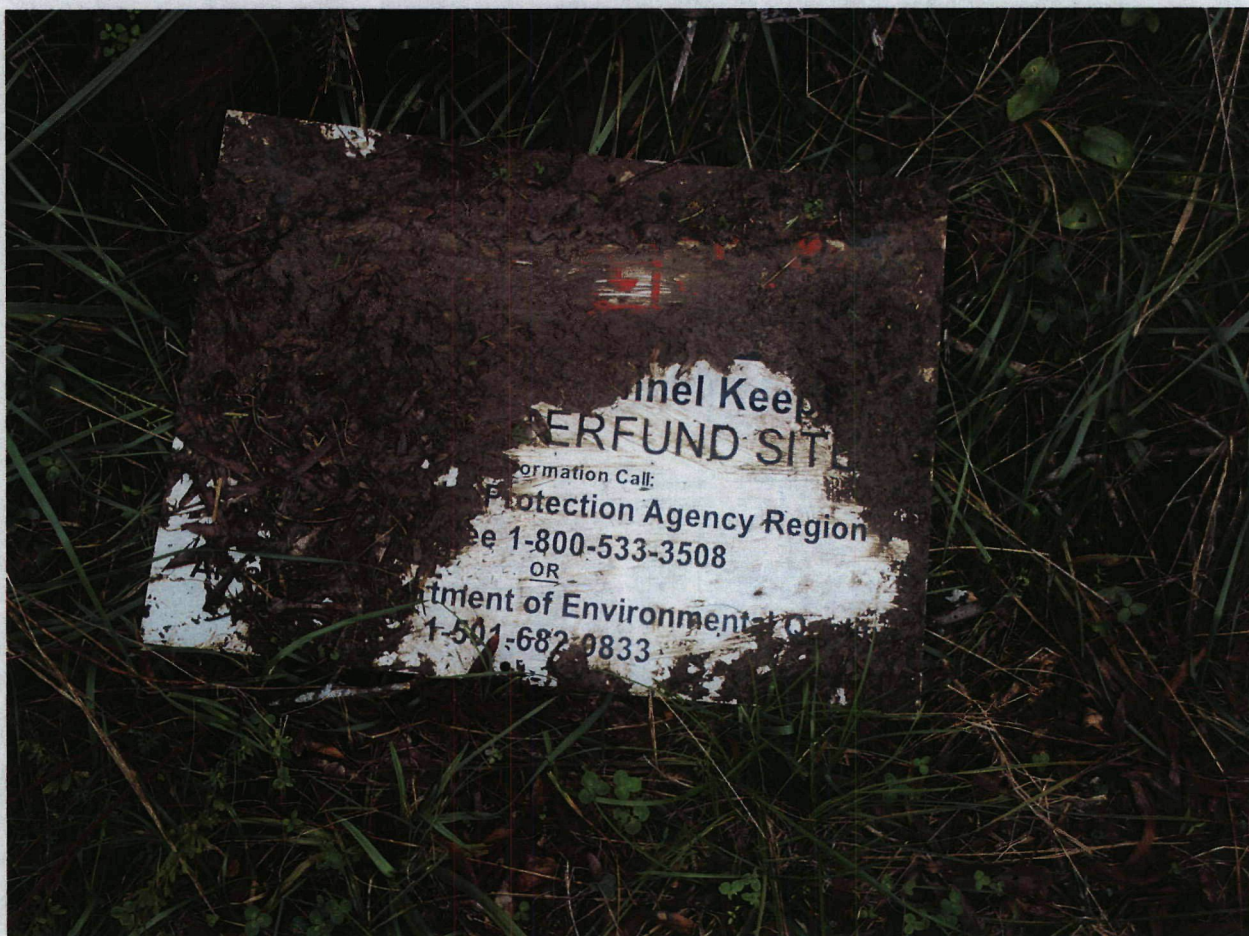
8.	There are no warning signs posted at the waste cell caps. The only warning signs observed at the waste cells caps during the site inspection were lying on the ground.	N	Potential Impact

Photo 13: Fallen warning sign.

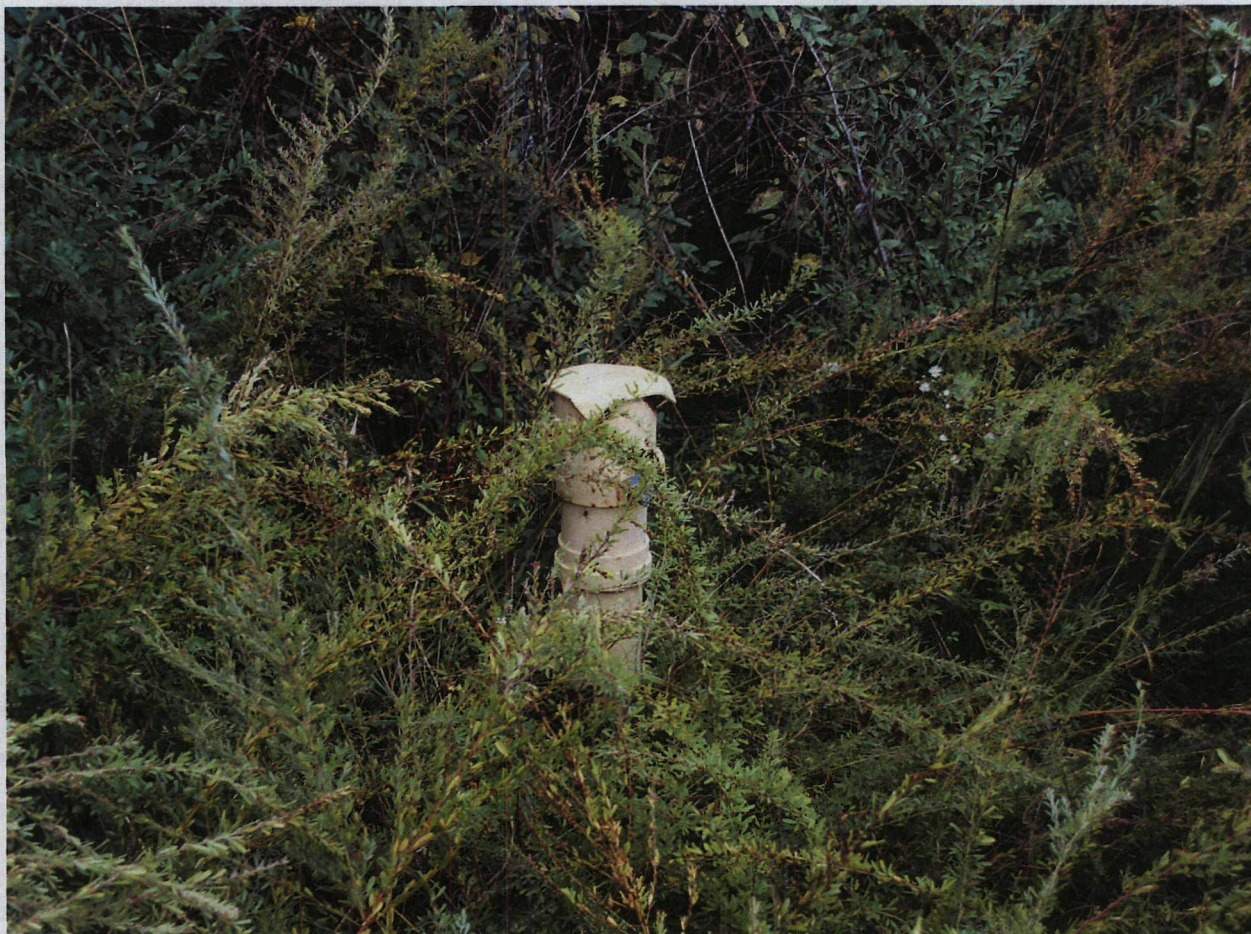
Photo 15: Well MW-29, overgrown.

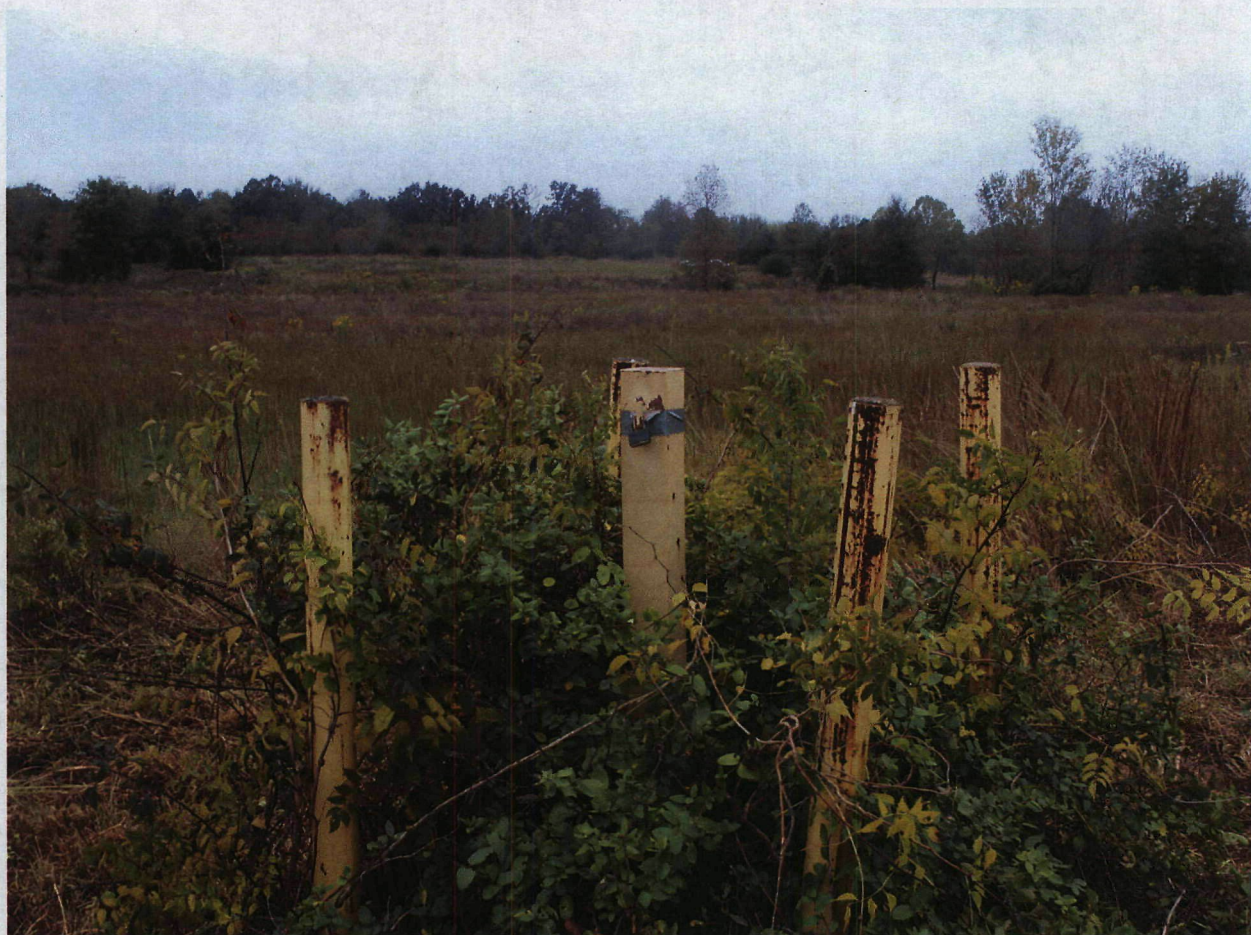
Photo 17: Well MW-109, overgrown.

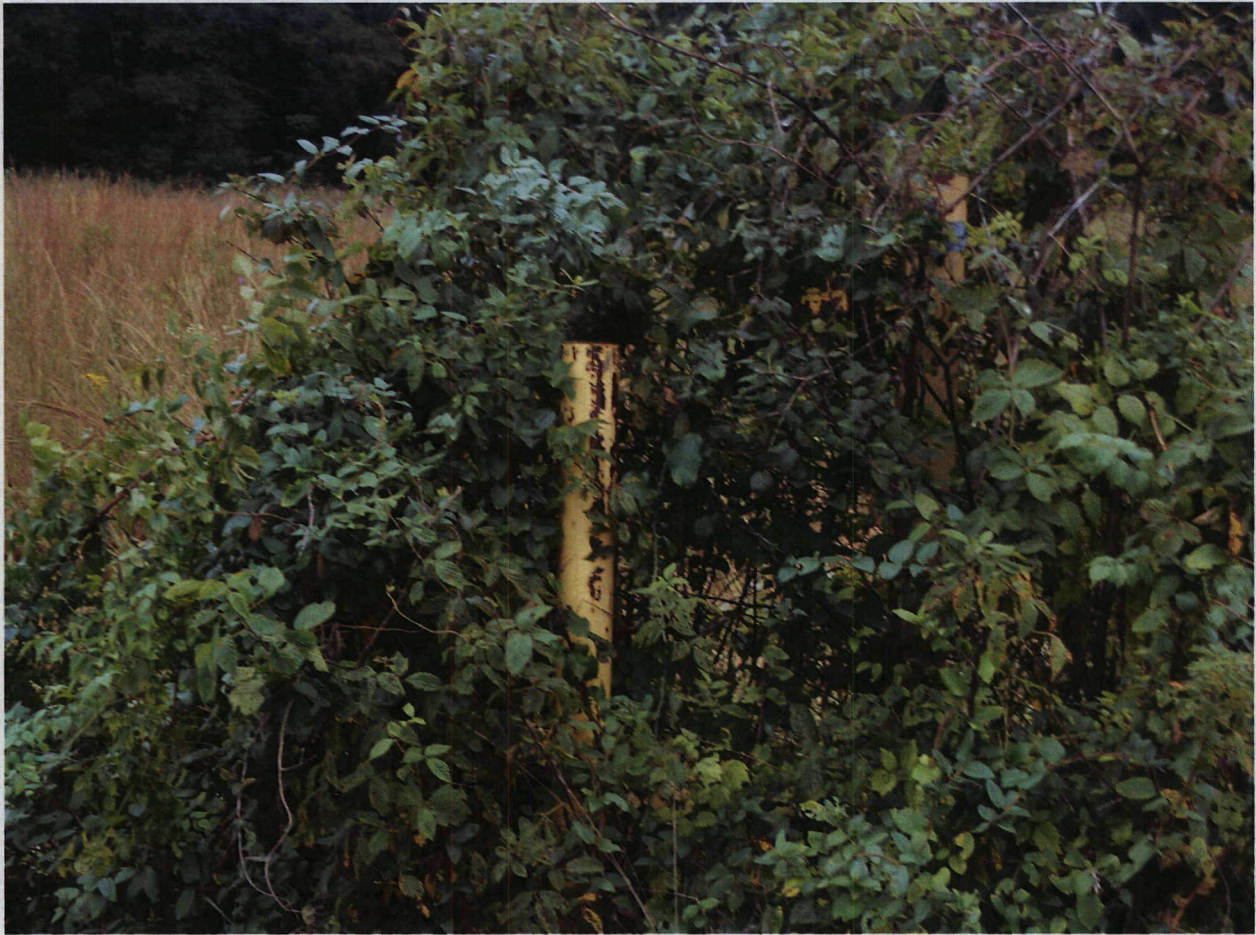
Photo 18: Well MW-108, overgrown.

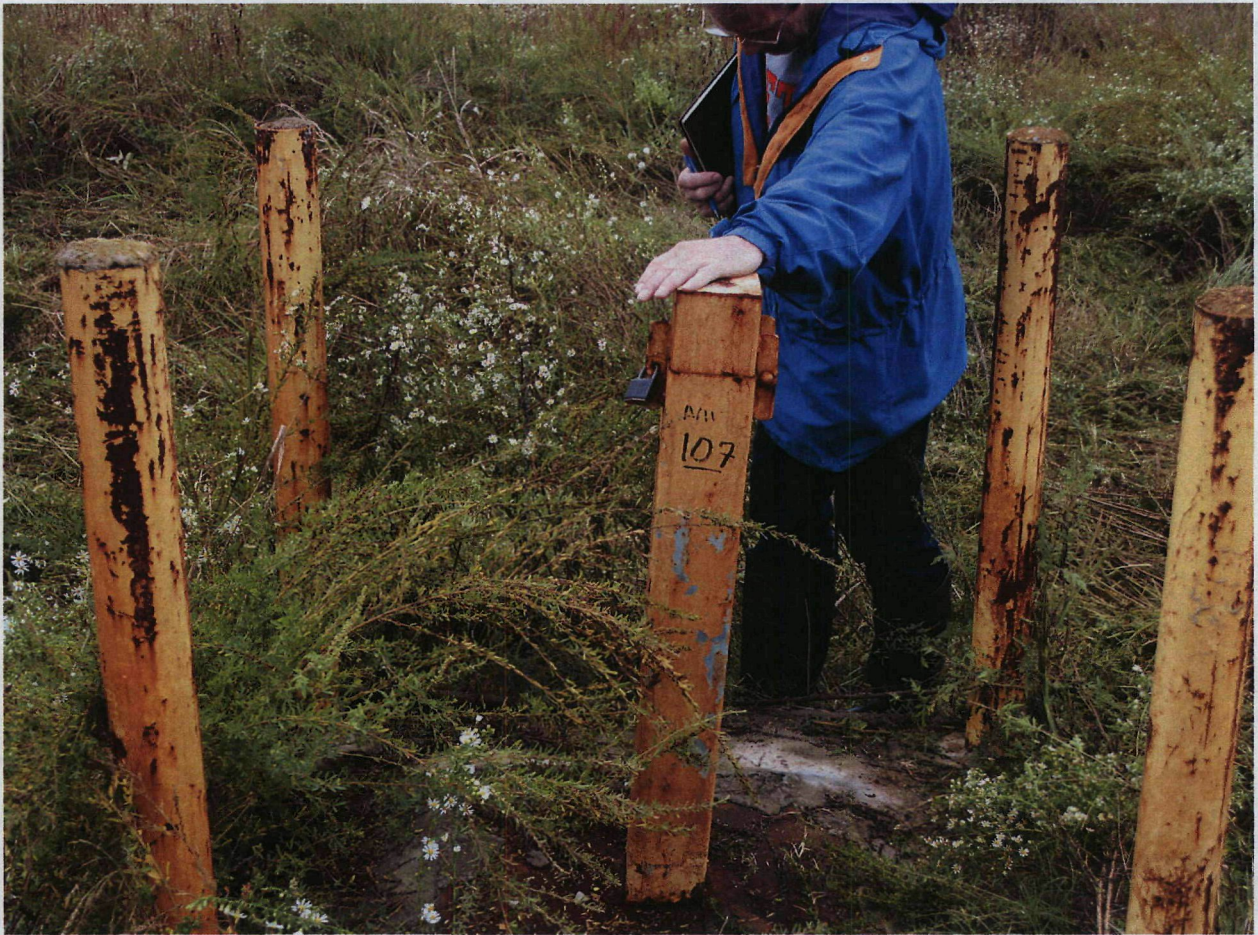
Photo 20: Well MW-107.

No.	Recommendations/Follow-up Actions	Party Responsible	Oversite Agency	Follow-up Actions: Affects Protectiveness (Y/N)	
				Current	Future
6.	Consider installing additional monitoring wells down-gradient of monitoring wells MW-107 and MW-119; and evaluate the extent and off-site migration potential of groundwater contamination. Although the City of Plainview owns the portion of the site remediated during the RA and groundwater is not being used at that portion of the site, there is a potential for off-site migration and well contamination.	EPA	EPA	N	Potential Impact

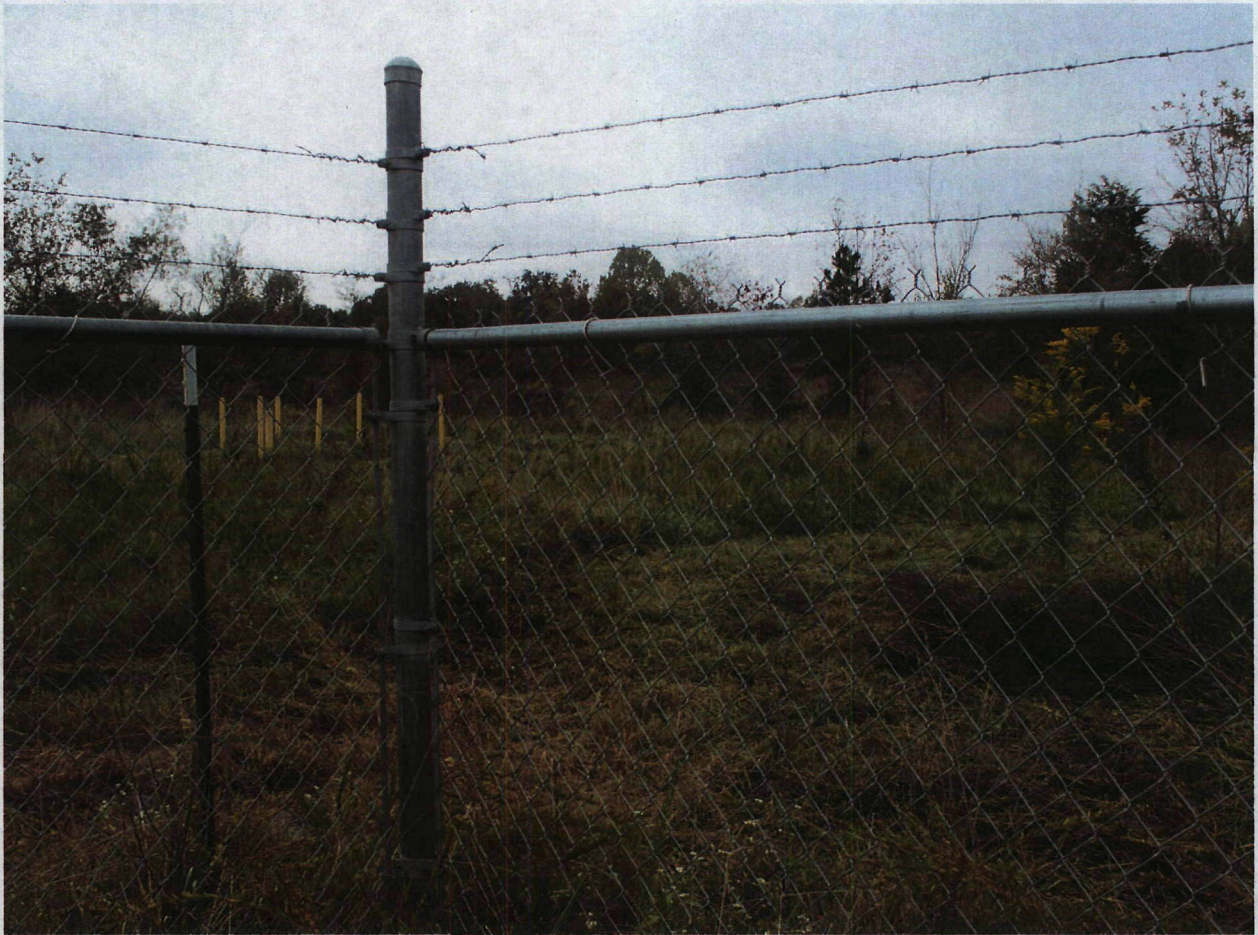
Photo 25: Gap in the fence line at the corner of the Prospect Steel lot. The gap is between the new chain link fence and the older barbed wire fence.

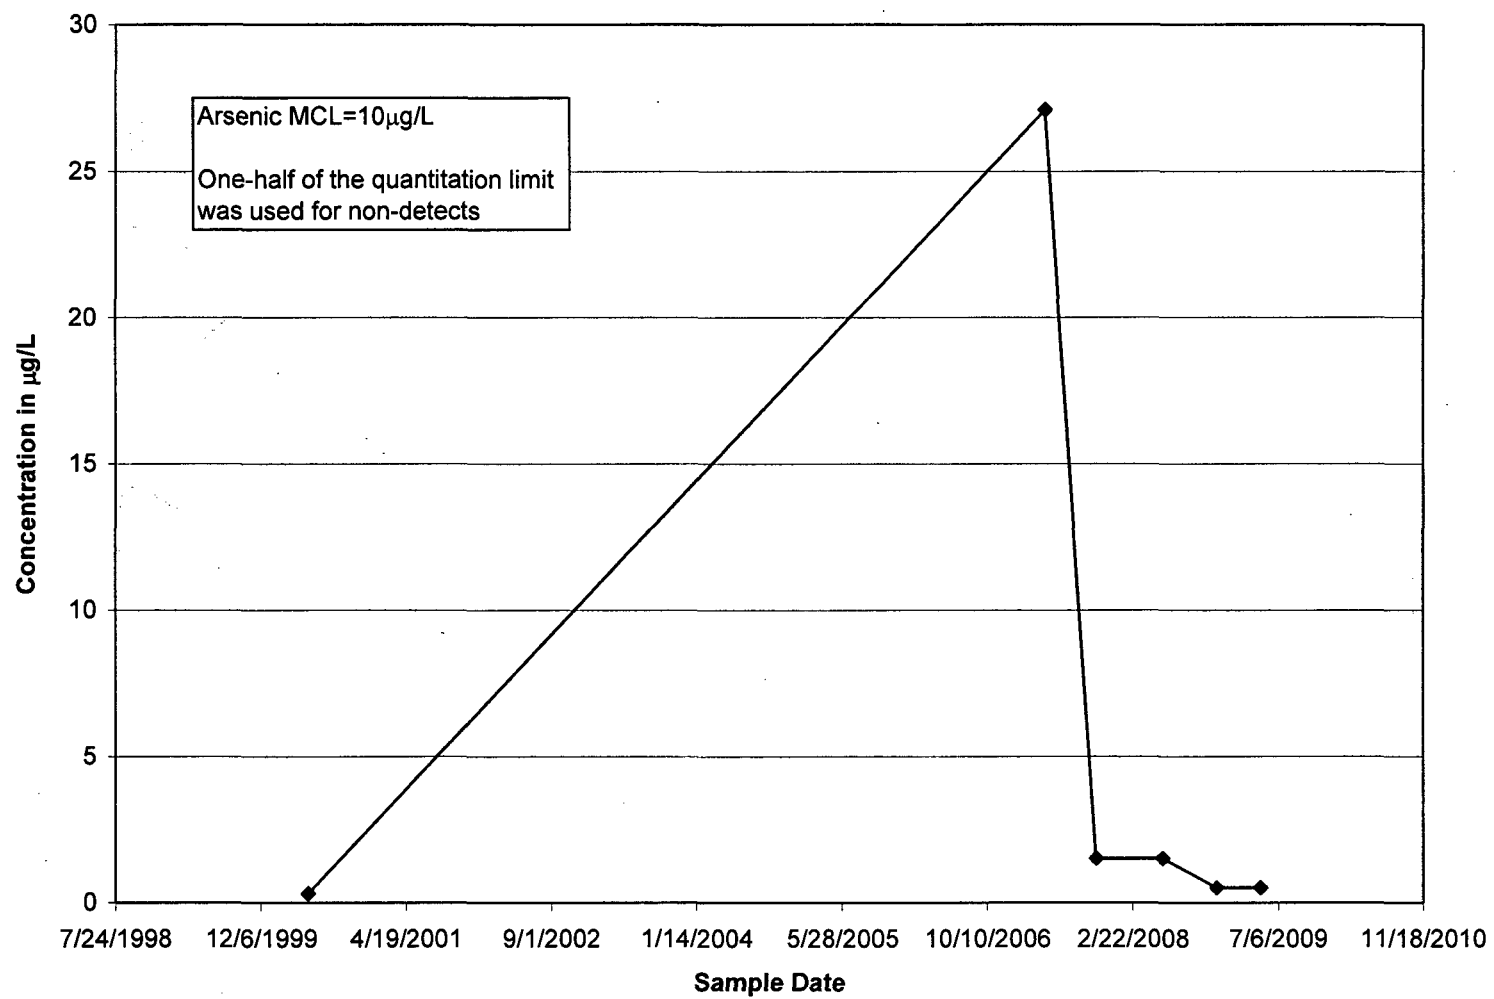
Attachment 5-7
Monitoring Wells in LWBZ With Arsenic Concentrations Above MCL Post Remedial Action

Groundwater contaminant levels of arsenic and PCP in the LWBZ have increased to levels above drinking water MCLs since the completion of the RA. The ARARs, compliance monitoring standards, HHRA, and site remedial goals should all be re-evaluated to address the current site conditions.

3.	Consider review of the HHRA at the site using current site groundwater conditions. The higher post-RA concentrations of arsenic and PCP in the LWBZ may result in a higher risk associated with potential groundwater use at the site than that presented in the ROD, which may require a modification of the remedial goals at the site.	EPA	EPA	N	Potential Impact
