# **An Environmental Cold Case Detective Story: Discovery and Repair of the Soil Cover on the Cell 3 Landfill**

# Ft Meade (FGGM) and the Closed Sanitary Landfill (CSL), which Contains Cell 3

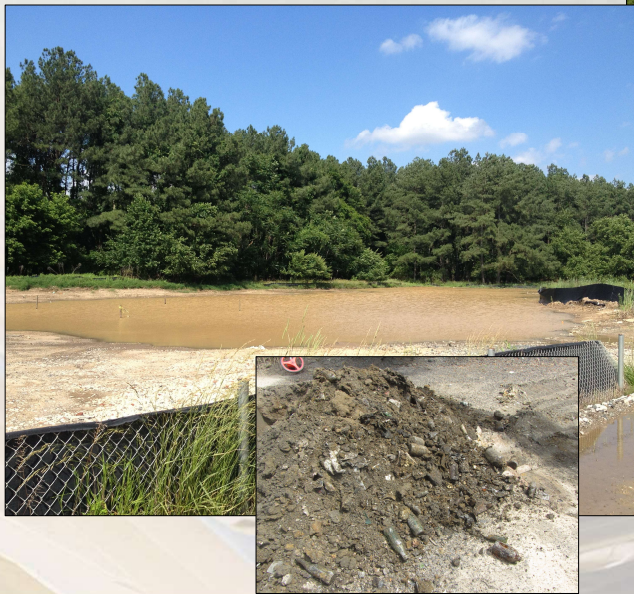
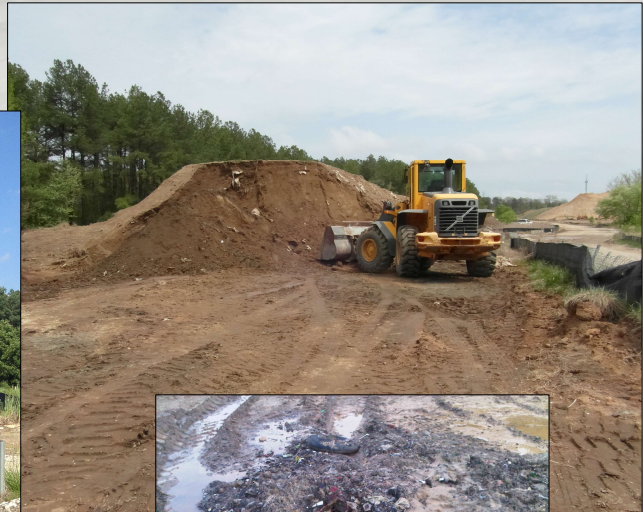
### Crime Scene Photos; June 2013

- Stockpiled waste soils were removed, creating a depression.
- The underlying 2-ft soil cover was also removed, revealing buried waste.
- Catalyst for inclusion of Cell 3 in the Installation Restoration Program (IRP).

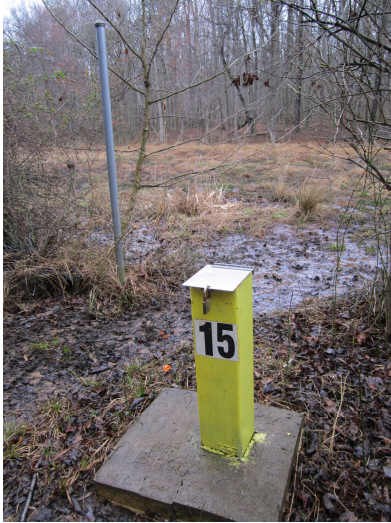
Typical Monitoring Well

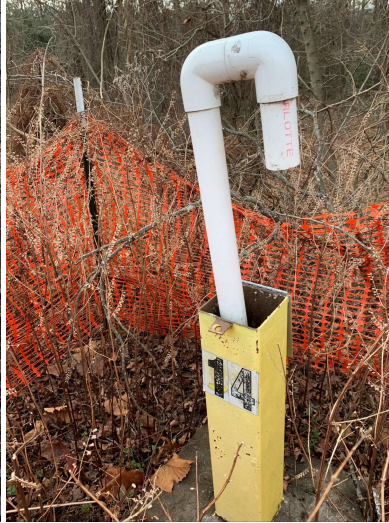
Typical Methane Monitoring Point

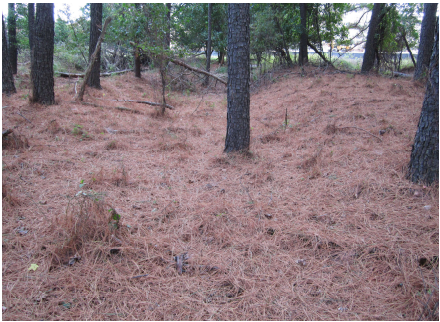
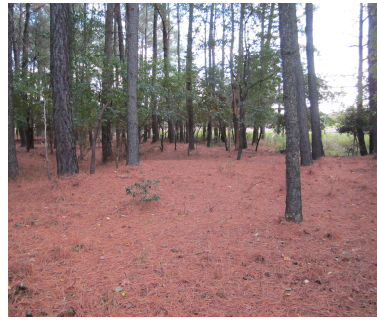
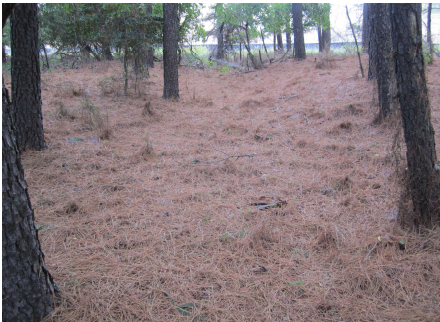
Hummocky landscape in wooded area.

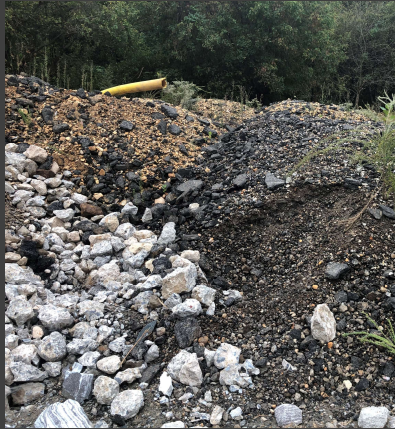
There were piles of construction debris in the western portion of Cell 3

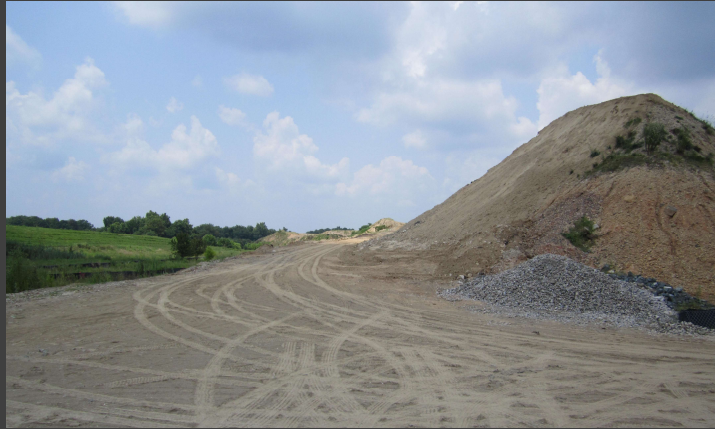
and soil stockpiles in the eastern portion of Cell 3

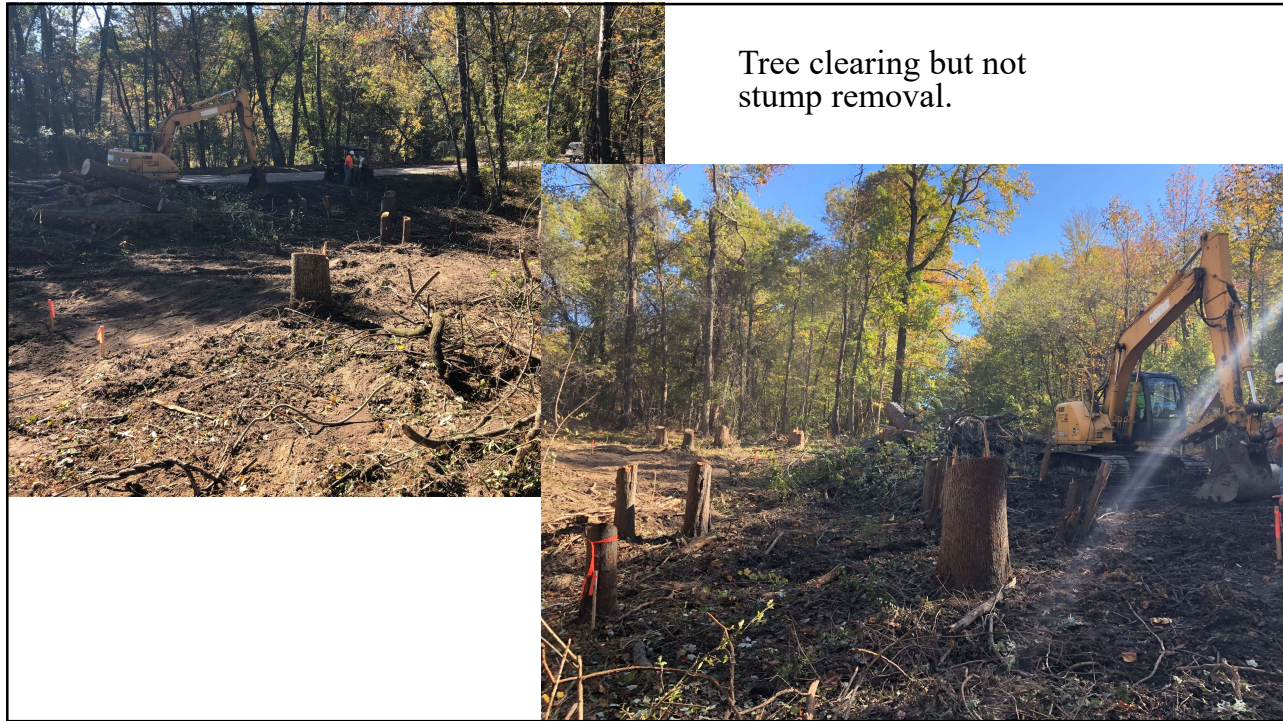
Tree clearing but not  
stump removal.

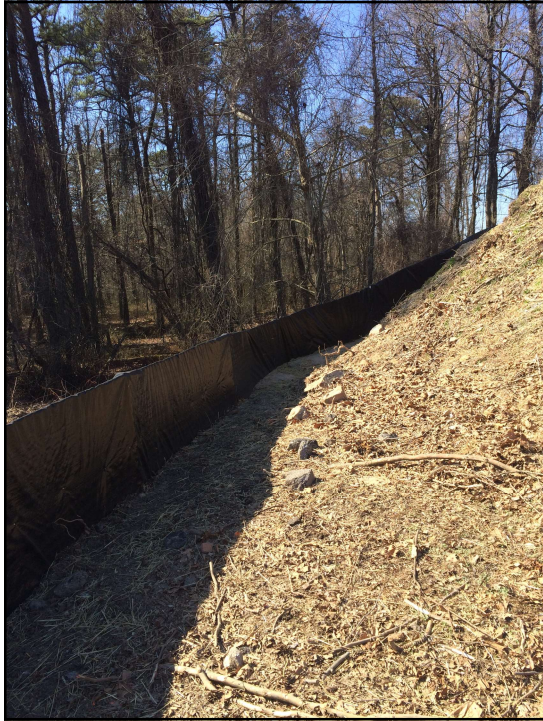
Protecting trees and installed super silt fence

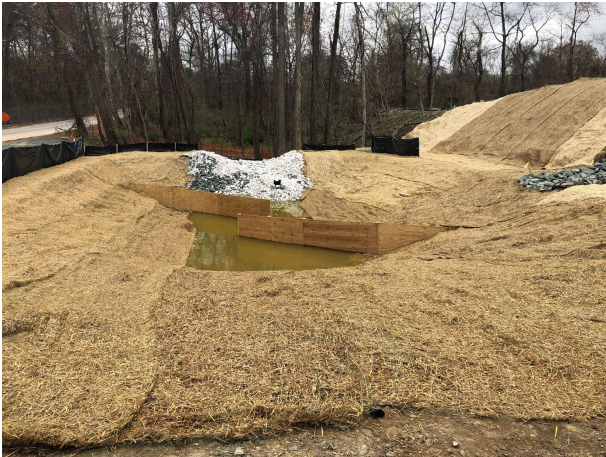
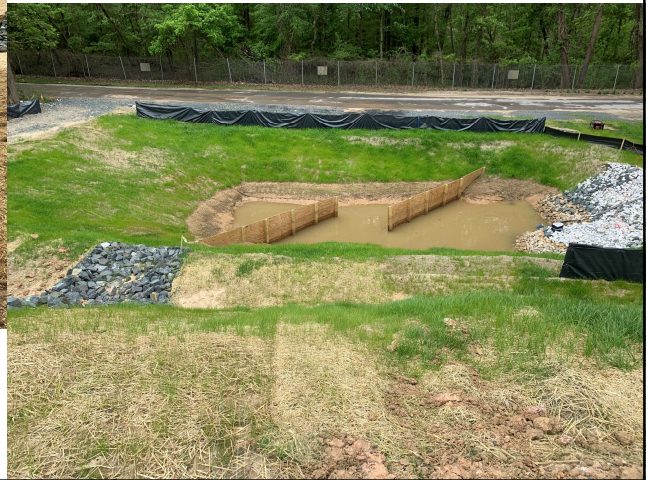
### Sediment Trap # 1 After Construction and After Grass Growth

Letdown # 1 is the grey gravel on the left side of this picture.

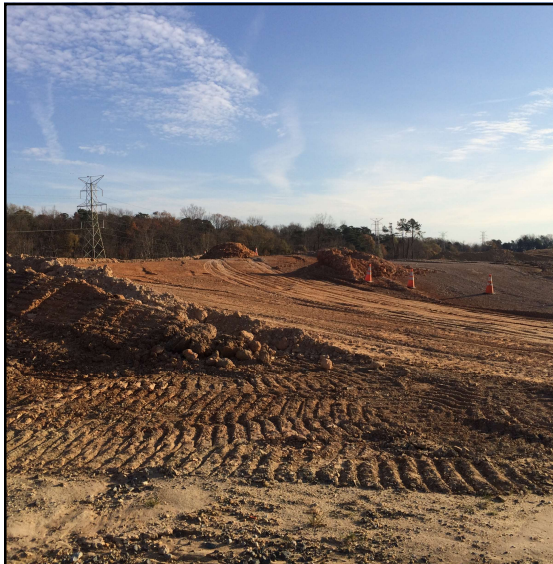
Moving soil and building up the existing berm

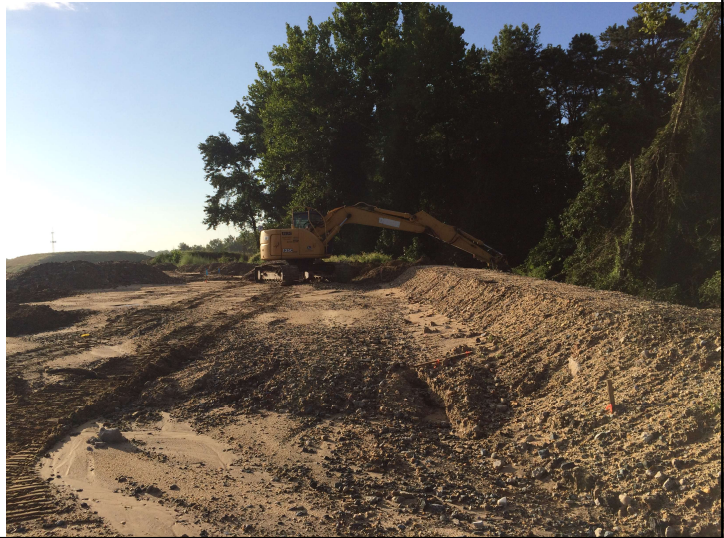
Modified 1,535' of existing berm and constructed 235' of new berm along the edges of the cover.

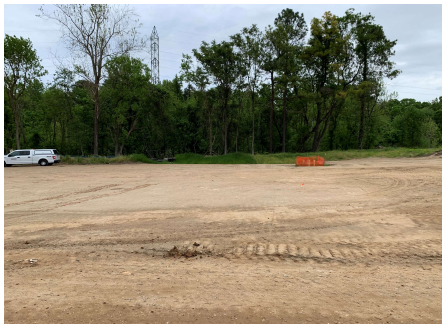
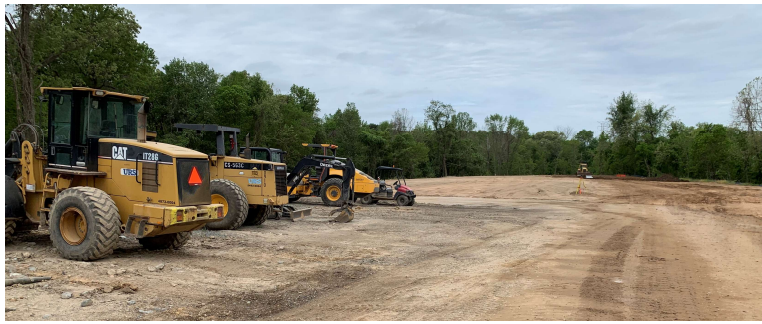
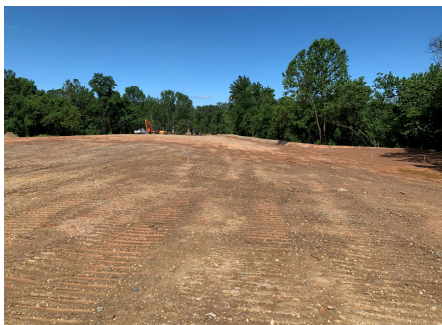
Obtaining a 4% slope.  
27,214 yds<sup>3</sup> of soil was used for landfill repair/upgrade

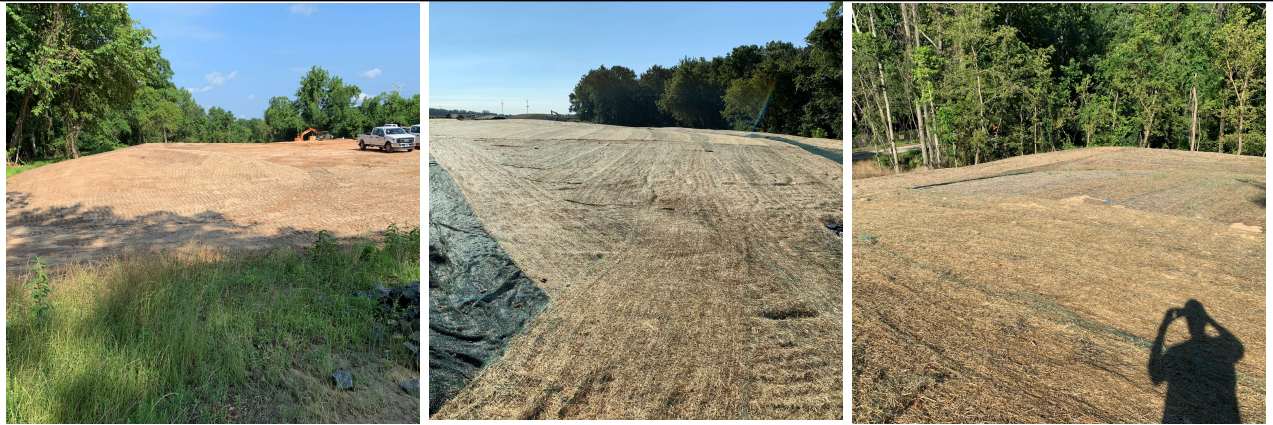
Progress on cover repair

Installed 26,550 ft<sup>2</sup> of erosion control matting to keep the soil in place until the grass could be established.

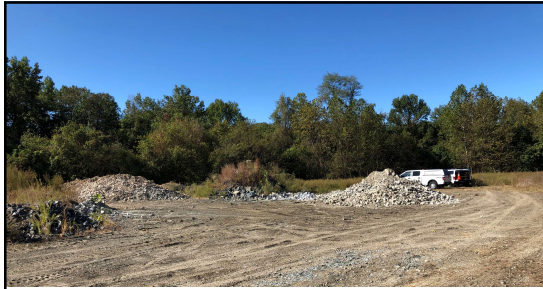
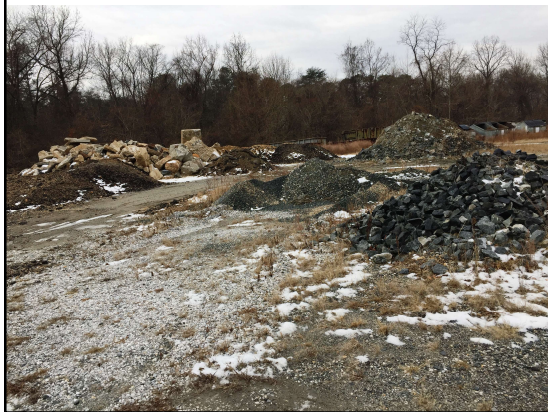
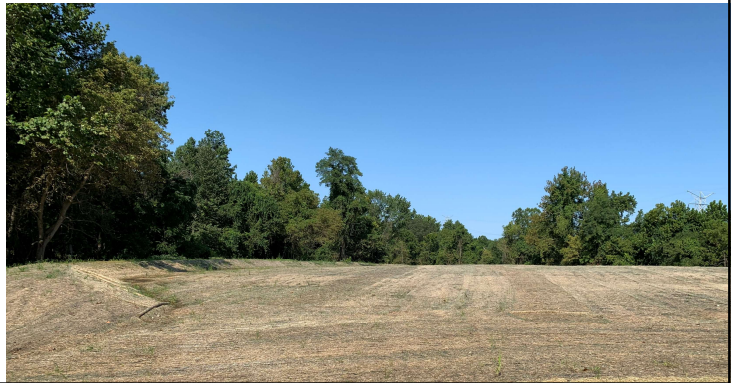
Before pictures of asphalt and concrete debris piles and picture after debris removed. 1,500 yds<sup>3</sup> of crushed concrete and asphalt was used as base material.
