# NORTH RIDGE ESTATES SUPERFUND SITE

REMEDIAL  
ACTION

KLAMATH FALLS, OR

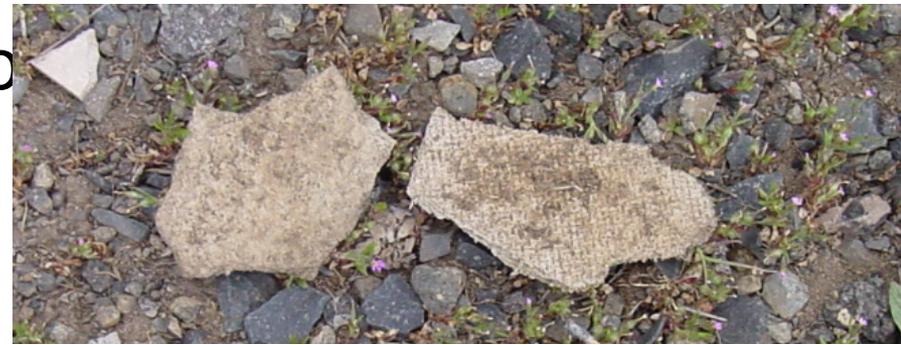
- Improper building demolition during residential development
- Asbestos containing materials (ACM) debris
  - Burial pits/waste piles
  - Surface/sub-surface disposal
  - Steam pipe insulation
  - Friable and non-friable

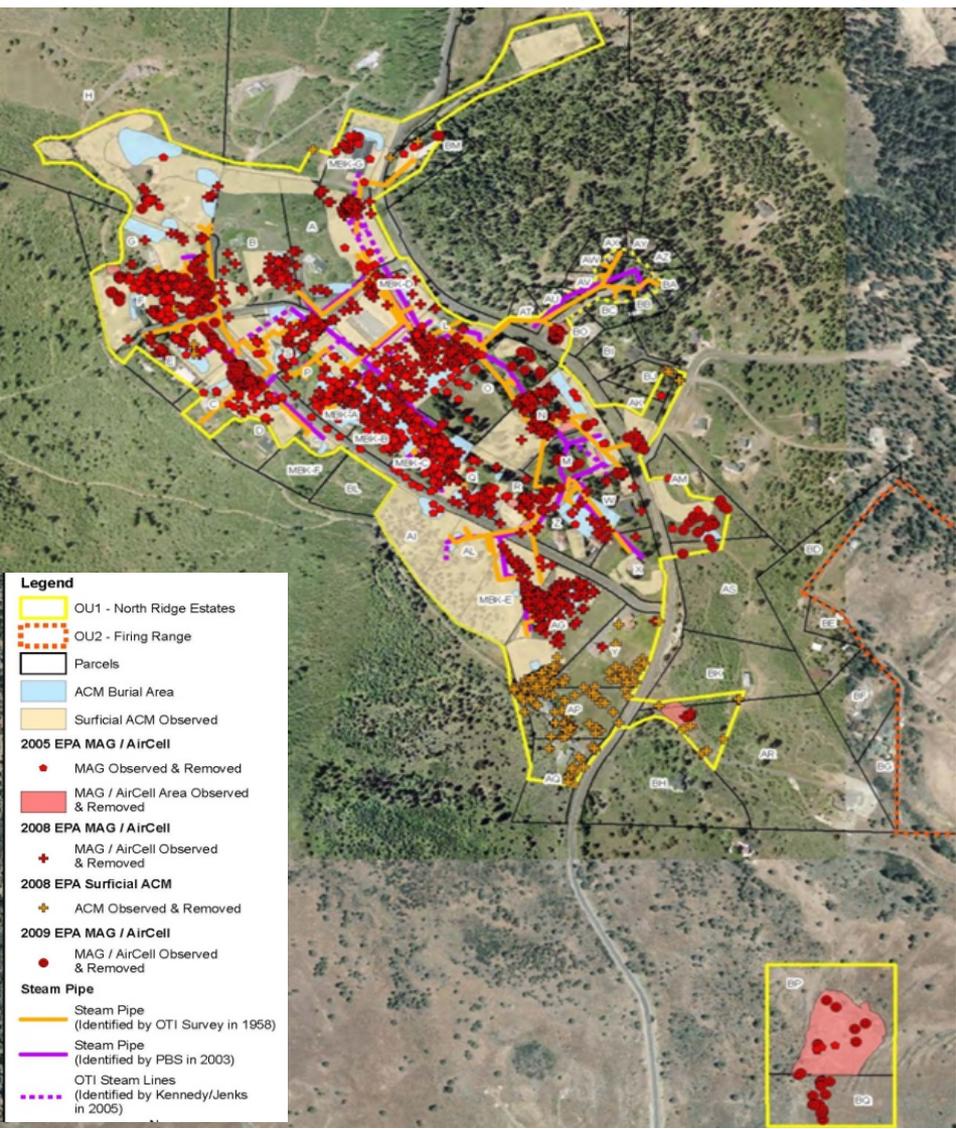
- Investigations estimated over 320,000 cubic yards contaminated soil; final number to be closer to 350,000 cubic yards
- Contamination can cover football field 150 ft. high
- Most places the debris is 2– 4 feet deep, but can be up to 12 feet deep

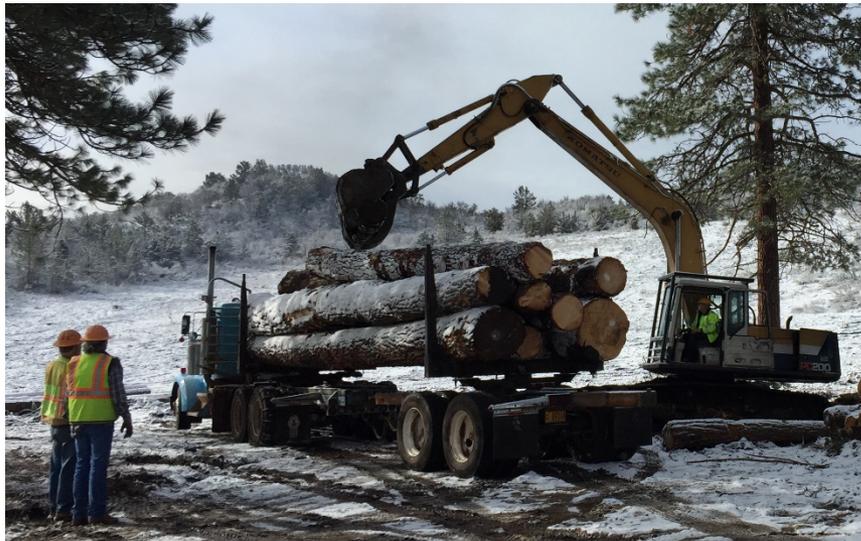
- Chipped trees reused at local bio-mass energy plant
- Large trees reused for lumber
- Scrap metal recycled
- Crushed concrete reused
- Reused existing buildings for offices and staff housing
- Reused existing storm piping when possible

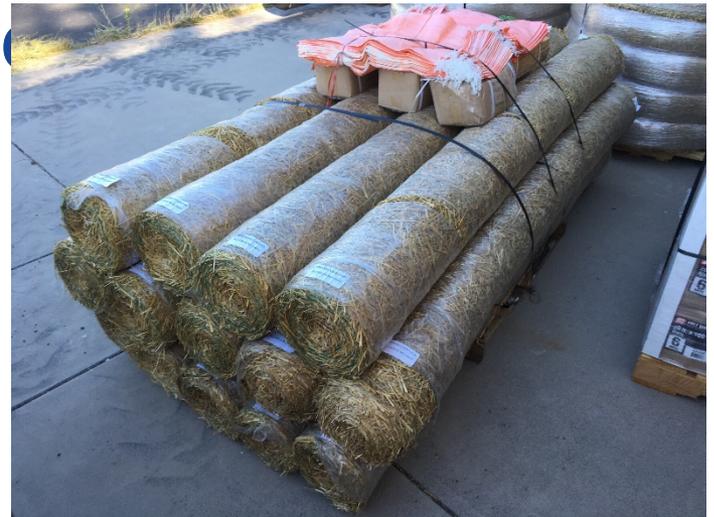
- Local sources of backfill (ODOT borrow pit)
- Revegetate quickly (end of each season)
- Native, drought resistant plant cover specified.
- Biodegradable, recycled sawdust waddles

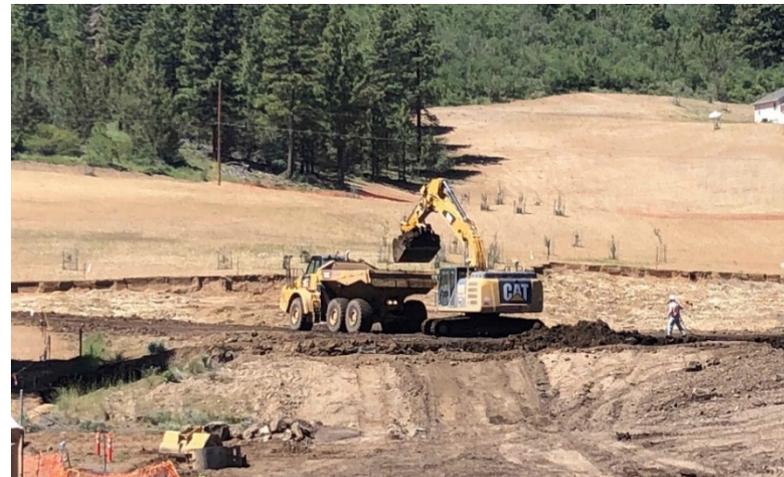
- All engines must meet at least EPA Tier 2 non-road emission standards
- Specifications Requirements
  - Meet Tier 4 (2008 or newer)
- OR
- Retro-fit for 85% reduction in particulate matter (PM) emissions
- Season 1:  $\geq 25\%$  of equipment
- Seasons 2 and 3:  $\geq 50\%$  of equipment

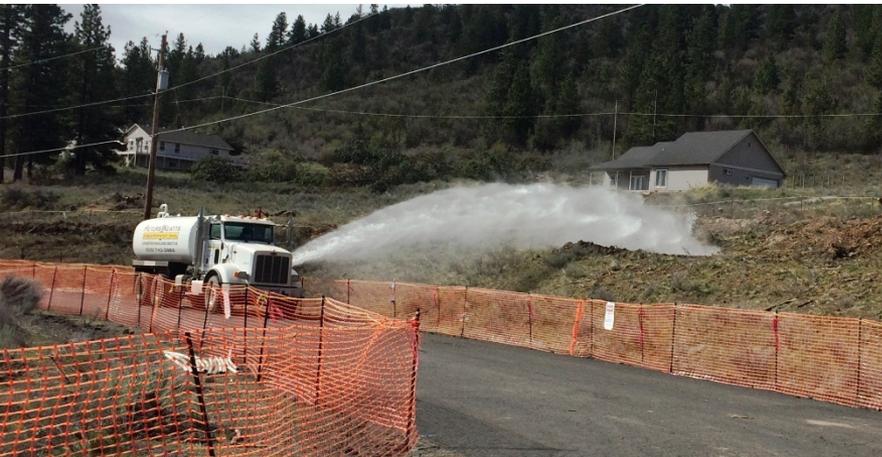
- At least 90% of diesel on-road vehicles :
  - Engines that meet EPA 2007 on-road emissions standards
  - OR
  - Emission control technology to reduce PM emissions by at least 85%
- Idling reduction plan for all diesel vehicles
