Example of Contaminated Groundwater Discharge to a Marine Waterway

Groundwater and Surface Water
Interaction Seminar
Seattle, WA November 16, 2018

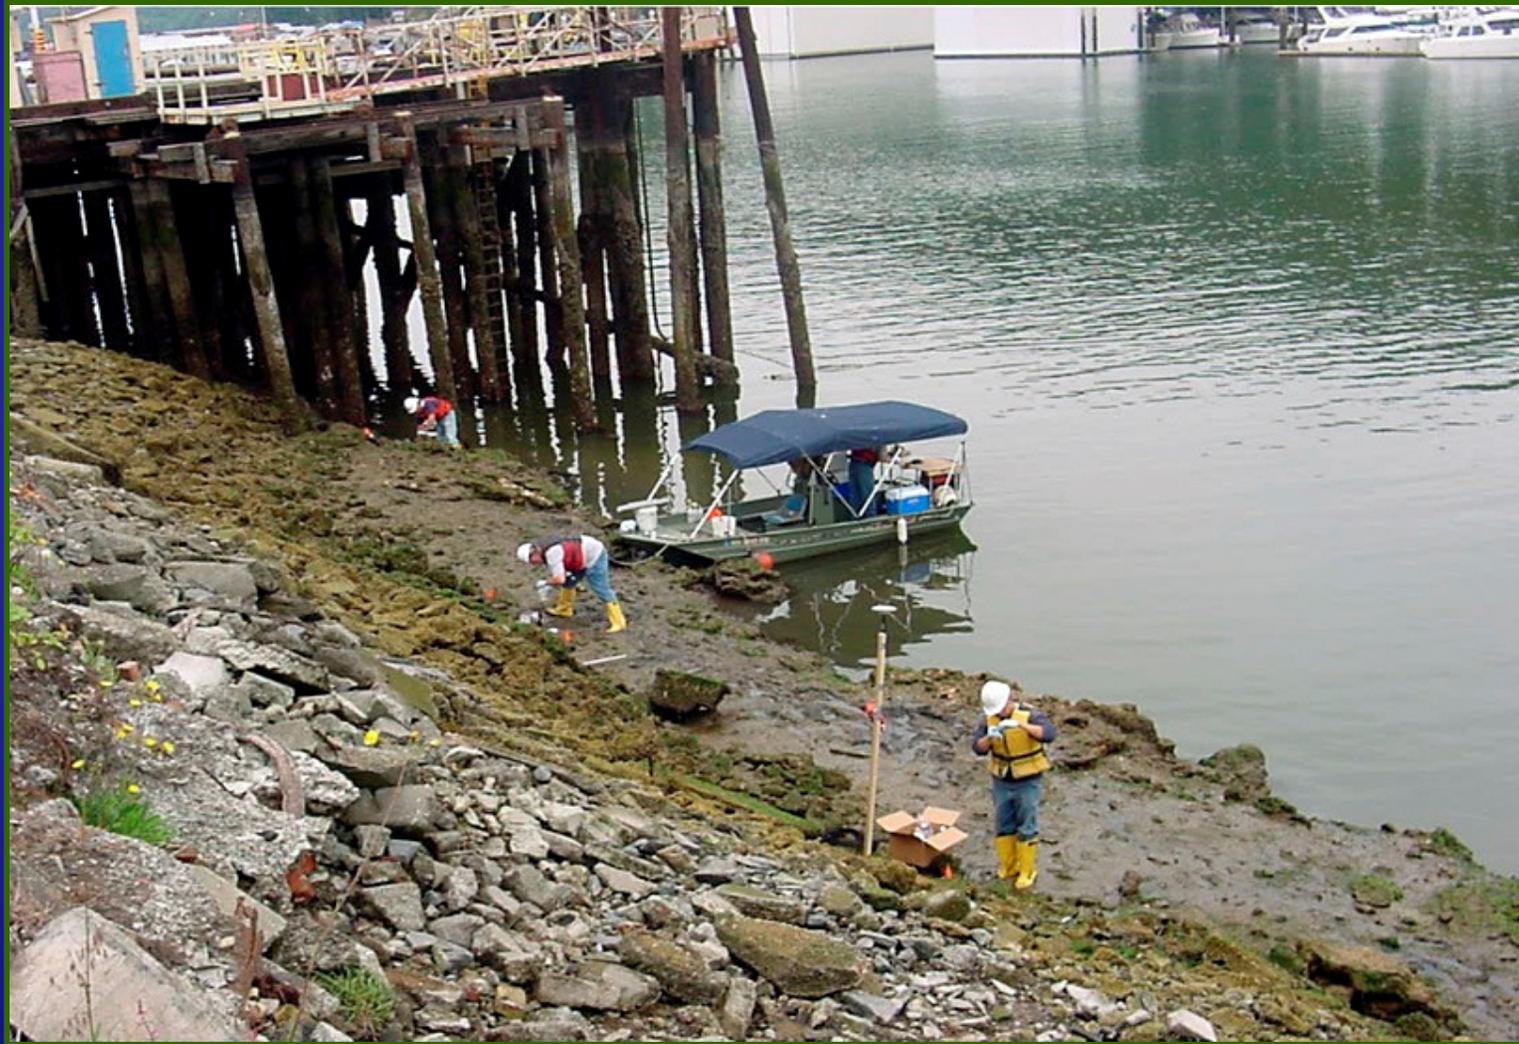
Low Tide Seep Sampling

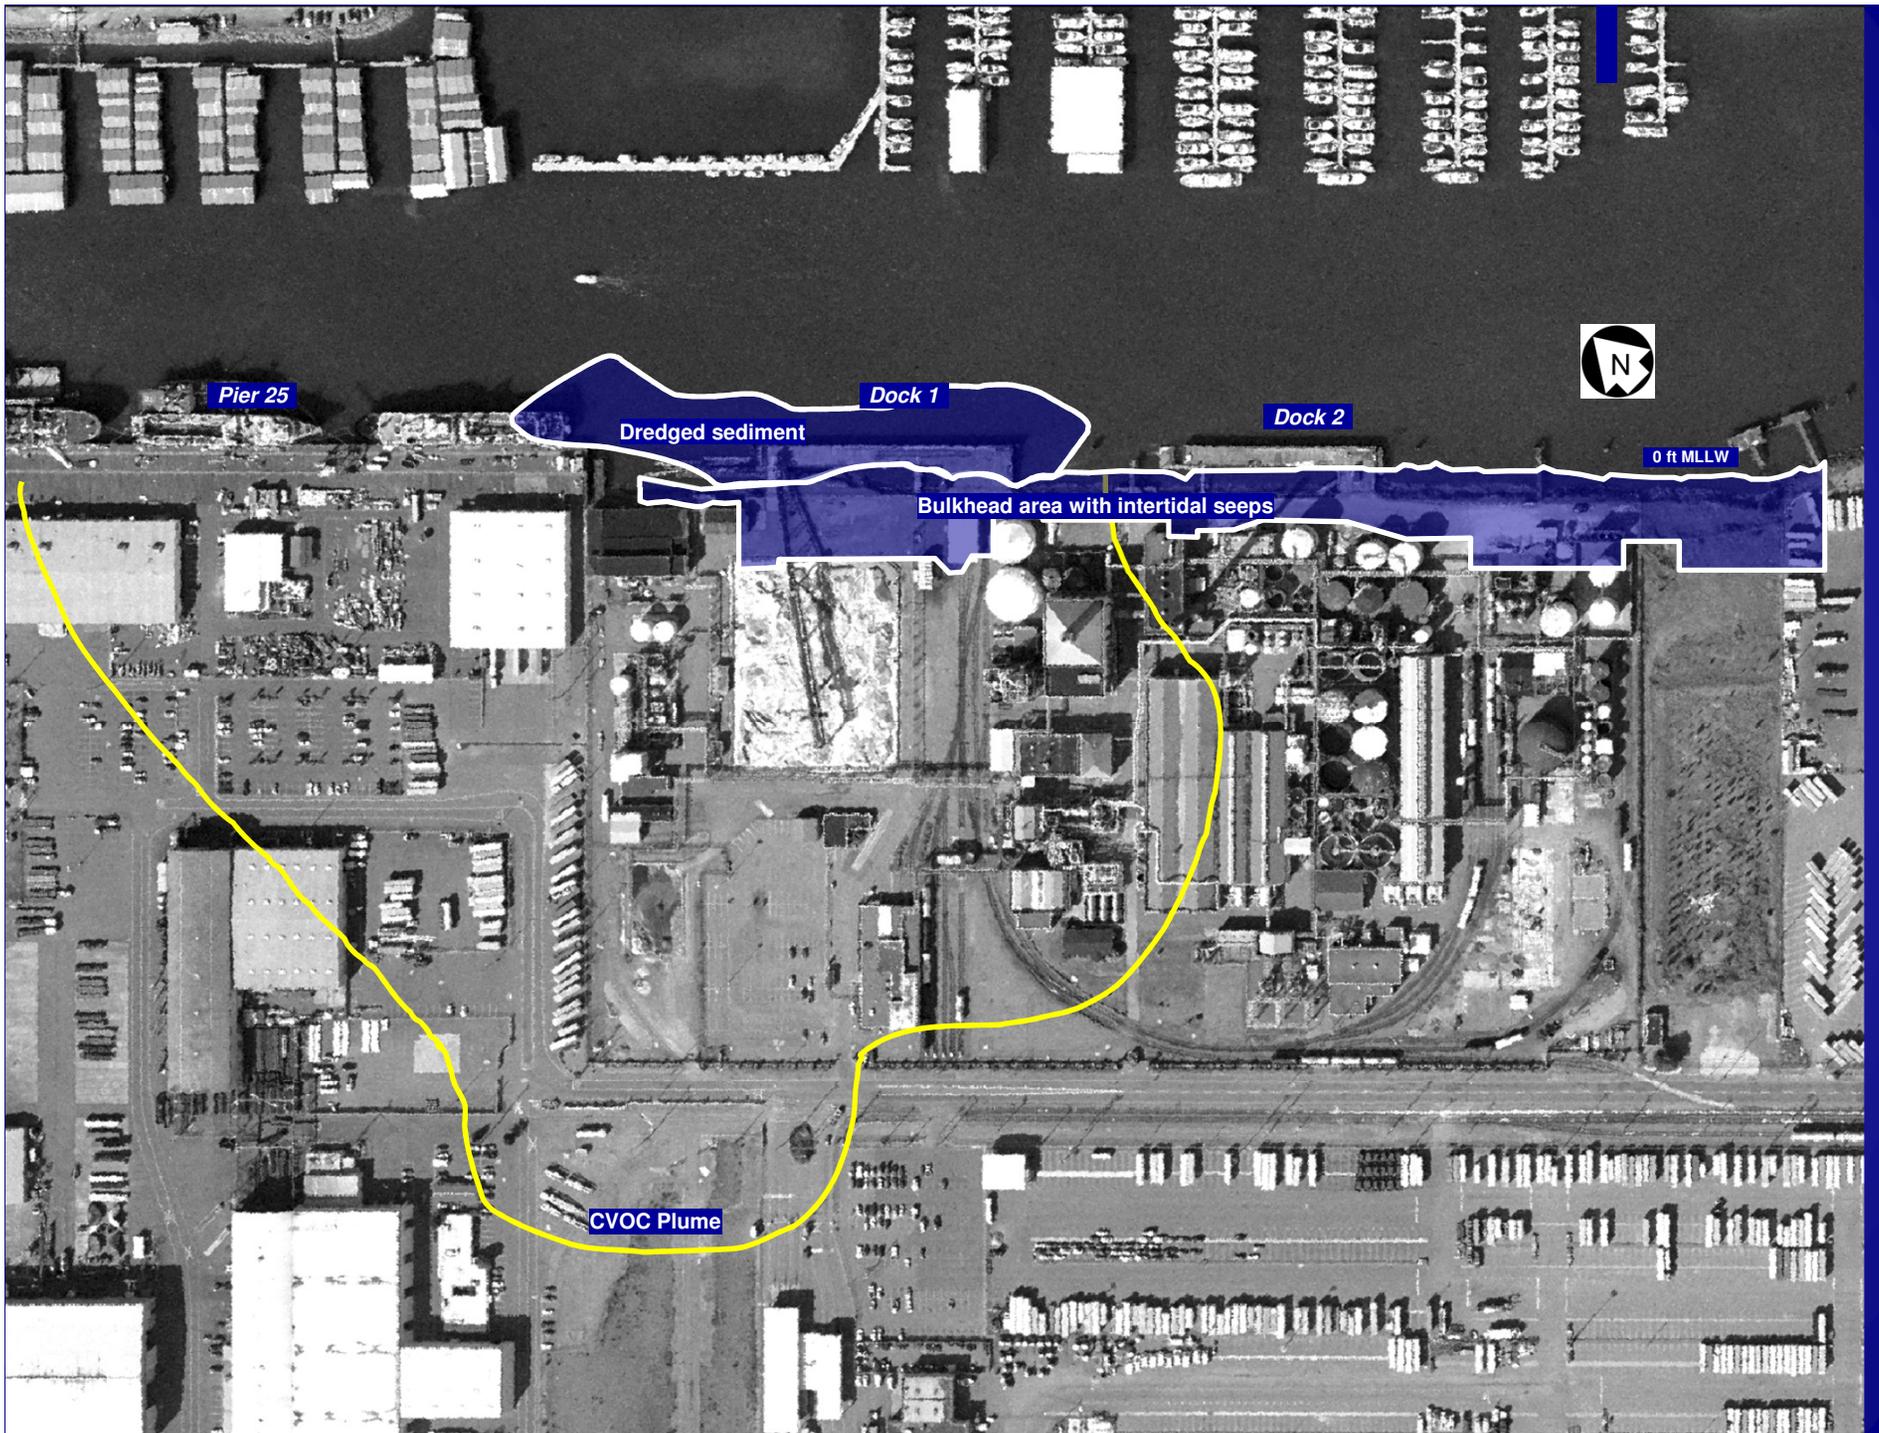
Bulkhead area with intertidal seeps

CVOC Plume

Pump and treat extraction system for VOCs in operation since 1997
