Mississippi Phosphates Corporation

Mississippi Phosphates Corporation
Bayou Casotte / Gulf of Mexico
Pascagoula, Mississippi

Step 2: Facility Tour and Findings – Berm Erosion

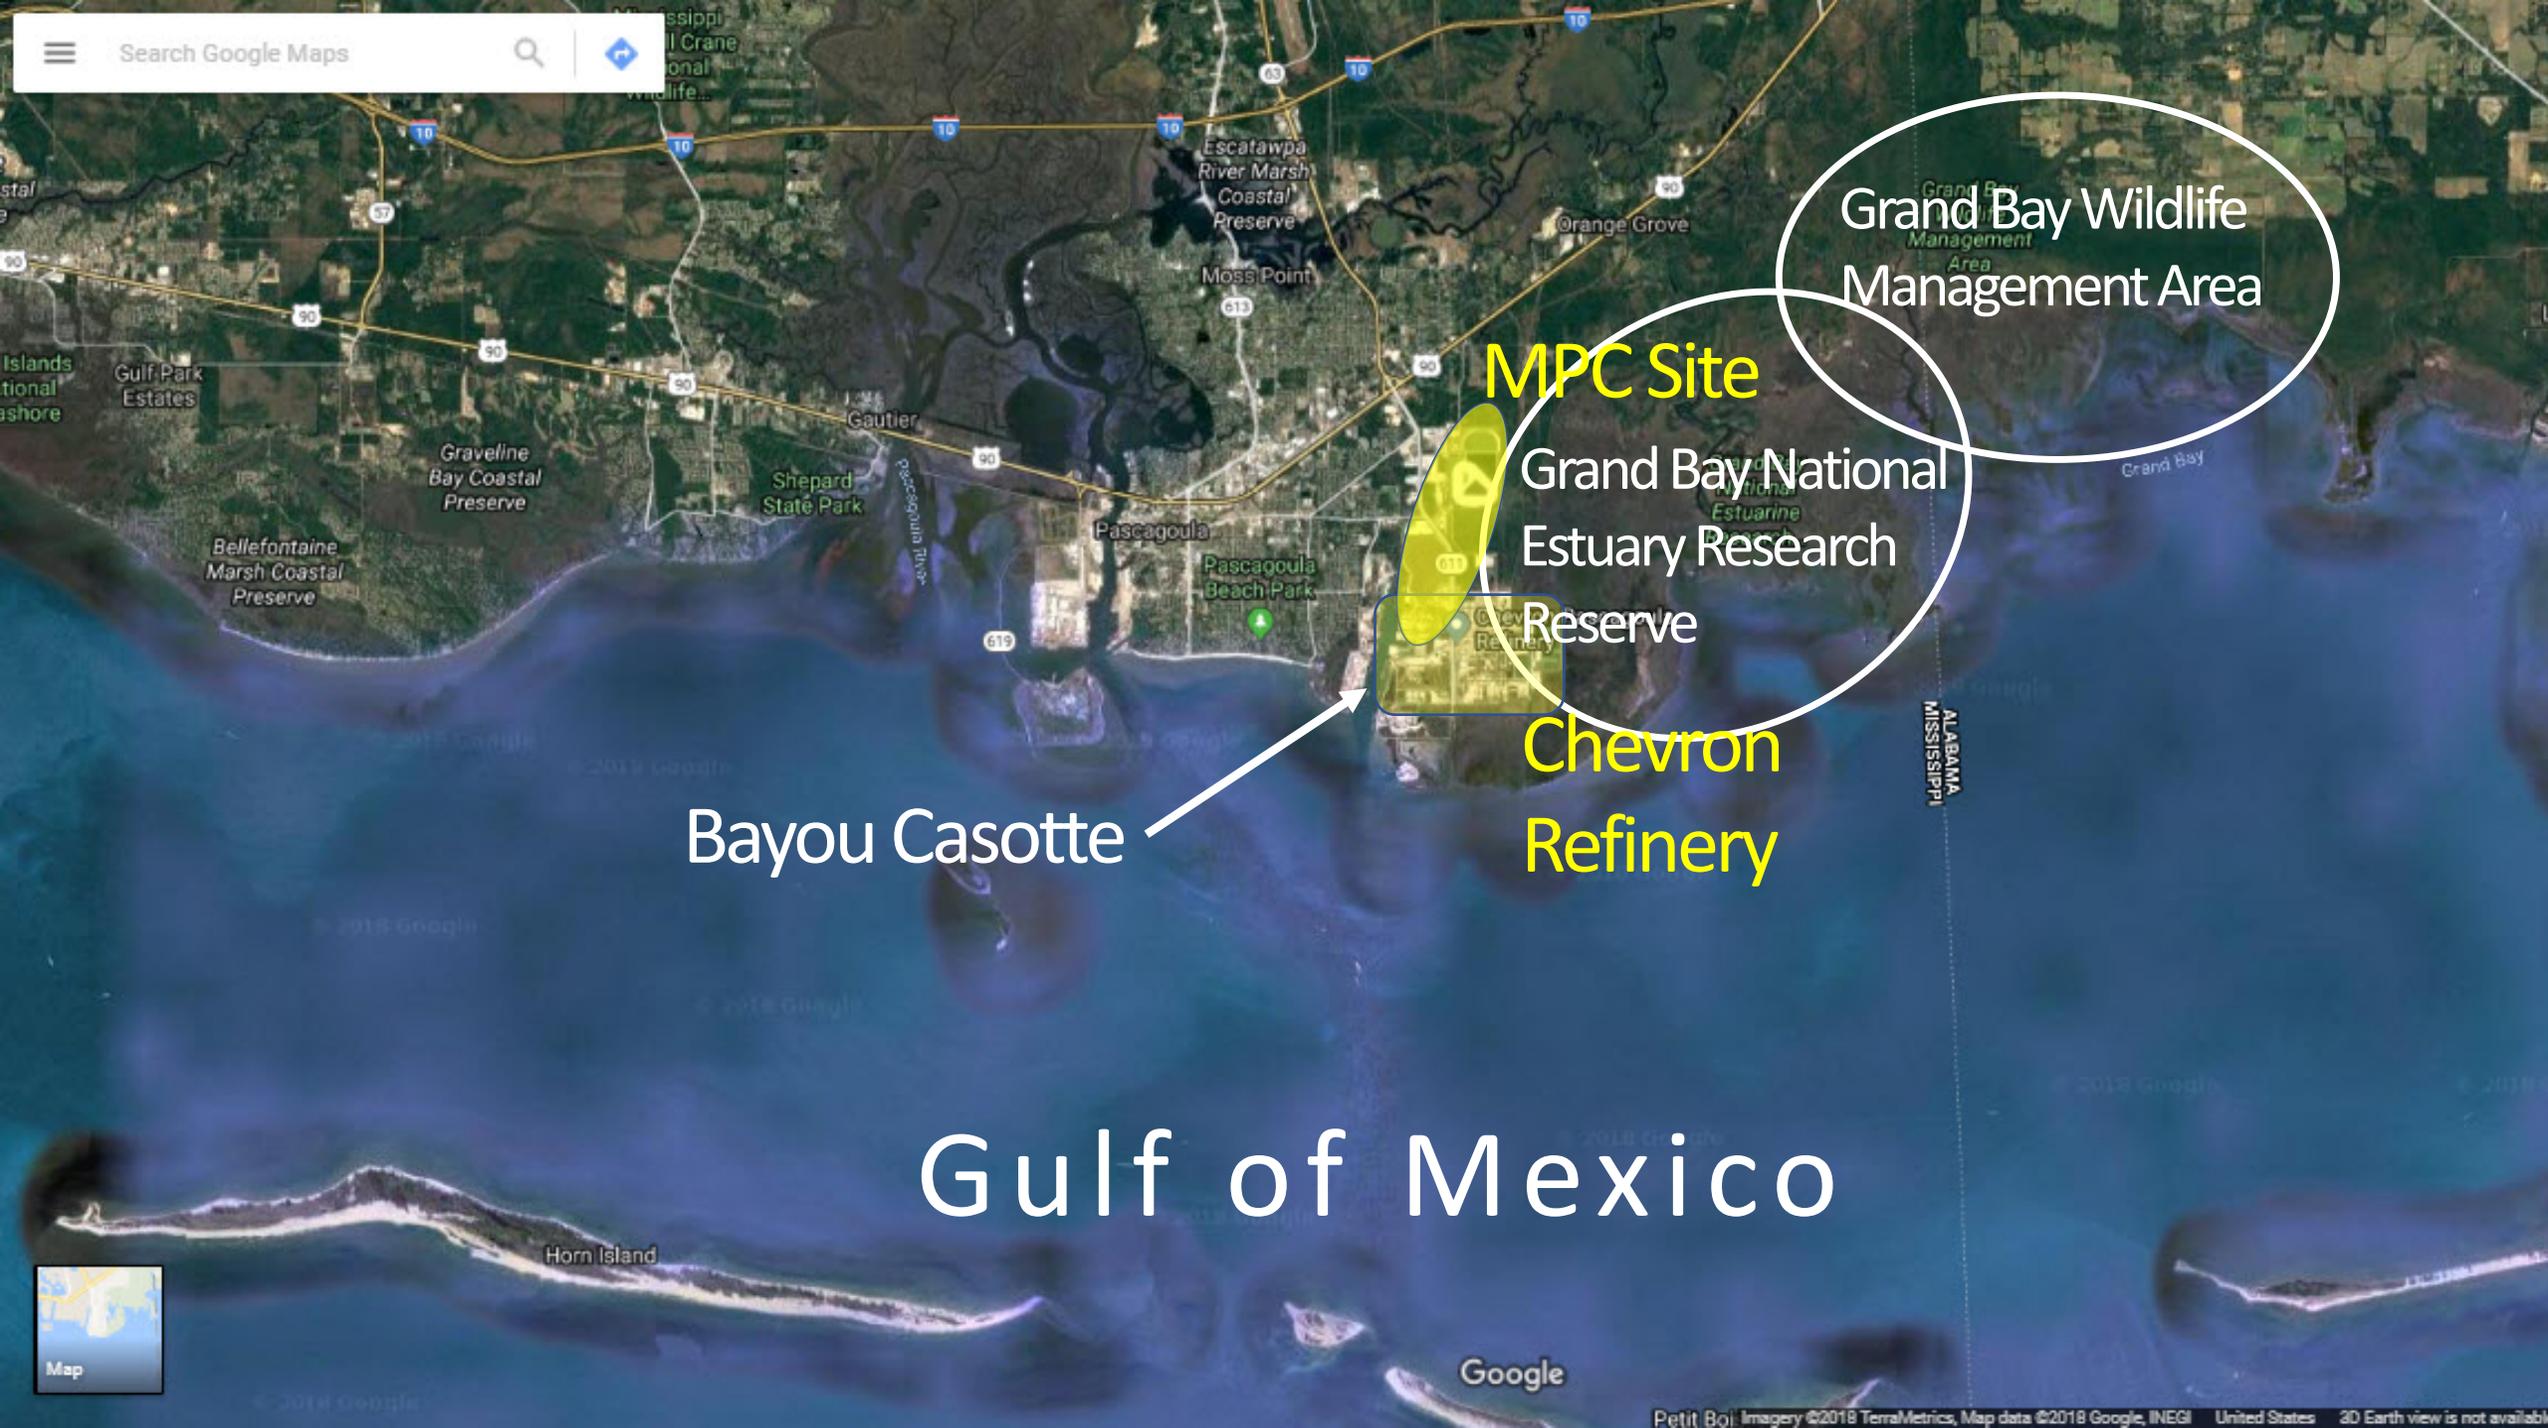
East Gypstack and Pond Complex

In Situ Treatment Ponds
4 ponds @ ~12 million gal
5-7 day batch treatment

West Gypstack
(in interim closure)

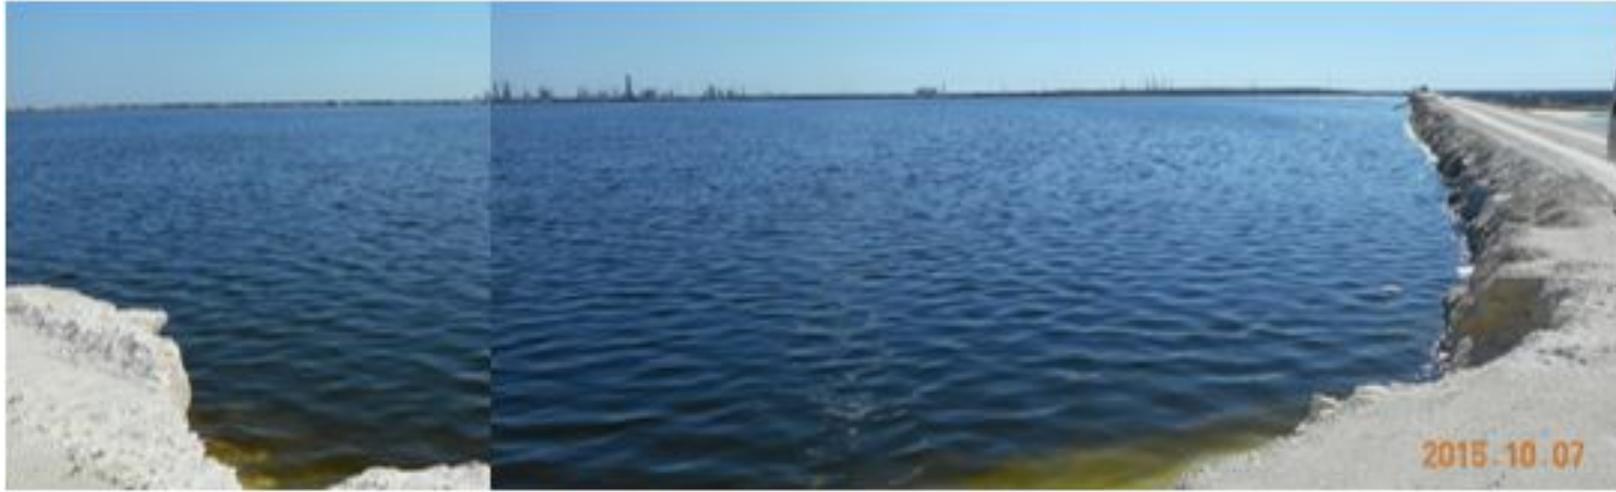
Figure 2: Pond 3 on Top of the East Gypsum Stack

Facility Tour Findings – Inadequate Freeboard

- ✓ Repair and maintain berms
- ✓ Reduce water levels to attain adequate freeboard
- ✓ Increase water treatment capacity
- ✓ Maintain high-level management visibility and support

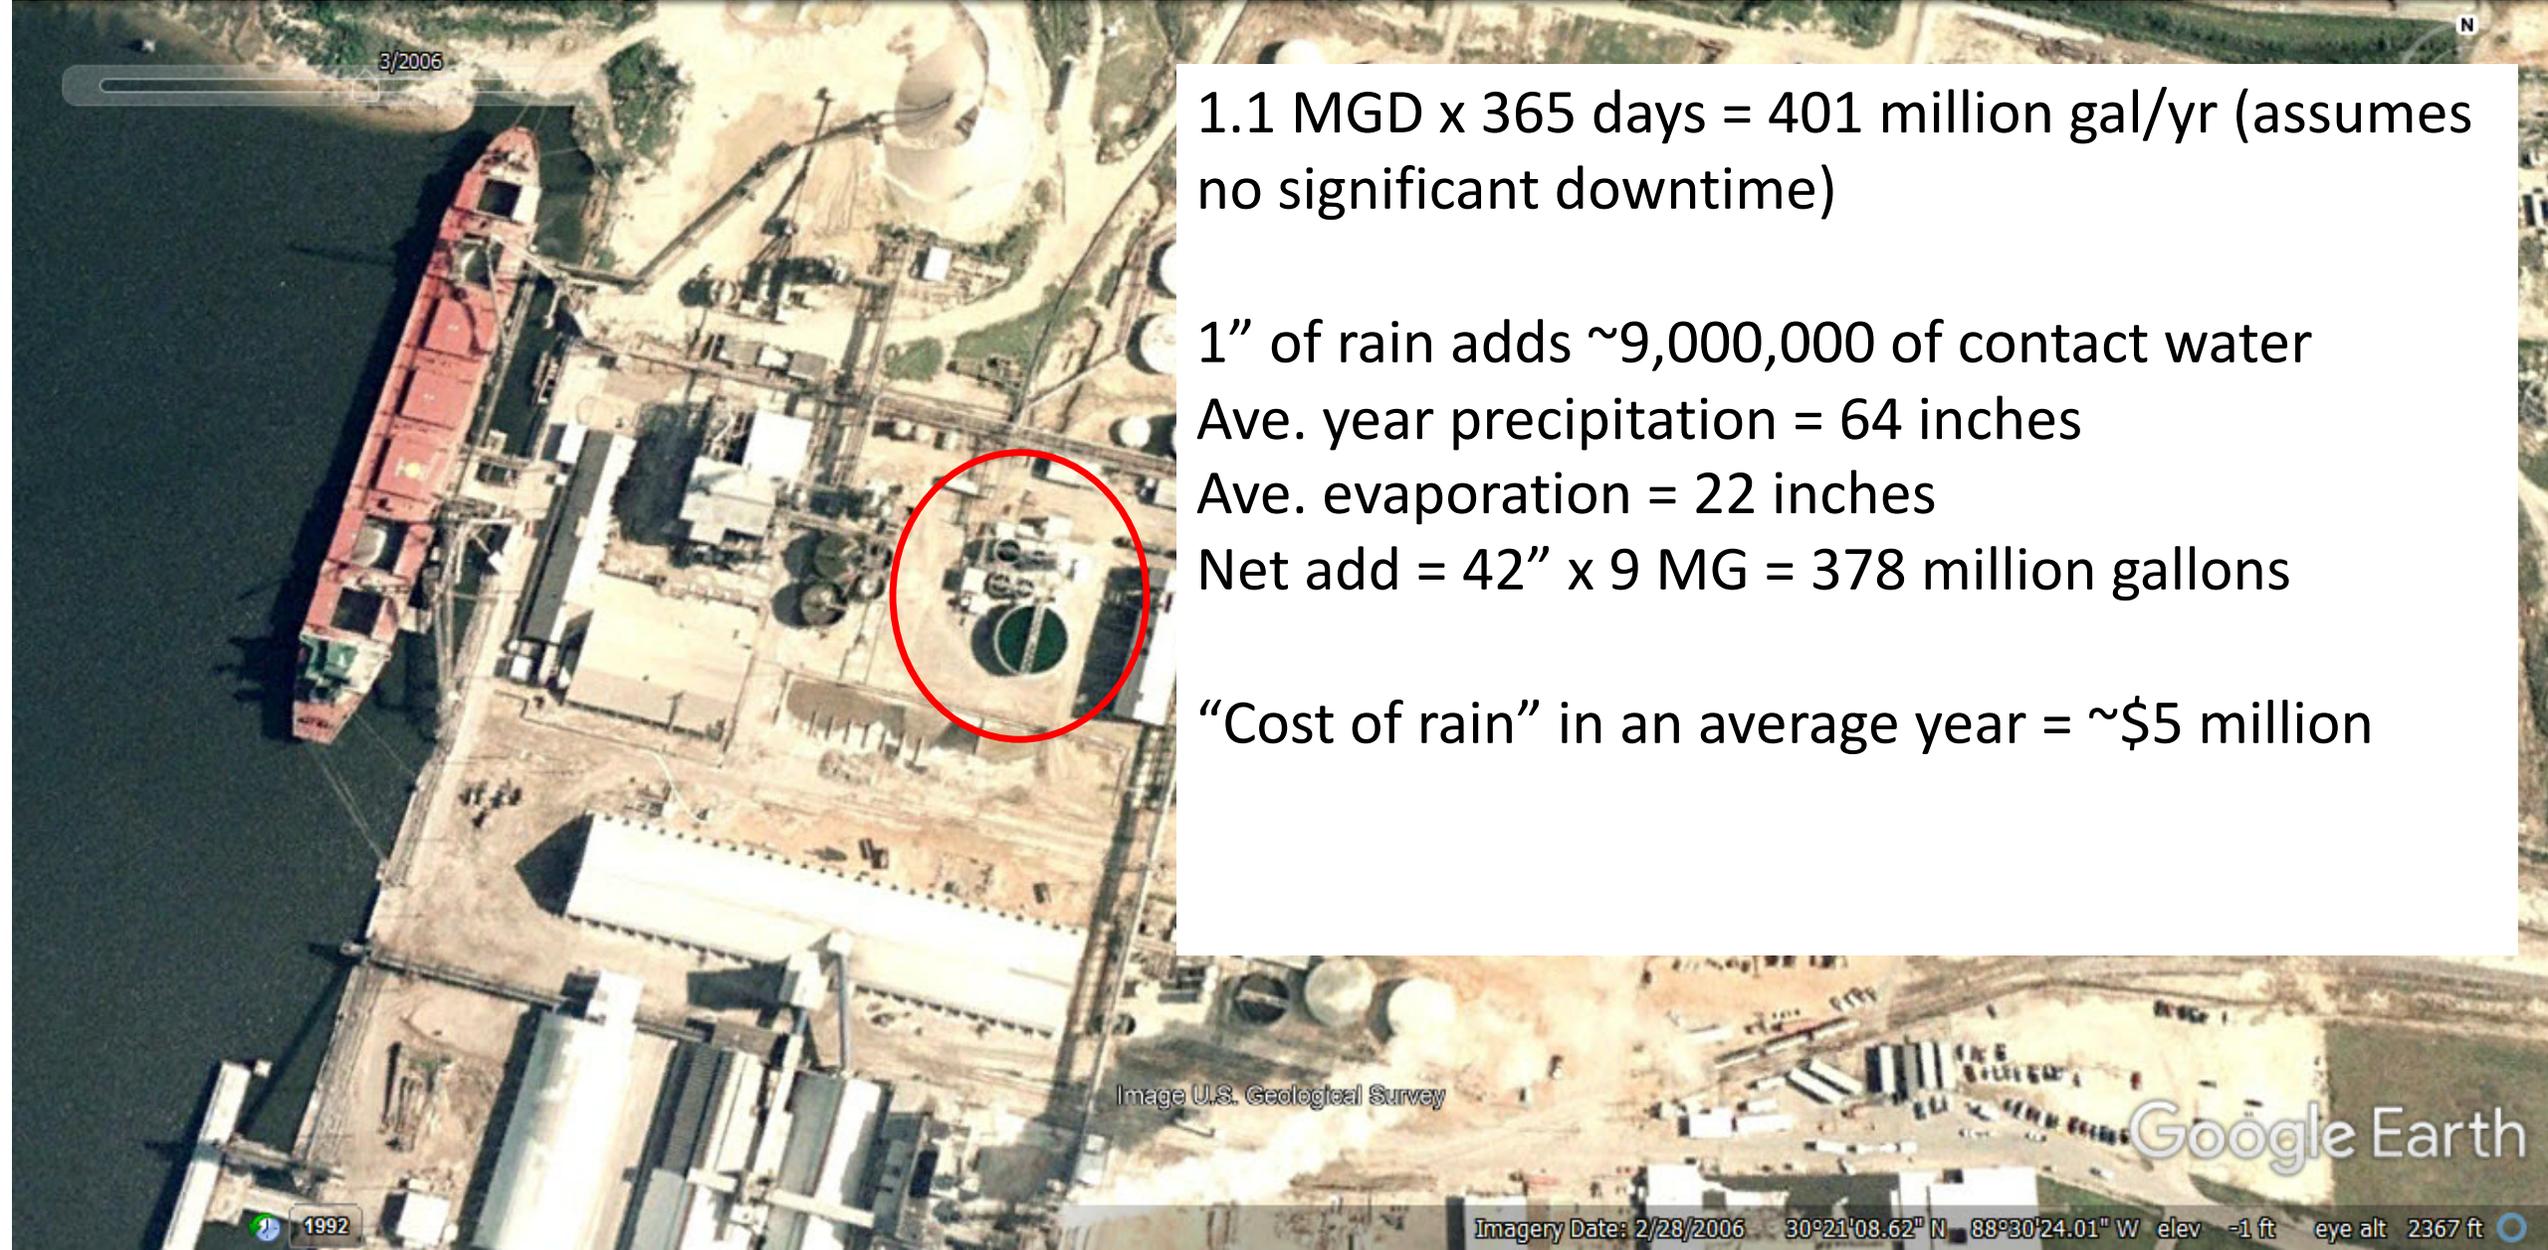
Facility Tour Findings – Inadequate Water Treatment Capacity

1.1 MGD x 365 days = 401 million gal/yr (assumes no significant downtime)

1" of rain adds ~9,000,000 of contact water
Ave. year precipitation = 64 inches

Ave. evaporation = 22 inches

Net add = 42" x 9 MG = 378 million gallons

“Cost of rain” in an average year = ~\$5 million

- Reduce contact water footprint to reduce “cost of rain”

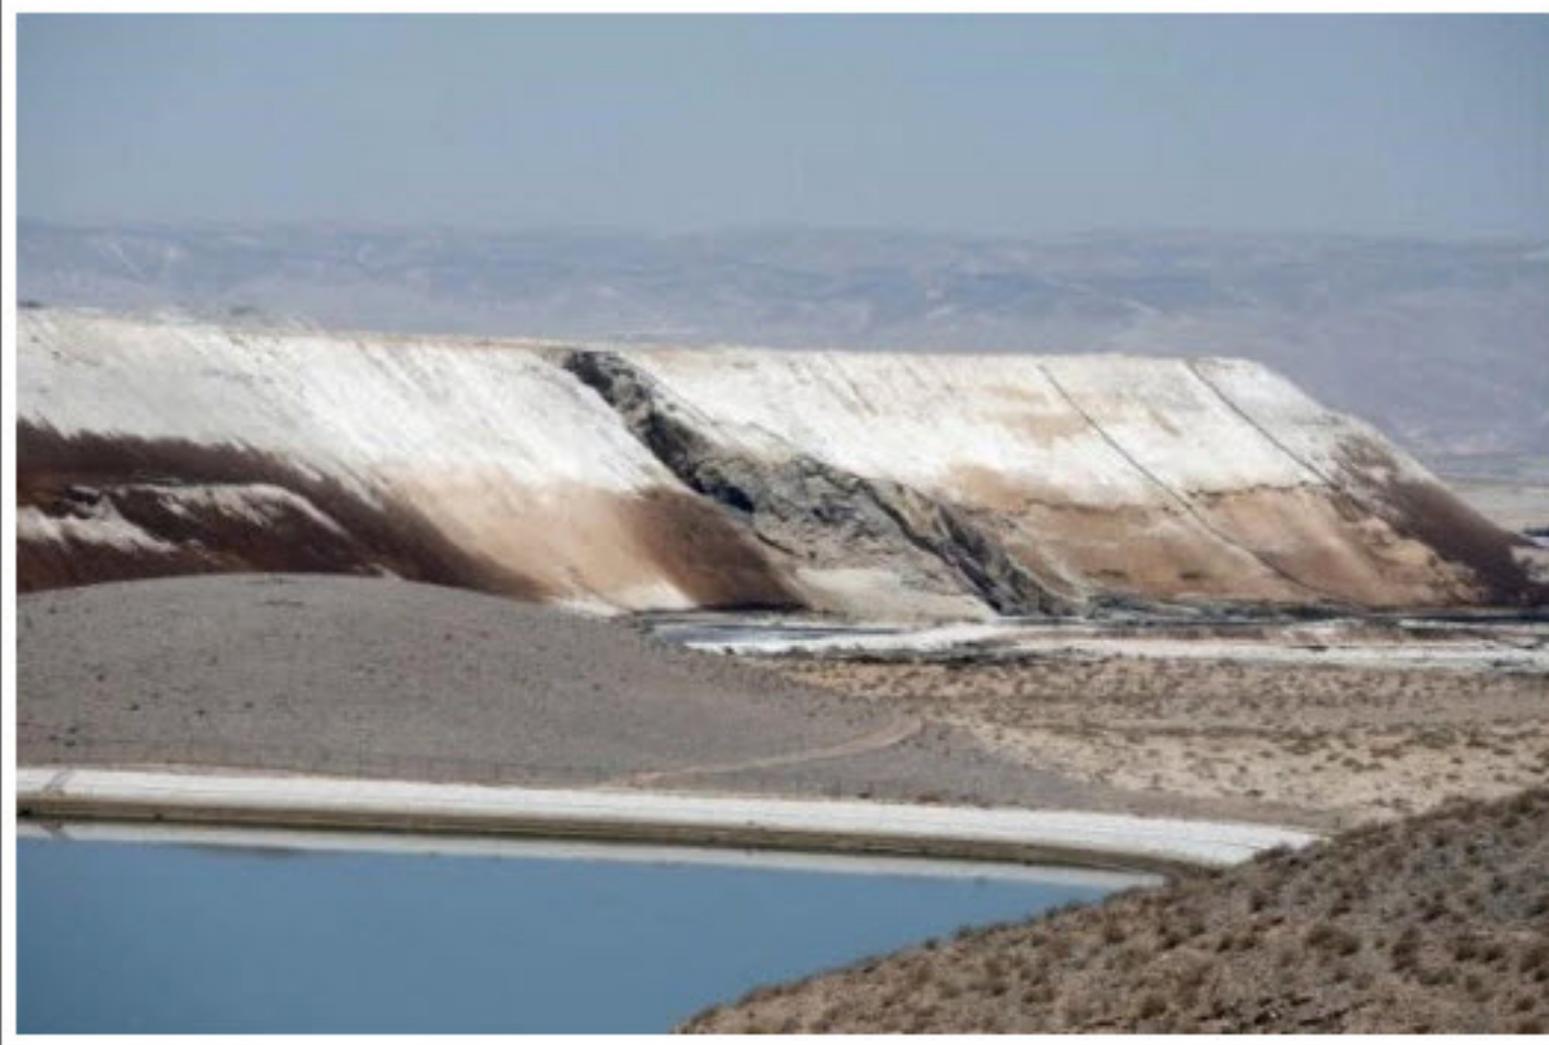
Israeli Chemicals Fertilizer Plant (June 2017)

- Partial collapse of 150-foot-high wall
- Released 26.4 million gallons of highly acidic wastewater in the Ashalim riverbed
- Wake of ecological destruction more than 12 miles long

A collapsed wall of a reservoir holding a highly acidic wastewater is seen in Mishor Rotem, in Southern Israel July 4, 2017. REUTERS/Baz Ratner

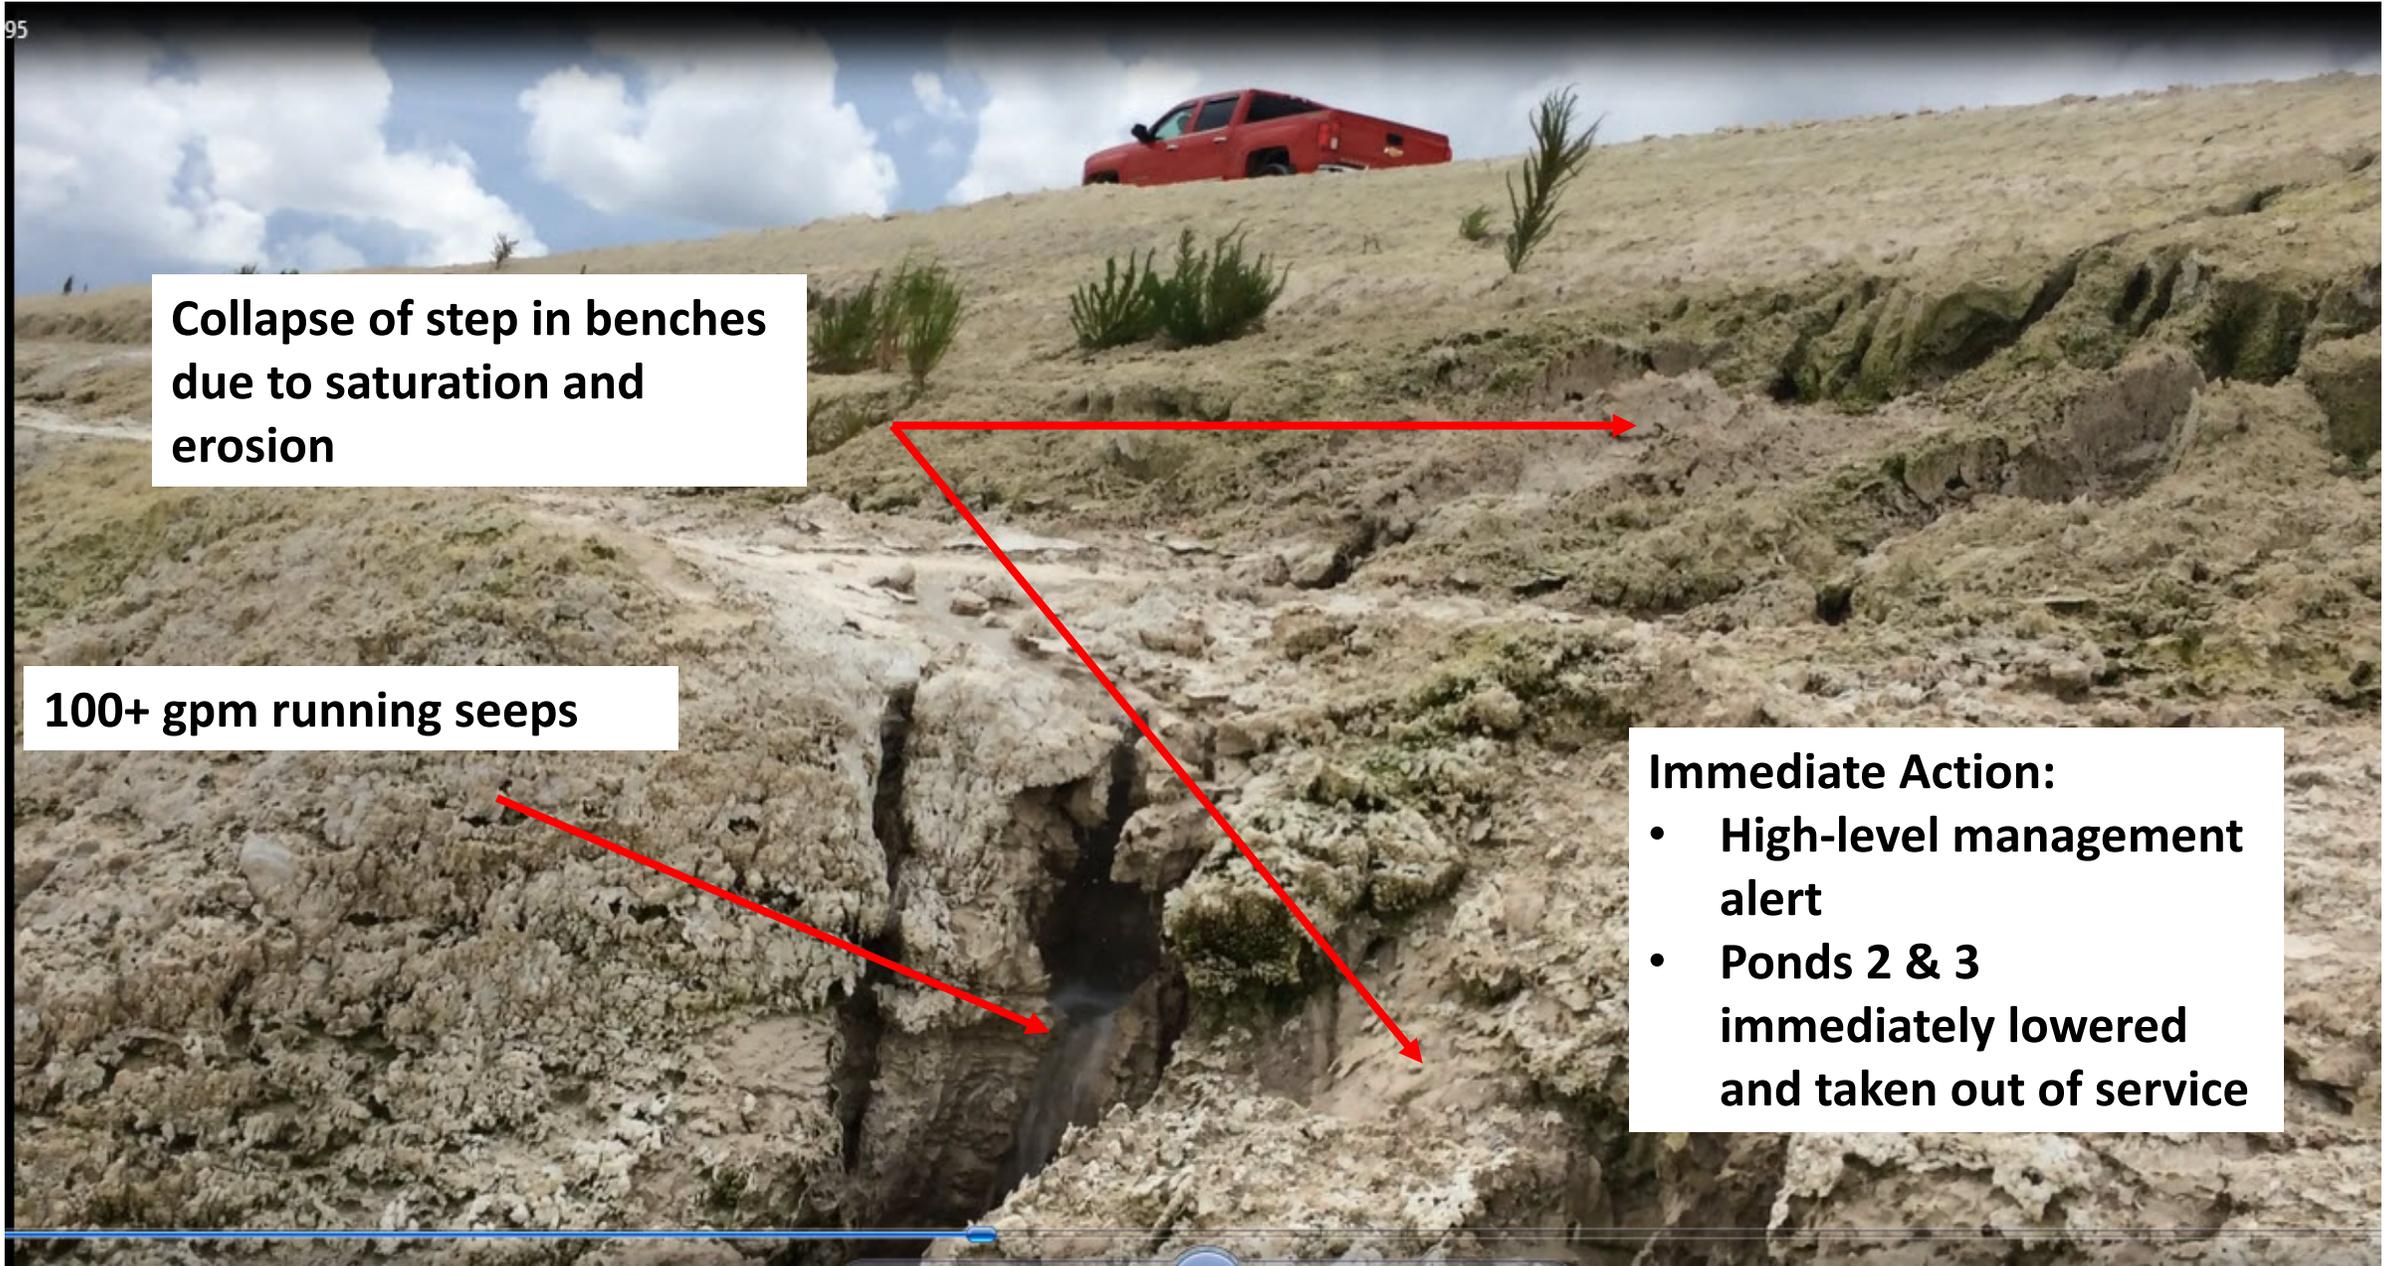
**Collapse of step in benches
due to saturation and
erosion**

100+ gpm running seeps

Immediate Action:

- **High-level management alert**
- **Ponds 2 & 3 immediately lowered and taken out of service**

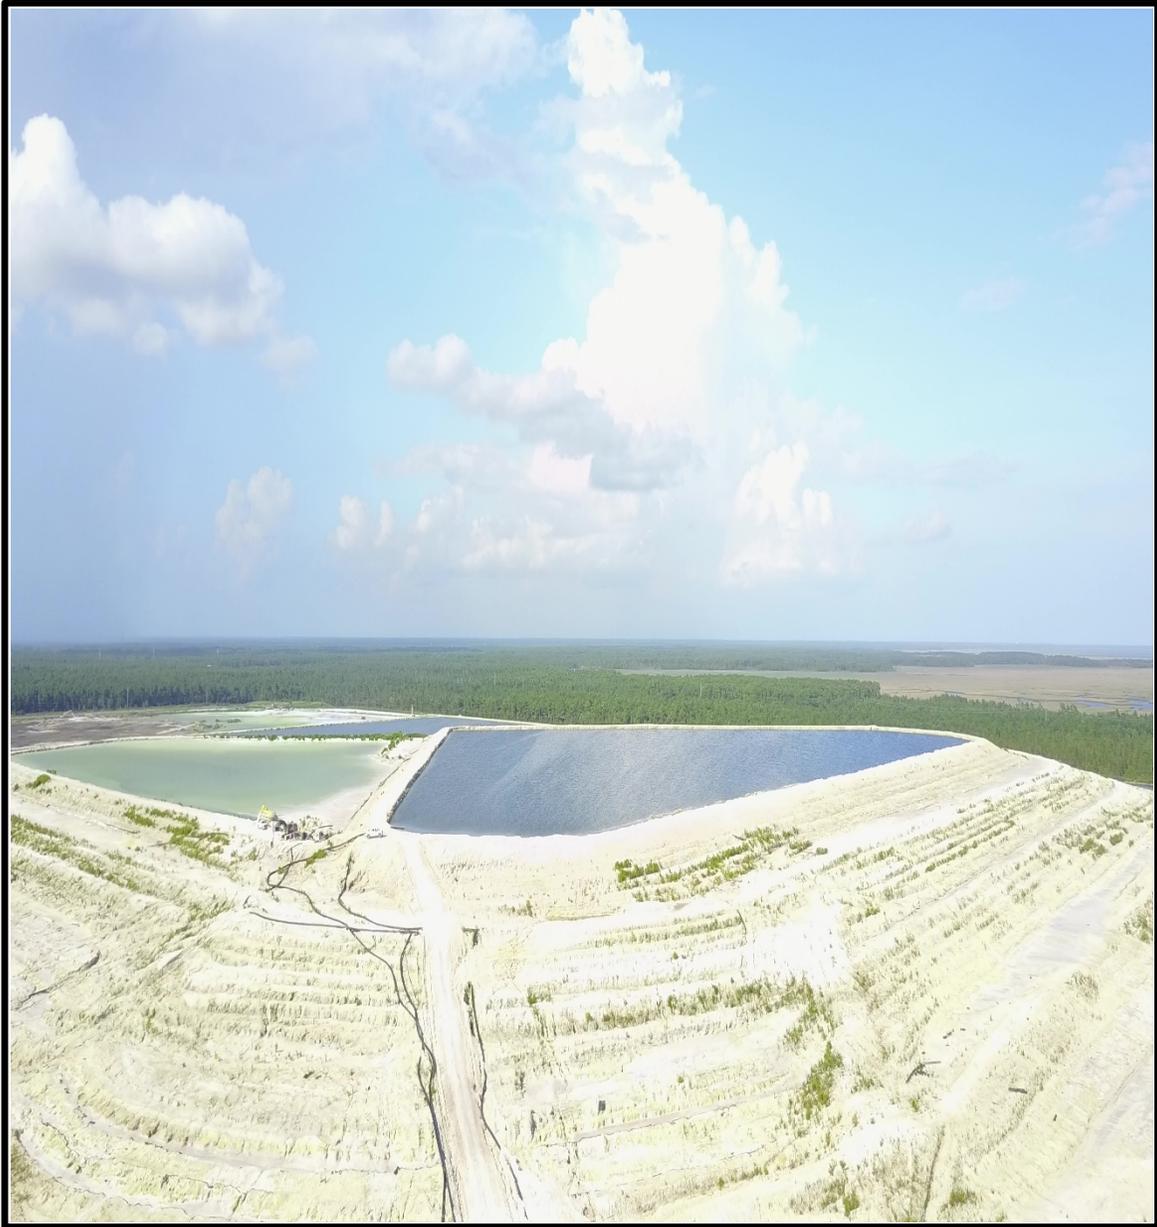
AFTER

- Dikes, berms & ponds of East Gyp Stack had structural integrity issues
 - Overtopping/desiccation/piping, etc.
 - Confirmed by multiple ERT inspections
- By-passes managed by EPA
 - pH neutralization only with sodium hydroxide
 - \approx 400 MGs over 5 events were by-passed between July and October 2017 to prevent uncontrolled releases from Ponds 3 and 4 on top of stack
 - Treatment costs per gallon = \$0.015727
 - Closely monitored to prevent eutrophication and algal blooms
 - No adverse impacts observed
