# Adaptation to Weather Impacts Grasse River Superfund Site

Young S. Chang  
EPA Region 2 RPM

Climate Change Adaptation Webinar 4/1/2015 [clu.in.org](http://clu.in.org)

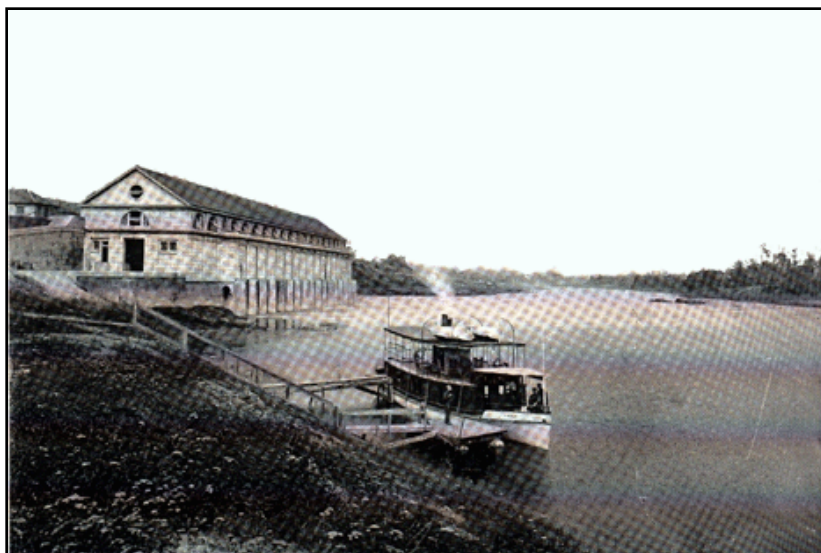
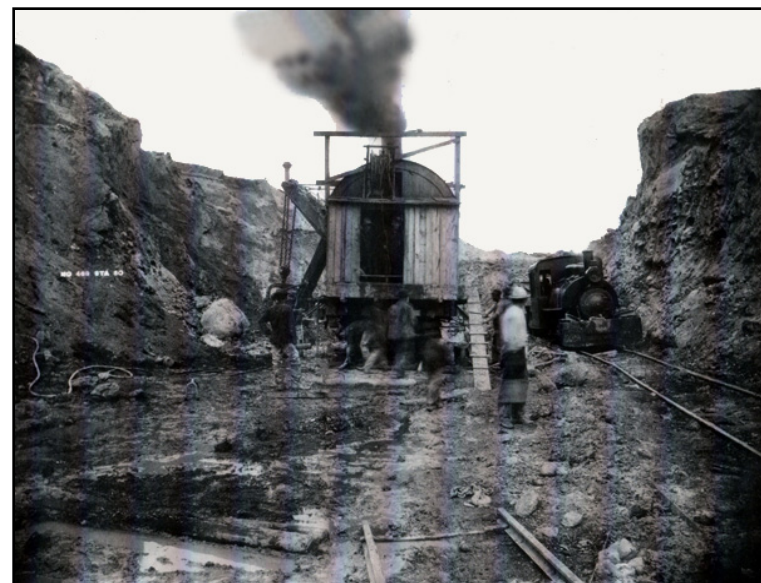
# History of Grasse River Development

- ◆ 1898 - 1903: Power Canal Construction
- ◆ 1902: Pittsburgh Reduction Company (Alcoa, Inc.) constructs aluminum plant in Massena
- ◆ Early 1900s: Lower Grasse River excavated, deepened and widened to support the increased flows from the Powerhouse

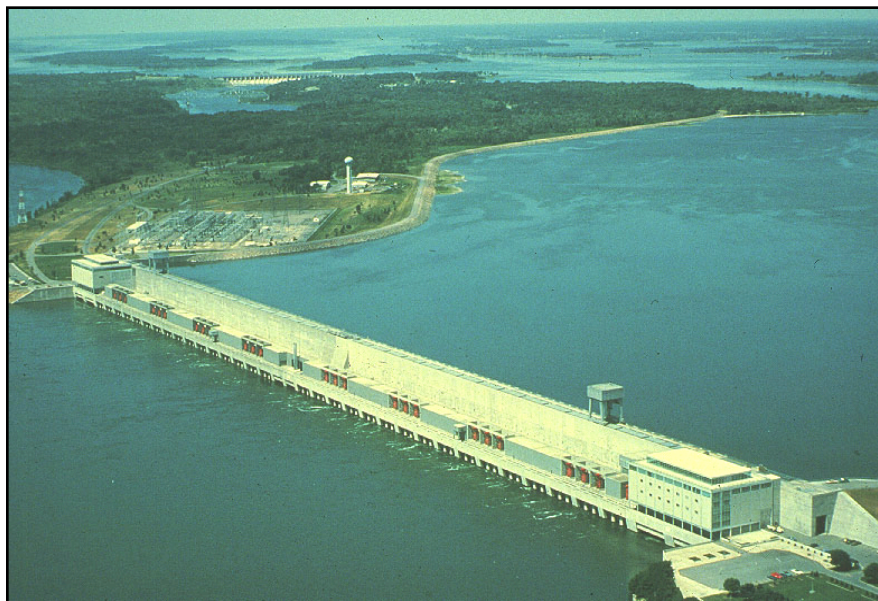
# History of St. Lawrence River Development

- ◆ 1954: Construction of the Eisenhower Locks System and the Moses-Saunders Power Dam (FDR Project), US & Canadian development project of the St. Lawrence River
- ◆ 1958: FDR Project started supplying hydroelectric power to Alcoa plant and ceased operation of the Massena Power Canal/ Powerhouse

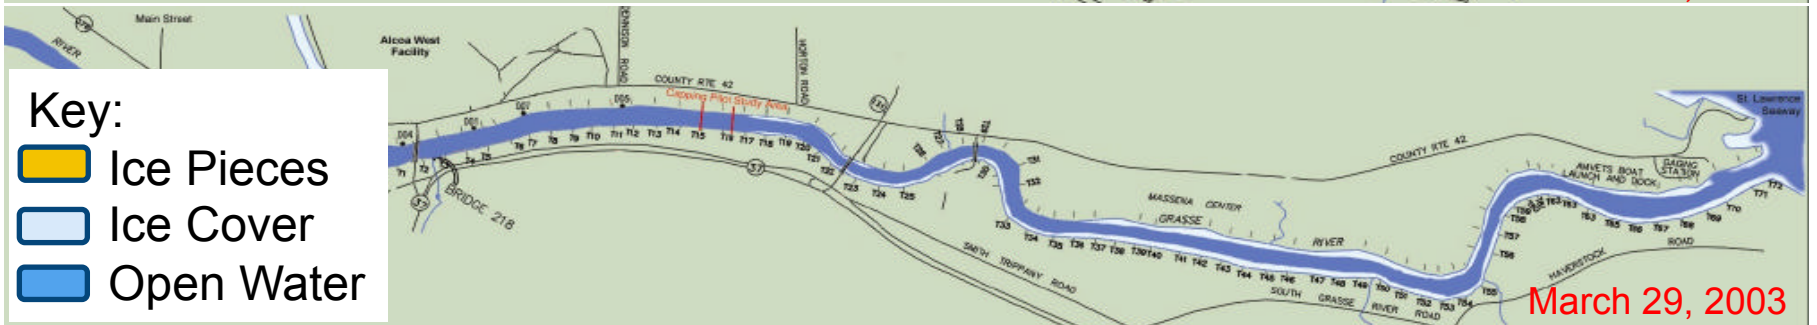
From the CCLGR Volume II – Appendix K Ice Breakup Photographs

Key:

-   Ice Pieces
-   Ice Cover
-   Open Water

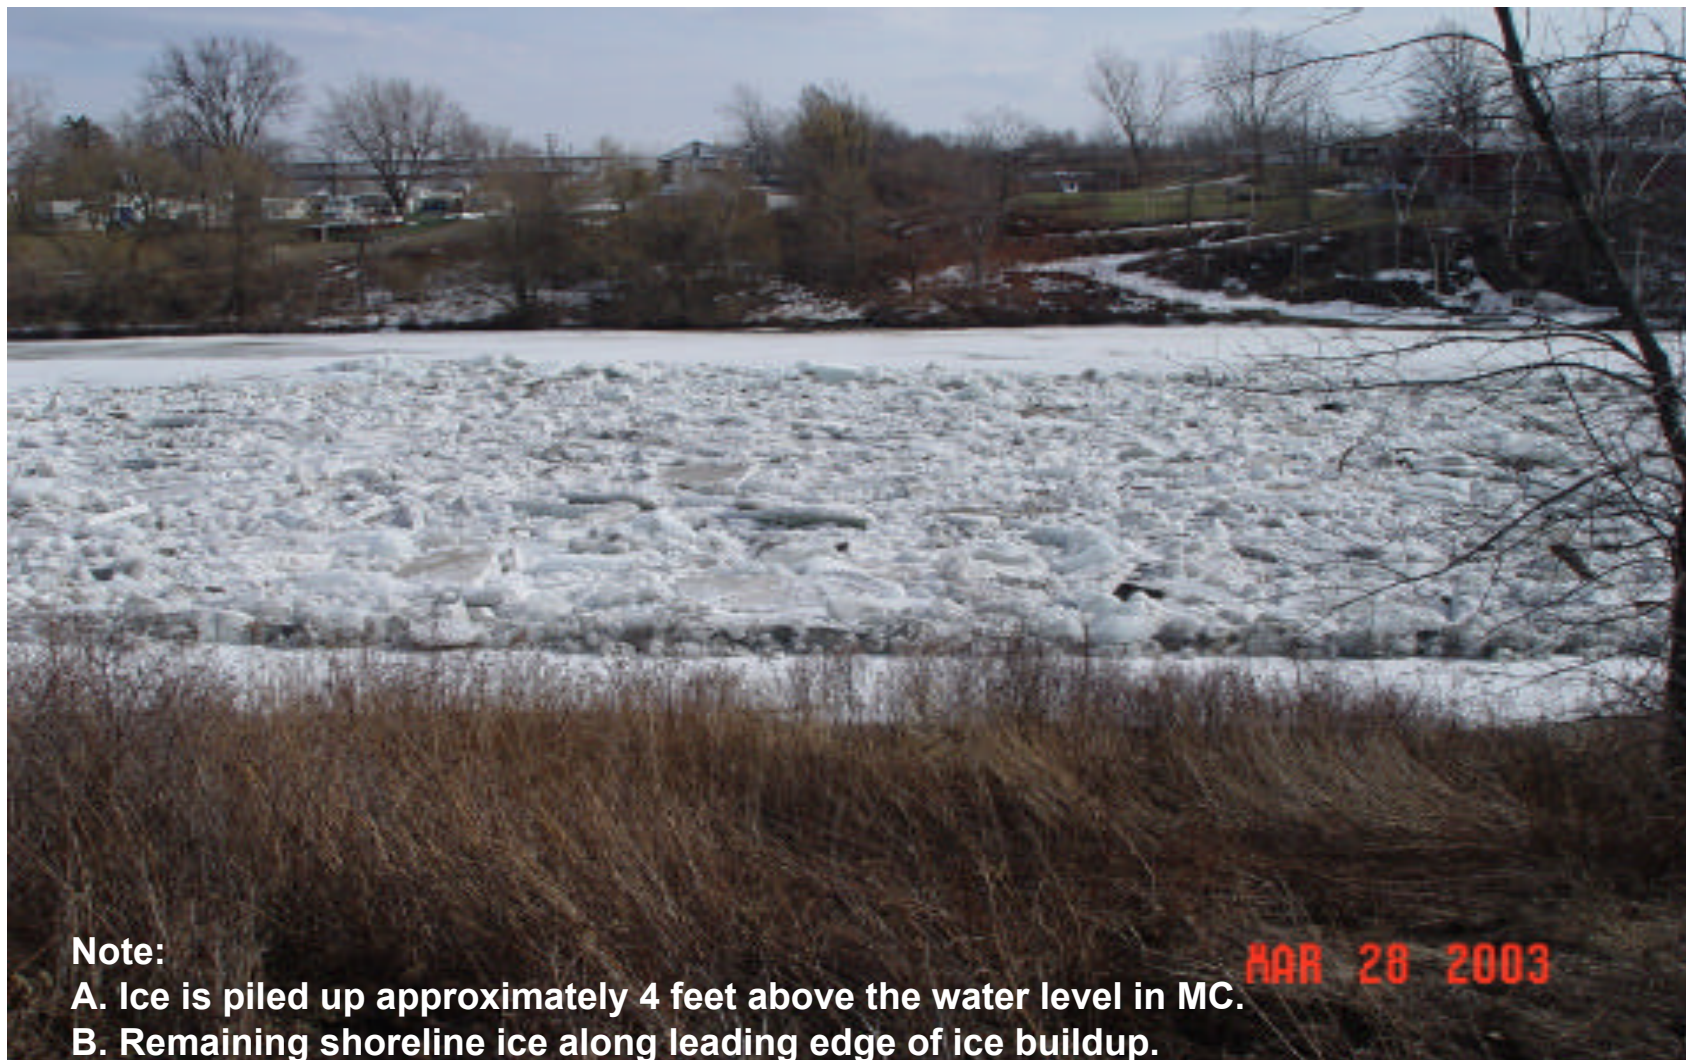
# Ice Breakup Photo

From the CCLGR Volume II – Appendix K Ice Breakup Photographs

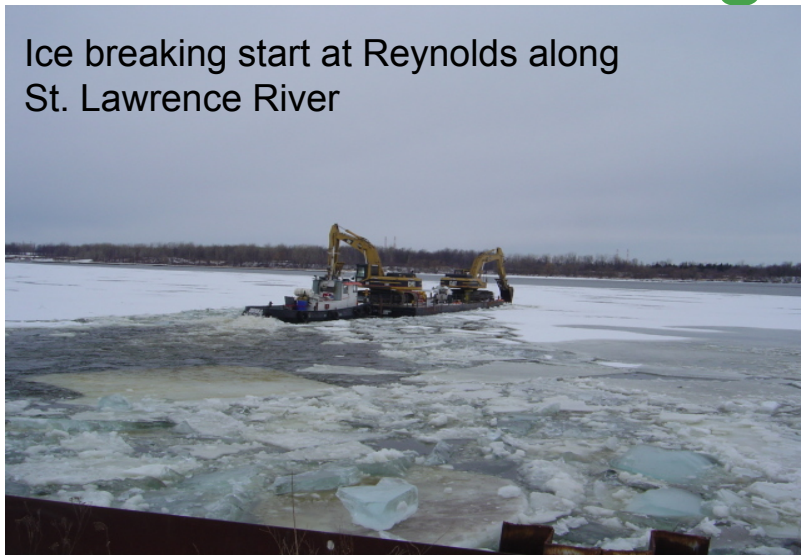
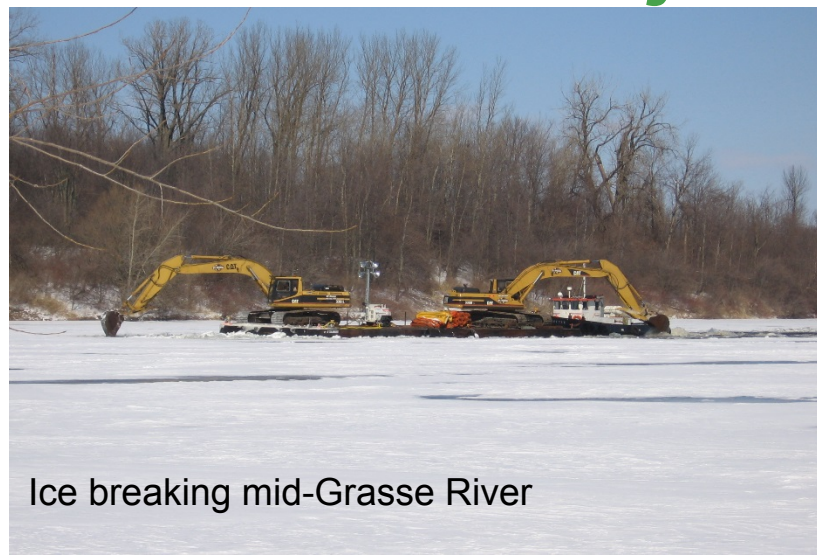
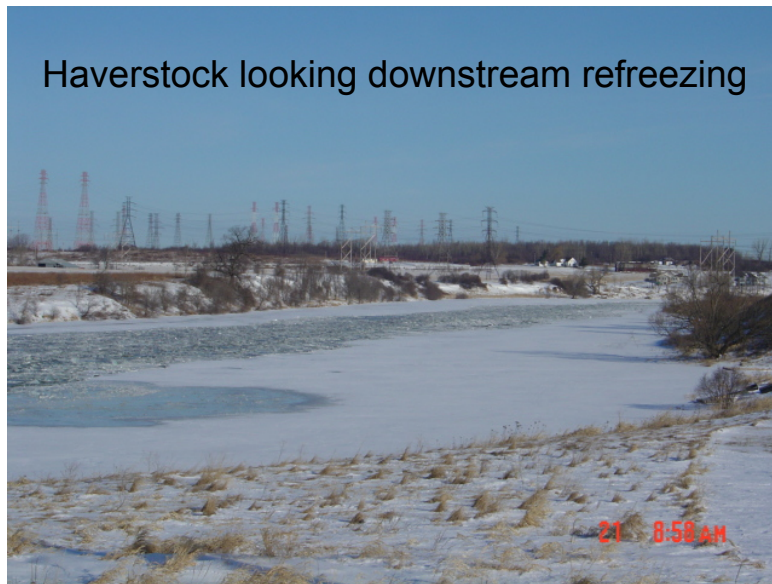
# 2007 Ice Breaking Demonstration Project

Ice breaking start at Reynolds along St. Lawrence River

Ice breaking mid-Grasse River

Haverstock looking downstream refreezing

- Ice Breaking Demonstration Project
- Consideration of Ice Booms to Retain Ice
