The Atlas Tack Superfund Site: an Example of Ecological Enhancement

Ken Finkelstein, NOAA
Office of Response and Rest.
Boston, MA

Elaine Stanley
EPA Region 1
Boston, MA

The Poudre River Site

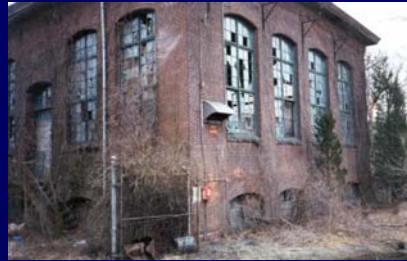
Phase I: Specific Buildings

- Demolish former one-story building slab, three-story rear building, power plant and two smaller sheds
- Excavate and remove plating pit, pickling trench, underground waste conveyance trenches and dispose off-site
- Excavate 775 cubic yards (cy) contaminated soil and sludge and dispose off-site
- Cost \$2,300,000
- Completed September 2006

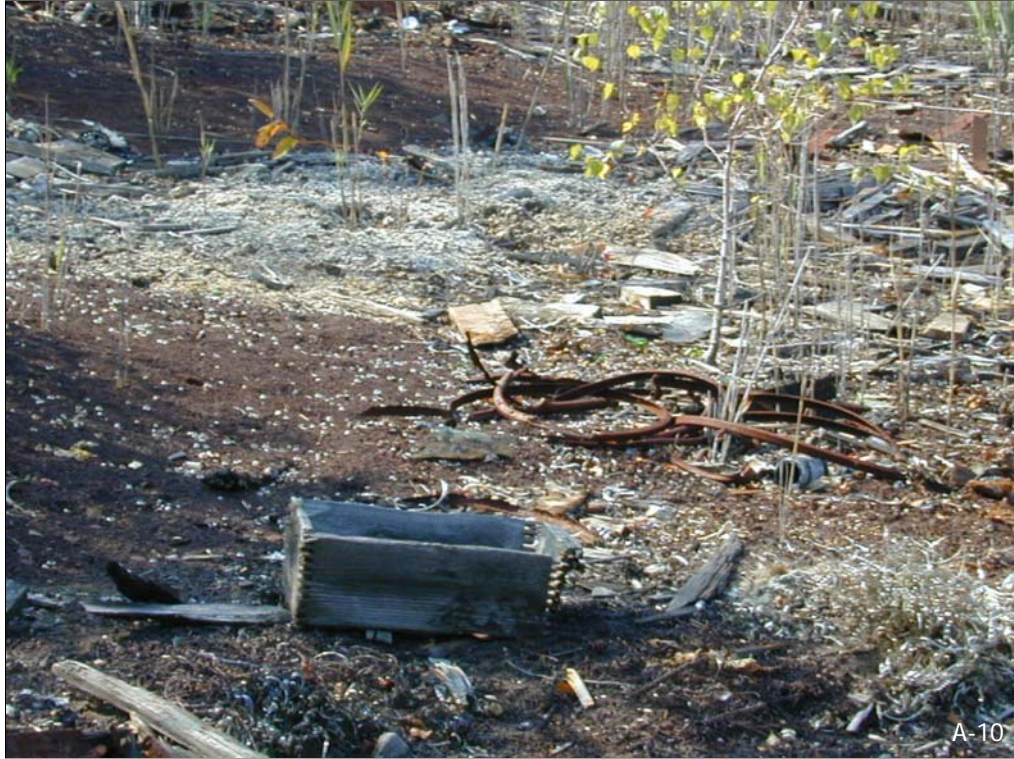
A-9

Phase II: Solid Waste and Disposal Area – 9 acres

- Excavation and off-site disposal of approx. 38,000 cubic yards of contaminated soil and debris in the Solid Waste and Disposal Area
- Contaminated soil and debris disposed off-site
- Cost \$14,000,000
- Completed April 2007

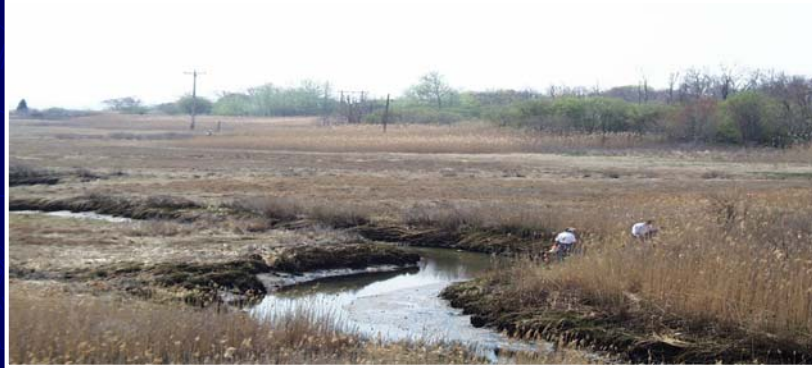
Phase III: Marsh Area – 5.4 acres

- Excavation of 20,000 cy contaminated marsh soil and creek bed sediment
- Restoration of the marsh
- Cost \$5,000,000

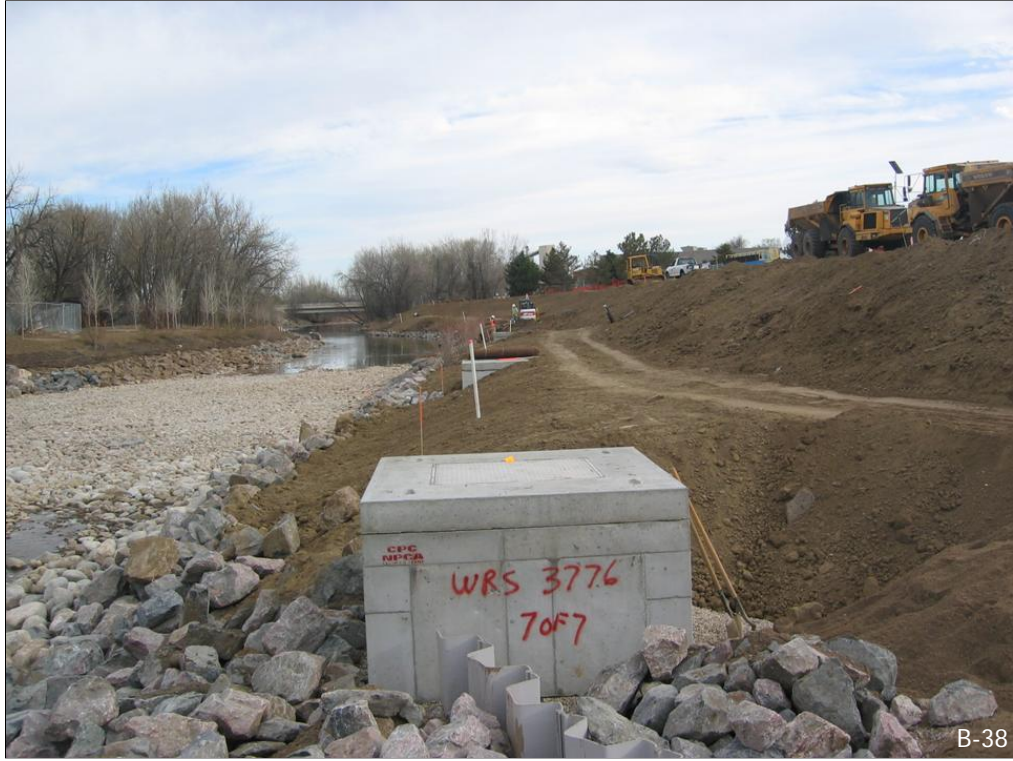
B-37

Hide and Stabilize

- Design Slope and Bank to Bury Wall and Pump system
- Properly Size and Compact Sub-grade of Streambed
- Restore Original Stream Elevations
- Discretely Armor and Key in Banks to Bed

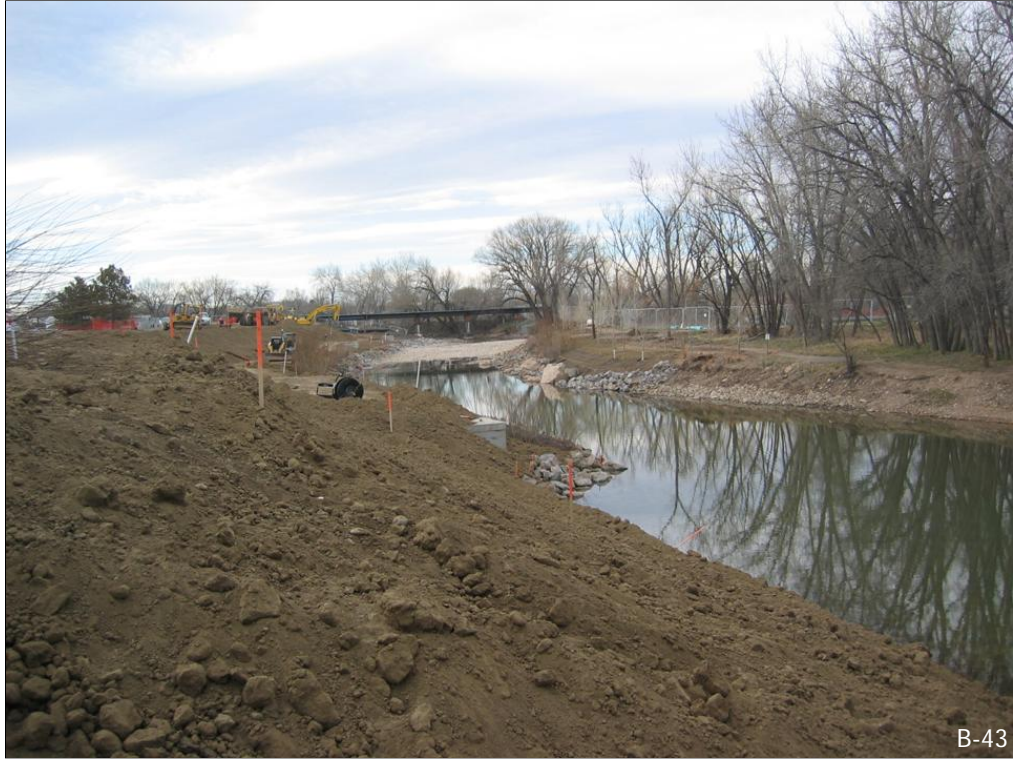
B-42

Example of Use of Native Species

- Bad
 - Russian Olives
 - Thistle Brush
- Good
 - Coyote Willows
 - Colorado Sedges

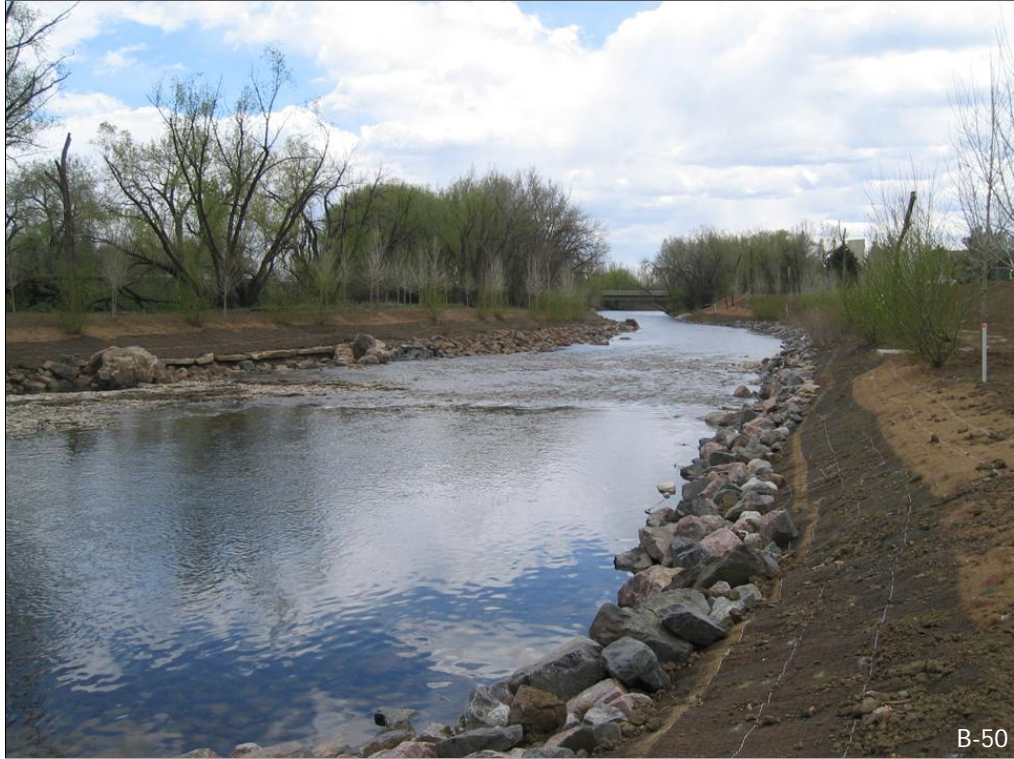
B-49

Examples of Habitat Concerns

- Fish Ledges
- Proper Large Trees
- Use of Snags
- Boulders

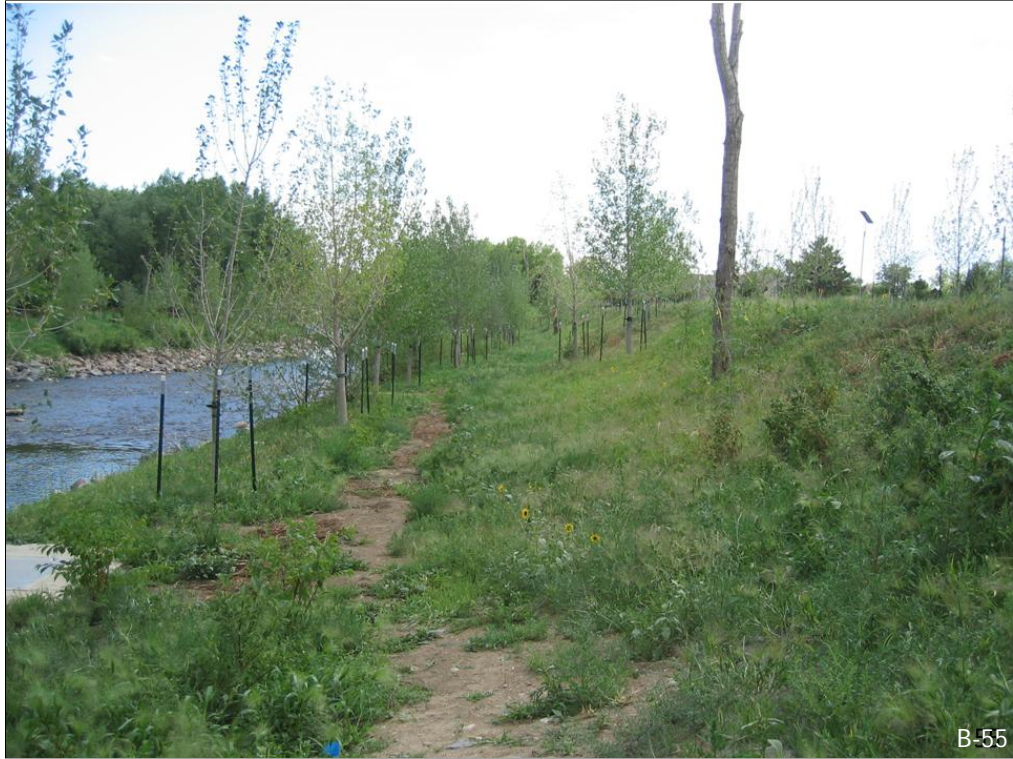
B-54

Public Access

- Varied Slope
- Flat Bank Along Water
- “Natural” Entry Points to Bank and Trails
