Carbon County, Pennsylvania

Reclamation of Palmerton Zinc Superfund Site

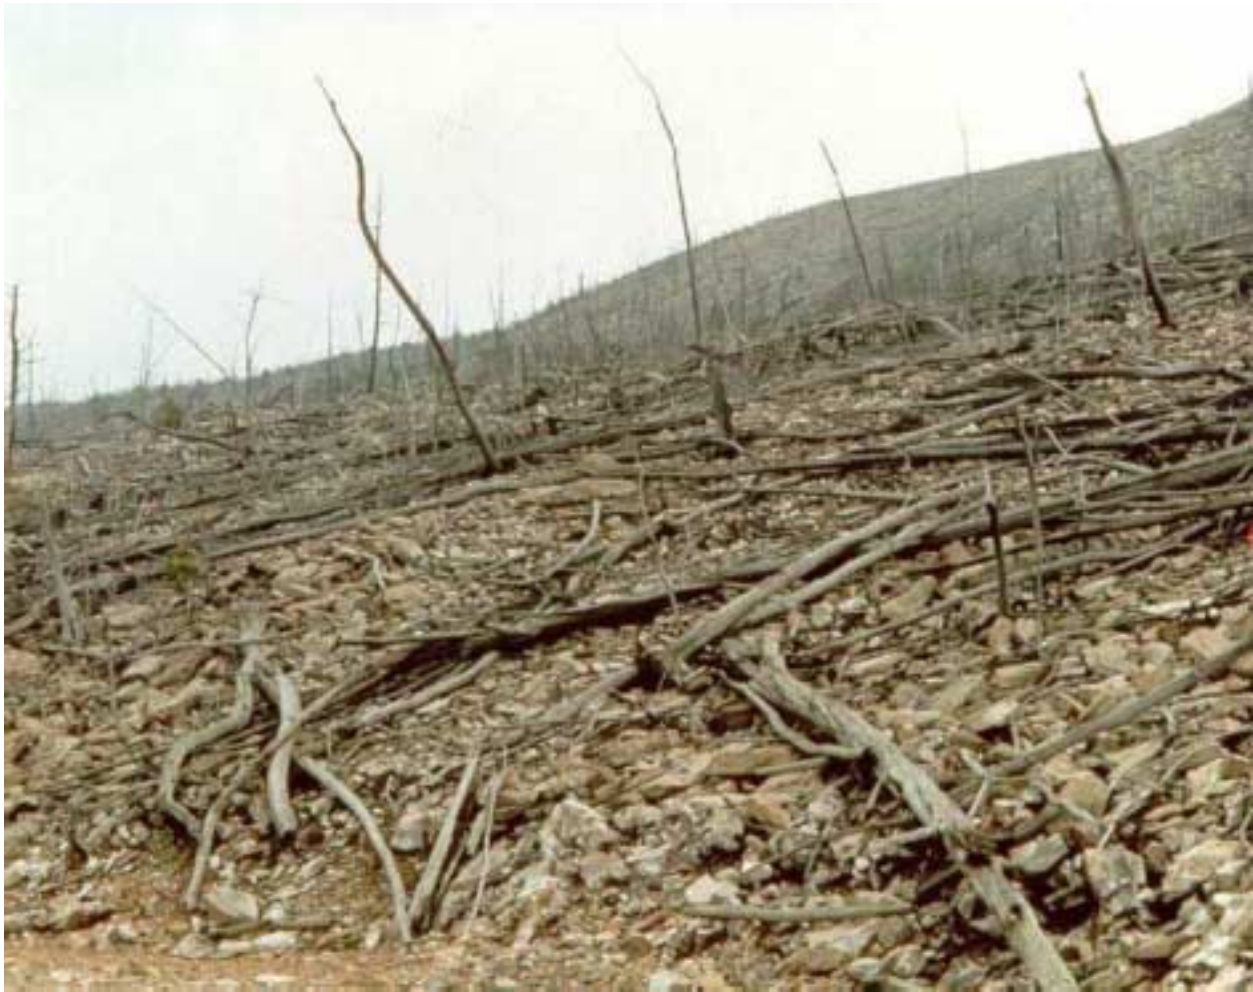
Primary smelting of concentrated zinc sulfide ores occurred from 1898 until December 1980, resulting in the emission of large quantities of zinc, lead, cadmium, and sulfur dioxide. The emissions caused the defoliation of more than 2,000 acres (400 ha) of vegetation around the East Plant. Environmental damage first was identified in a 1951 aerial photograph as isolated patches on the steep, north face of Blue Mountain located adjacent to the East Plant. By 1980, vegetation damage had left a wide, continuous area of Blue Mountain barren and eroded (Figure 1). By the time the original forest was

Figure 1. Typical condition on Blue Mountain, Palmerton, PA, after 82 years of zinc smelting.

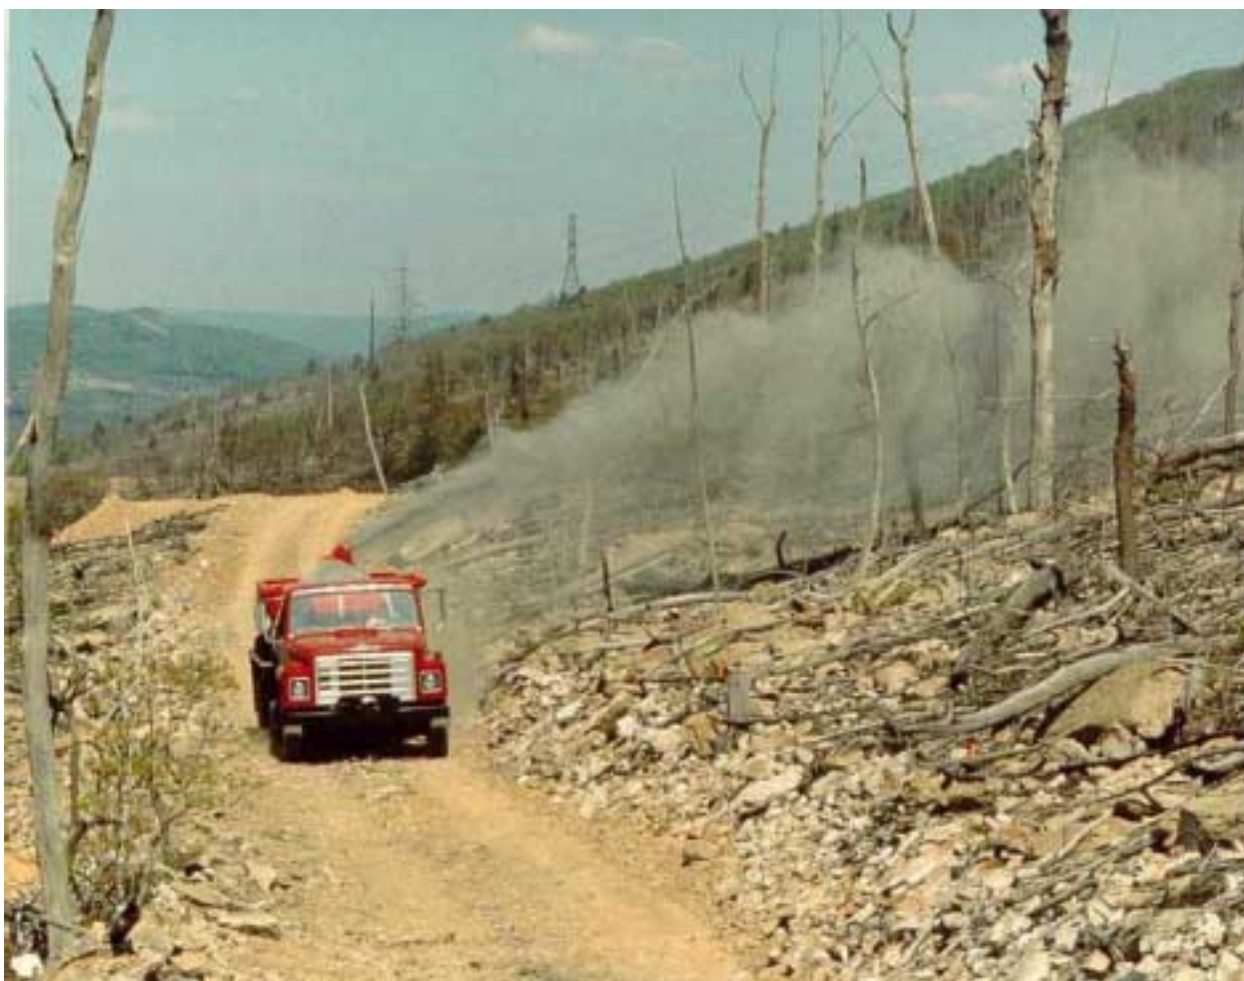
Figure 2. Biosolids and fly ash were thrown from the rear of the spreader by a fan

spinning at 800 to 1200 rpm.

The biosolids and fly ash were loaded into a dump truck in alternating layers to achieve the desired ratio. Mixing occurred during transport to the work site, dumping, and loading into the spreader truck. The material was then thrown from the rear of the spreader by a fan spinning at 800 rpm to 1,200 rpm.

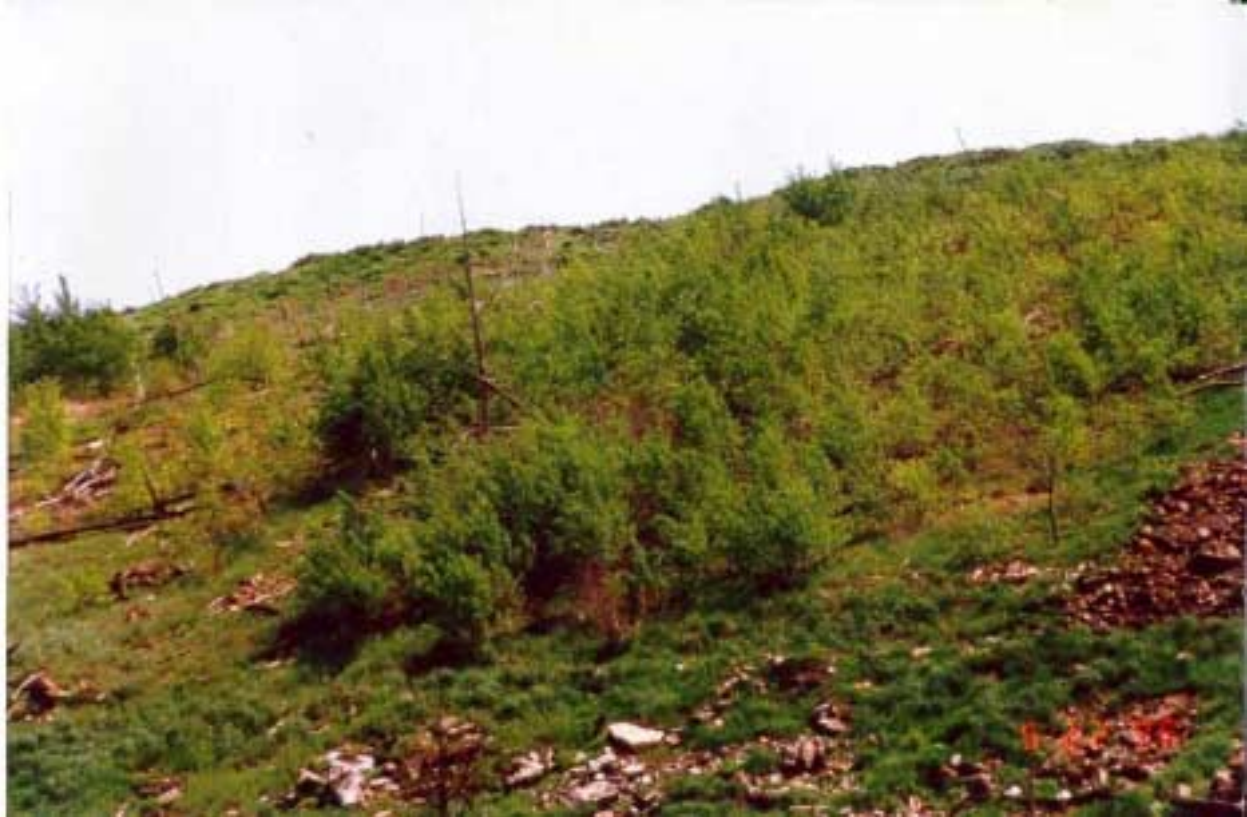
Figure 3. Typical conditions on Blue Mountain after application of biosolids, limestone, potash and fly ash.

The Blue Mountain restoration project was concluded in 1995. In March of that year, restoration experts from the U.S. Army Corps of Engineers reported that Ecoloam appeared to stabilize soil in treated areas, reduce soil erosion, and reduce the amount of metals dissolving into runoff (Table 3).
