OB/OD Closure Project

Vadose Zone Monitoring to Meet RCRA
Closure/Post Closure Groundwater
Monitoring Requirements
Camp Navajo, AZ

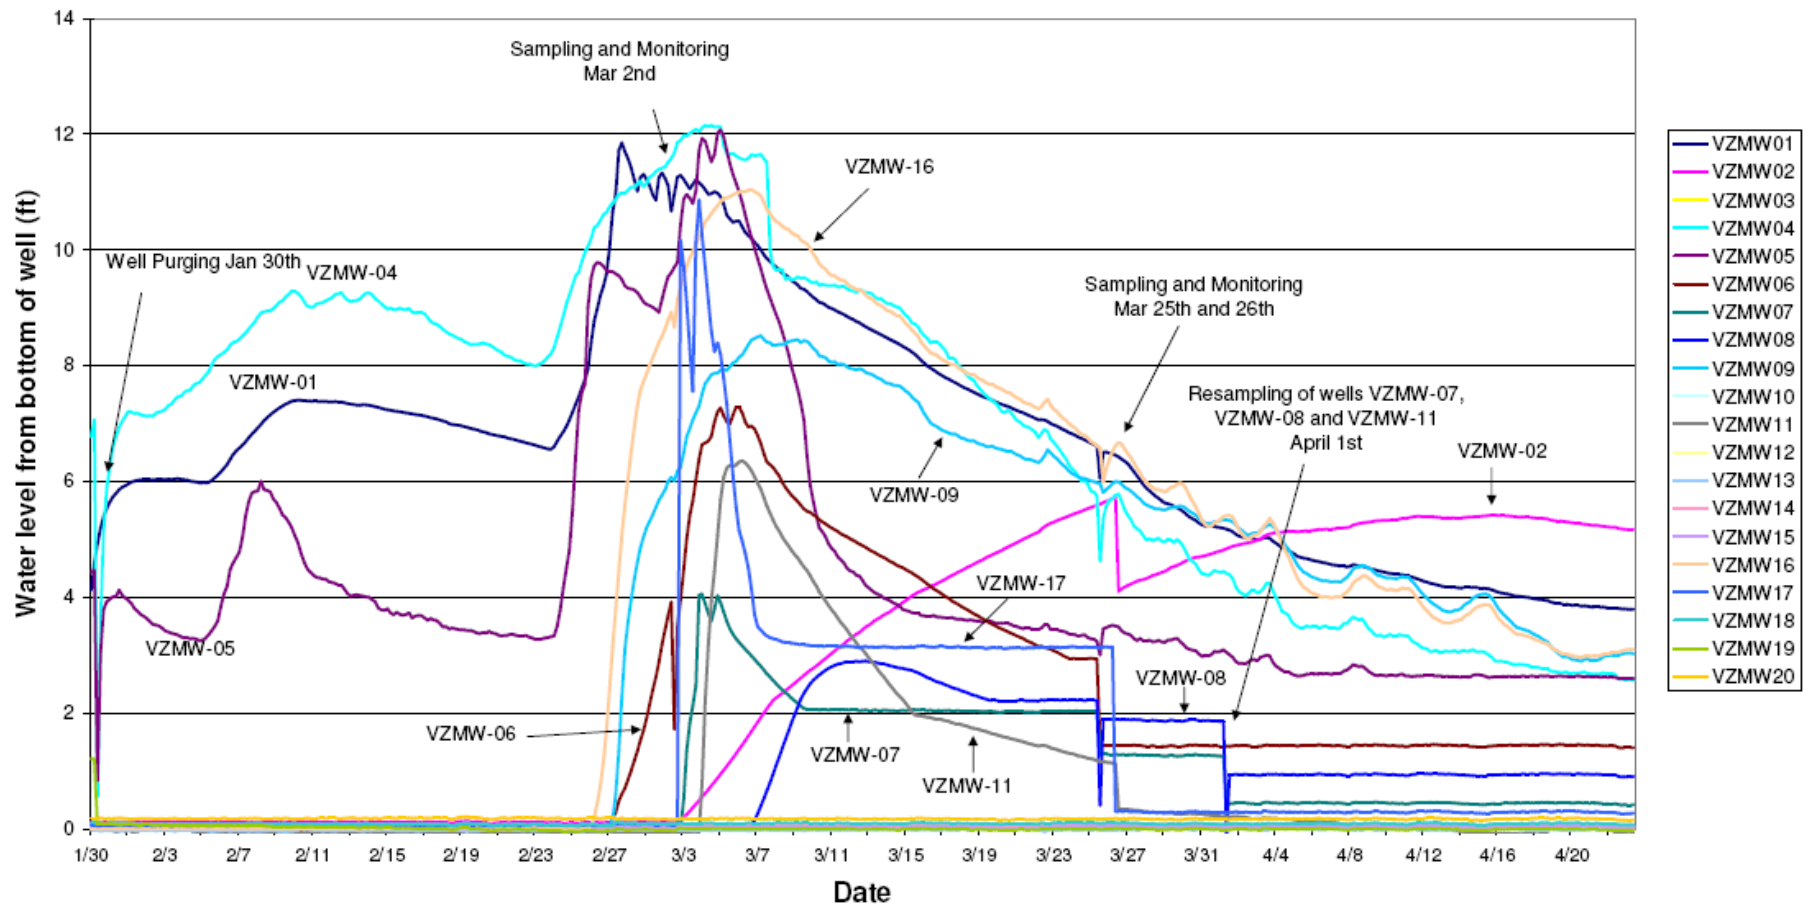
VZMW Hydrographs

- The amount and duration of water moving through the soil vadose zone was unknown
- Remote area, difficult access, 7,300' elevation
- Two infiltration events – spring snowmelt and summer monsoon
- Not known if results would be repeatable

- Four proof-of-concept baseline sampling periods were completed
- 3 to 17 VZ wells had sufficient water to sample
- RDX and perchlorate were detected at a number of locations
- Analytical results were repeatable
- A robust solution that meets the intent of the technical requirements for post-closure detection monitoring
