Beach Replenishment Operational Challenges

Paul Greene

USACE Baltimore District

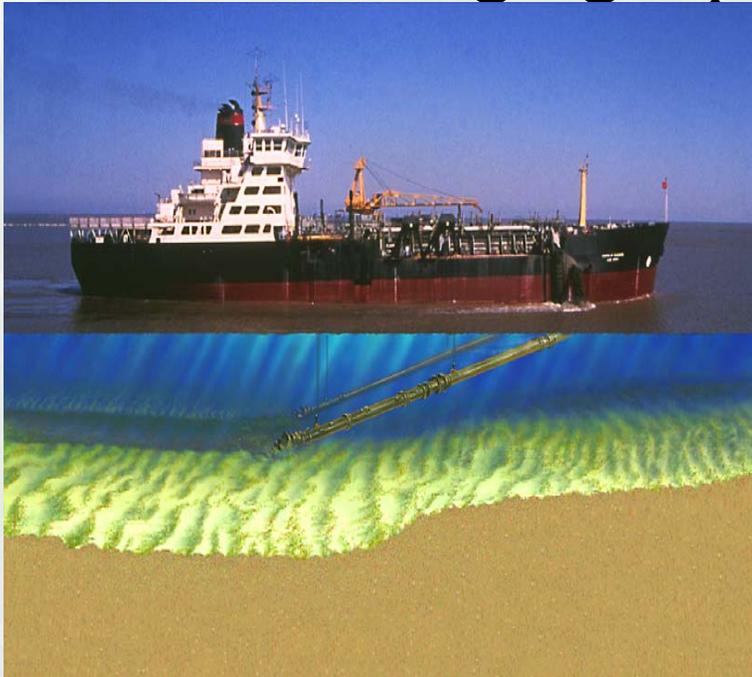
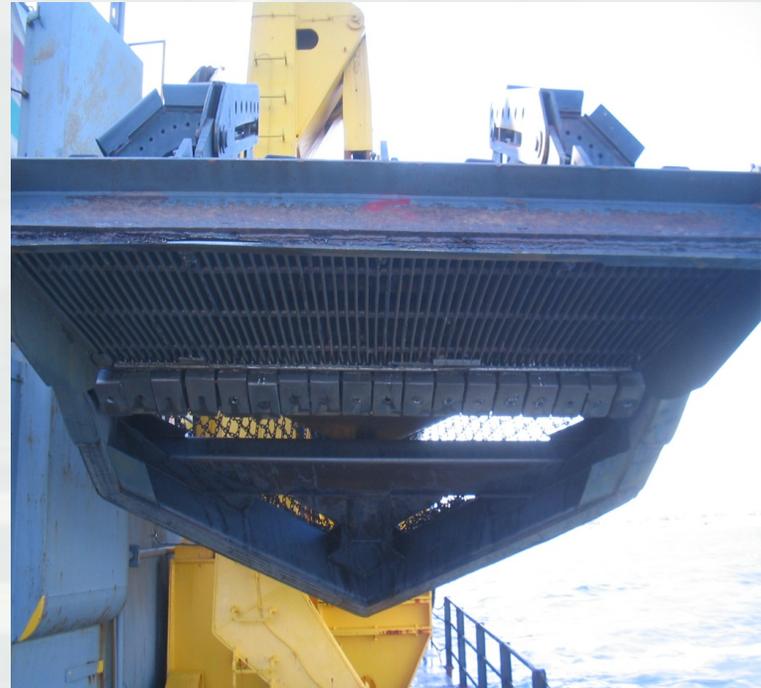
Dredging Operations at SEA

- 1.25 inch screens on dredge intakes (37mm about 1.4" diameter)
- .75 inch screens on outflow basket
- MEC training for dredge and beach crews
- MEC training for USACE personnel
- QA inspection of placed material by OESS.

- Intakes on Dredging Operations

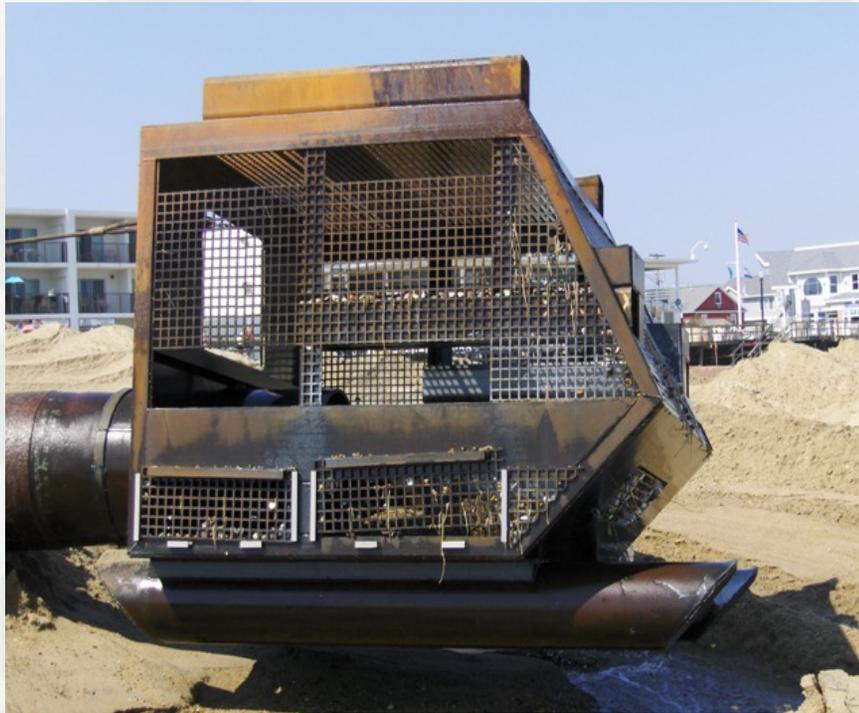
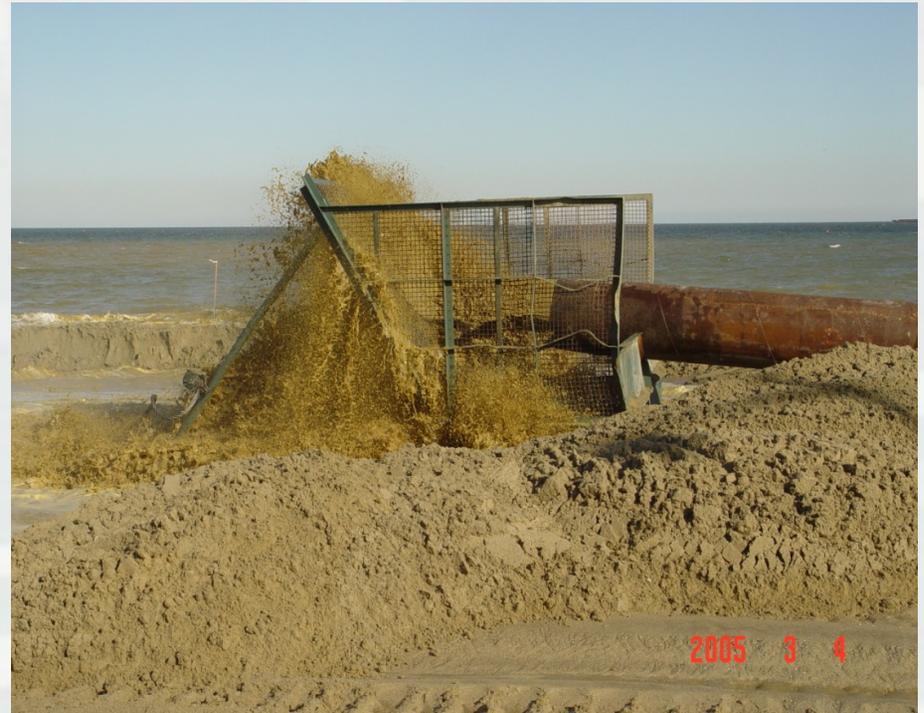
Replenishment Operations on shore

Screens on Shore

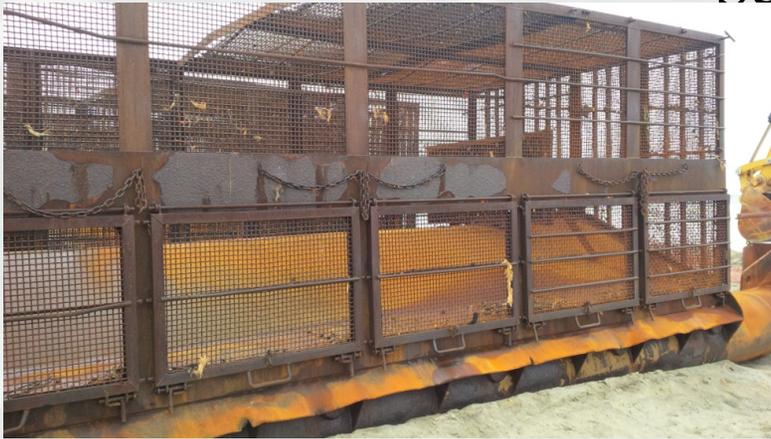
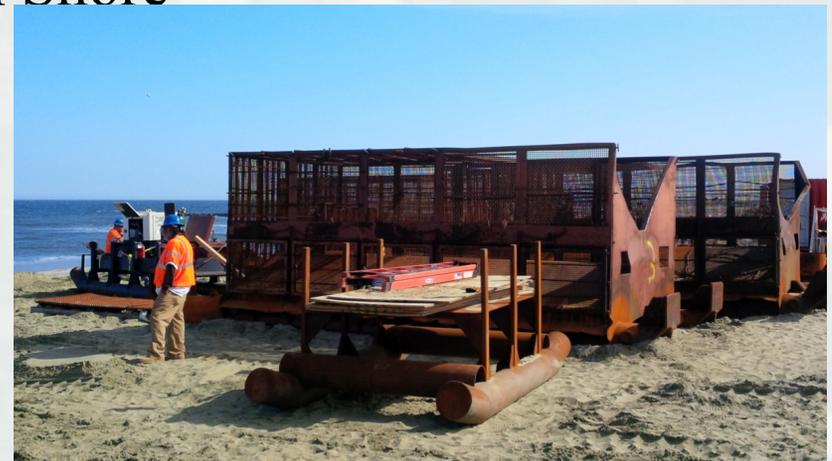
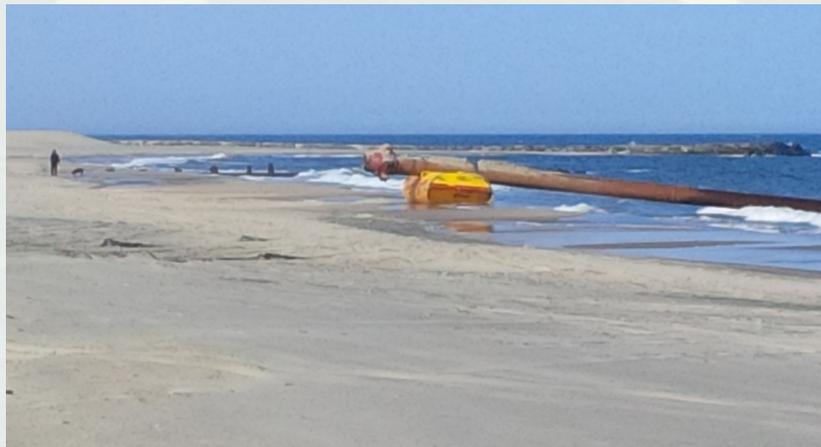
Replenishment Operations on shore

Screens on Shore

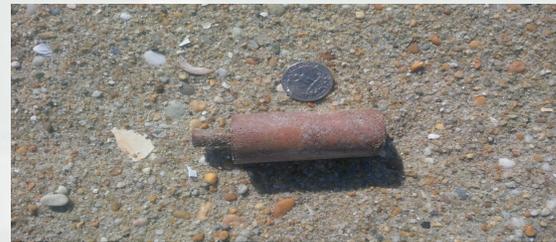
- On 5 May 2015 a beach patron with a metal detector recovered a MK II booster (non-ferrous).

- The USACE team quickly conducted a QA of placed material and discovered that a number of these items had escaped the basket and been placed on the beach.

- Non-ferrous composition of boosters
 - ▶ Non ferrous items were never anticipated
 - ▶ OESS QA was conducted with magnetometers (ferrous)
 - ▶ Non-ferrous boosters were not detected during routine QA sweeps of placed material

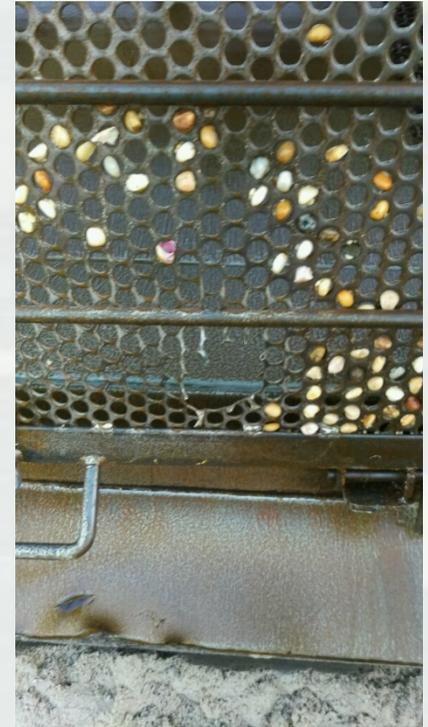
- Preventative Measures Employed
 - ▶ Relocated to alternate borrow area
 - ▶ Modified basket designs
 - ▶ Relief port screens
 - ▶ Reinforcing of baskets
 - ▶ Close inspection after each pumping evolution
 - ▶ QA with all metals detector
- Approximately 932,000 cubic yards of sand will require sifting.
