# Remedial Action, Remedy Performance, and Long-Term Land Management

*Anaconda Smelter NPL Site*

June 2015

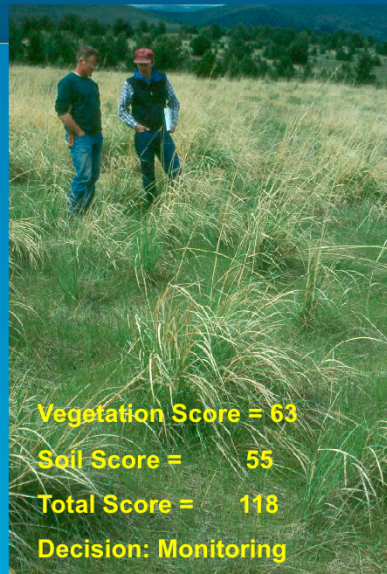
The site on the left had a total vegetation/soil score of 142. The decision for this site was “no action”. This site was definite a candidate for de-listing.

The decision for the site on the right, which had a score of 118 was to continue to monitor it to determine if conditions were improving.

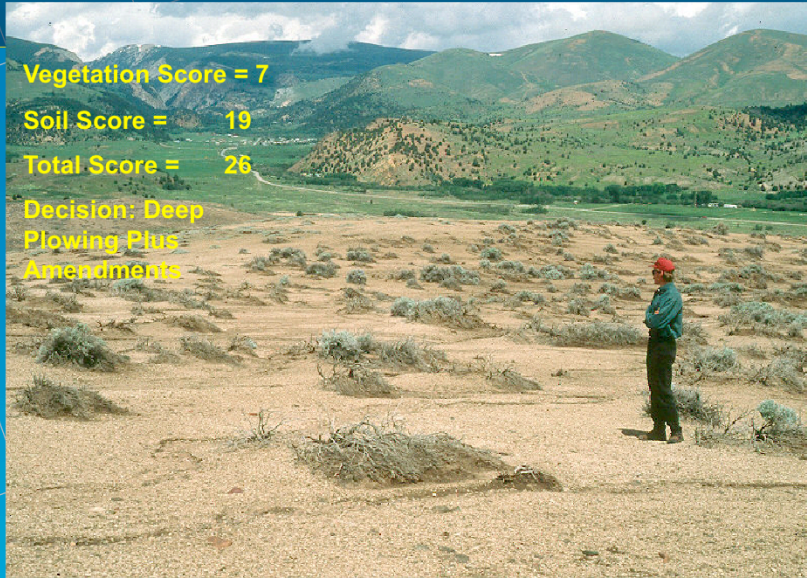
Vegetation Score = 7

Soil Score = 19

Total Score = 26

Decision: Deep  
Plowing Plus  
Amendments

This site is adjacent to the old smelter at Anaconda. The decision for this severely impacted site is deep plowing and the application of lime and organic amendments.

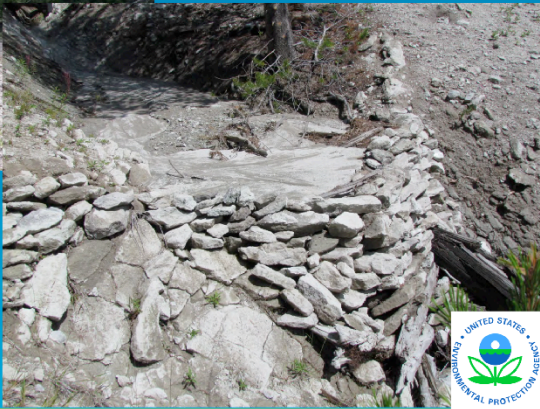
## Constructing Rock Check Dams

Rock Check Dams work well, but rock is hard to find, and they fill up with sediment after 1-2 field seasons

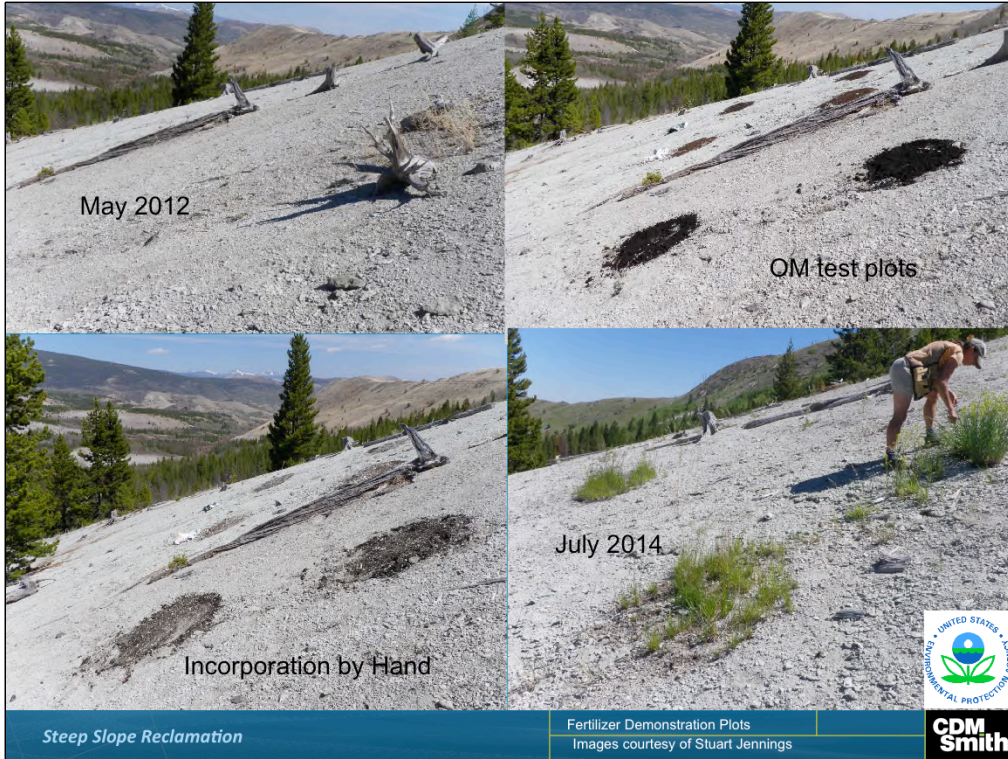
QM test plots

Incorporation by Hand

Fertilizer Demonstration Plots  
 Images courtesy of Stuart Jennings

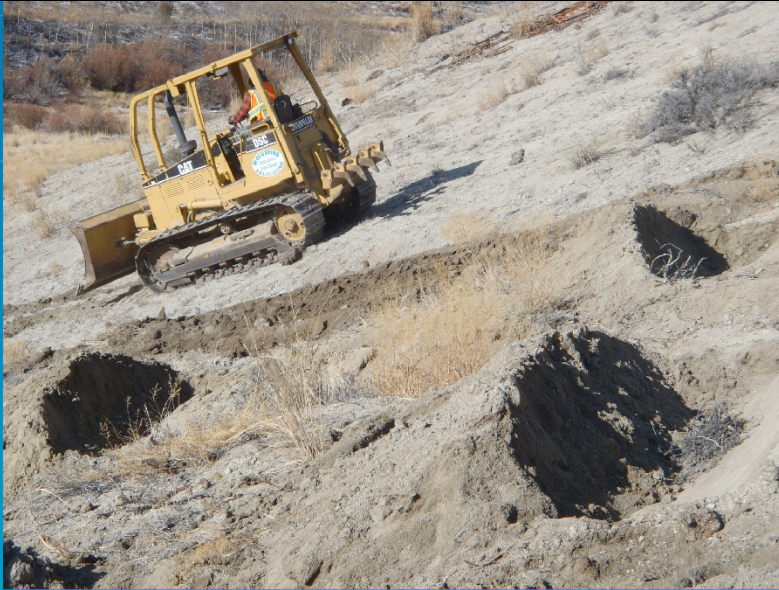
## Constructing Dozer Basins

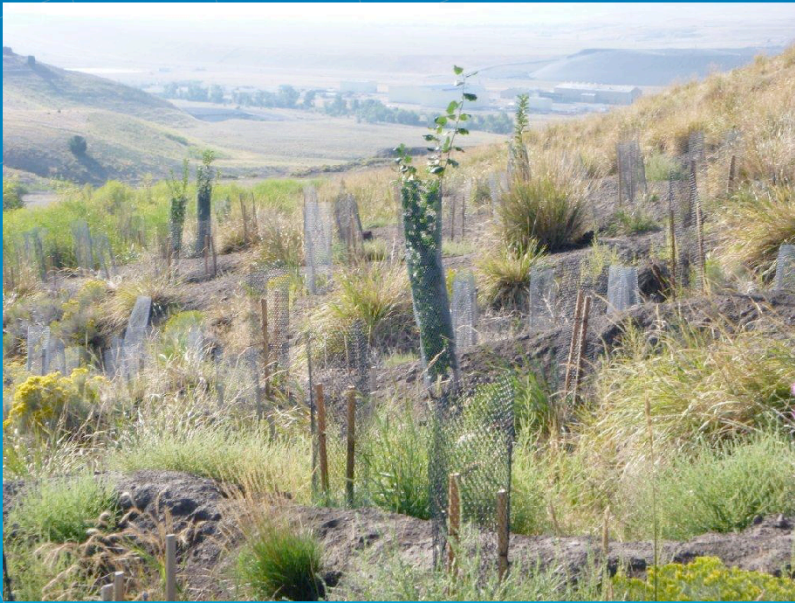
Planting of Trees, Shrubs and Grasses

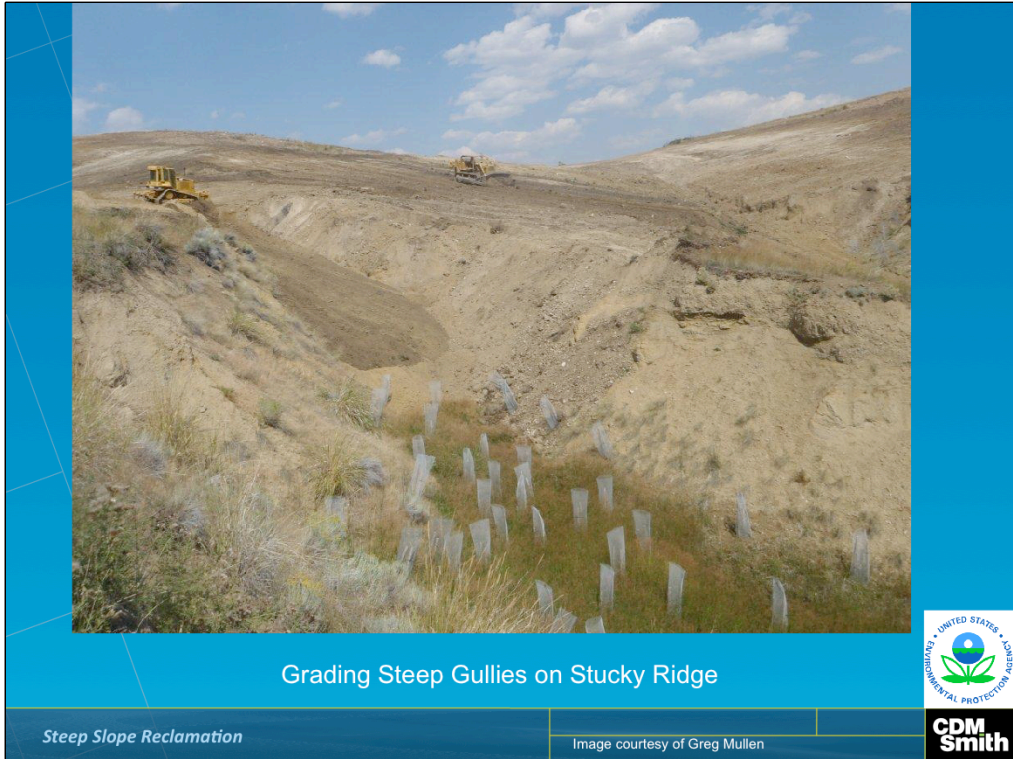
Grading Steep Gullies on Stucky Ridge

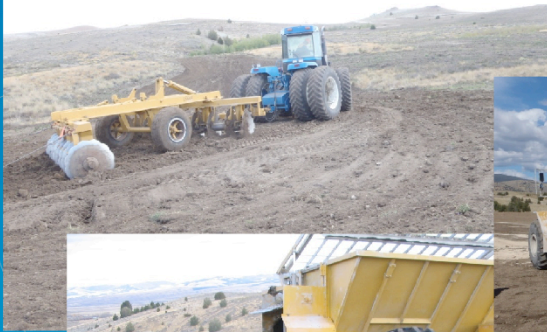
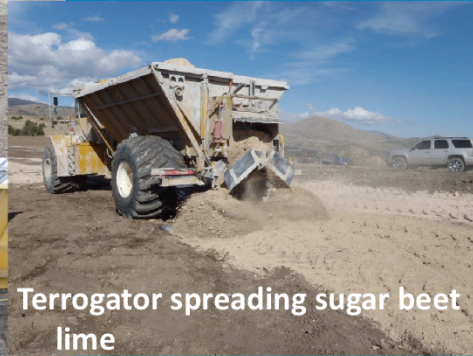
Terrogator spreading sugar beet lime

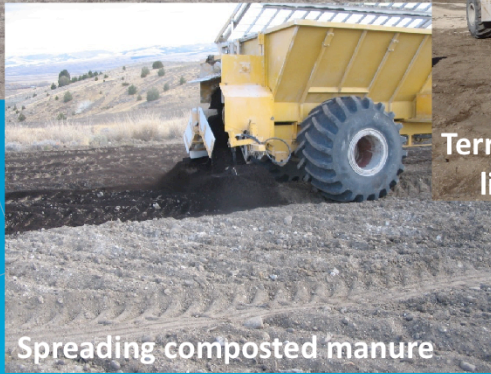
Spreading composted manure

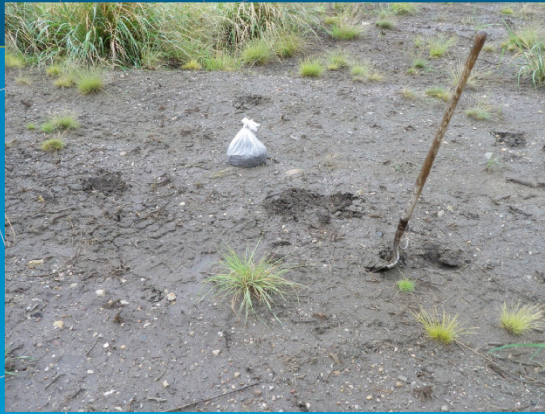
Stressed, chlorotic bunchgrasses in the Stucky Ridge Moto-X Demo Plots

Photograph taken in July 2010 during FYR site inspection

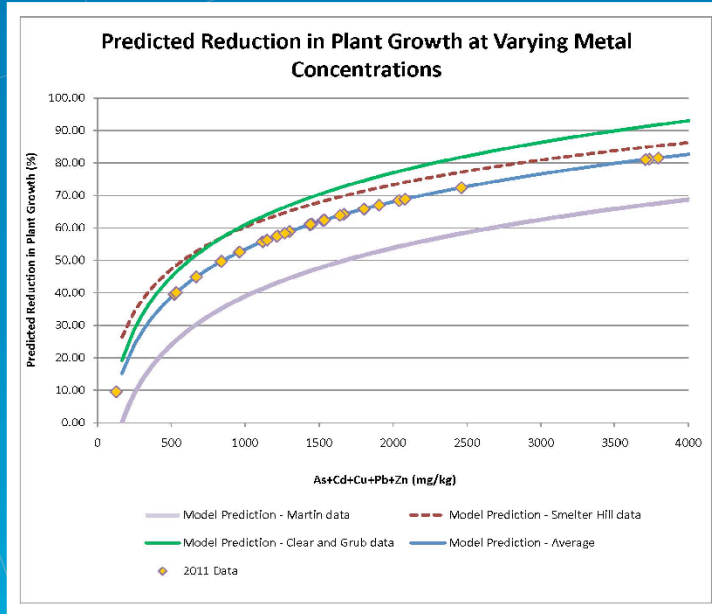
## Curves for all species in each greenhouse study

Comparison between three ARWW&S phytotoxicity models based on soil total metal levels and greenhouse measured reductions in plant root and shoot biomass across all species.

The field metal concentrations measured during the 2011 VS Investigation are plotted against each model suggesting expected reductions in field plant growth using greenhouse measured plant response.

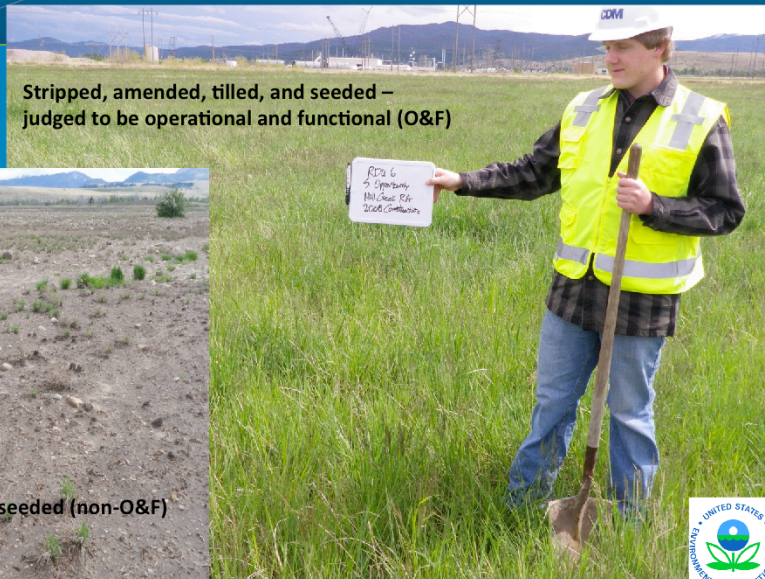
Treated In-Place and seeded (non-O&F)
