# **Technology Demonstration of Sensor Applications to Direct Push Platforms and Monitoring and Operations**

**Contract # F41624-00-C8045**

Technical Report for Field Test 6  
Period of Performance: December 11 – 17, 2003  
Report Date: March 26, 2004

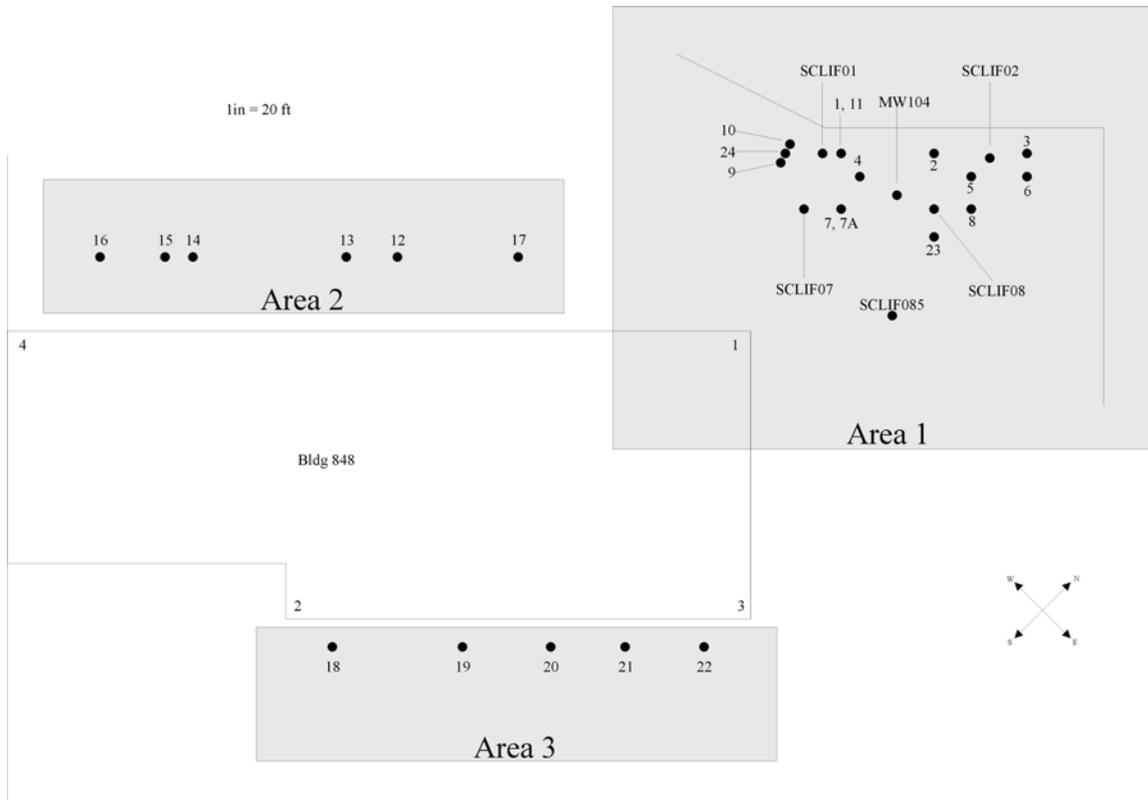
Figure 3. Building 848 site, Rickenbacker IAP, OH

In order to facilitate the data interpretation, the site was split into three areas (Figure 3). By doing this, each of the areas could be more easily represented by a transect of the pushes conducted at that area. For area 1, it was necessary to use three different transects to fully evaluate the area.

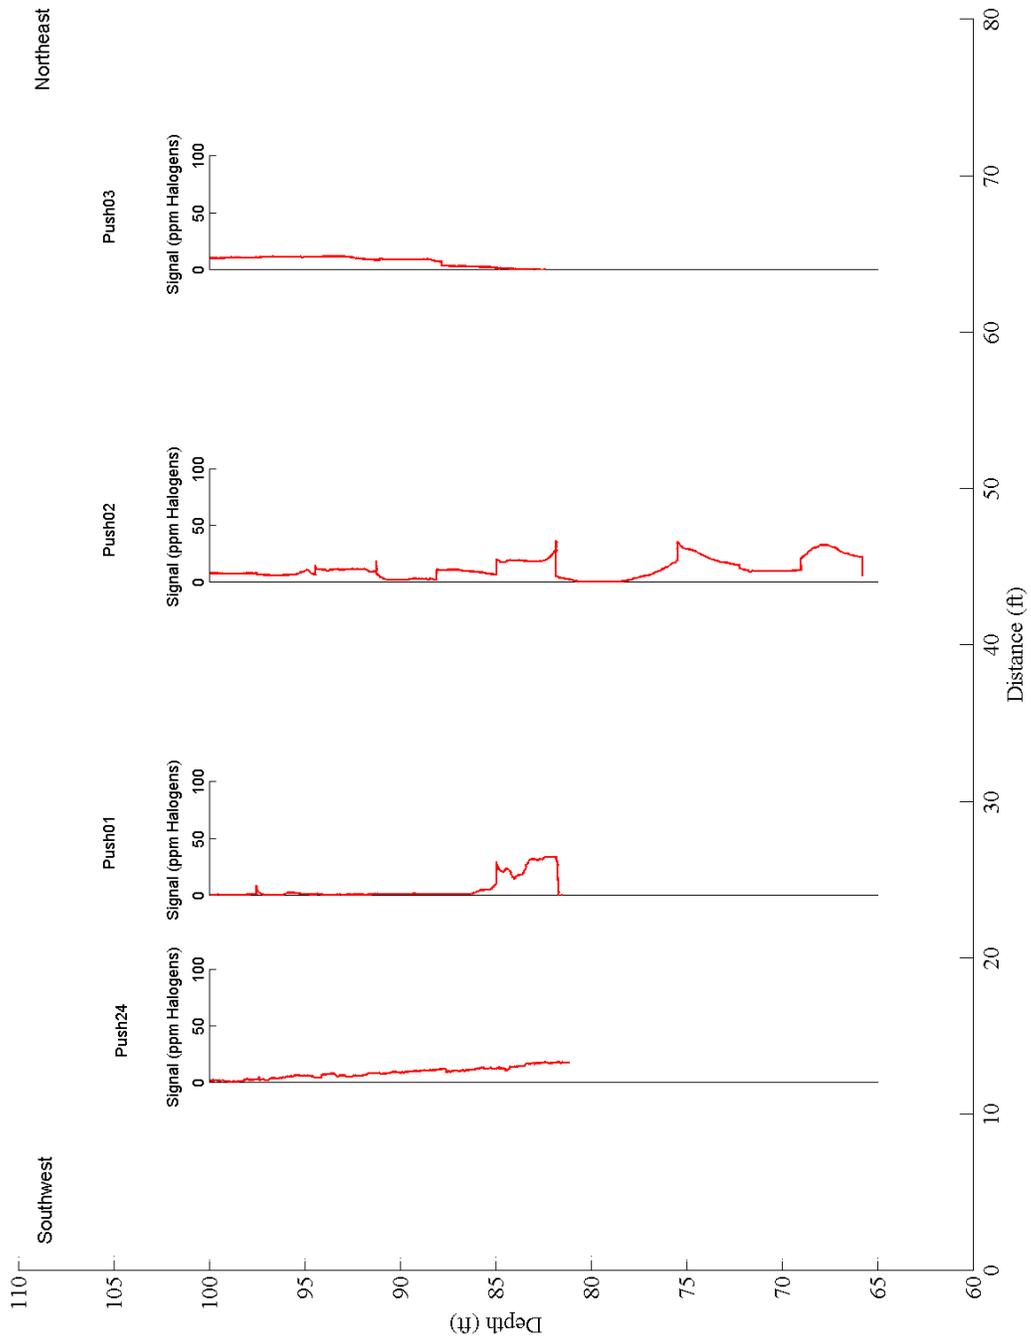
Figure 4. Area 1 transect 1 (concentration scale: 200 ppm Halogens)

The pushes done in area 1 (near MW104) showed most contamination to be just SSW of MW104 (Figures 4, 5, and 6). Pushes at two adjacent locations 07, and 07A had the highest concentrations of halogenated compounds. However, the area of contamination seems to be localized to within a few feet of these pushes since pushes to the south and north had no detectable chlorinated compounds. Several replicate pushes were done; 1 and 11, 7 and 7A, 9, 10 and 24. There was good agreement between 7 and 7A, and among 9, 10 and 24, however pushes 1 and 11 did not have good agreement. This discrepancy may be due to problems discussed previously with the MIP. An interesting feature of pushes 3, 4, 5, and 6 was the baseline decrease in the middle of the push. Currently it is unclear what type of phenomenon would cause a signal decrease in the Haloprobe system

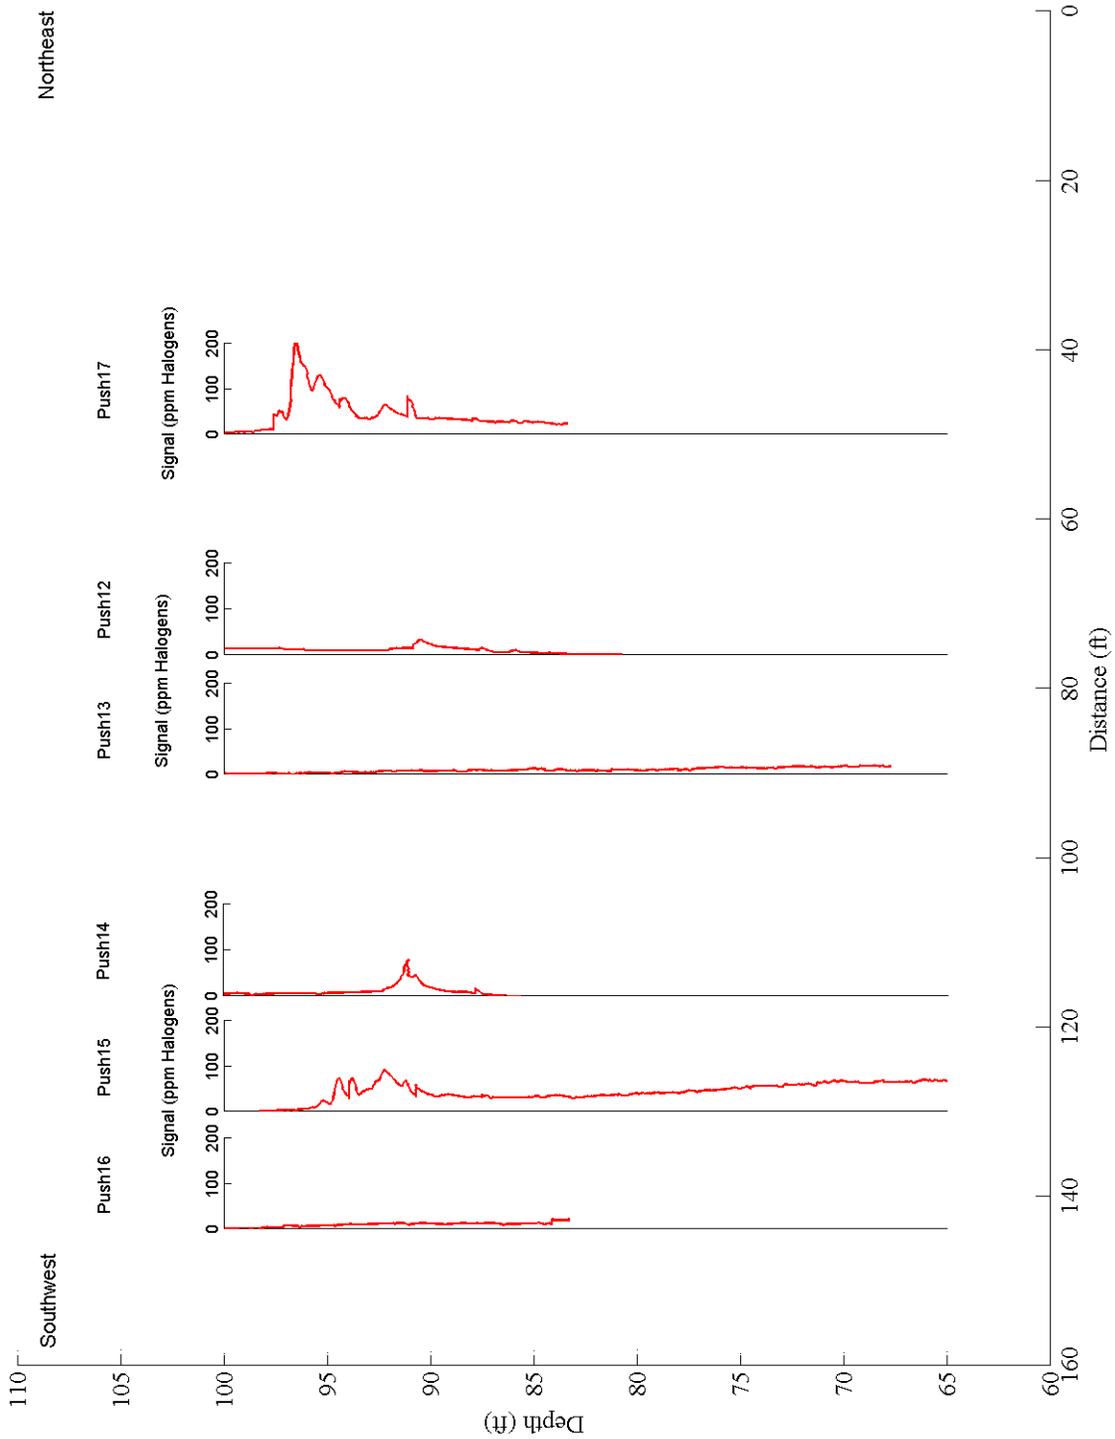
Figure 7. Area 2 transect 1 (concentration scale: 200 ppm Halogens)

Area 2 transect in Figure 7 lies along the Northwest side of building 848. The greatest amount of contamination was noted at push locations 17, 14, and 15 with lesser contamination at location 12. The most heavily impacted area was push location 17

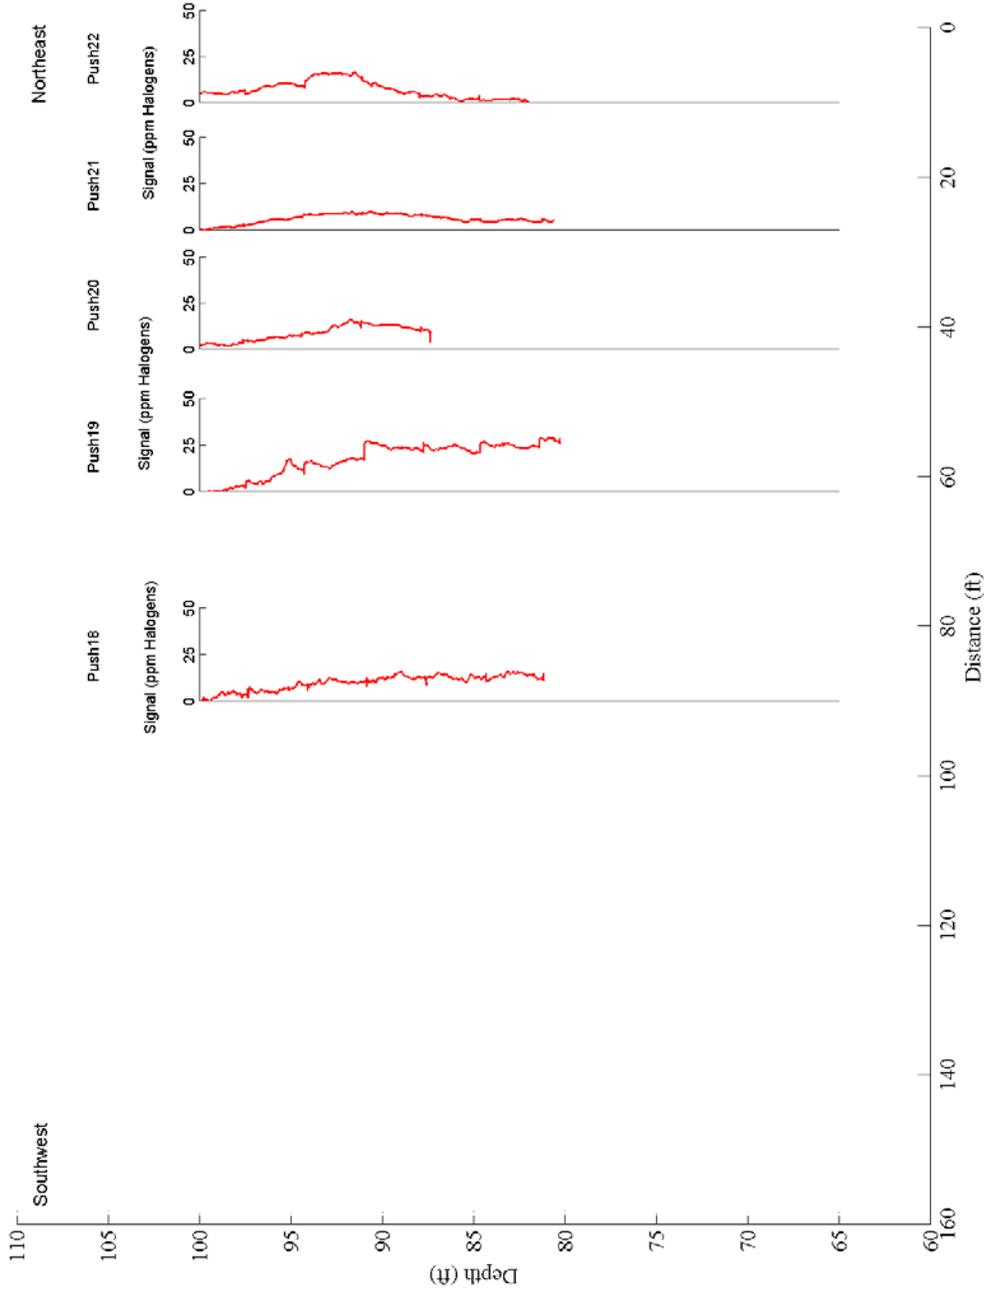
Figure 8. Area 3 transect 1 (concentration scale: 50 ppm Halogens)

The Area 3 transect shown in Figure 8, along the Southeast side of building 848 had low levels of contamination at three of the push locations (20, 21, and 22). Signal increases in pushes 18 and 19 are indicative of baseline drift rather than actual contamination. This is evidenced by the change in the signal levels at rod breaks rather than during actual probe movement. An interesting feature of the logs in this area is the amorphous shape of the logs. It is unclear whether this shape is due to a low concentration, homogeneous distribution through the soil or from system drift.

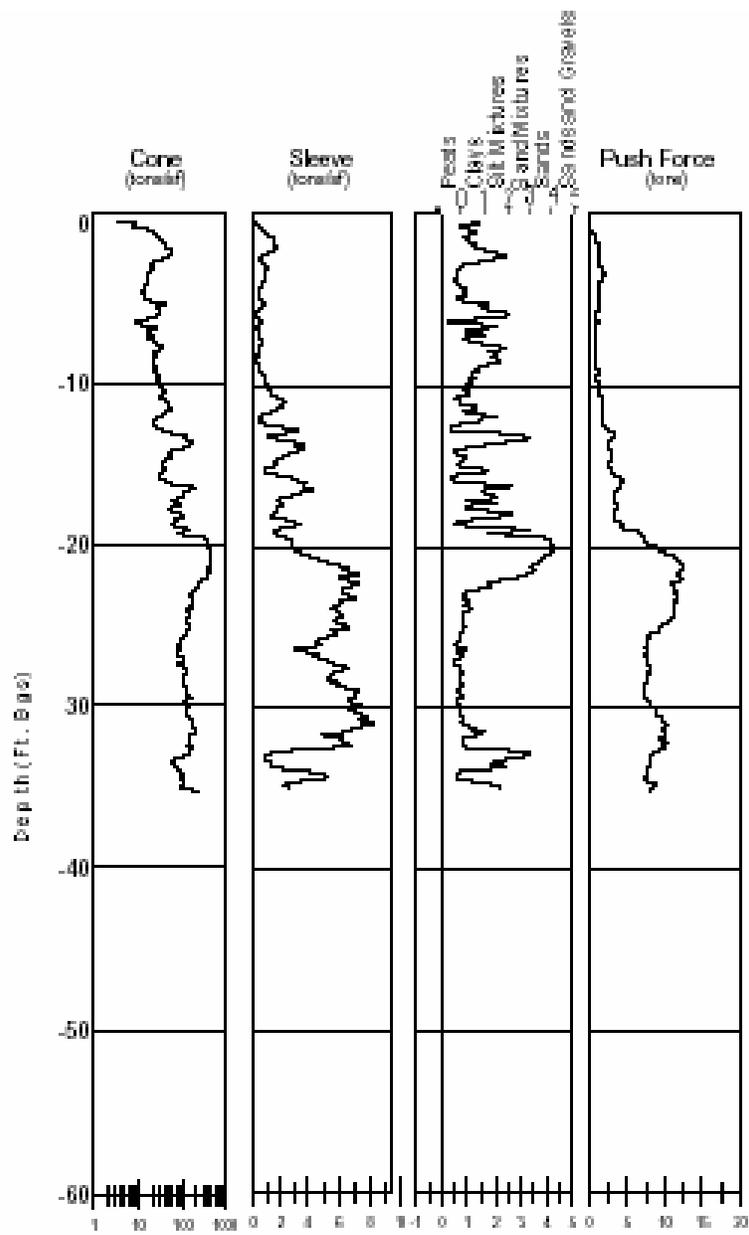
Site Characterization and Analysis Reference System	Push Date 12/12/20 Prepush Depth (Ft) 0.00	Project: Rickenbacker Site 41
	U.S. Army Engineer District Kansas City Geotechnical Branch	Probe Depth (Ft) 35.37 Scale 1"=10'	Push Name SCAPS2.GRF

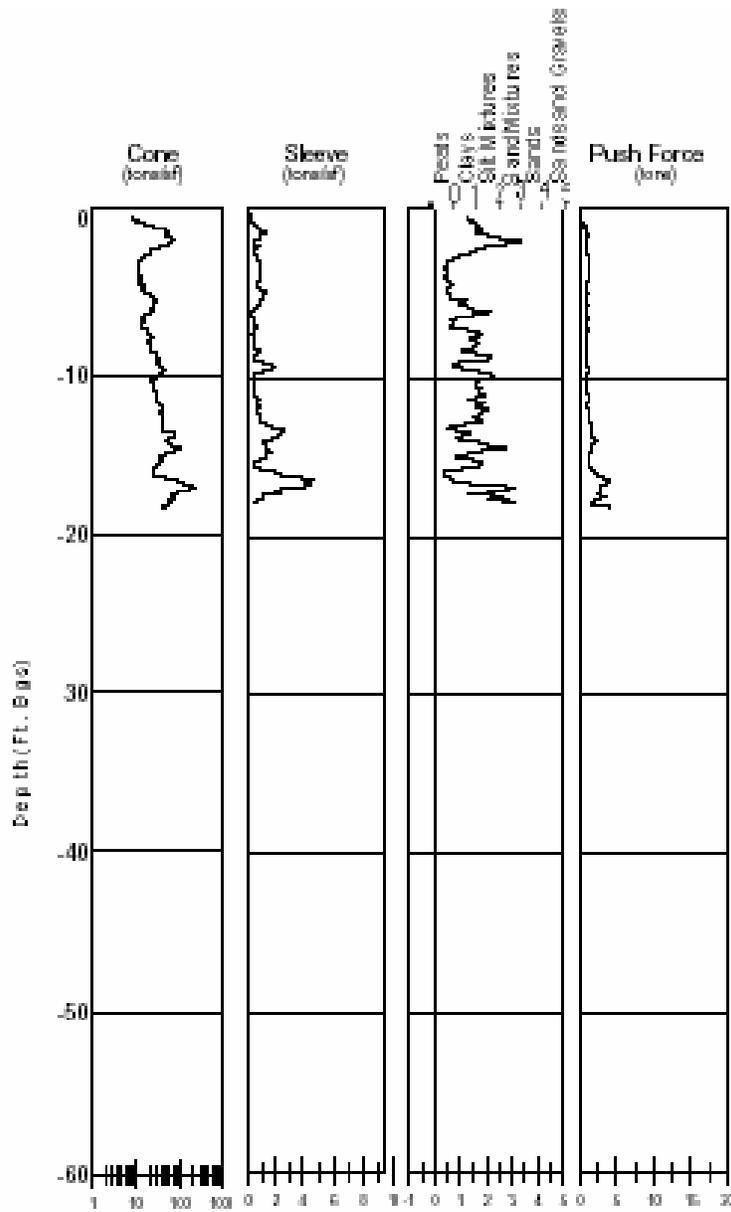
<p><b>NWK</b> <b>SCAPS</b></p>	<p>Site Classification and Analysis Pneumatic System</p>	<p>Push Date 12/12/20</p>	<p>Project: Rickenbacker Site 41</p>
	<p>US Army Engineer District Kansas City Geotechnical Branch</p>	<p>Prepush Depth (Ft) 0.00</p>	<p>Probe Depth (Ft) 18.73</p>
		<p>Scale 1"=10'</p>	<p>Push Name SCAPS3.GRF</p>

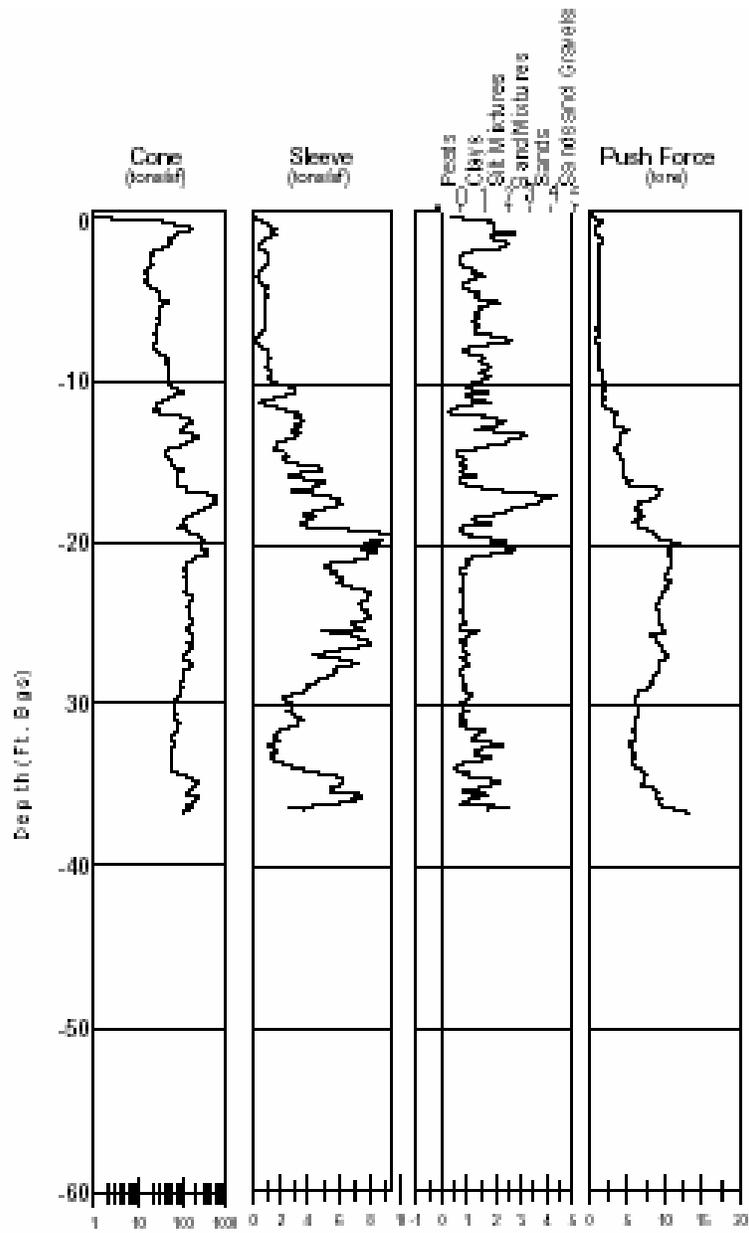
<p><b>NWK</b></p> <p><b>SCAPS</b></p>	<p>Site Characterization and Analysis Reference System</p>	<p>Push Date 12/12/20</p>	<p>Project: Rickenbacker Site 41</p>
	<p>U.S. Army Engineer District Kansas City Geotechnical Branch</p>	<p>Prepush Depth (Ft) 0.00</p>	<p>Probe Depth (Ft) 38.80</p>
	<p>Scale 1"=10'</p>	<p>Push Name SCAPS4.QRF</p>

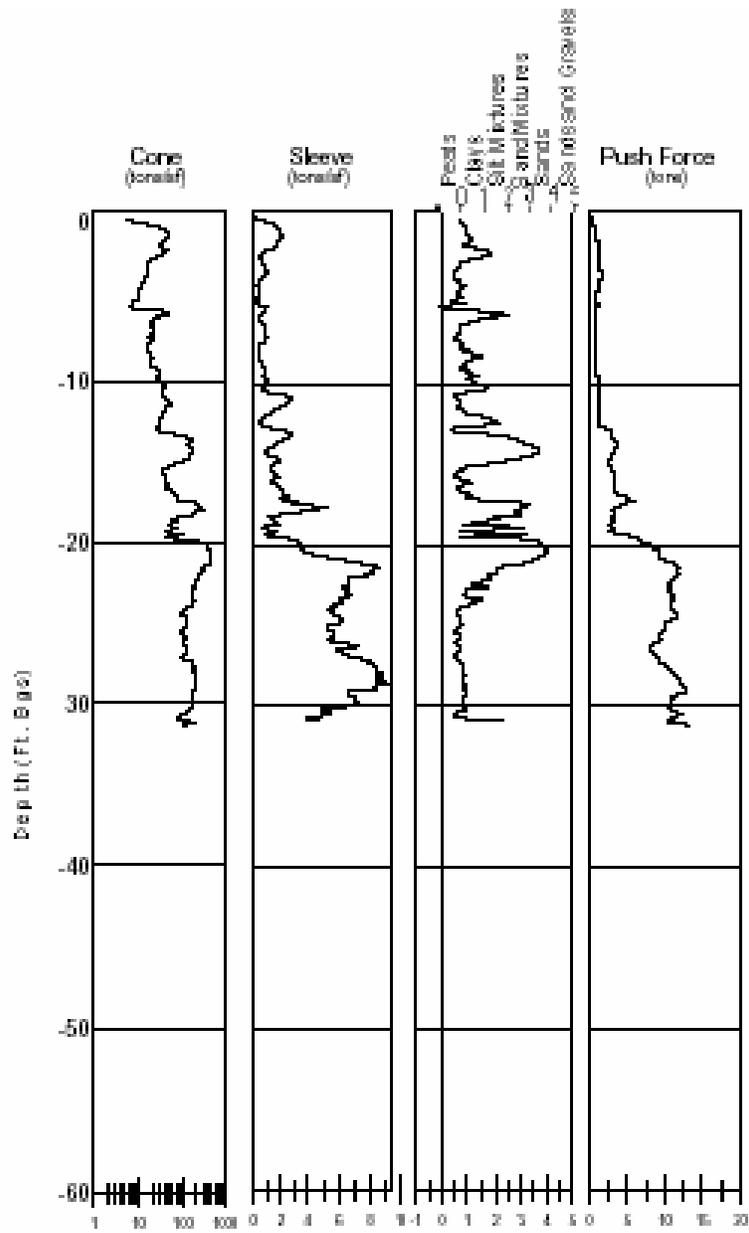
<b>NWK</b>  <b>SCAPS</b>	Site Characterization and Analysis Reference System	Push Date 12/12/20  Prepush Depth (Ft) 0.00	Project: Rickenbacker Site 41
	U.S. Army Engineer District Kansas City Geotechnical Branch	Probe Depth (Ft) 31.53  Scale 1"=10'	Push Name SCAPS5.QNF

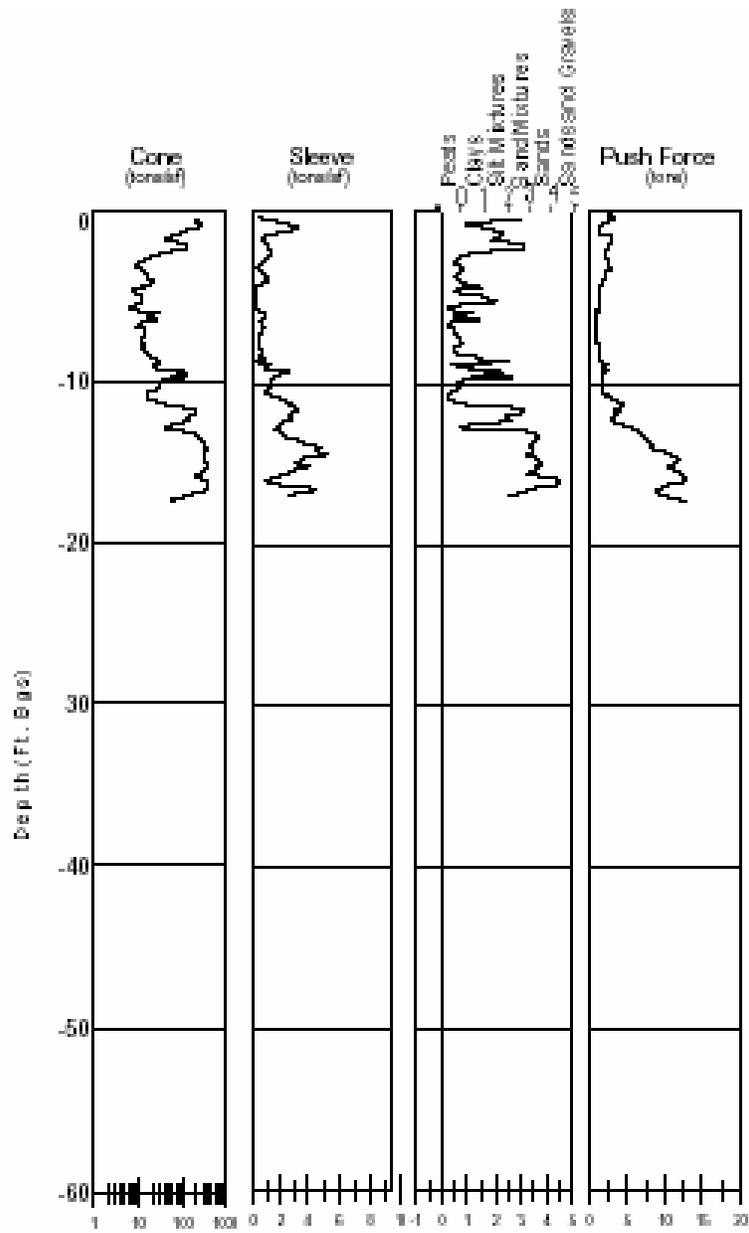
<p><b>NWK</b></p> <p><b>SCAPS</b></p>	<p>Site Characterization and Analysis Reconnaissance System</p>	<p>Push Date 12/17/20</p>	<p>Project:</p>
	<p>US Army Engineer District Kansas City Geotechnical Branch</p>	<p>Prepush Depth (Ft) 0.00</p>	
		<p>Probe Depth (Ft) 17.75</p>	
		<p>Scale 1"=10'</p>	<p>Push Name SCAPS17.QNF</p>

Three soil samples were obtained. Soil sample intervals were based on Haloprobe response. Three analytical samples were obtained with a direct push Vertek sampler and placed in jars provided by Parsons and in the custody of Shaw Environmental. Shaw Environmental handled all labels and custody requirements. Sample borings were placed as close as possible to the corresponding Haloprobe push. One sample was obtained from each of the three areas identified around building 848. Table 1 summarizes the soil sampling efforts.

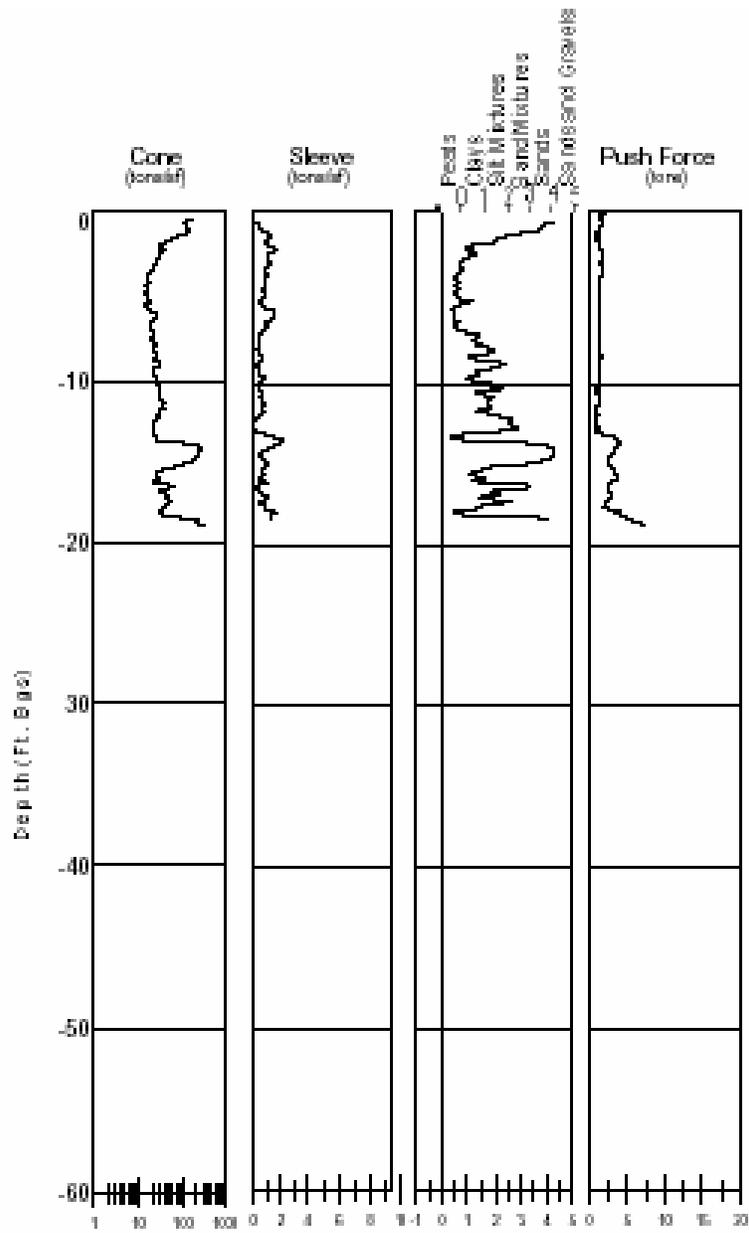
Site Characterization and Analysis Reconnaissance System	Push Date 12/17/20	Project: Rickenbacker
	U.S. Army Engineer District Kansas City Geotechnical Branch	Prepush Depth (Ft) 0.00	
		Probe Depth (Ft) 19.23	
		Scale 1"=10'	Push Name SCAPS22.QNF

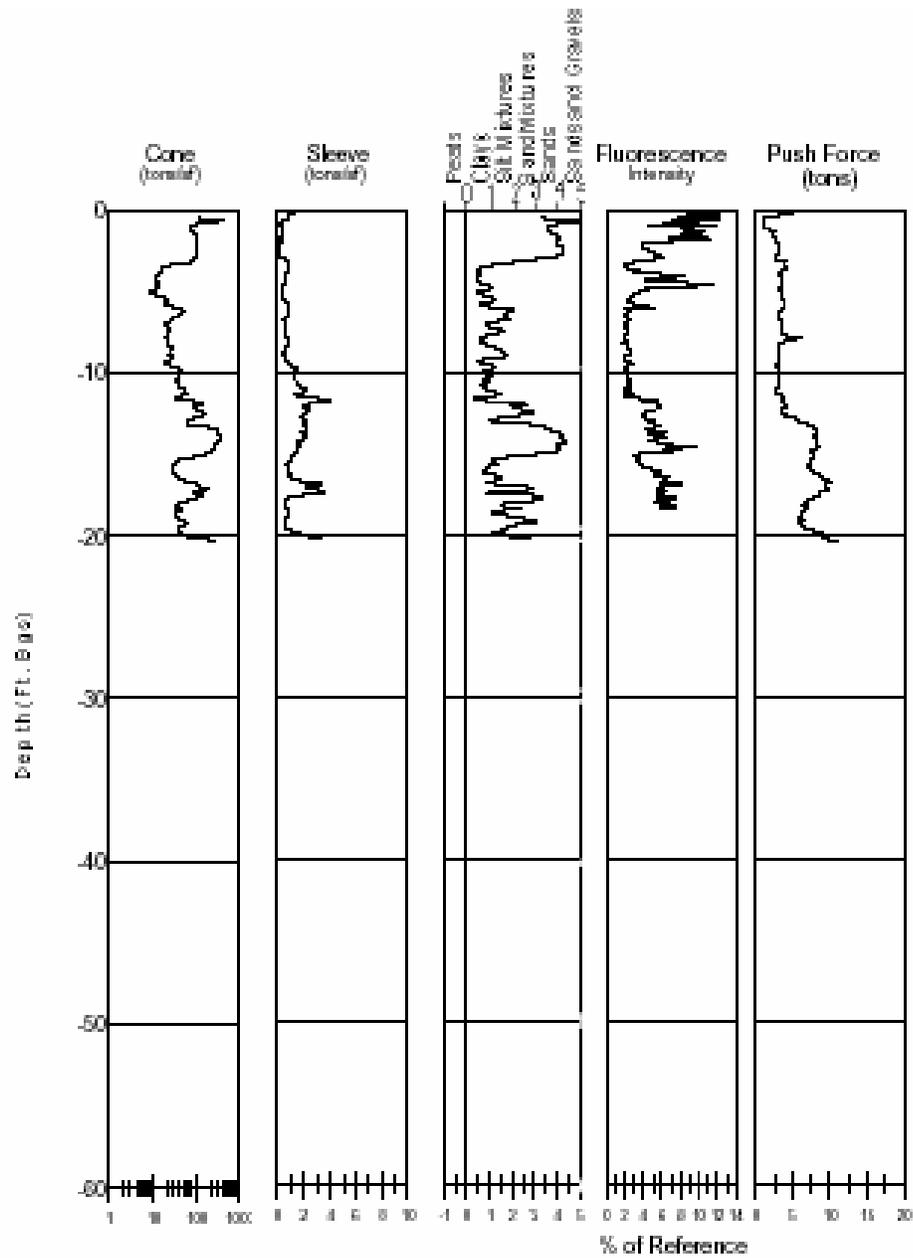
<p><b>NWK</b></p> <p><b>SCAPS</b></p>	<p>Site Classification and Analysis Rackmaster System</p>	<p>Push Date 12/15/200</p>	<p>Project Rickenbacker Site 41</p>
	<p>US Army Engineer District Kansas City Geotechnical Branch</p>	<p>Prepush Depth (Ft) 0.00</p>	<p>Push Name SCLIF01.QNF</p>
	<p>Probe Depth (Ft) 20.44</p>

Visual or odiferous evidence of fuel was at the top of many of the thirteen pushes so while waiting to rebuild the Haloprobe, the SCAPS used laser induced fluorescence (LIF) to investigate the same area. LIF is sensitive to polycyclic aromatic hydrocarbons which are present in fuels, and thus are an indirect measurement of the presence of fuels. Five LIF pushes were made near several of the Haloprobe holes. These holes are identified as SCLIF01, SCLIF02, SCLIF07, SCLIF08, and SCLIF8.5. A fluorescence response indicative of hydrocarbons was noted in 4 of the 5 pushes between 5 and 10 feet and /or 10 and 20 feet.

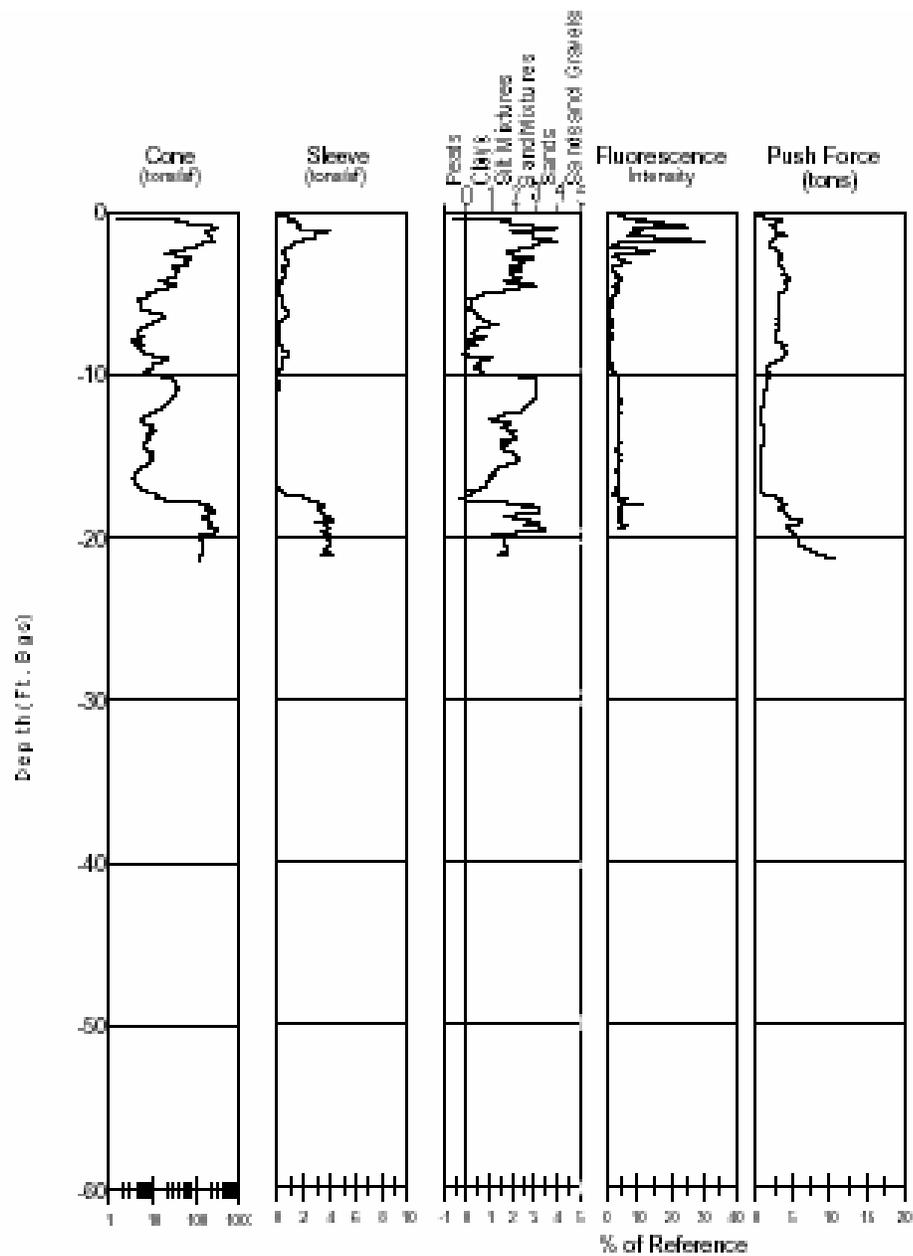
<p><b>NWK</b></p> <p><b>SCAPS</b></p>	<p>Site Classification and Analysis Rackmaster System</p>	<p>Push Date 12/15/200</p>	<p>Project Rickenbacker Site 41</p>
	<p>US Army Engineer District Kansas City Geotechnical Branch</p>	<p>Prepush Depth (Ft) 0.00</p>	
		<p>Probe Depth (Ft) 21.44</p>	<p>Push Name SCLIF85.QNF</p>

One push (SCLIF8.5) had some response at the surface and a minor response at approximately 18 feet coincident with a clay-silty sand contact. The deeper response may be due to the presence of hydrocarbons or to some naturally occurring organics.
