Two-Dimensional Resistivity Investigation of the North Cavalcade Street Site, Houston, Texas, August 2003

Scientific Investigations Report 2005-5205

By Wade H. Kress and Andrew P. Teeple

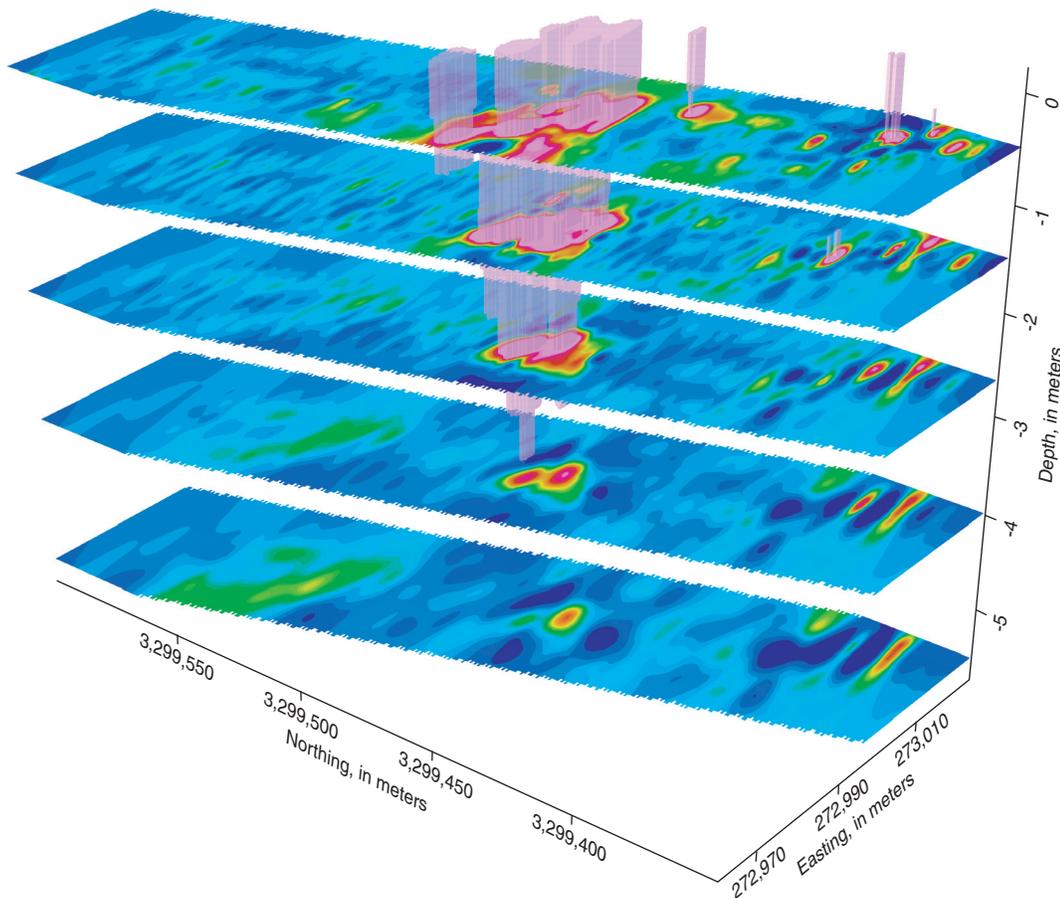
Cover illustration created using Oasis Montage to show geophysical results identifying possible areas of creosote contamination at the North Cavacade Street site, Houston, Texas.

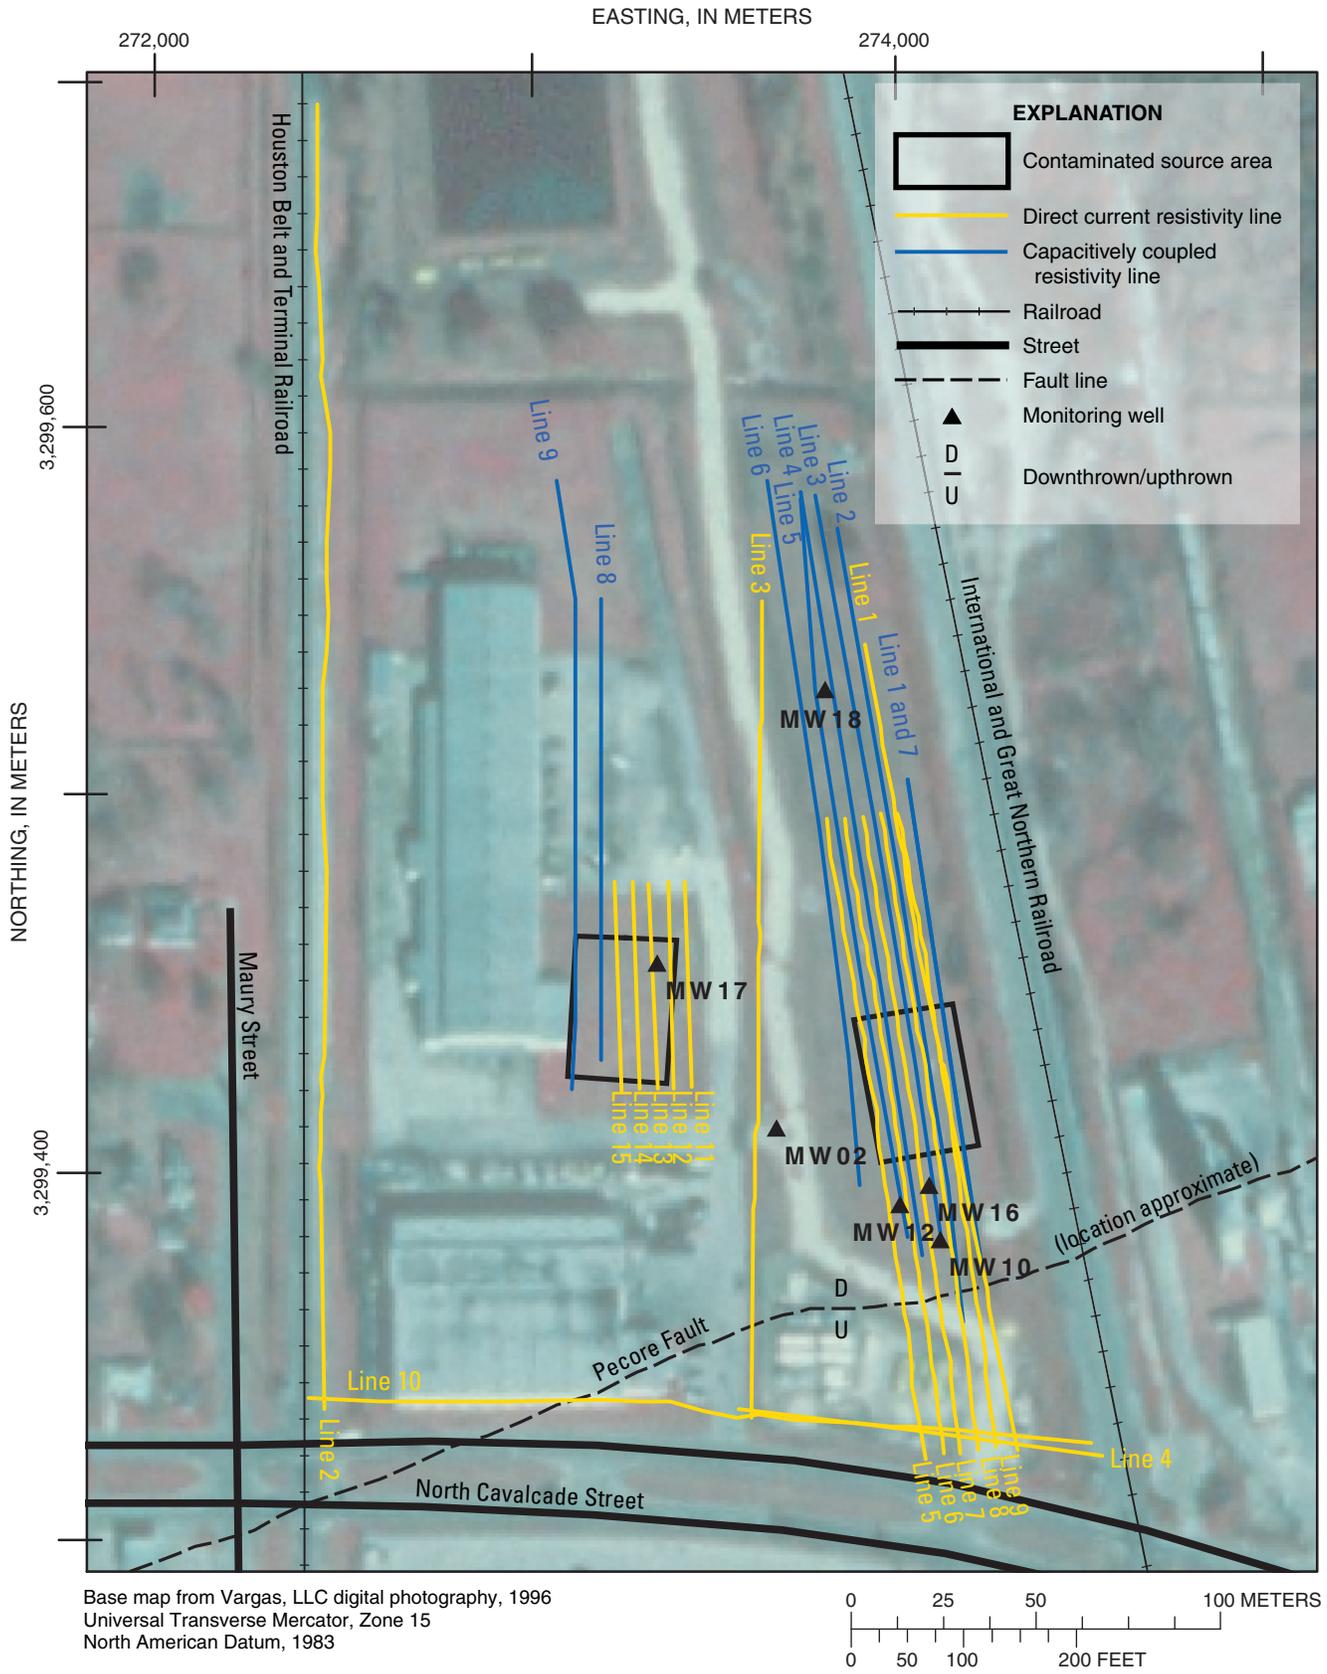
Figure 2. Map of the North Cavalcade Street site showing the direct current and capacitively coupled resistivity data locations, as well as the location of monitoring wells and infrastructure. Location of the contaminated source areas and the Pecore Fault were digitized from Camp Dresser & McGee (figure 2-4 and exhibit 2, 1987).

The DC resistivity data at the North Cavalcade Street site were collected along 15 lines (fig. 2) using an IRIS Syscal R1

Data from lines 1 through 4 and 10 were collected to define the extent and thickness of strata surrounding the North Cavalcade Street site (fig. 2). Lines 1, 3, and 10 also were positioned to collect data near the Pecore Fault. Resistive anomalies identified in the inversion results of the CC resistivity data (figs. 5-6) were used to aid in the placement of 10 additional DC resistivity lines (fig. 2). Data from lines 5 through 9 were collected near the eastern contaminated source area and data from lines 11 through 15 were collected near the western contaminated source area to further define resistive anomalies identified in the CC resistivity data and to provide additional information on the extent and thickness of the strata associated with these resistive anomalies. Lines 5 through 9 also were positioned to collect data near the approximate location of the Pecore Fault (based on fig. 2-4 of Camp Dresser & McGee Inc. (CMD), 1987).

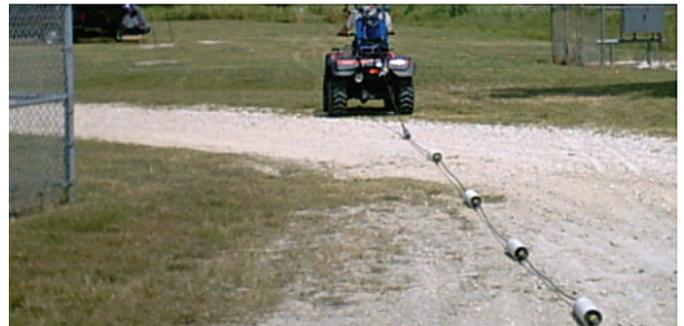
The Geometrics TR4 OhmMapper (fig. 3), a mobile resistivity measuring system, was used to perform the CC resistivity survey. This system uses one transmitter dipole and four receiver dipoles, which establish electrical contact with the earth through capacitive coupling. The transmitter dipole and receiver dipoles were towed across the ground surface behind an all-terrain vehicle (ATV) as resistivity data were continuously collected in a series of nine lines (fig. 2). A sub-meter accuracy, differentially corrected global positioning system (DGPS), interfaced directly with the logging unit of the OhmMapper, was used to collect continuous locational data. The use of the ATV and the DGPS provide the user with the ability to characterize the subsurface over a large area in a relatively short amount of time (Geometrics, 2004).

Figure 3. Photograph showing the Geometrics OhmMapper capacitively coupled resistivity system towed behind an all-terrain vehicle.

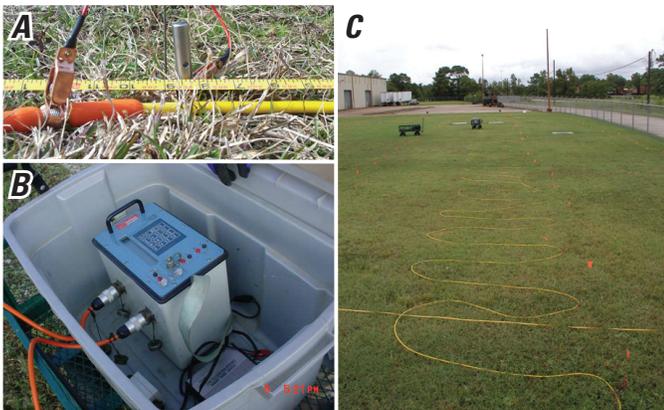
The electrodes were connected to electrode terminals built into multi-conductor cables (fig. 4a) and joined by an automatic switching unit (fig. 4b). These units are designed to automatically perform pre-defined sets of resistivity measurements using multiple electrodes to facilitate more rapid data collection (Stanton and others, 2003).

Plus switching unit (fig. 4b). Using four electrodes at a time, the unit switches among a combination of four sets of multi-conductor cables (fig. 4c) to collect multiple points from a single layout. Electrodes were typically placed every 5 meters, and spacing was decreased where needed to accommodate field conditions or to increase data density. After the initial section of data was collected, the first cable of 18 electrodes was moved ahead of the survey line. A partial section of data was then collected using the previous 56 electrodes (electrodes 19-72) and the 18 electrodes (electrodes 73-90) that were just moved. This process, known as the roll-along technique, was continued until all data along the desired line length were collected. The data from the roll-alongs were combined into a single dataset during processing.

Figure 4. Photographs showing (A) a stainless steel electrode connected to the electrode takeout built into the multi-conductor cable, (B) IRIS Syscal R1 Plus resistivity meter connected to multi-conductor cables, and (C) direct-current resistivity equipment set up on survey line 12.

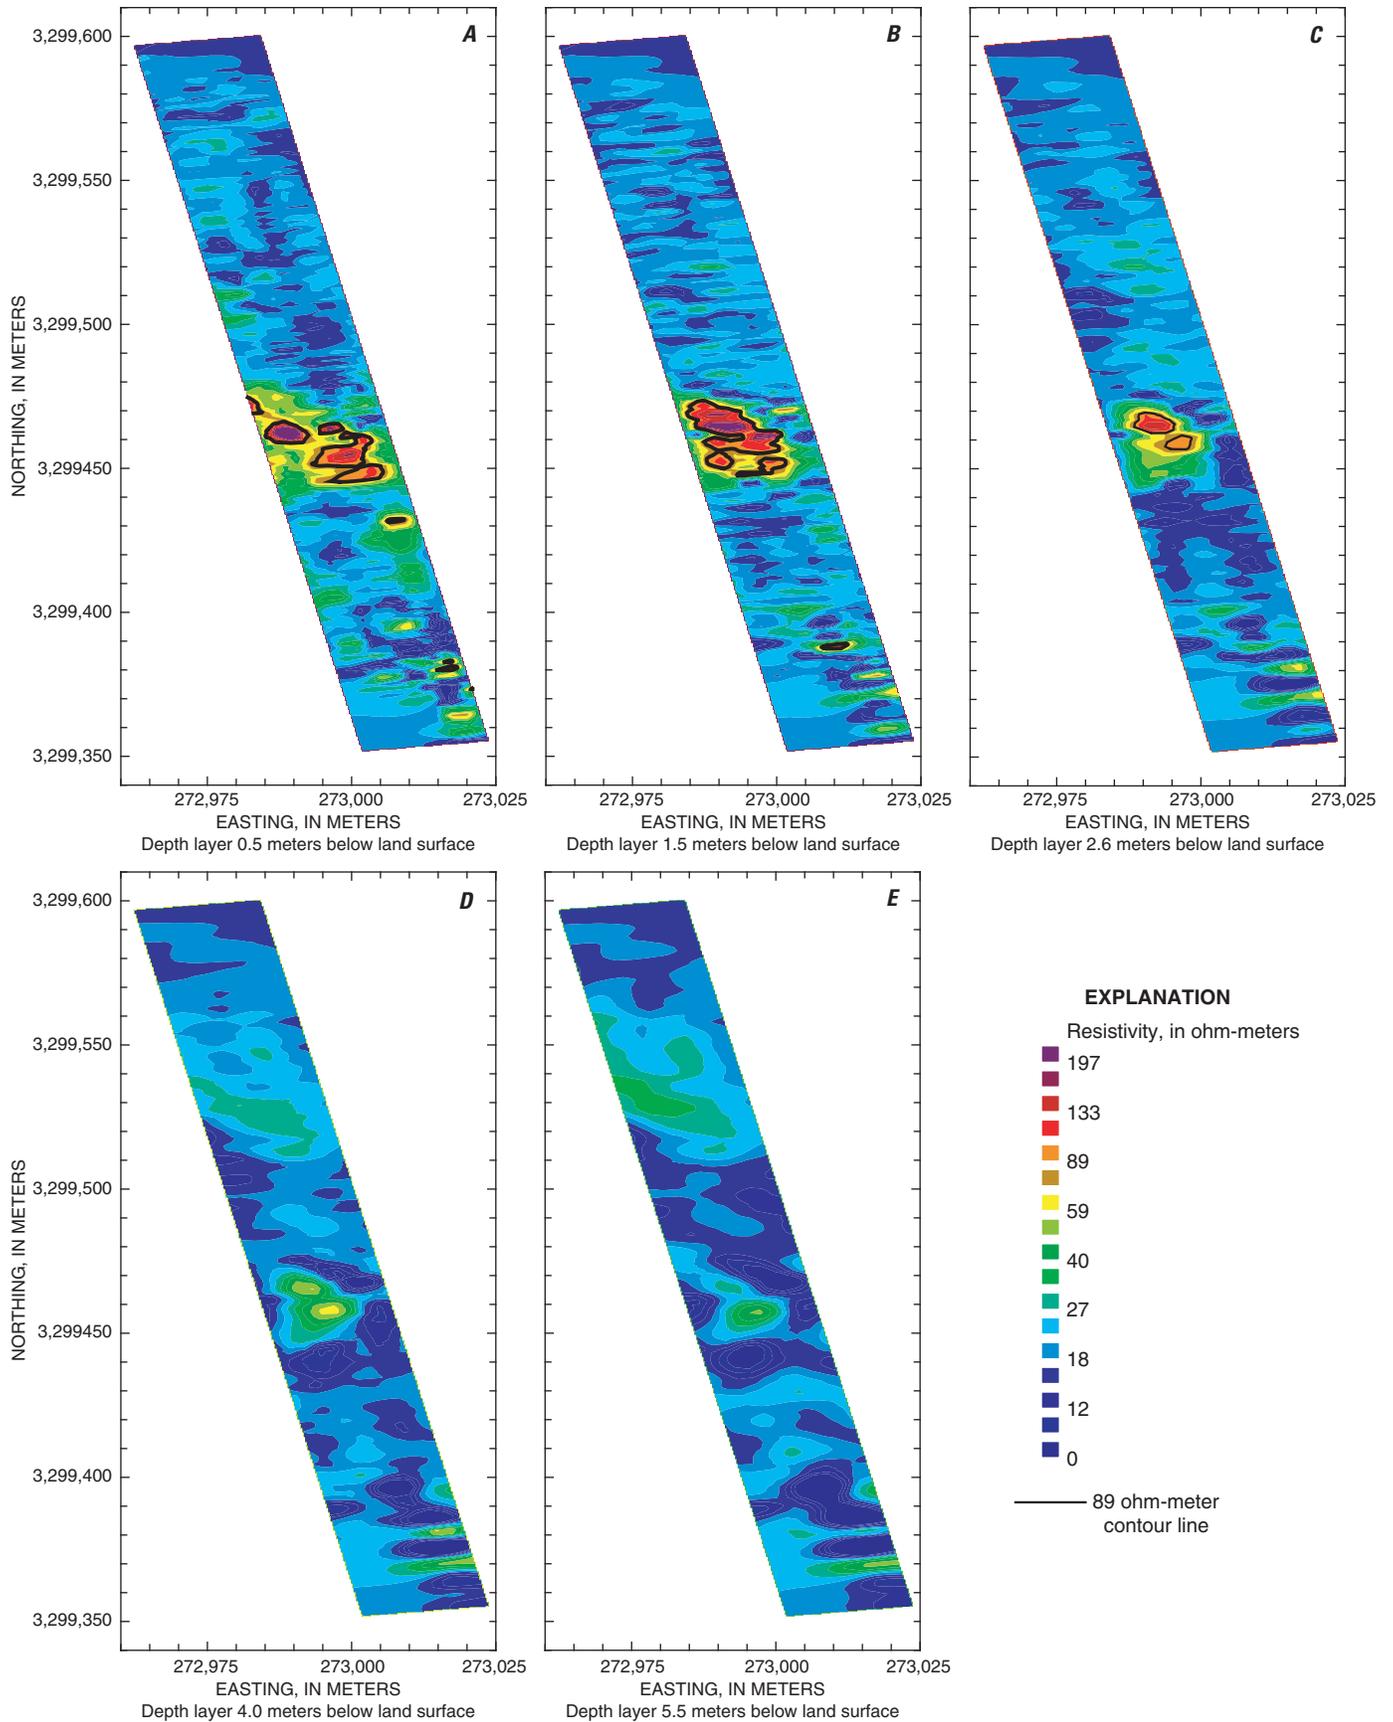
Figure 5. Two-dimensional plan view of depth layers showing the inversion results of capacitively coupled resistivity data from lines 1 through 7.

CC resistivity data were collected in the eastern and western contaminated source areas. The data were collected in a series of nine lines. Lines 1 through 7, trending south to north (fig. 2), targeted the eastern contaminated source area. Lines 1 and 7 (represented as a single line on the eastern-most side of the contaminated zone) were overlapping lines to evaluate the repeatability and quality of the CC resistivity surveying method. Data from lines 1 through 7 were combined into one dataset in the software Magmap 2000 (Geometrics, Inc., 2002) and inverted as a 3D dataset. The inversion results from lines 1 through 7 are presented in a series of five horizontal depth layers representing layers 0.5, 1.5, 2.6, 4.0, and 5.5 meters below land surface. Each depth layer (fig. 5) was analyzed to identify resistivity anomalies. Resistivity values greater than 89 ohm-meters were identified as anomalously high resistivity values. A contour line at the value of 89 ohm-meters was used to identify areas containing anomalously high resistivity data. The locations of these resistive anomalies were used to determine the location of the DC resistivity survey.

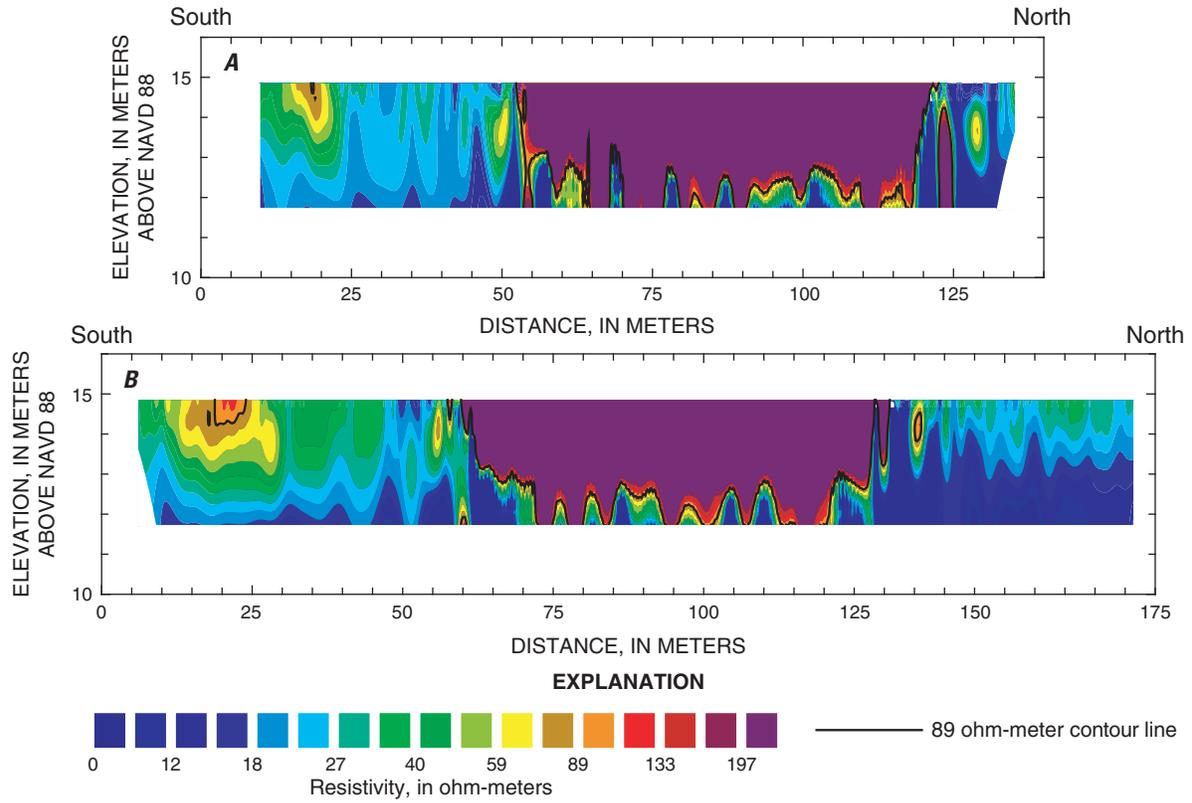
Figure 6. Sections showing inversion results of capacitively coupled resistivity data for (A) line 8 and (B) line 9.

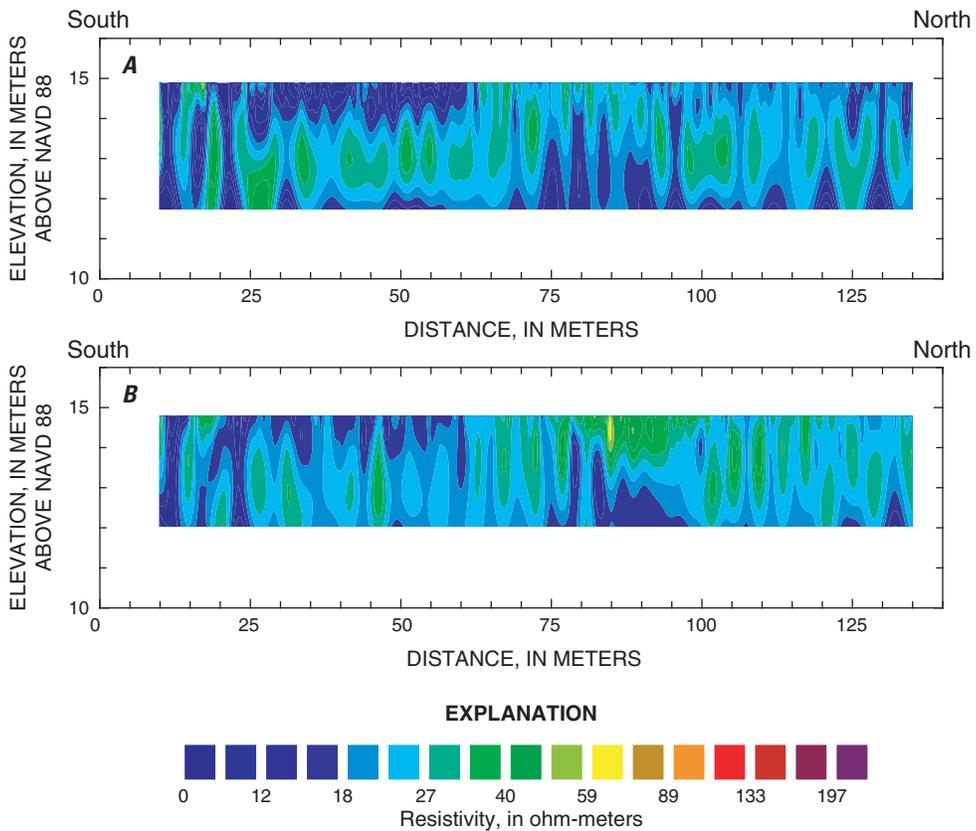
Figure 7. Sections showing inversion results of capacitively coupled resistivity data for (A) line 1 and (B) line 7.

To evaluate the repeatability of the OhmMapper data, data from two overlapping lines were compared. Data along line 1 were collected by profiling from south to north along the eastern edge of the eastern contaminated source area. After data along lines 2 through 6 were collected, data at line 1 were recollected as line 7 by profiling from south to north. Lines 1 and 7 (fig. 7) produced similar datasets with small differences between the two resistivity profiles. Variations in the datasets were probably caused by the difficulty of towing the array in exactly the same path as the original line. The similarities

between these two datasets indicate that the results of the CC resistivity were reproducible.

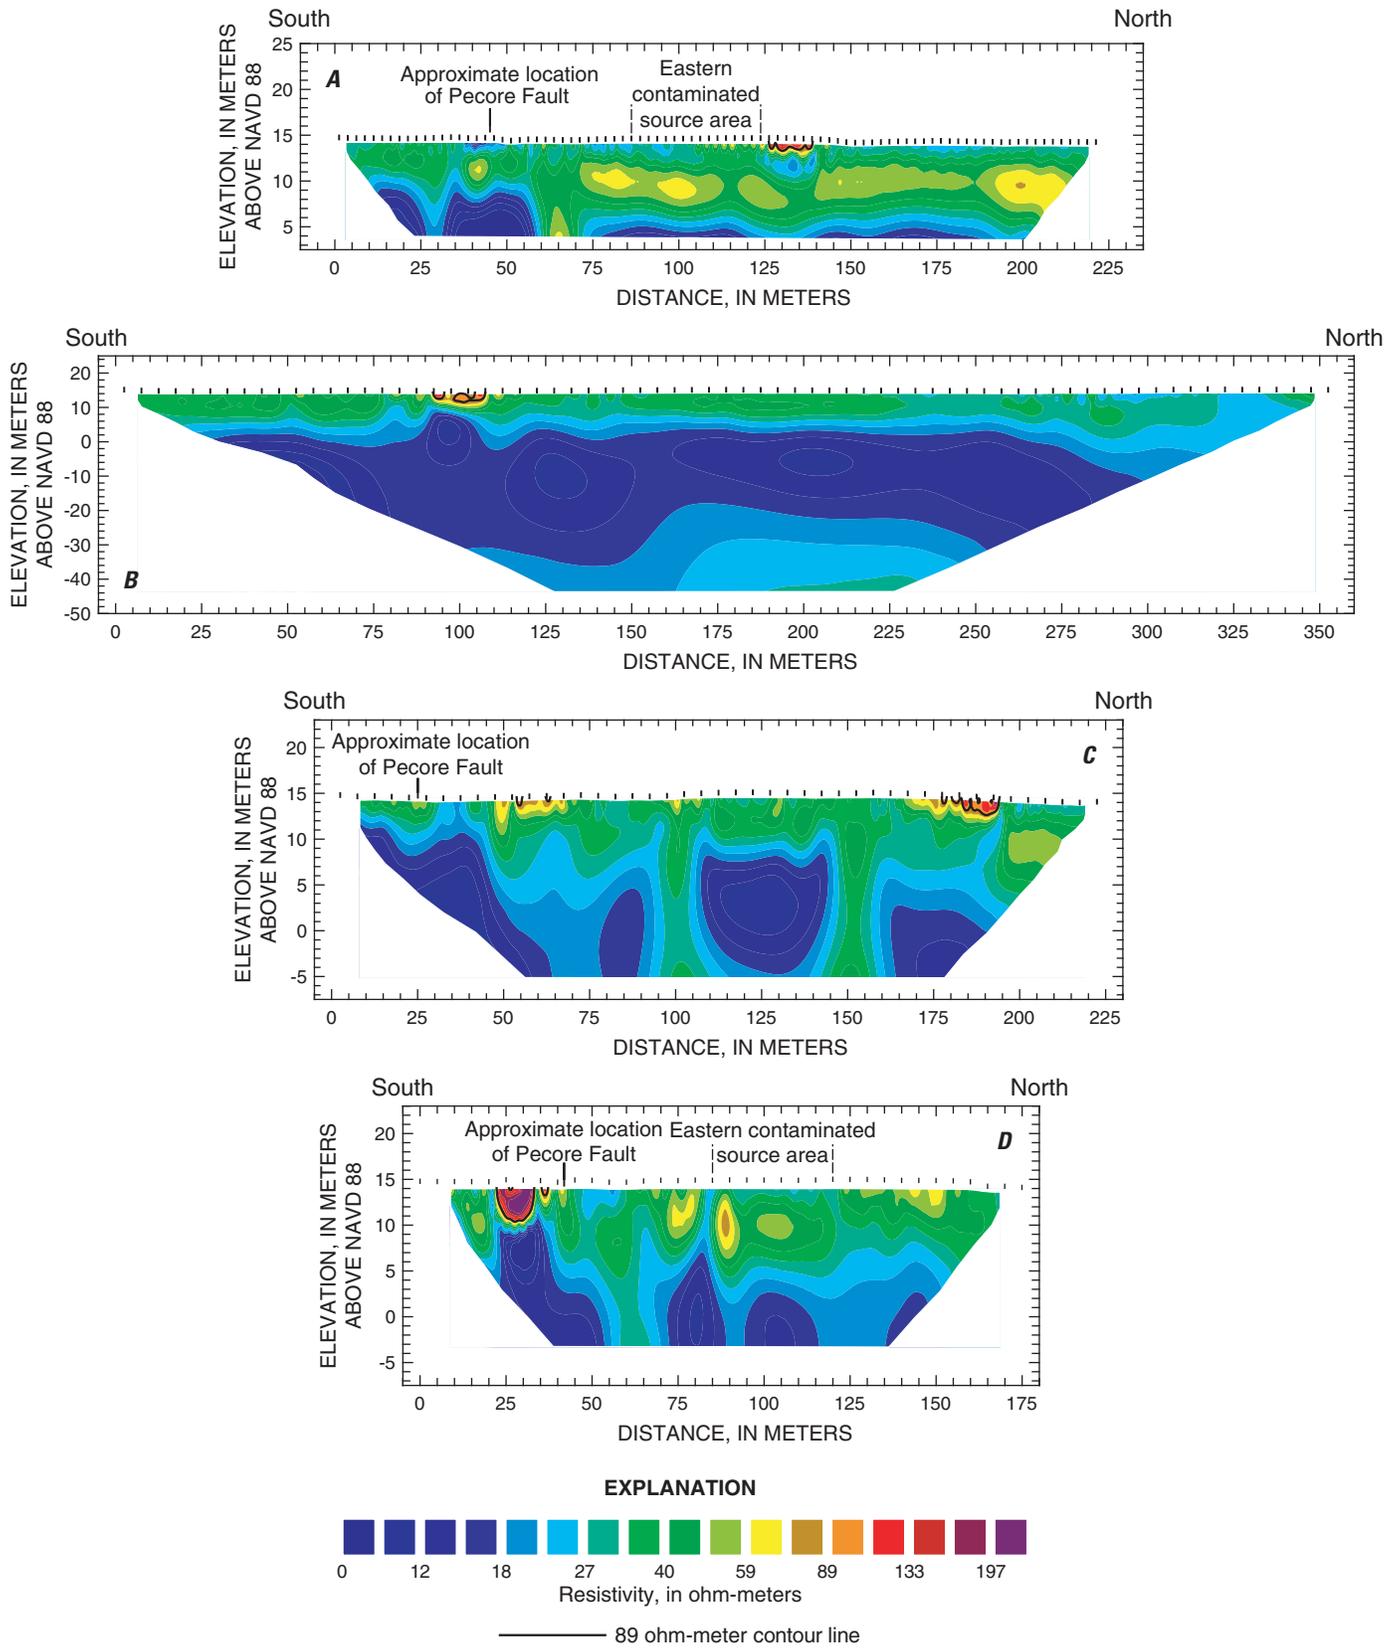
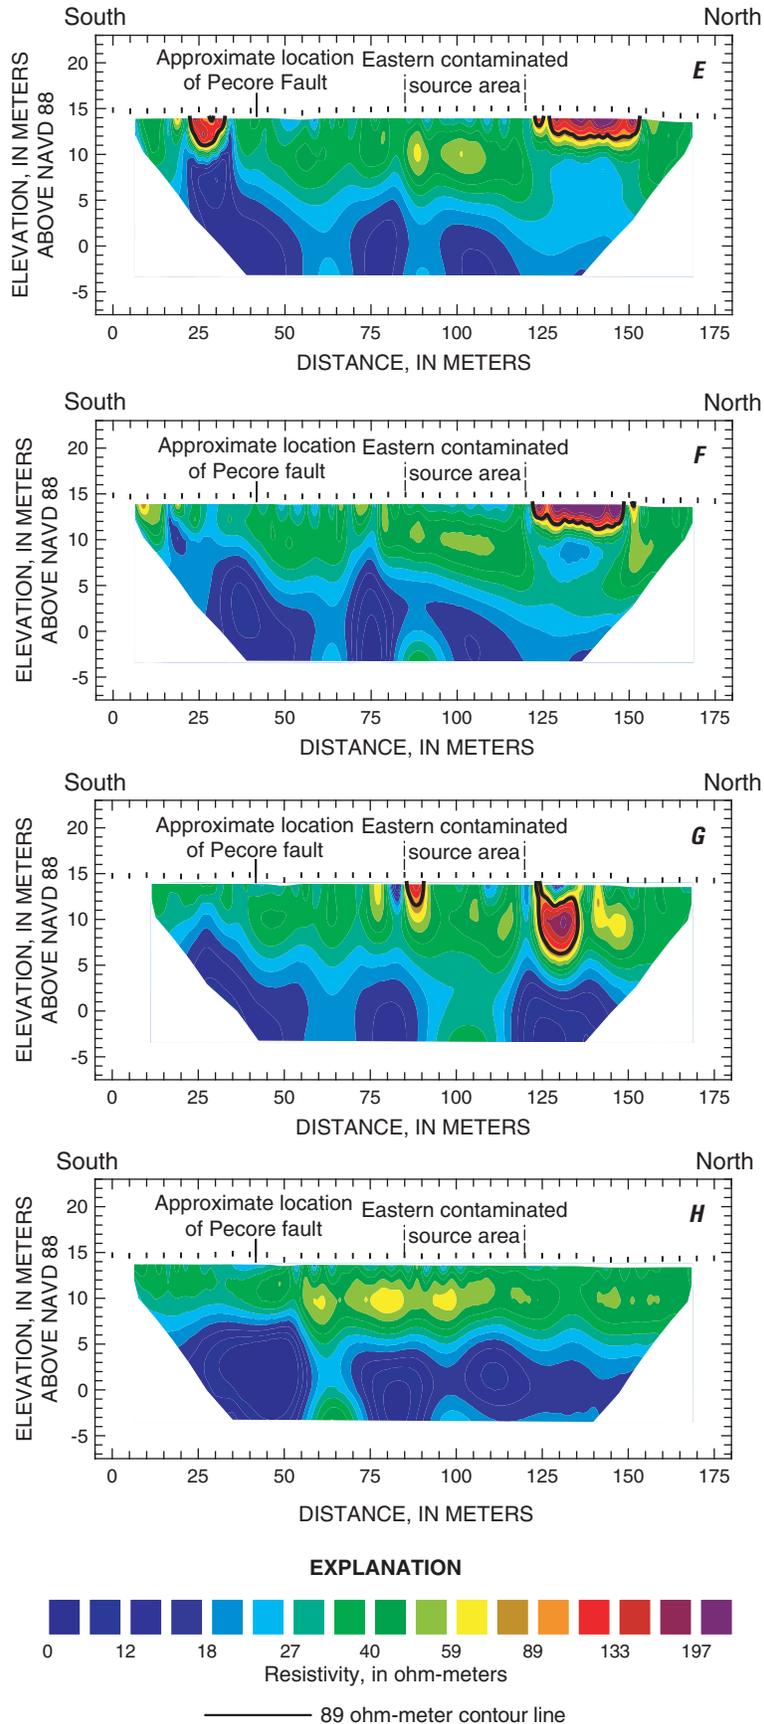
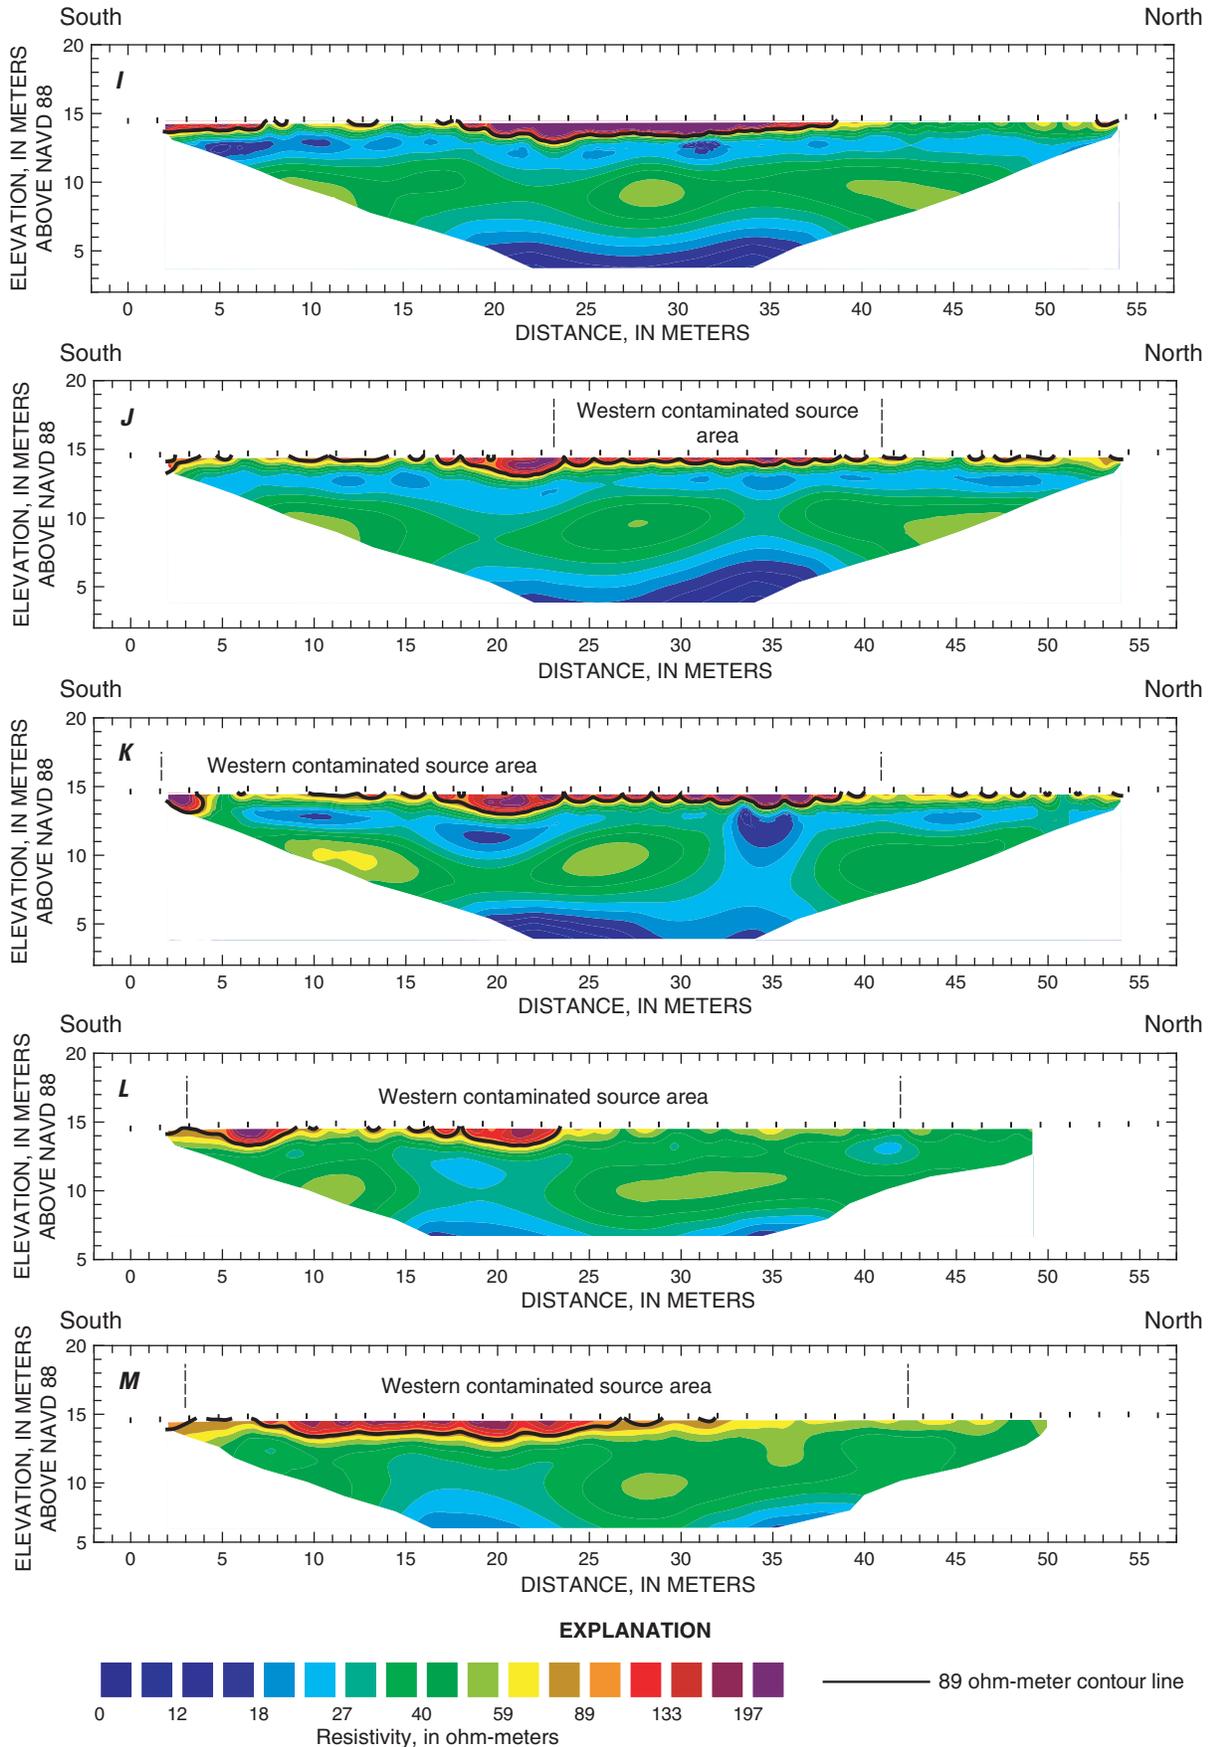
Figure 8. Sections showing inversion results of direct-current resistivity data for (A) line 1, (B) line 2, (C) line 3, and (D) line 5.

Figure 8. Sections showing inversion results of direct-current resistivity data for (E) line 6, (F) line 7, (G) line 8, and (H) line 9.—Continued

Figure 8. Sections showing inversion results of direct-current resistivity data for (I) line 11, (J) line 12, (K) line 13, (L) line 14, and (M) line 15.—Continued

The inversion results of lines 1 through 3, 5 through 9, and 11 through 15 (fig. 8) were displayed by plotting vertical 2D sections of the resistivity data for each line. A contour line at the value of 89 ohm-meters was used to identify areas containing anomalously high resistivity data. The inversion results from lines 4 and 10 were eliminated due to poor quality data resulting from underground utilities located immediately north of North Cavalcade Street.
