Two-Dimensional Resistivity Investigation of the North Cavalcade Street Site, Houston, Texas, August 2003

Scientific Investigations Report 2005-5205

By Wade H. Kress and Andrew P. Teeple

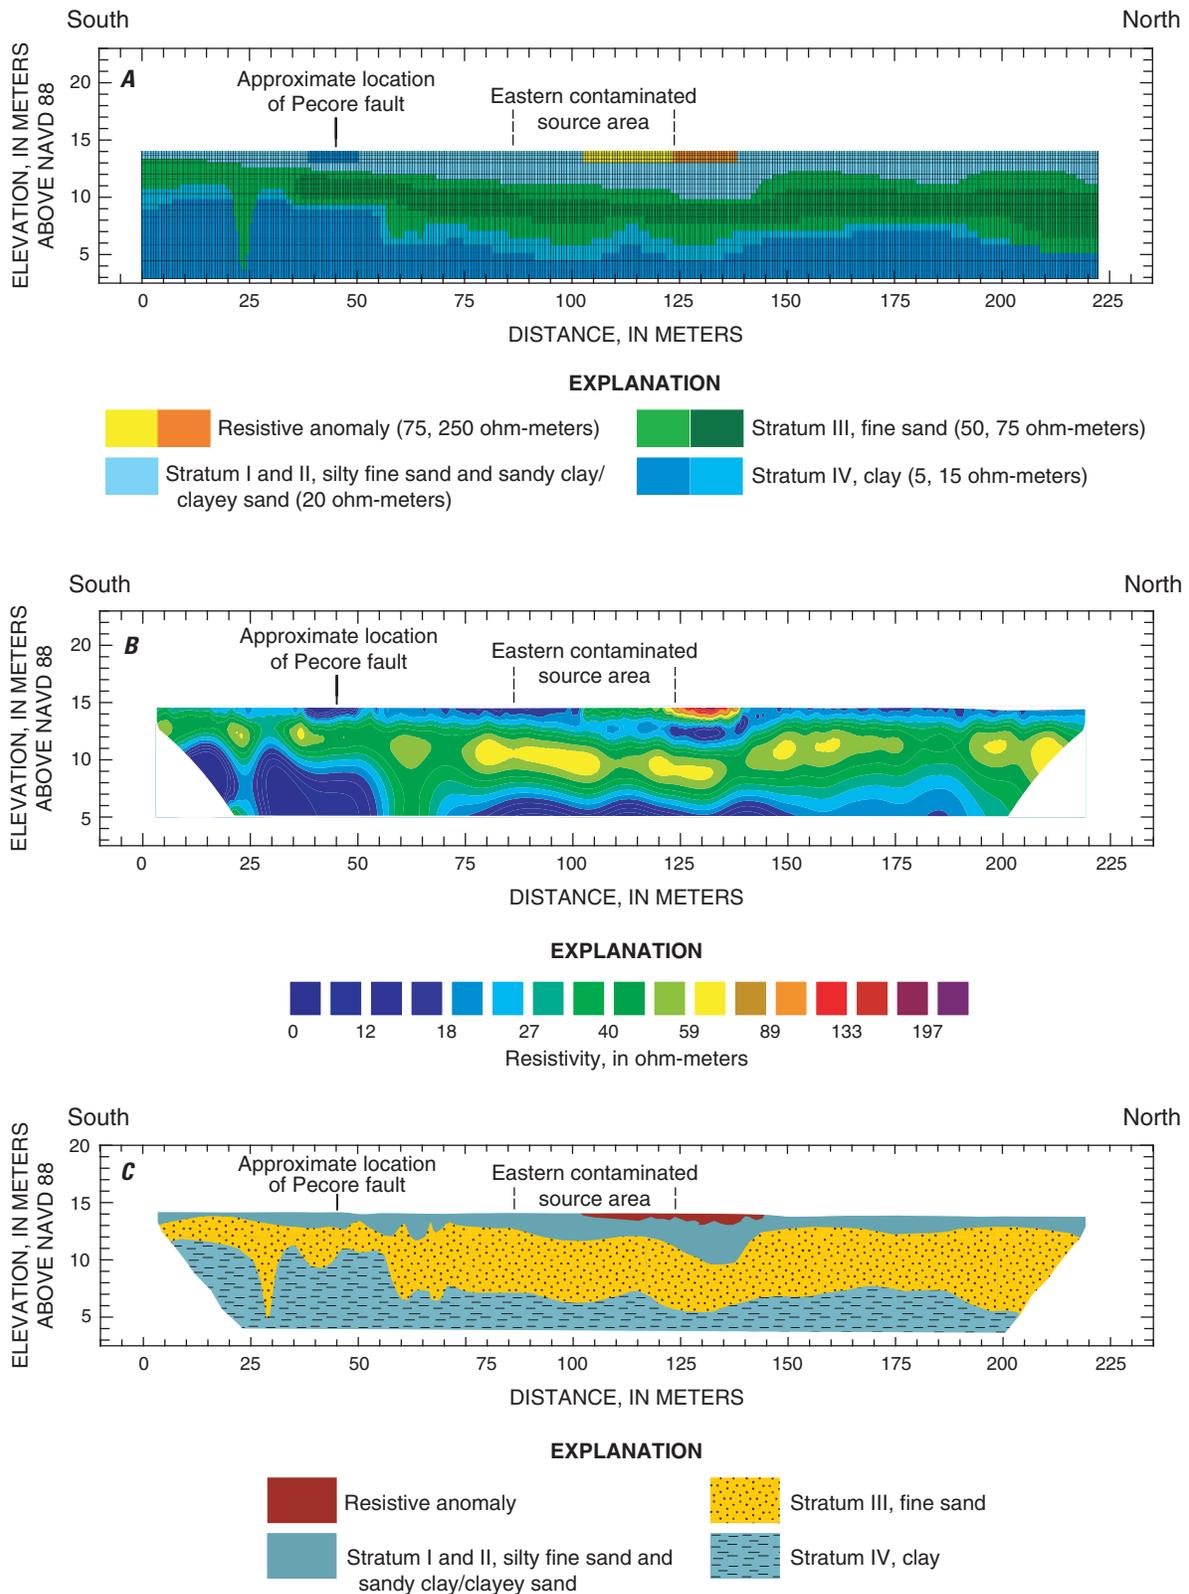
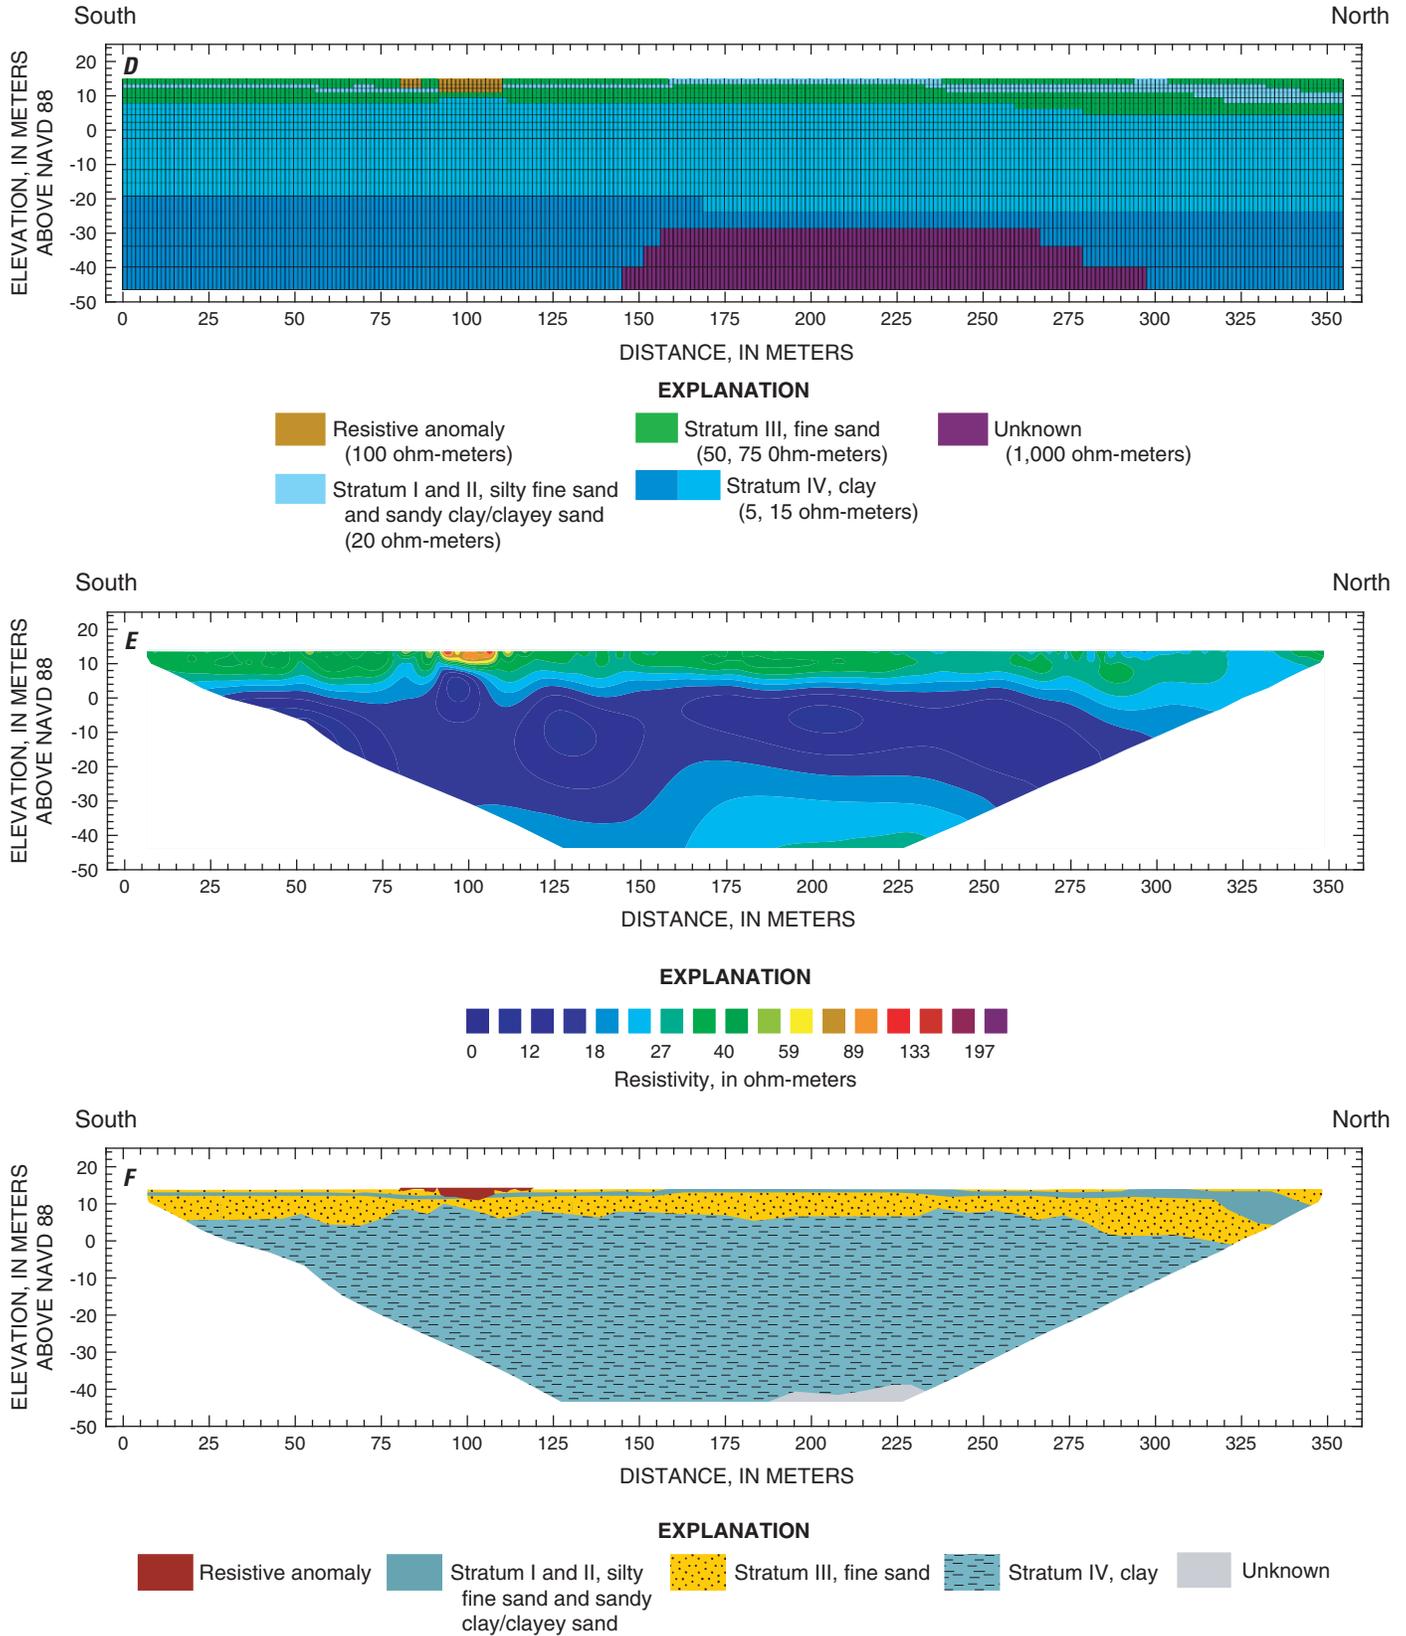
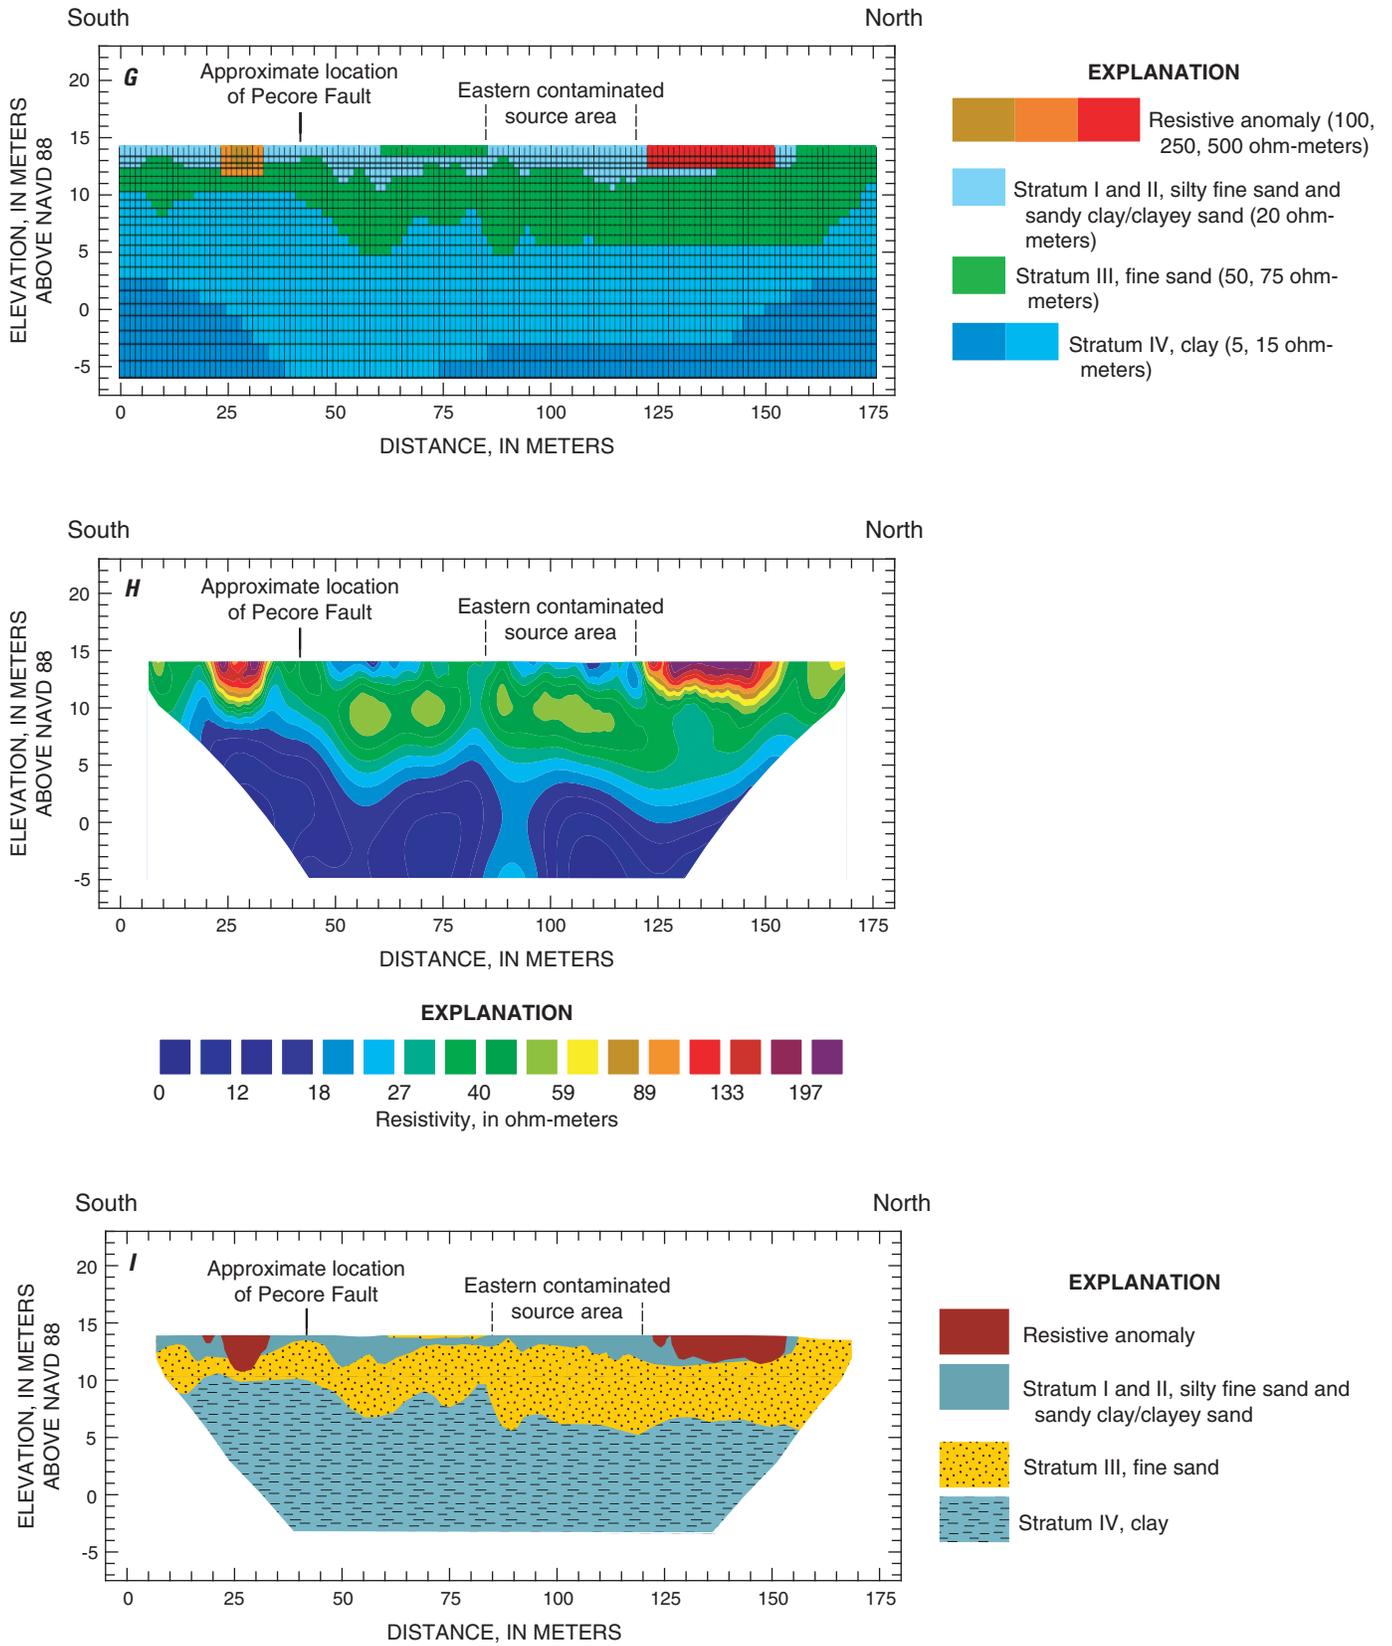
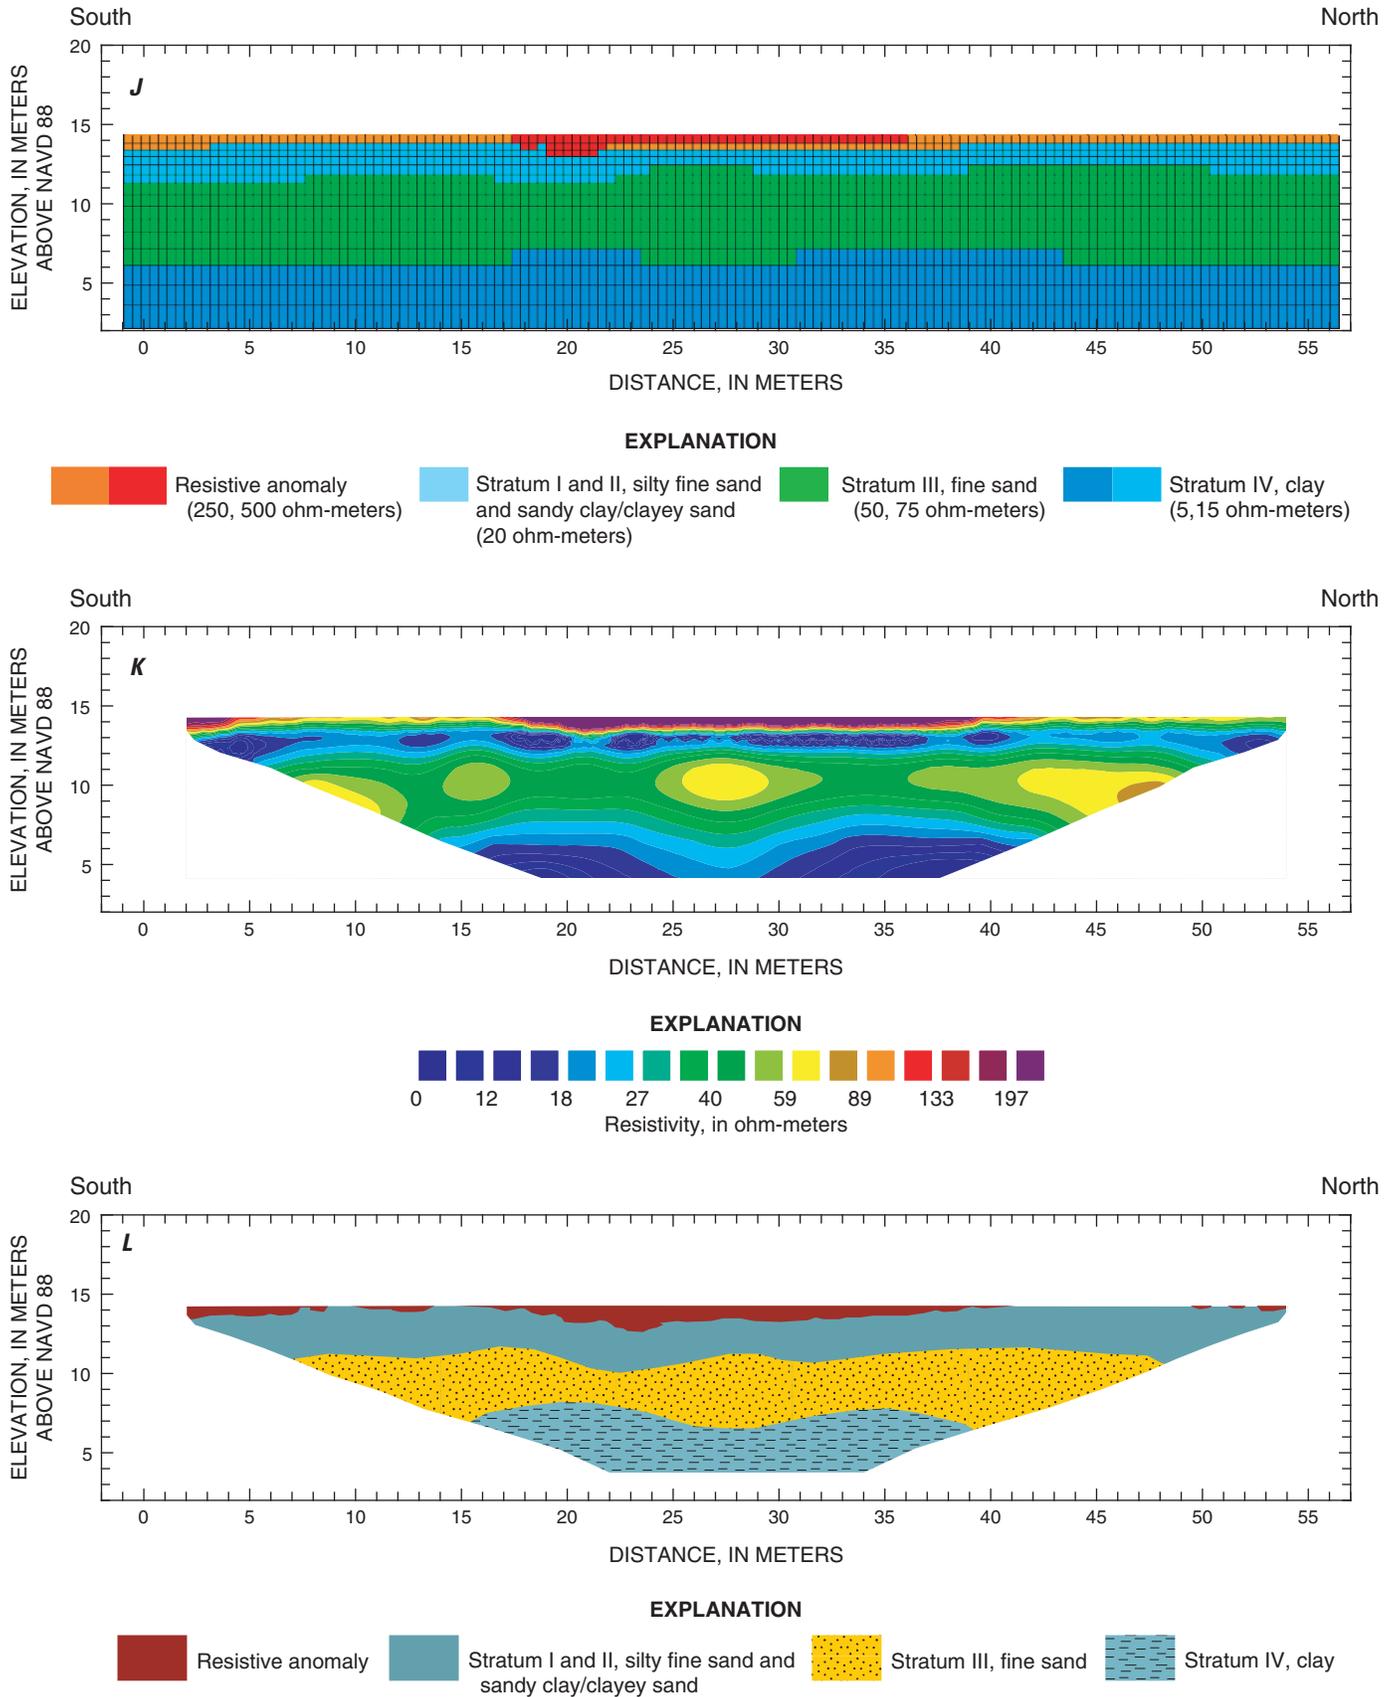
Figure 9. Sections showing (A) forward model, (B) inversion result of forward model for direct-current resistivity line 1, and (C) interpretation of direct-current resistivity inversion results of line 1.

Figure 9. Section showing (D) forward model, (E) inversion result of forward model for direct-current resistivity line 2, and (F) interpretation of direct-current resistivity inversion results of line 2.—Continued

Figure 9. Section showing (G) forward model, (H) inversion result of forward model for direct-current resistivity line 6, and (I) interpretation of direct-current resistivity inversion results of line 6.—Continued

Figure 9. Section showing (J) forward model, (K) inversion result of forward model for direct-current resistivity line 2, and (L) interpretation of direct-current resistivity inversion results of line 11.—Continued

continuous low resistivity FMU did not adequately simulate the increase in resistivity at approximately -28 meters elevation between 160 and 245 meters along the line 2 (fig. 8b). No borehole data were available to determine the cause for the increase in resistivity at that depth along line 2. Therefore, another FMU of unknown lithology was used in line 2. To estimate the resistivity structure of this feature, several configurations of the depth, thickness, extent, and resistivity were simulated. An FMU with a resistivity of 1,000 ohm-meters was determined to best represent this increase in resistivity.

After the forward model representing the different strata was developed for DC resistivity data along lines 1, 2, 6, and 11, the displacement observed for the Pecore Fault was incorporated into the forward models for lines 1 and 6. The RI defined the approximate location of the Pecore Fault along the North Cavalcade Street site. The RI also indicated that lithologic units on the north side of the fault plane are slipping down relative to the lithologic units on the south side. To adequately forward model DC resistivity lines 1 and 6 assumptions about the exact location of the Pecore Fault and the amount of displacement along lines DC resistivity lines 1 and 6 were made to estimate the true resistivity structure. These assumptions were tested primarily using the forward model for DC resistivity line 1. When the inversion results of both the forward model data and the field data for line 1 approximately matched, a forward model for line 6 was developed and tested using the forward model for line 1 as a starting point.

Resistive anomalies also were forward modeled in lines 1, 2, 6, and 11. Because “ground truthing” of the inversion results of the CC and DC resistivity data was not part of this study, resistive anomalies identified in the inversion results of the DC resistivity data for lines 1, 2, 6, and 11 (figs. 8A, 8B, 8E, and 8I) were forward modeled by hypothesizing the true resistivity structure. To determine the configuration of depth, thickness, extent, and resistivity of resistive anomalies used in the forward models of DC resistivity lines 1, 2, 6, and 11, several hypotheses were tested independently for each line using an iterative forward modeling process. FMUs representing resistive anomalies were modeled with resistivity values of 75, 100, 250, and 500 ohm-meters. When resistive anomalies in the inversion results (fig. 9B, 9E, 9H, and 9K) of a forward model closely matched resistive anomalies of the inversion results of the field data, the resulting forward model (fig. 9A, 9D, 9G, and 9J) was used to develop the interpretation of each line (fig. 9C, 9F, 9I, and 9L).

The final forward models for lines 1, 2, 6, and 11 were used as an estimate of the true resistivity structure occurring along those lines. Using these forward models as the estimated true resistivity structure, features showing similar characteristics in lines 3, 5, 7 through 9, and 12 through 15 were interpreted similarly. The forward model, inversion result of the forward model, and interpretation for line 1 were used to interpret strata and resistive anomalies occurring in the subsurface distribution of resistivity of line 3 (fig. 10A). The forward model, inversion of the forward model, and interpretation for lines 6 and 11 were used to interpret strata and resistive

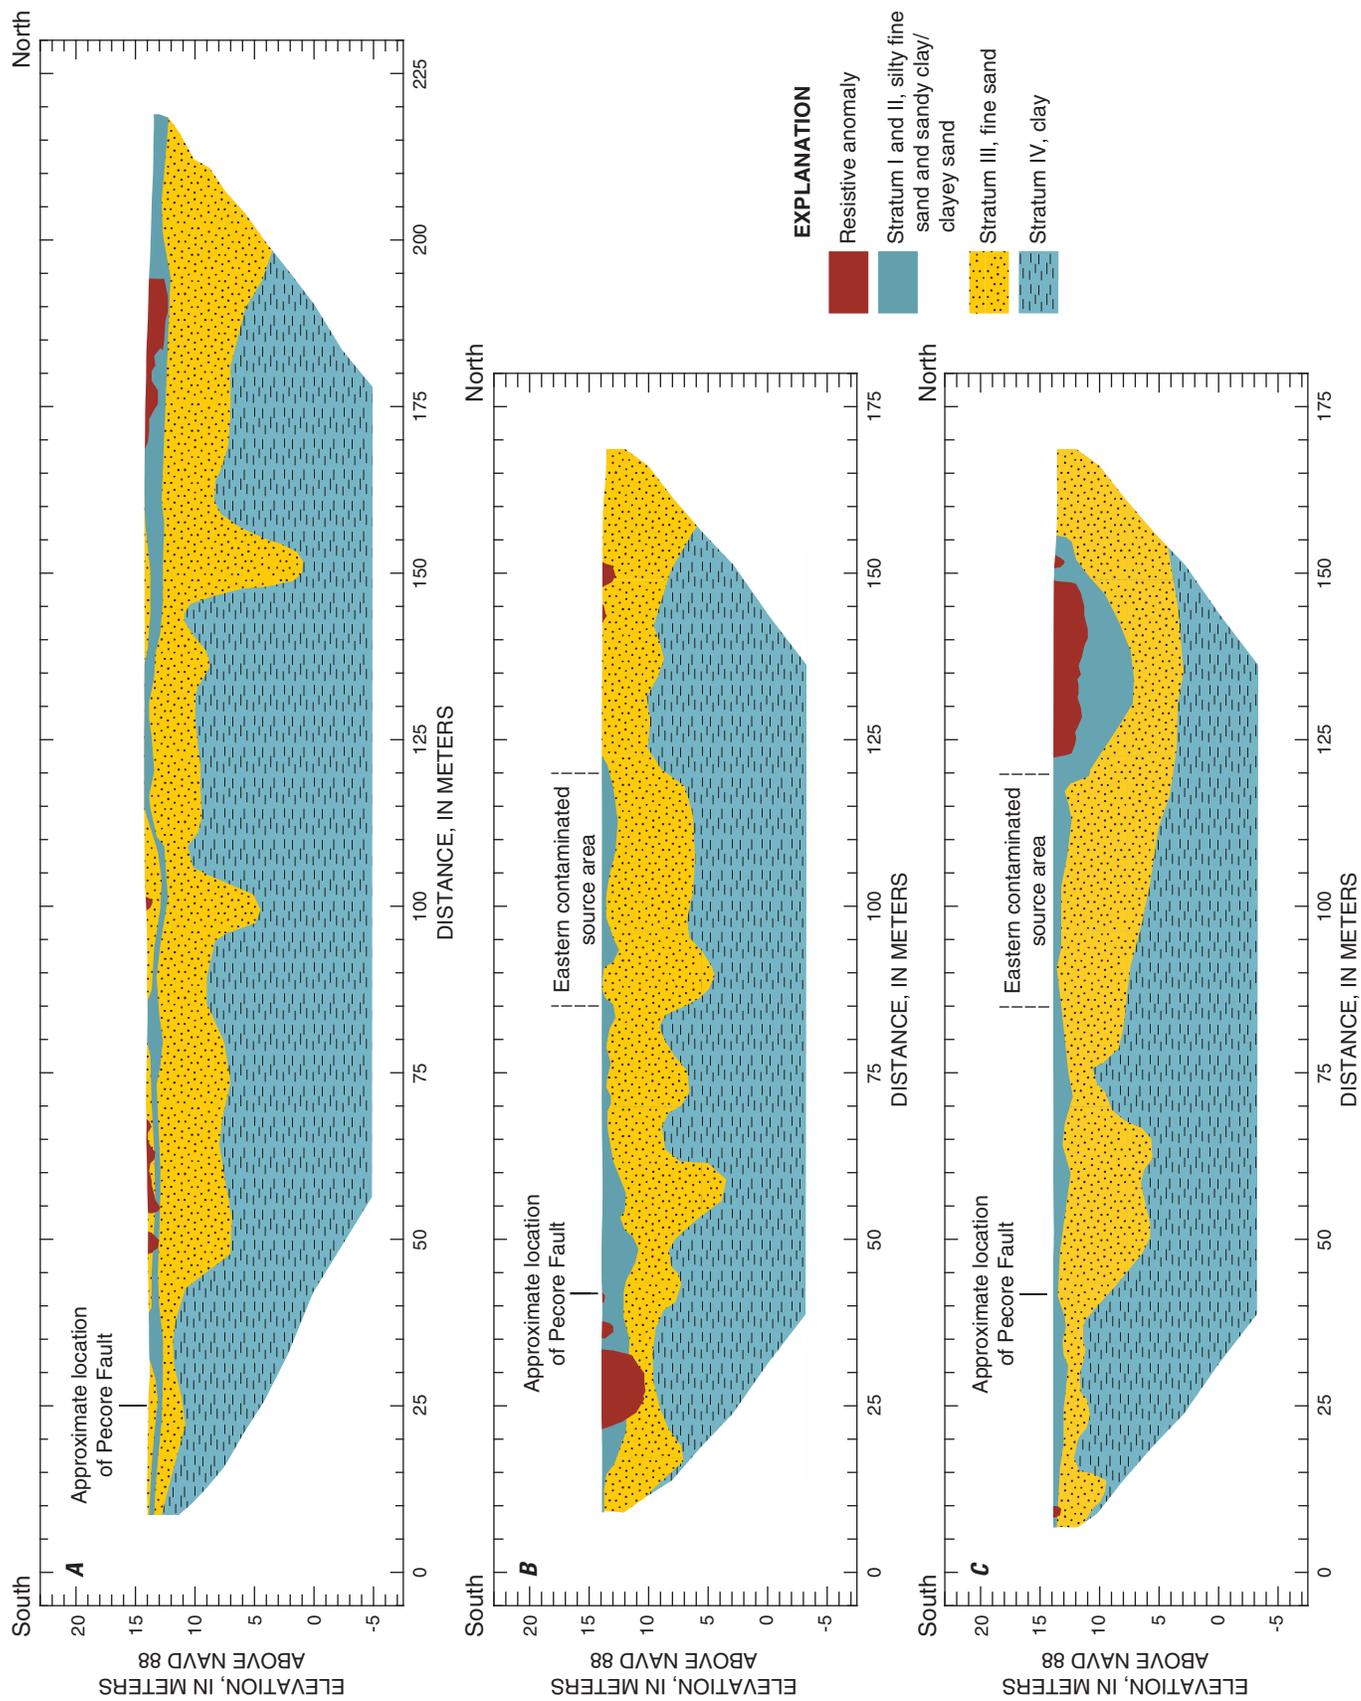
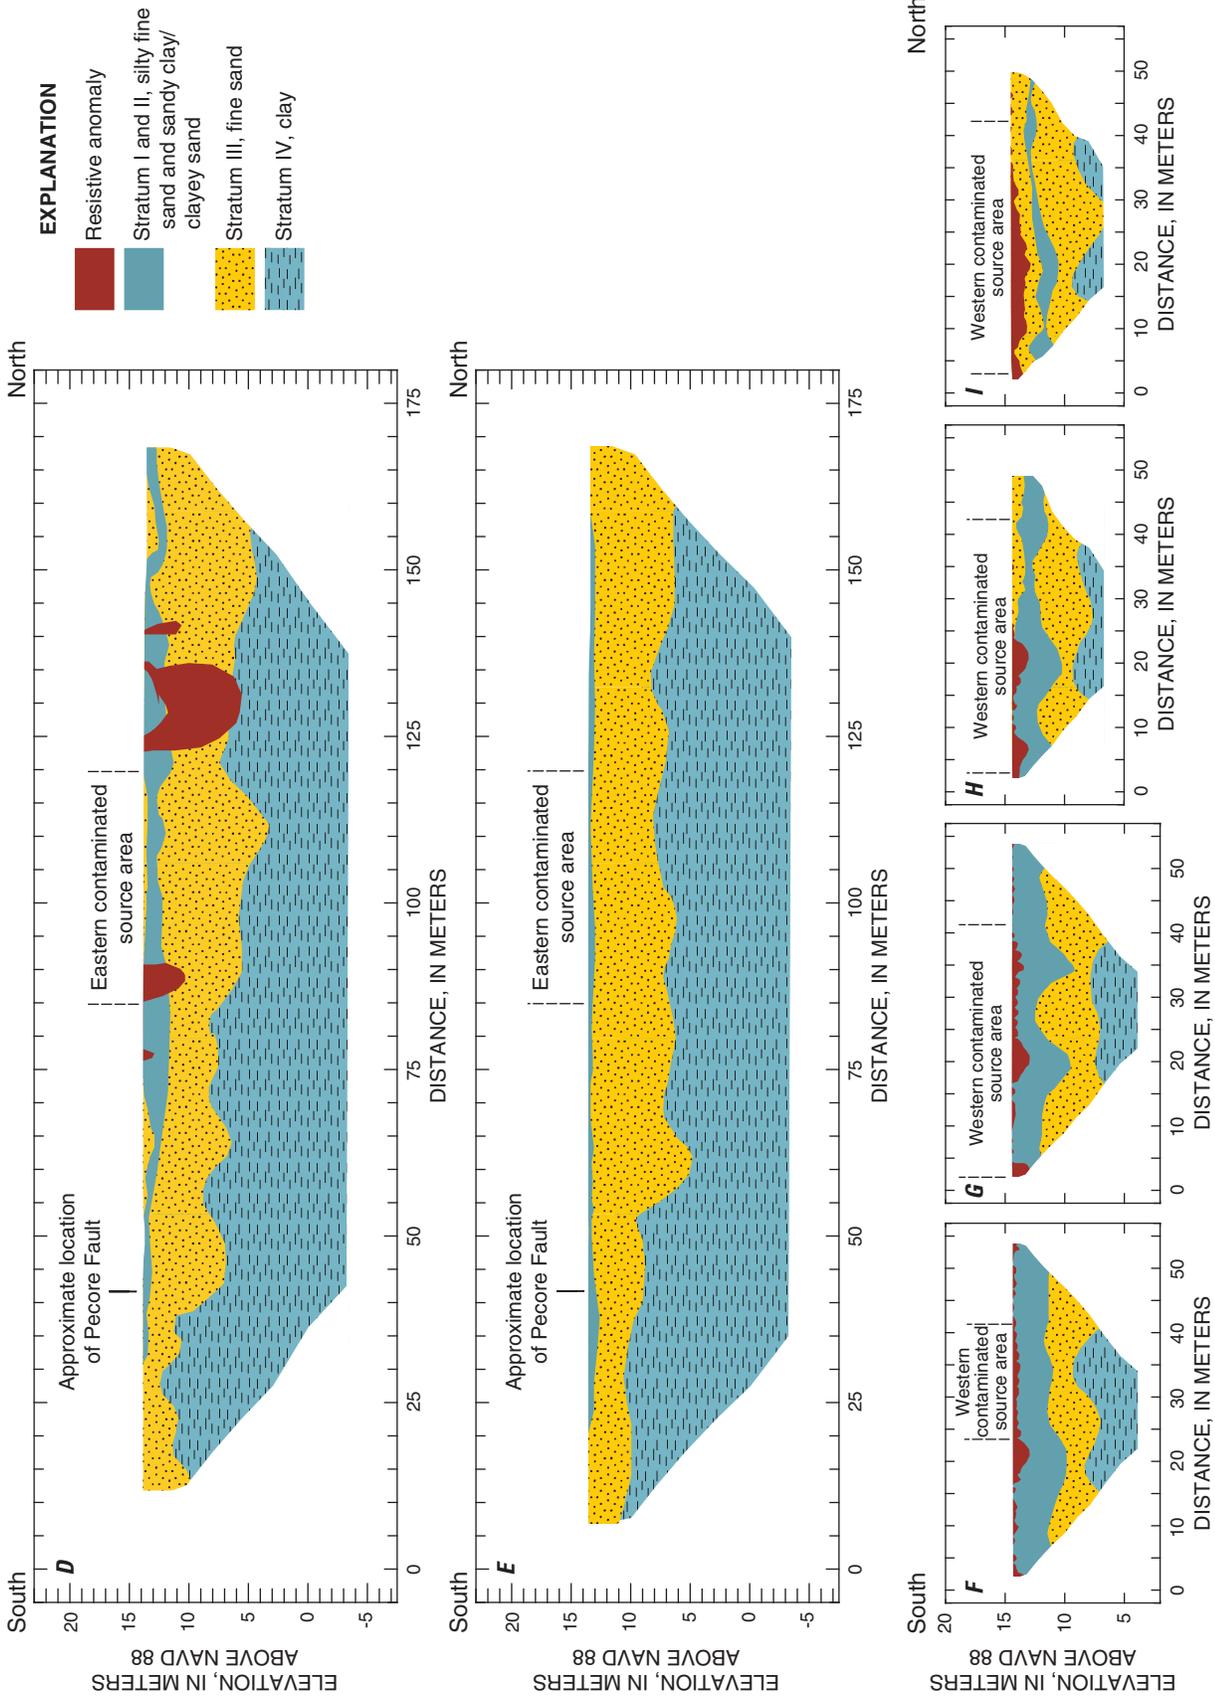
Figure 10. Sections showing interpretation of direct-current resistivity inversion results of (A) line 3, (B) line 5, and (C) line 7.

Figure 10. Sections showing interpretation of direct-current resistivity inversion results of (D) line 8, (E) line 9, (F) line 12, (G) line 13, (H) line 14, and (I) line 15.—Continued

anomalies in the subsurface distribution of resistivity for DC resistivity lines 5, 7, 8, and 9, near the eastern contaminated source area (fig. 10B, 10C, 10D, and 10E) and DC resistivity lines 12, 13, 14, and 15, near the western contaminated source area (fig. 10F, 10G, 10H, and 10I).
