**OW-5/55R Area In-Situ Geochemical
Stabilization Remediation
Performance Evaluation
Former Koppers Wood Treating Plant
Hills Ferry Road, PO Box 3485
Nashua, New Hampshire**

**NHDES Site #:198708017
Project Type: HAZWASTE**

OW-5/55R Area In-Situ Geochemical Stabilization Remediation Performance Evaluation, Former Koppers Company, Inc. Site, Nashua, New Hampshire

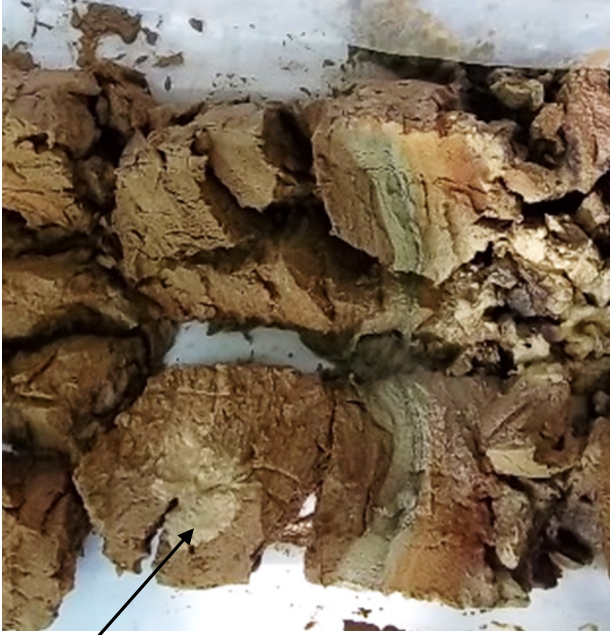
ROI-3 (28 ft bgs)

Applied neutralizer

Borehole ROI-3 was drilled on June 10, 2015 to a depth of 40 feet bgs. Thin NAPL zones (< 1 in.) were observed at 27.5 and 28.7 ft bgs, and NAPL mottling was observed in disturbed core from 30 to 32 ft bgs. The application of reagent-neutralizing solution to the core produced visible reaction from 27.5 to 28.5 and 30-33.5 feet bgs, resulting in an ISGS reagent rating of 3. In addition, soil core with color consistent with reagent oxidation was observed at depth intervals above and below the reacted intervals.

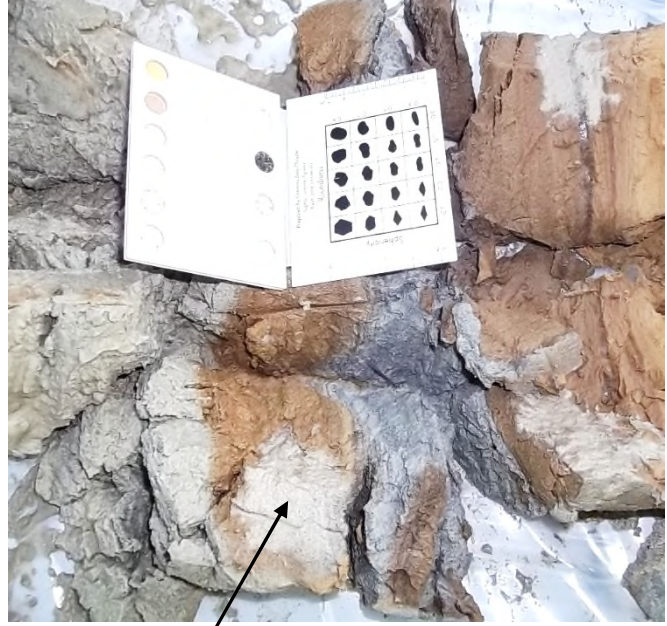
ROI-8 (29.5 ft bgs)

Applied neutralizer

Borehole ROI-8 was drilled on June 8, 2015 from land surface to a depth of 45 feet bgs. Thin NAPL seams (< 1 in.) were observed from 28.3 to 28.5 and at 30 feet bgs. The application of neutralizing solution to the core produced visible reaction from 29.5 to

30.5 and 38 to 38.5 feet bgs; therefore, these zones were assigned an ISGS reagent rating of 3. Color consistent with reagent oxidation was observed in the depth interval from 25 to 29.5, 35 to 38, and 38.5 to 40 feet bgs. These depth intervals were assigned an ISGS reagent rating of 2.

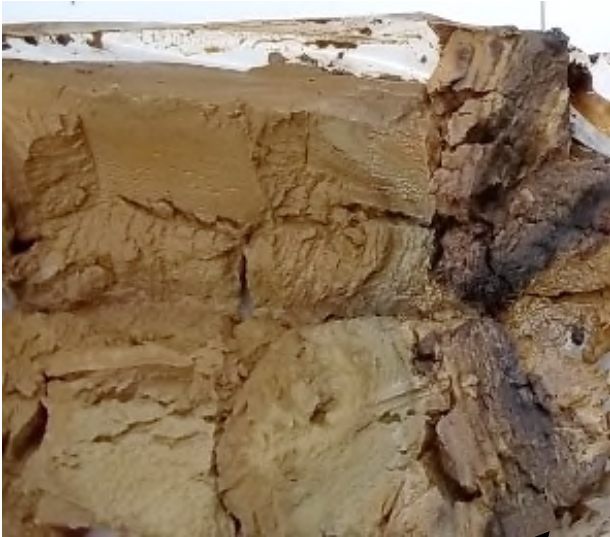
ROI-5 (27 ft bgs)

DNAPL Seam

TITLE:	DETAIL OF POST-ISGS CORE		
LOCATION:	Former Koppers Company, Inc. Site Nashua, New Hampshire

Borehole ROI-5 was drilled on June 9, 2015 to a depth of 40 feet bgs. A thin NAPL seam (< 1 in.) was observed at 27.5 feet bgs, and sheens were observed from 30 to 31 ft bgs and from 35.5 to 36.5 feet bgs. The application of neutralizing solution to the core produced visible reaction from 25 to 27.5, 30 to 30.5 and 35.2 to 35.8 feet bgs, which corresponds to an ISGS reagent rating of 3.

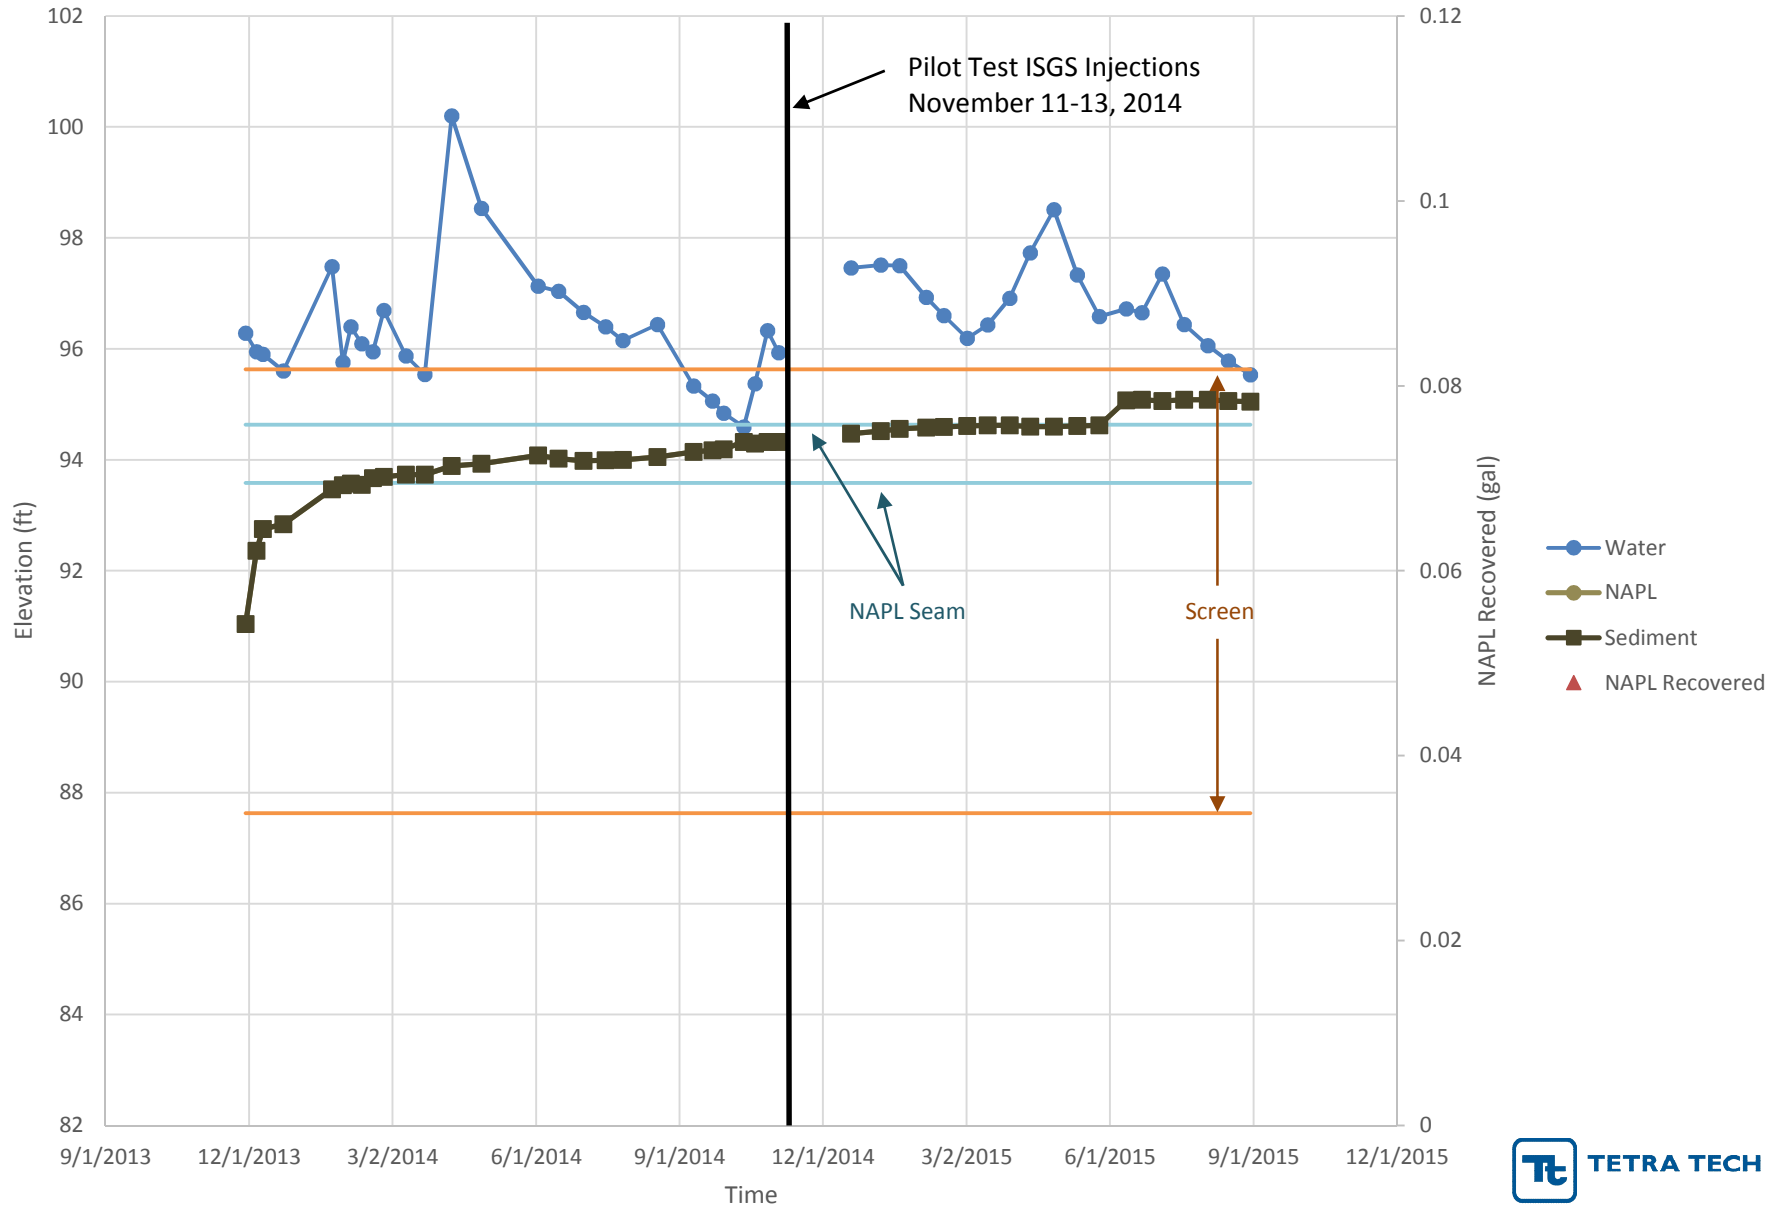
Figure 6. Temporal Changes in NAPL and Sediment Elevations Relative to IP13-07 Construction and NAPL Seam

TIP IP13-07 is located approximately 17 feet west of monitoring well OW-56. NAPL zones were noted in the drilling log at 26 and 27 feet bgs (Elevations 94.6 and 93.6 amsl, respectively). There were 27 NAPL monitoring events pre-ISGS injections and 20 events post-ISGS injections. However, NAPL was not observed in IP13-07 in any of the NAPL monitoring events pre- and post-ISGS injections.
