# Demonstration of the AquaBlok<sup>®</sup> Sediment Capping Technology

## Innovative Technology Evaluation Report

**Final**

National Risk Management Research Laboratory  
Office of Research and Development  
U.S. Environmental Protection Agency  
Cincinnati, Ohio 45268

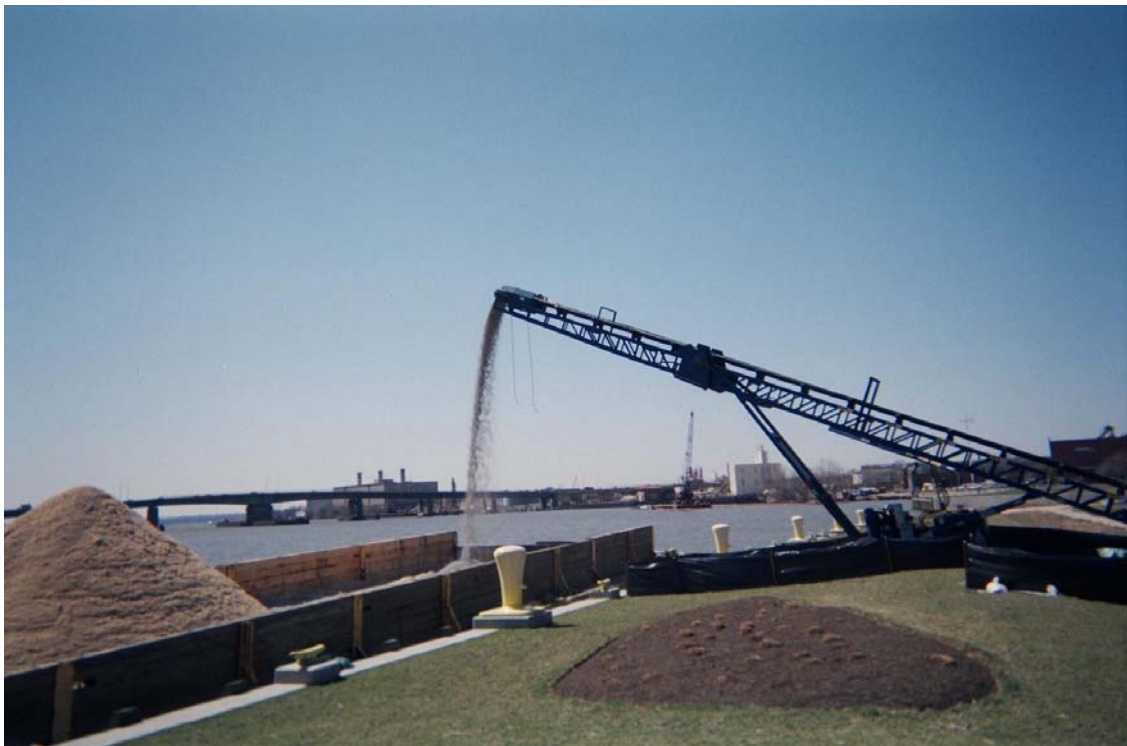
**Figure 3-7. Transferring Cap Material to Barge Using Conveyor**

nearshore loading area. A belt conveyor system was then used to transfer the materials from the nearshore material stockpile area to a material barge secured along the shoreline (see Figure 3-7). After loading, a tugboat was used to move the material barge beside a crane barge that was used to actually construct the caps (see Figure 3-8).

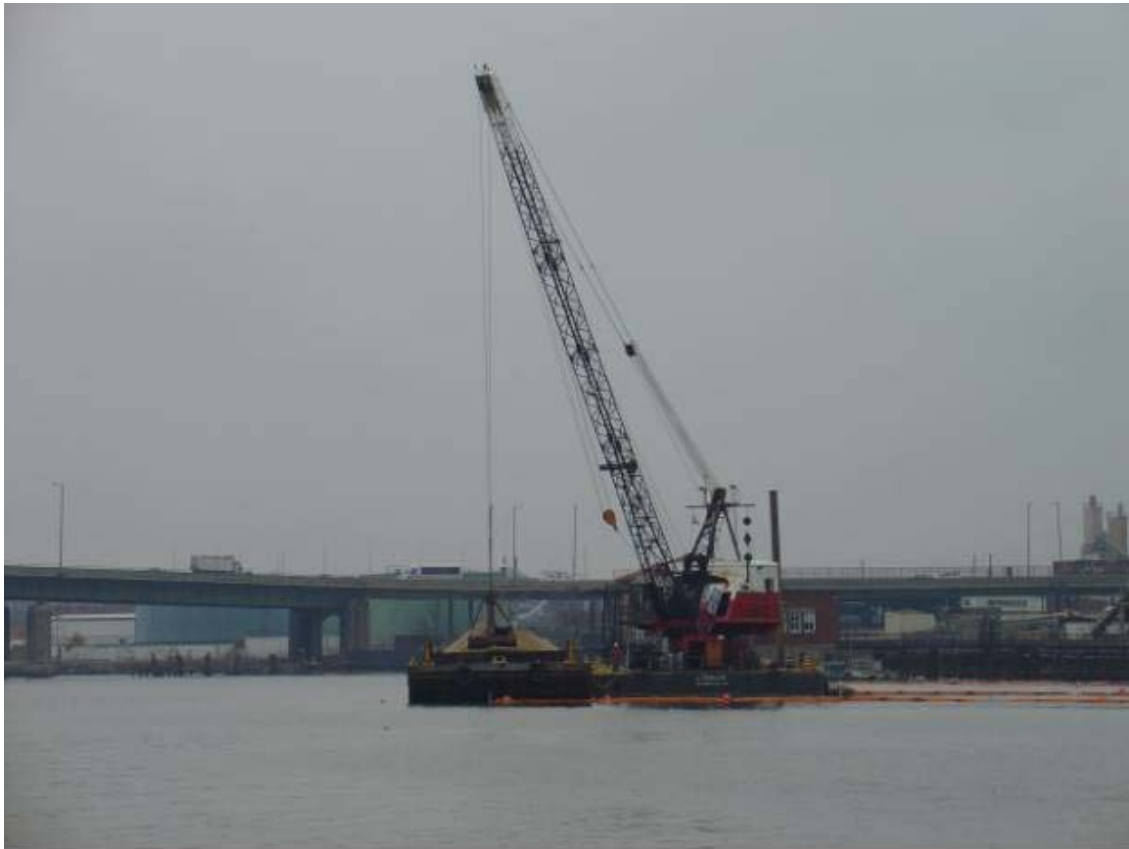
**Figure 3-8. Crane Barge Used to Place Caps in Demonstration Area**

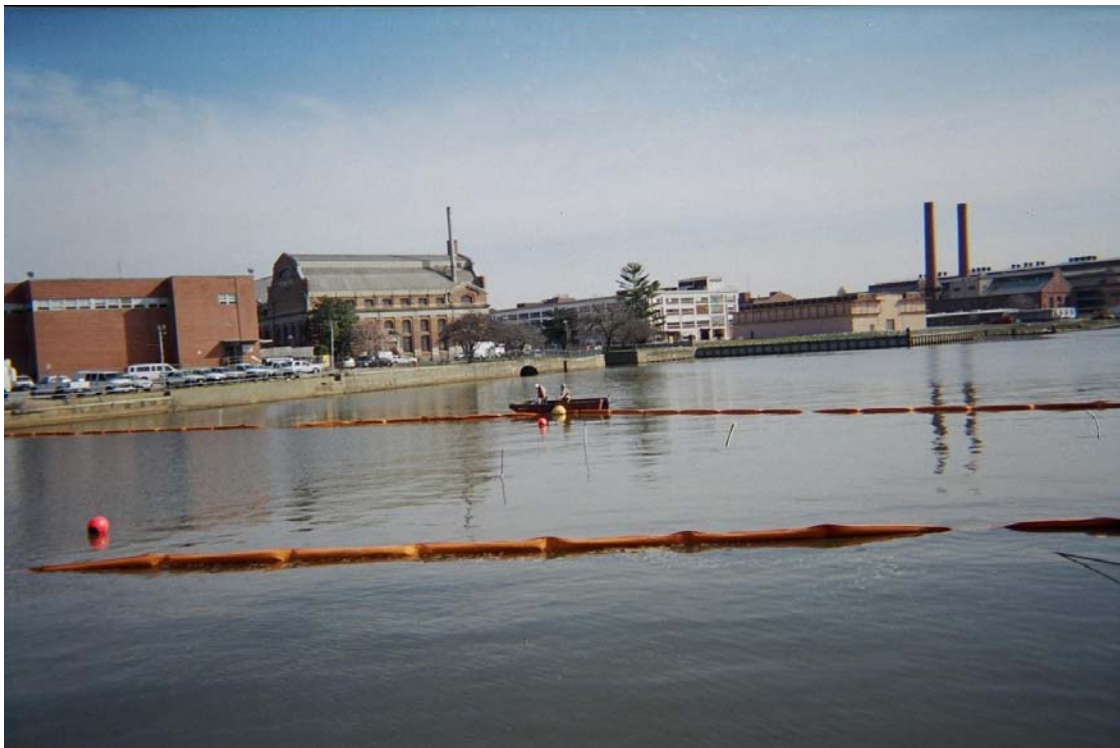
**Figure 3-9. Silt Curtains Deployed Around Demonstration Area Capping Cells**

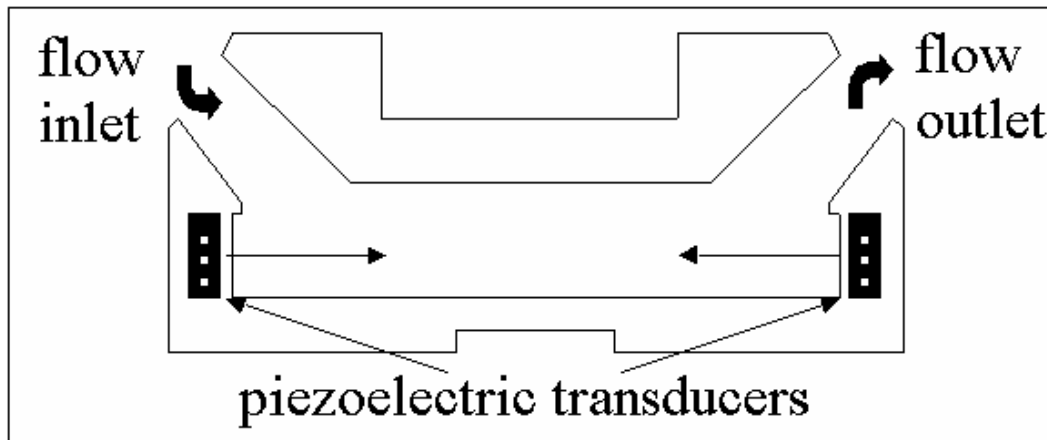
Figure 3-15. Conceptual Cross-Section of Ultrasonic Seepage Meter Flow Tube (from Paulsen et al., 2001)

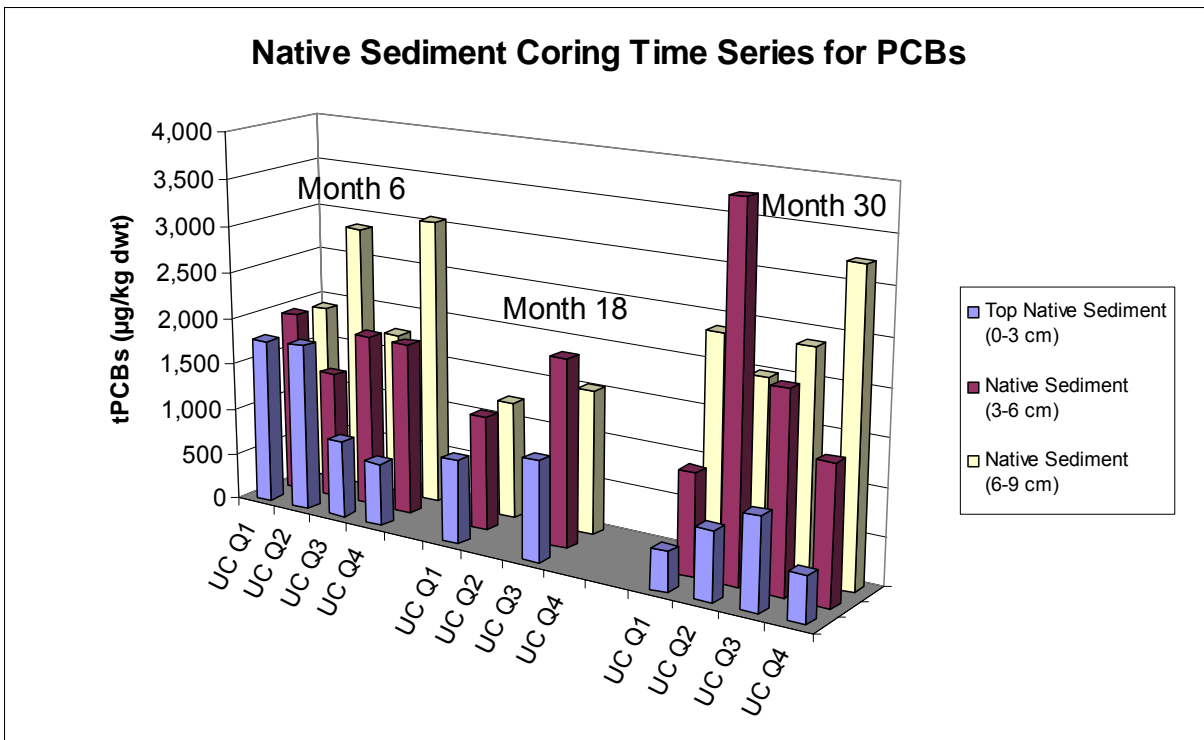
Figure 3-26. Total PCBs in Control Cell Cores

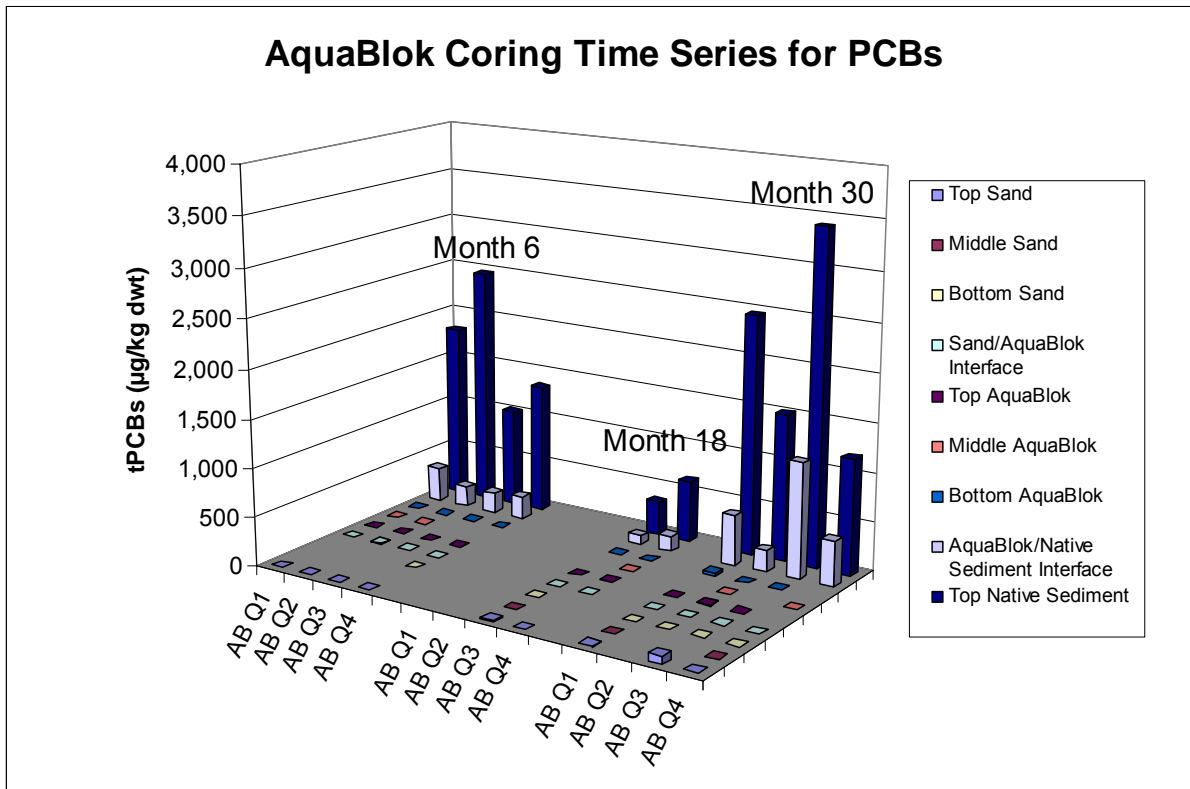
**Figure 3-27. Total PCBs in AquaBlok® Cell Cores**

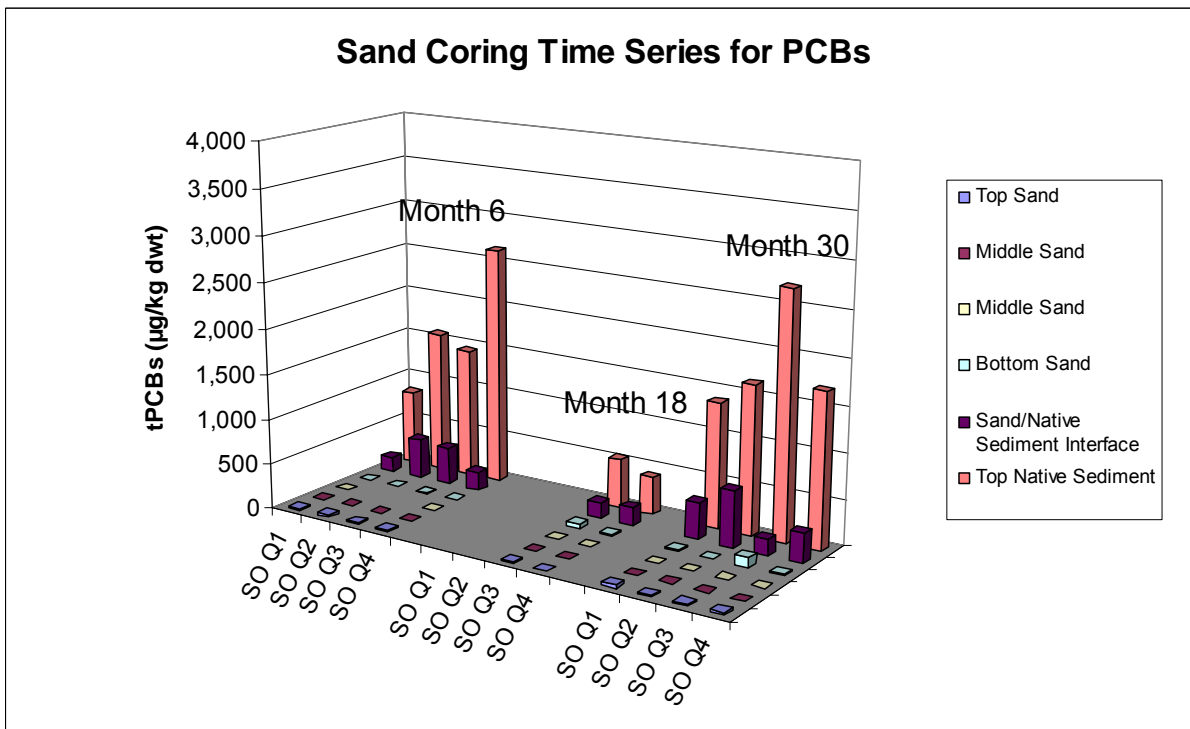
**Figure 3-28. Total PCBs in Sand Cell Cores**

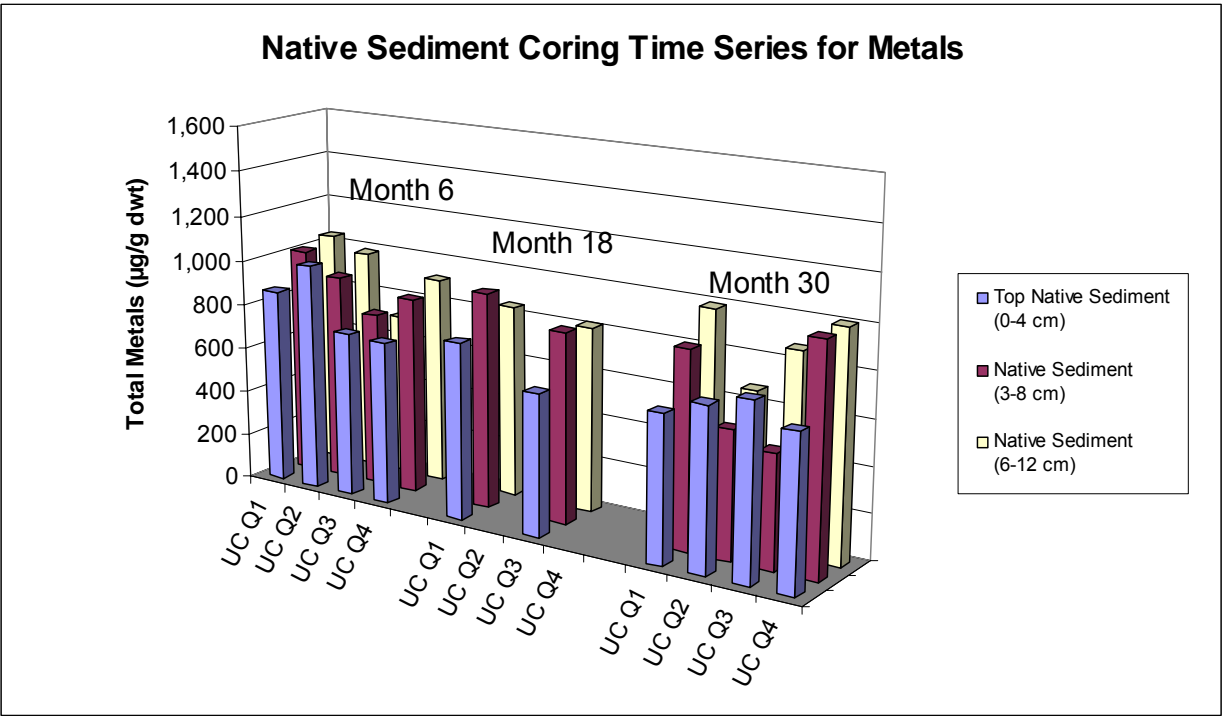
**Figure 3-29. Total Metals in Control Cell Cores**

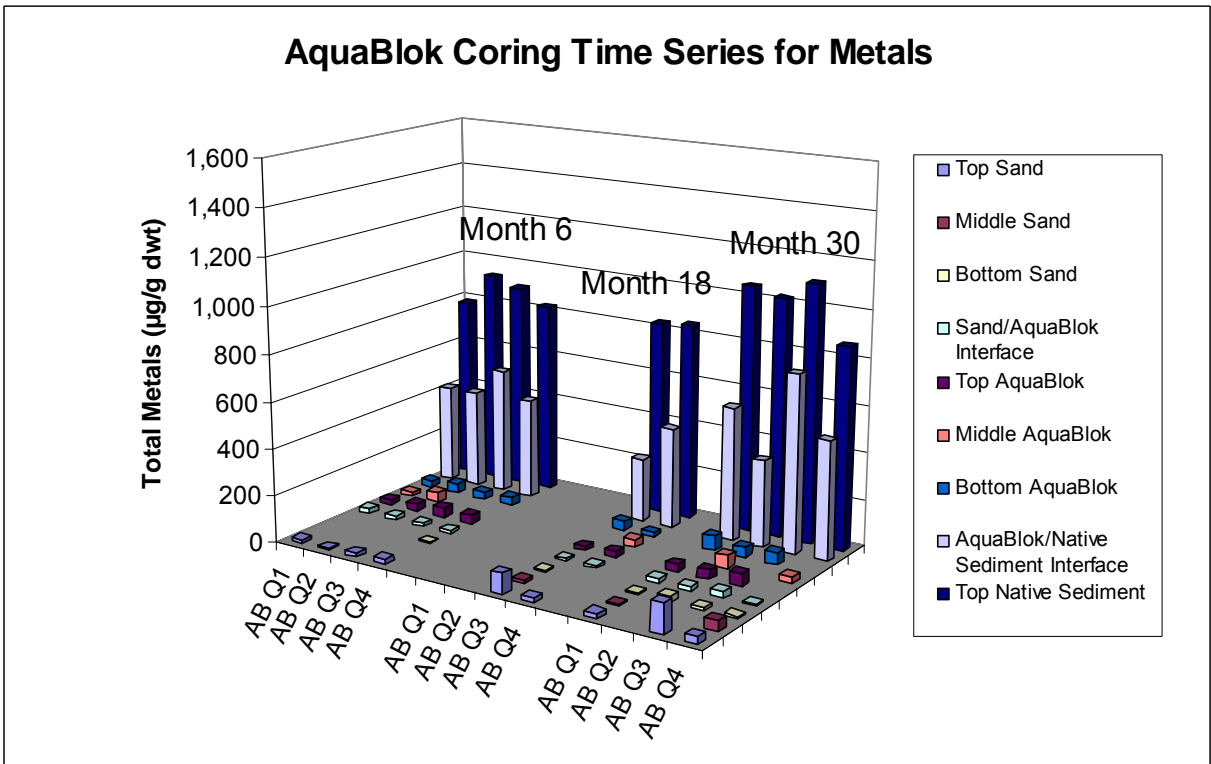
**Figure 3-30. Total Metals in AquaBlok® Cell Cores**

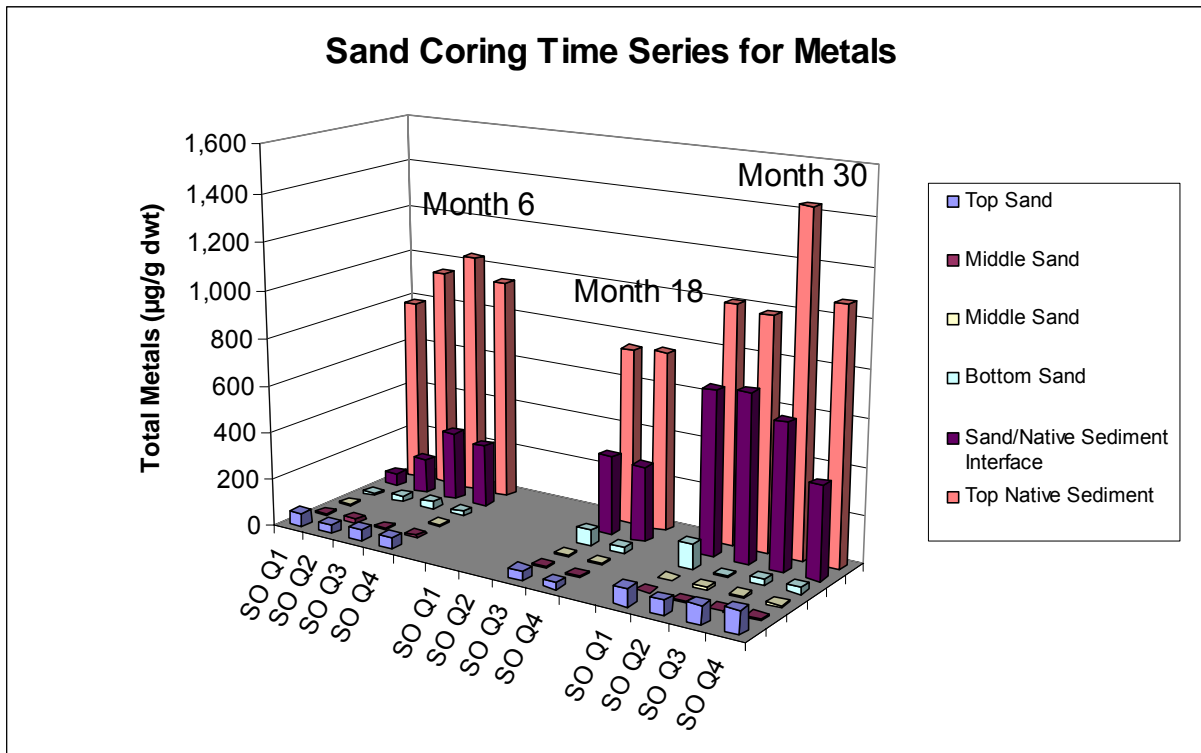
**Figure 3-31. Total Metals in Sand Cell Cores**

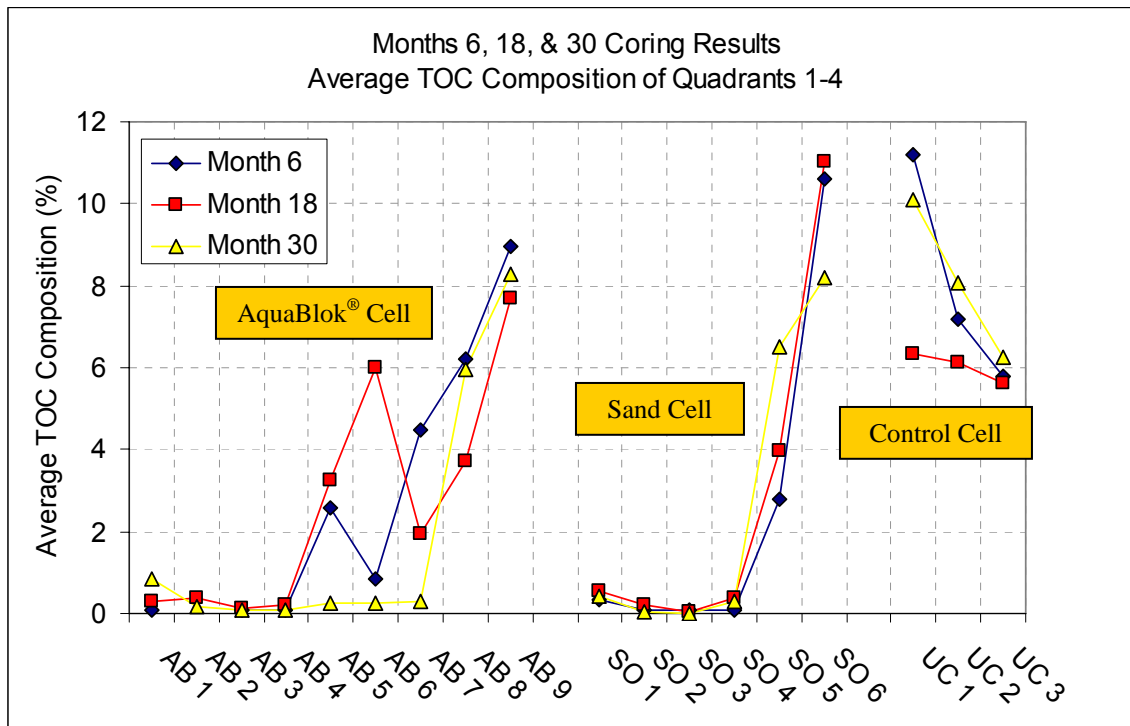
**Figure 3-40. Average TOC Concentration in Demonstration Area During SITE Demonstration (x-axis represents vertical core profile from shallowest at left to deepest at right)**

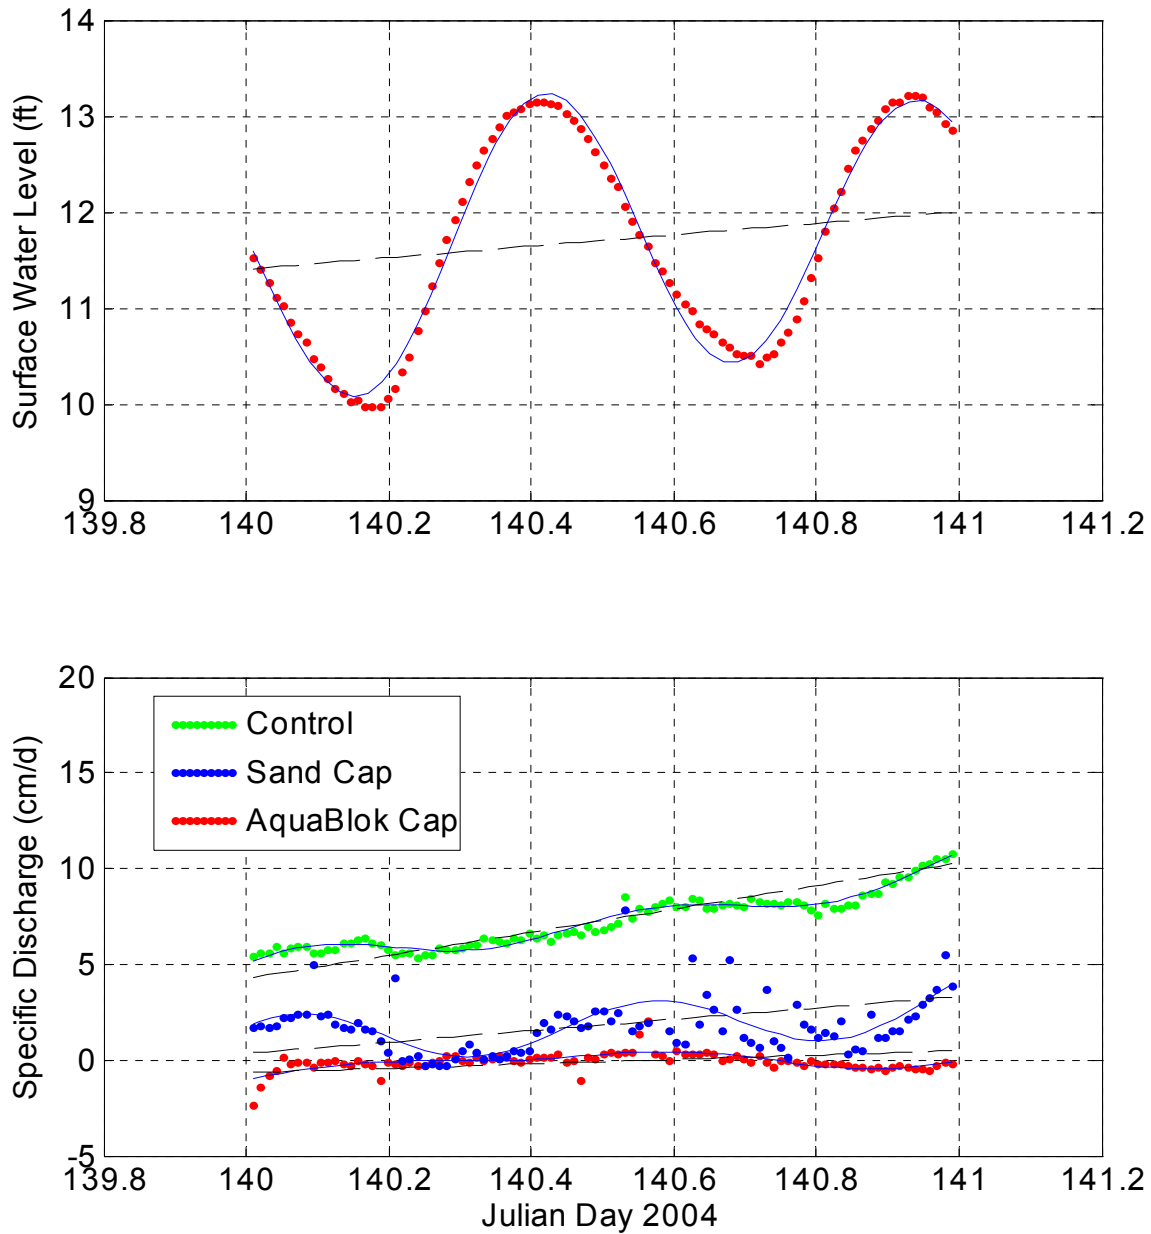
**Figure 3-42. Specific Discharge Rates in Demonstration Area During One-Month Post-Capping Survey (top panel is tidal phase, lower panel shows discharge as points, harmonic fit as solid curve, and trend as dashed line)**

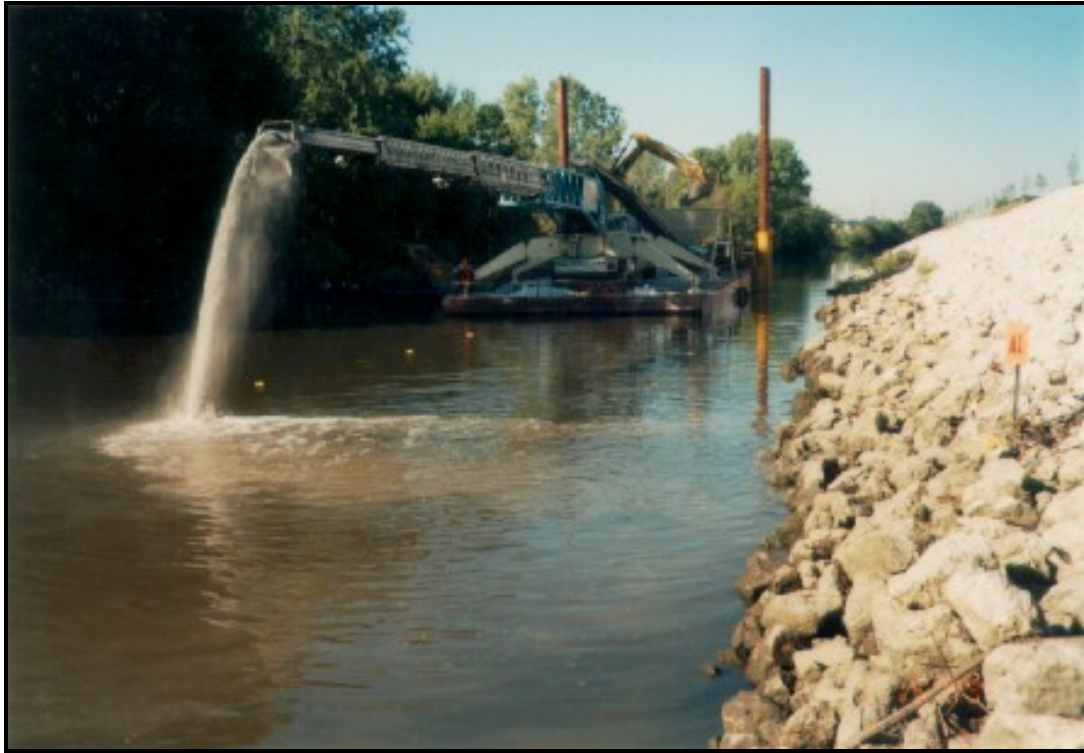
**Figure 4-1. Typical Barge-Mounted Material Conveyor**

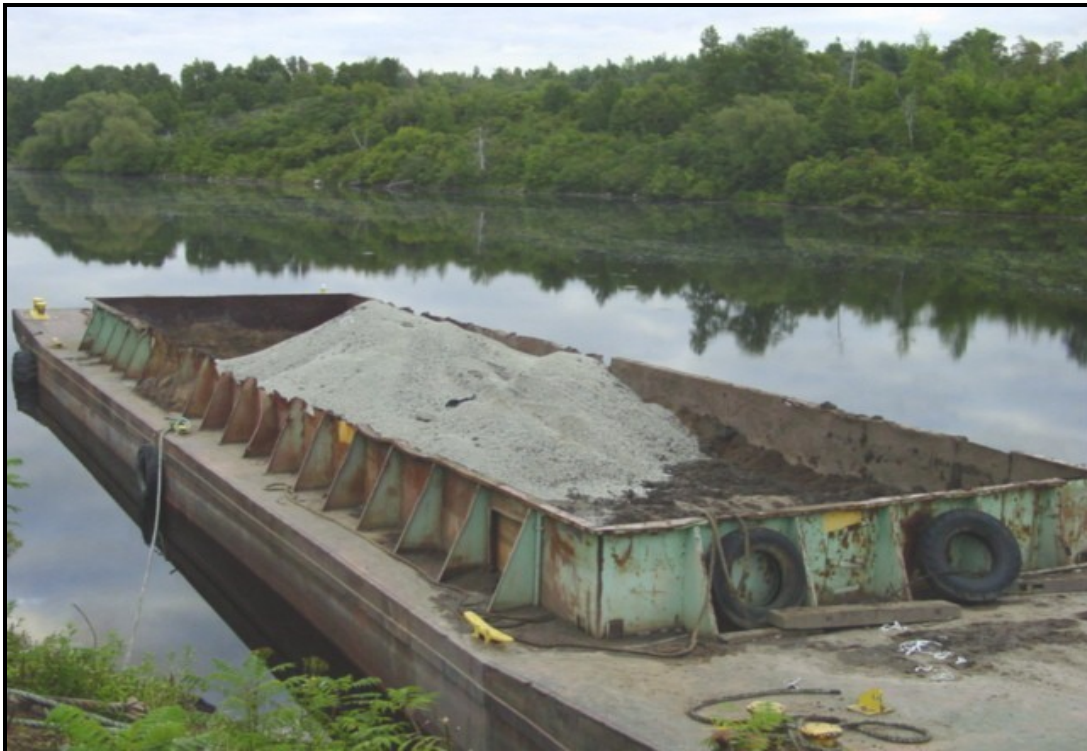
**Figure 4-2. Typical Material Barge**
