# ESTCP Cost and Performance Report

(RC-200610)

## Application of a Solvent Emulsion Technology for PCB Removal from Older Structures on DoD Facilities

November 2011

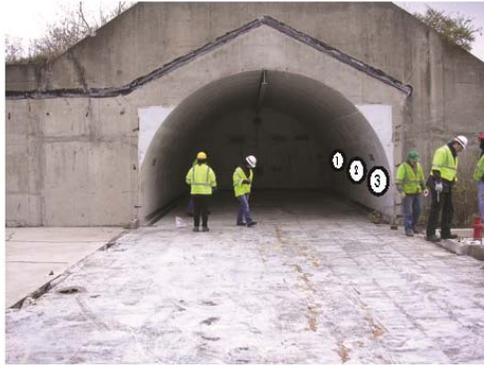
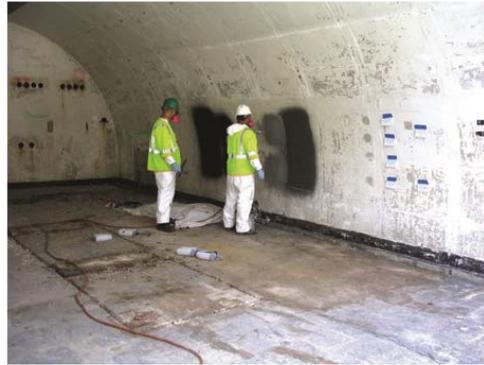
<b>Bunker/Press House 6810-11</b> BTS Paste Application		<b>Figure 5.2</b>
Guelph	February 2010

**Figure 4. Bunker/Press house 6810-11.**

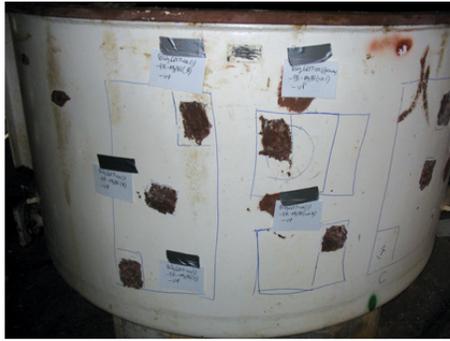
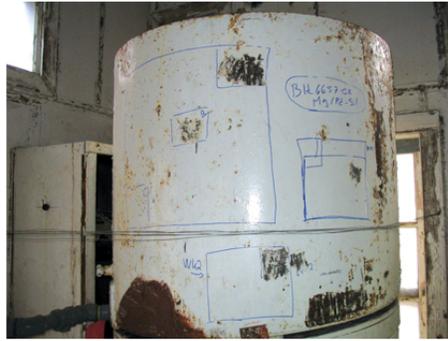
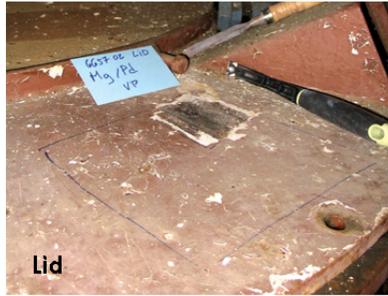
**Large Tank**  
Mg/PD and NM-VP

**Small Tank**  
Mg/Pd Sil

<b>Nitrating House 6657-02</b> BTS Paste Application		<b>Figure 5.4</b>
Guelph	February 2010

**Figure 6. Nitrating house 6657-02.**

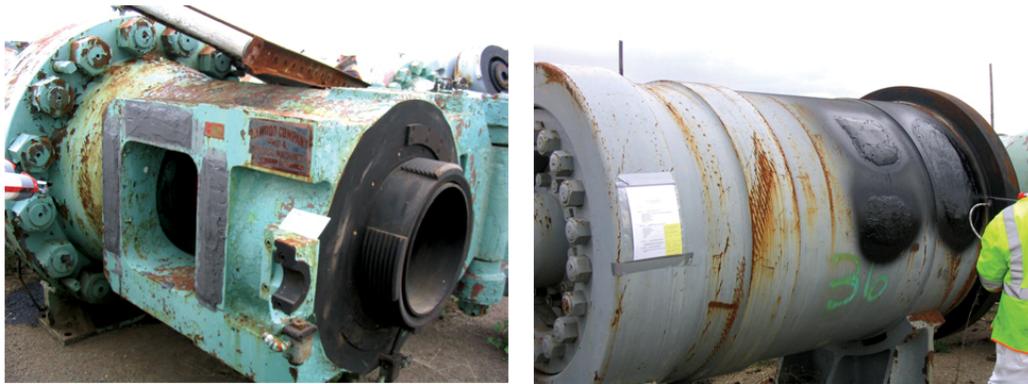
BTS Paste applied to various spots on press #4, 12, 14, 15, 36

**Figure 7. BTS paste applied to presses.**
