Brenda L. Pohlmann  
Perchlorate Occurrence in  
Nevada

Environmental Scientist, Supervisor  
State of Nevada  
Division of Environmental Protection  
Las Vegas, Nevada

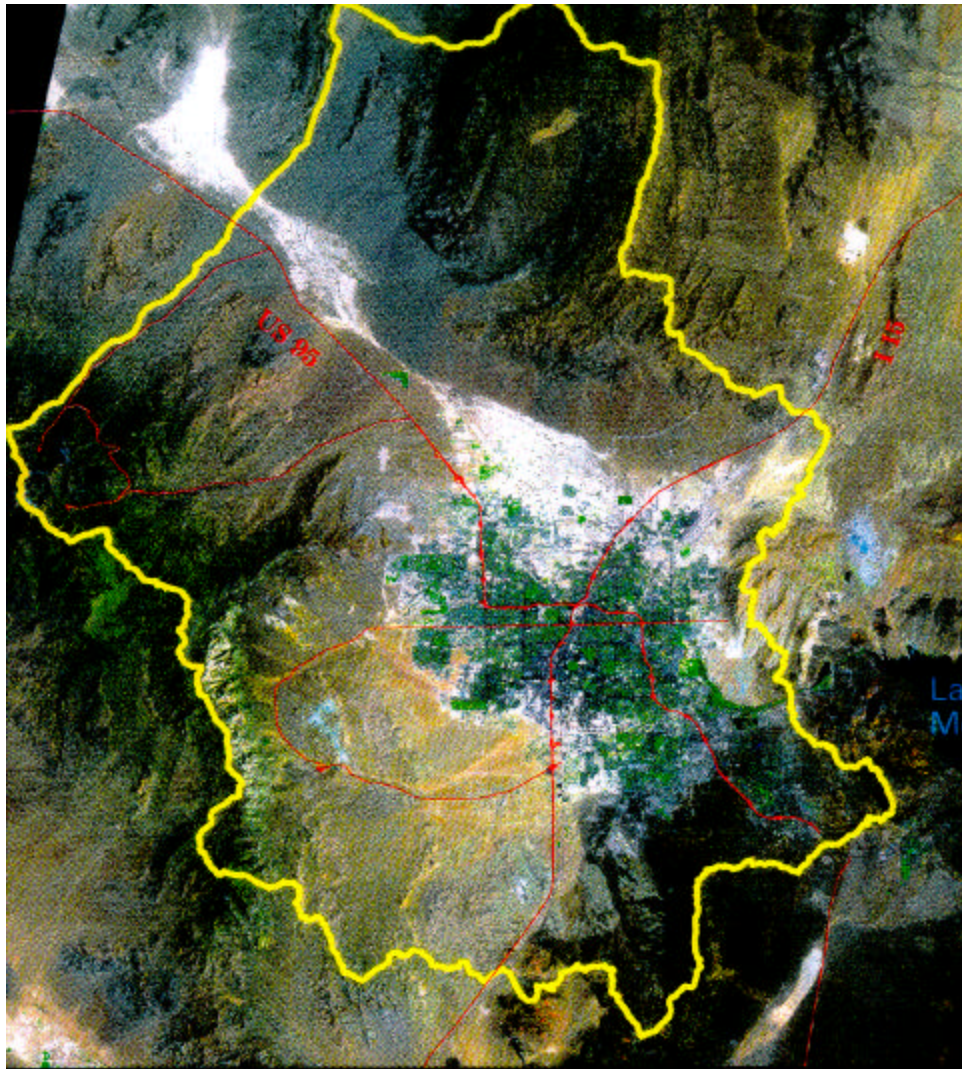
Satellite Image of Las Vegas Valley, Nevada  
Bands 7 4 2 June, 1996

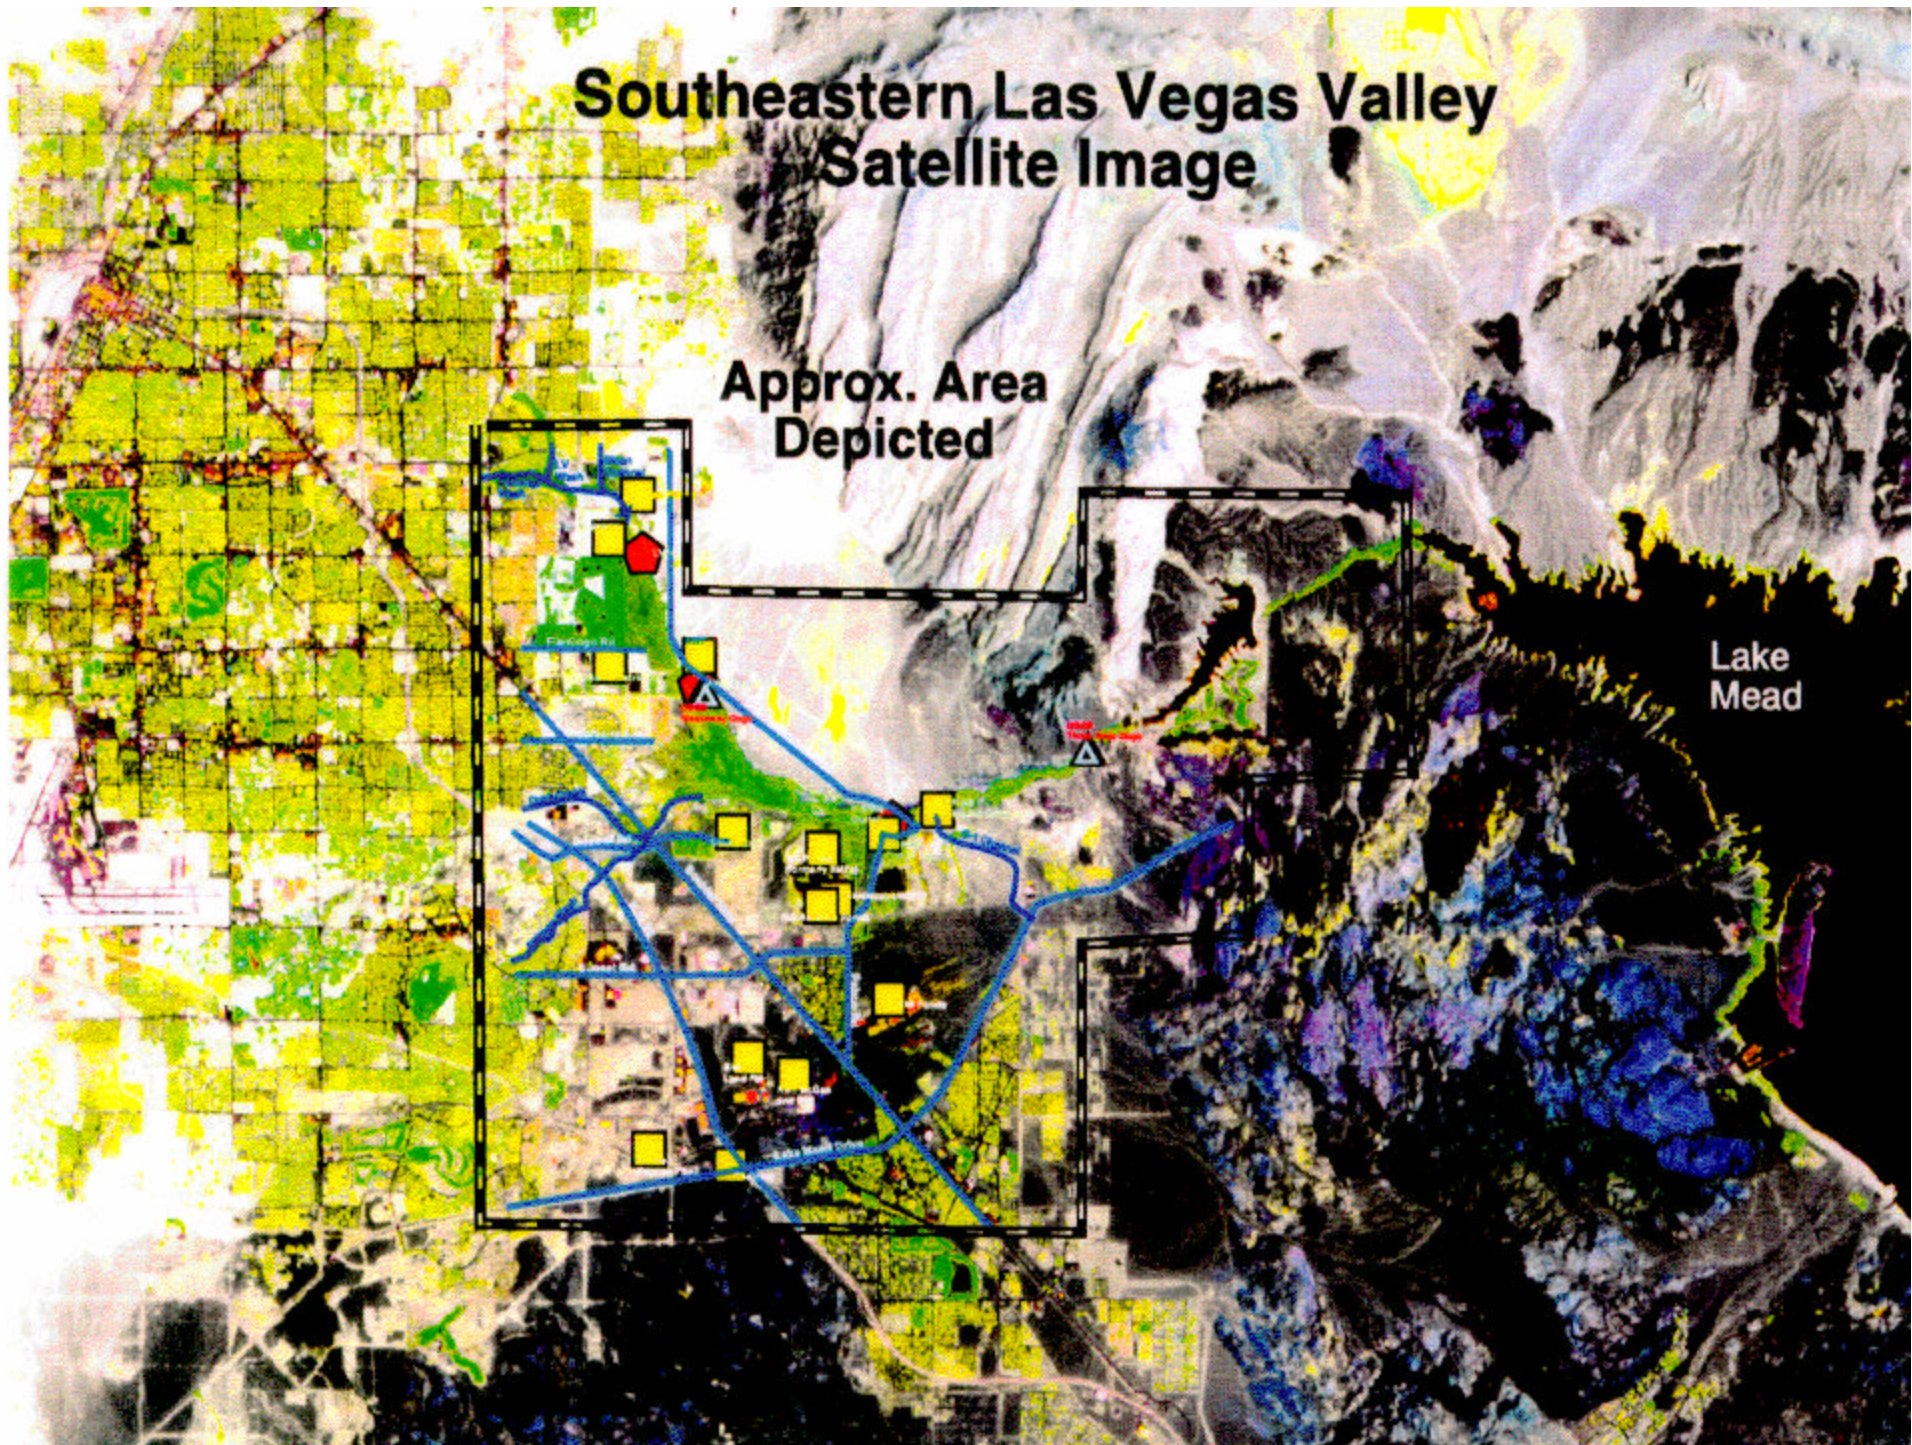
# July 1997 Lake Mead Perchlorate Results ( $\mu\text{g/L}$ )

Sampled July 23 & 24, 1997

Las Vegas Wash--86	Arch Mountain--7
Las Vegas Bay--42	Overton Arm--ND
Black Island--19	Muddy River--ND
Hoover Dam--15	Virgin River--ND
Beacon Rock--12	Temple Bar--ND
Callville Bay--12	Little Burro Bay--ND
Callville Wash--11	Iceberg Canyon--ND
West End Wash--11	(ND = Not detected)

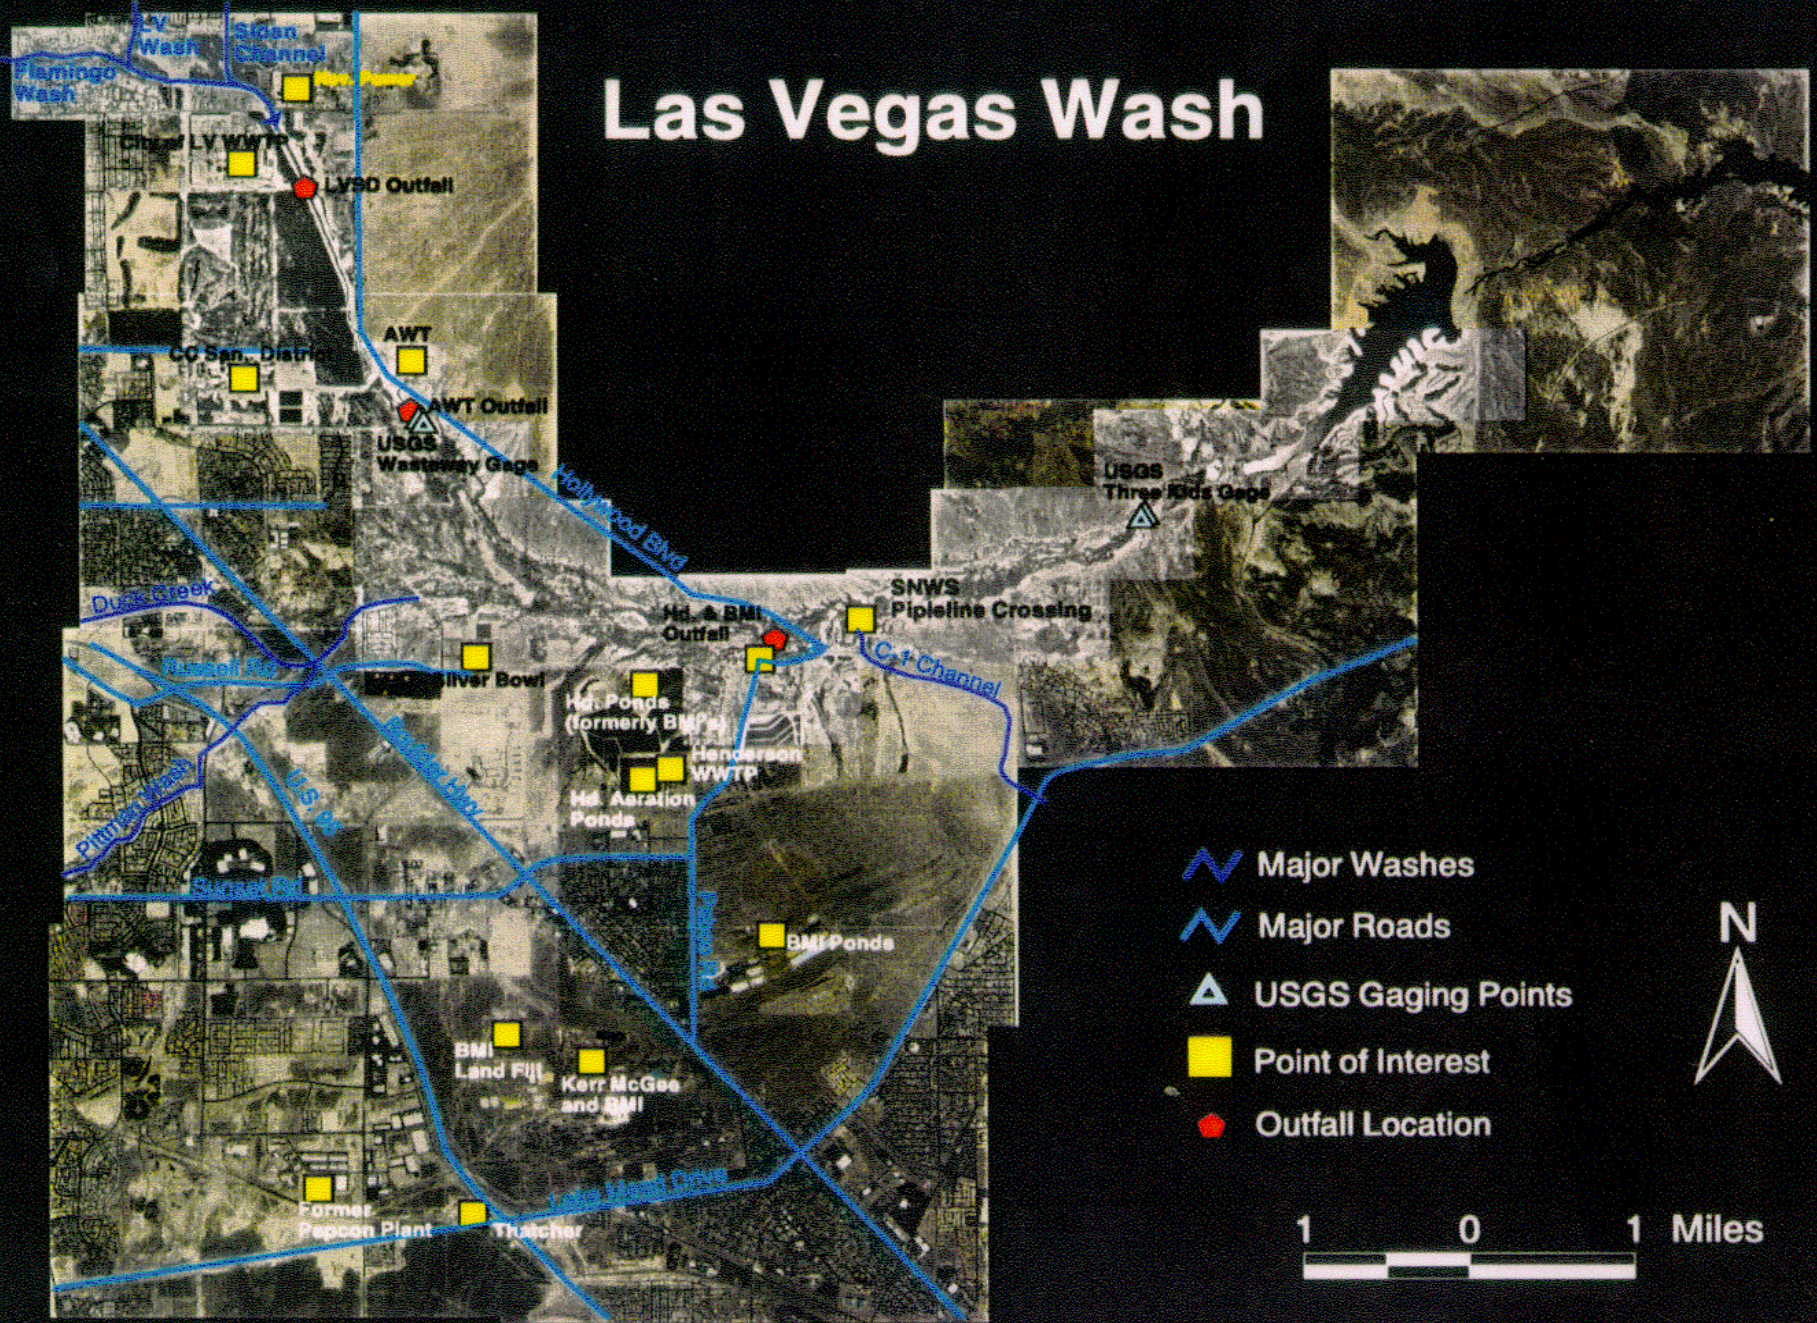
# Las Vegas Wash

- Major Washes
- Major Roads
- USGS Gaging Points
- Point of Interest
- Outfall Location
