ASTSWMO

**Sediment Remedy Effectiveness and
Recontamination: Selected Case Studies**

April 2013

Sediment Remedy Effectiveness and Recontamination: Selected Case Studies

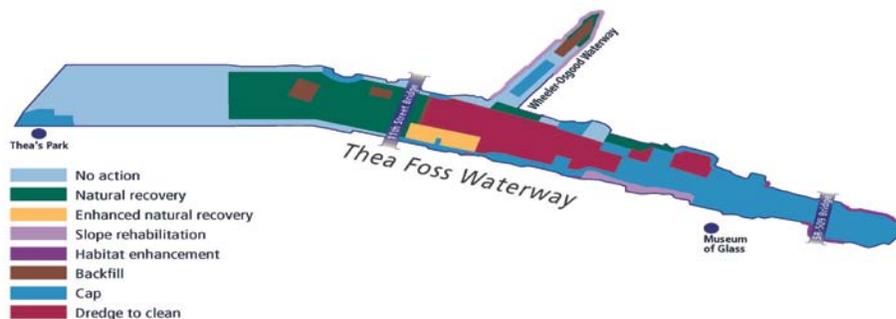
Figure 1: Thea Foss Waterway cleanup design.

Summary of Remediation: In 1994, the City of Tacoma began developing a cleanup plan and investigated the sources and extent of contamination in the Thea Foss Waterway. This included hundreds of sediment samples from various depths and extensive chemical and biological tests. Based on the results of those tests, along with navigational uses of the waterway, cleanup options were developed. The City cleaned up 80 percent, an area extending from near the State Route (SR) 509 Bridge to the mouth of the waterway. Two utility companies (Utilities) cleaned up the other 20 percent, an area extending just north of the SR 509 Bridge to the head of the waterway. Beginning in 2002, about 425,000 cubic yards of contaminated sediments were dredged and placed behind a containment berm. Other areas of the waterway were capped with clean sediments (Figure 1).

The cap in the head of the waterway was completed by the Utilities in 2004, and in that same year recontamination of the sediment surface on top of the cap was discovered north of the SR 509 Bridge. The cause of the recontamination was determined to be dredging of contaminated sediment by the City in an area directly north of the Utilities' completed cap. In December 2005, additional cap material was placed by the City in the northern section of the head of the Thea Foss Waterway to address recontamination of the cap.

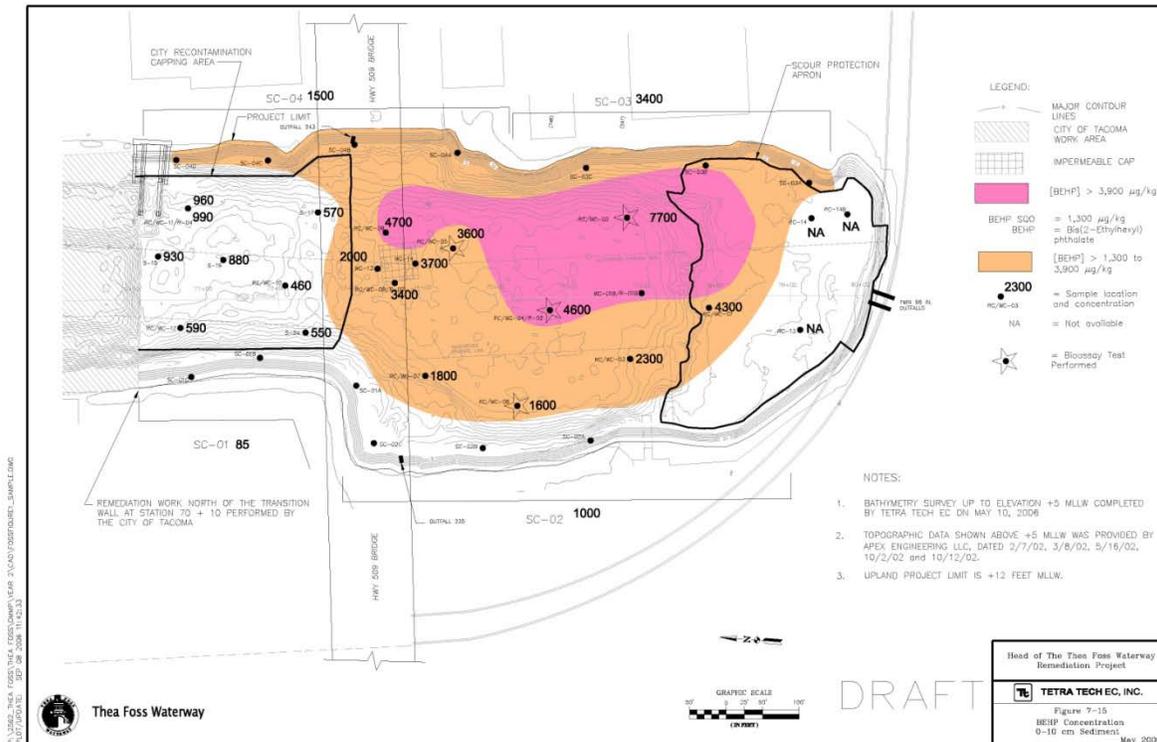
Figure 2: BEHP recontamination in the Thea Foss Waterway.

Monitoring and Maintenance Plan (OMMP) Year 2, 3, and 4 post-cleanup monitoring (2006, 2007, and 2008, respectively) results confirmed that BEHP had recontaminated the cap at the head of the waterway (Figure 2).

In response to the recontamination, the OMMP required specific next steps:

- Evaluate biological toxicity response to the BEHP chemical exceedances.
- Evaluate the probable cause of the BEHP exceedance.
- Consider the need for additional sampling to either define nature and extent or to determine the source.

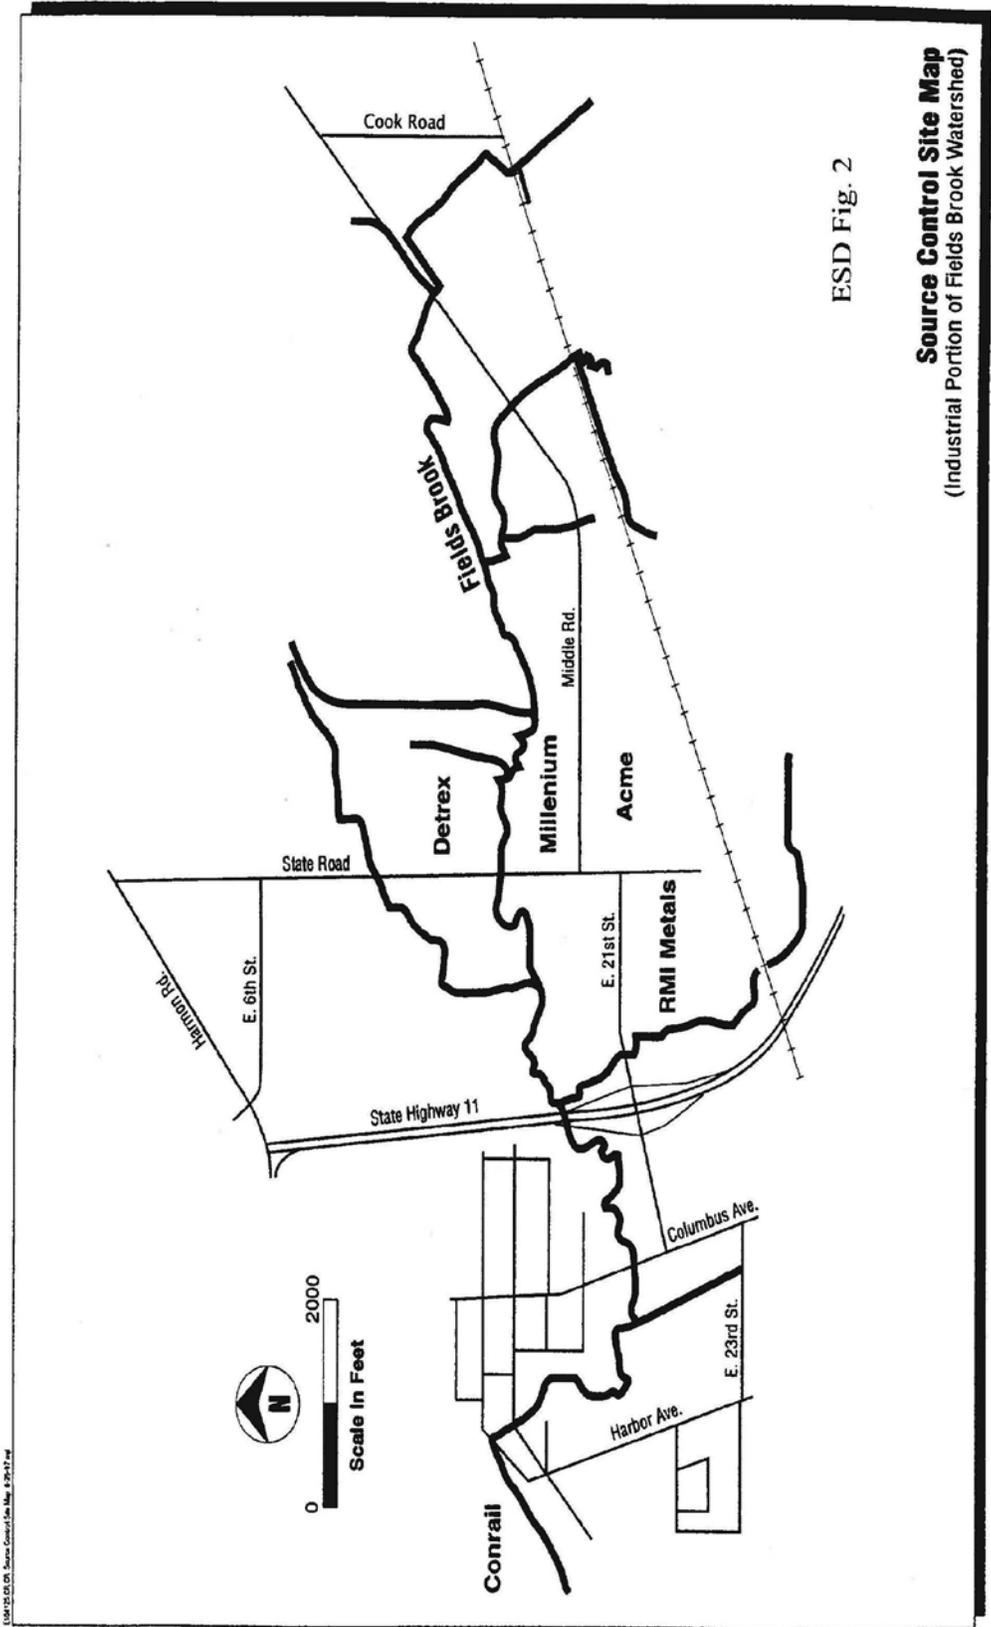
ESD Fig. 2

Source Control Site Map
(Industrial Portion of Fields Brook Watershed)

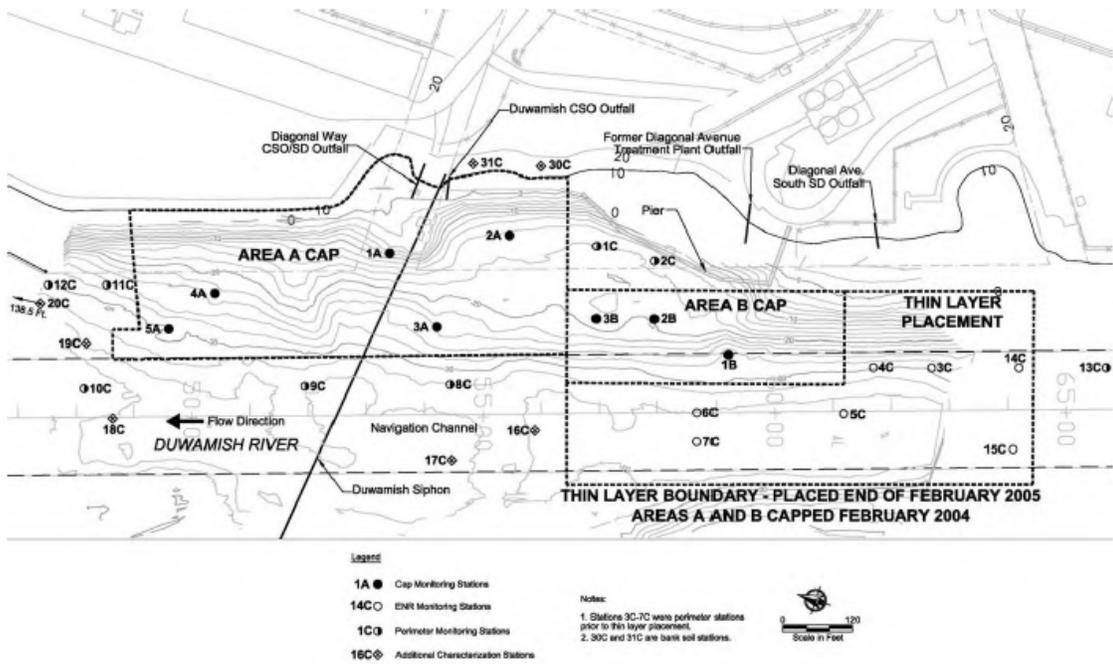
Figure 1. Duwamish Diagonal Site and Monitoring Stations

FIGURE 2: Duwamish/Diagonal Monitoring Stations. (from King County. May 2010. *Duwamish/Diagonal Sediment Remediation Project: 2008/2009 Monitoring Report*. Elliott Bay/Duwamish Restoration Program Panel Publication 42.)

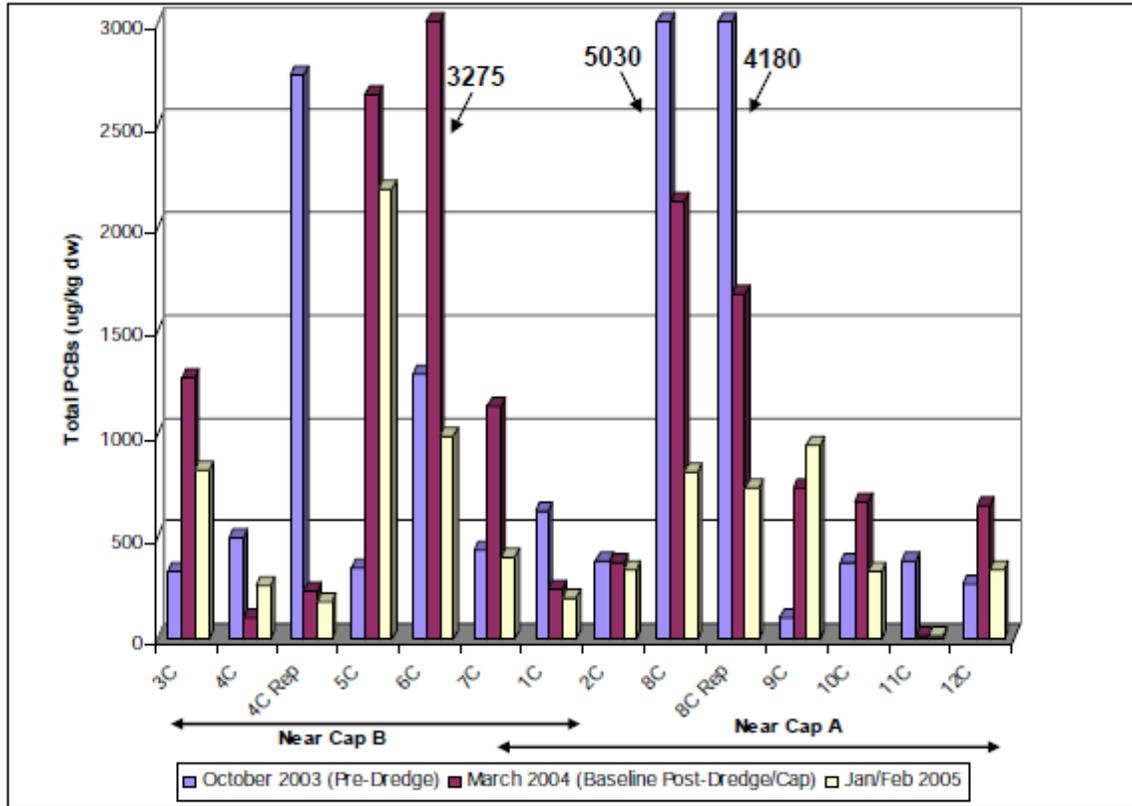
Figure 2. Changes in PCB Concentrations at Duwamish Diagonal Perimeter Stations (2003-2005)

FIGURE 4: Duwamish/Diagonal Pre-/Post-Dredging PCB Concentrations. (from King County. May 2010. *Duwamish/Diagonal Sediment Remediation Project: 2008/2009 Monitoring Report*. Elliott Bay/Duwamish Restoration Program Panel Publication 42.)

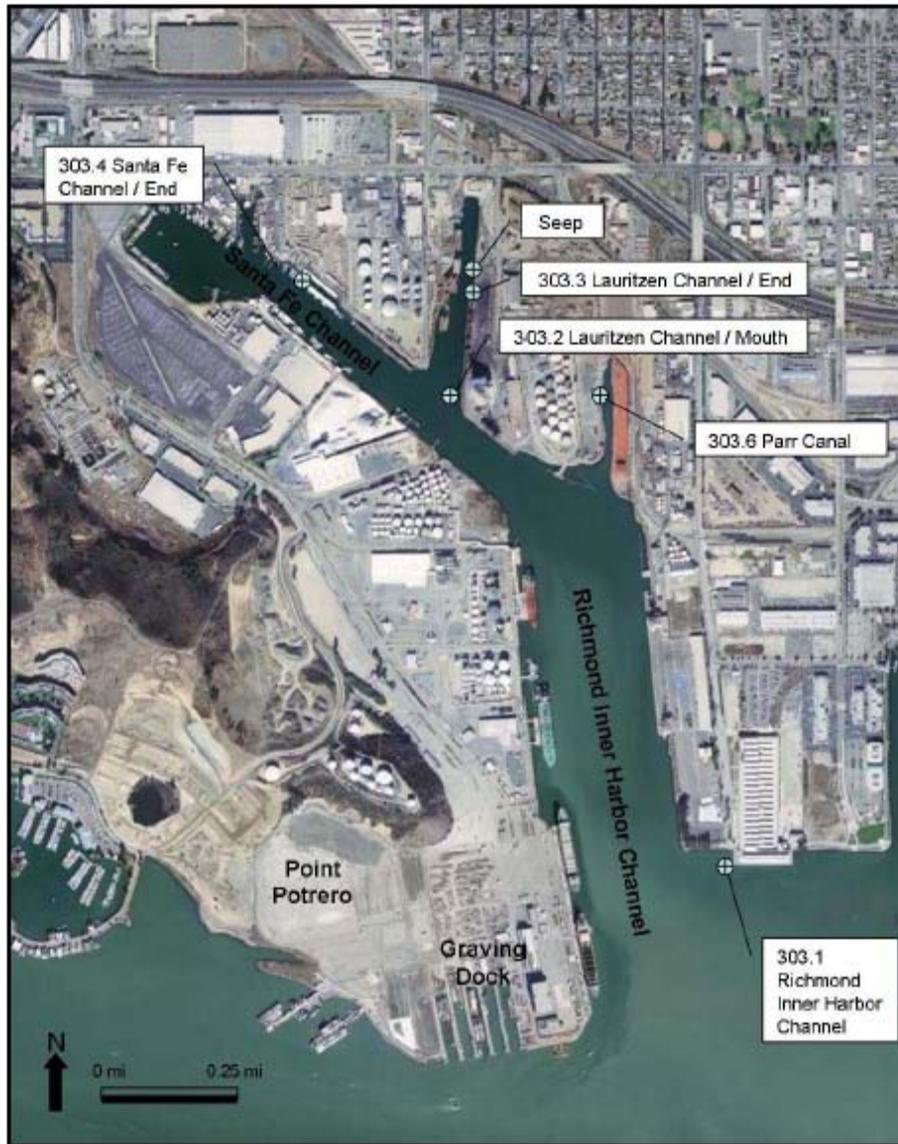
FIGURE 4-2
Sampling Locations for Marine Biomonitors Program

Figure 2: Aerial photograph of United Heckthorn Site with sampling locations for marine biomonitors (from EPA, 2006; Figure 4-2).
