Joint Expeditionary Base Little Creek - Fort Story Site 8, Demolition Debris Landfill Virginia Beach, Virginia FFRRO Case Study

Former Landfill Converted to Tidal Wetlands In the Chesapeake Bay

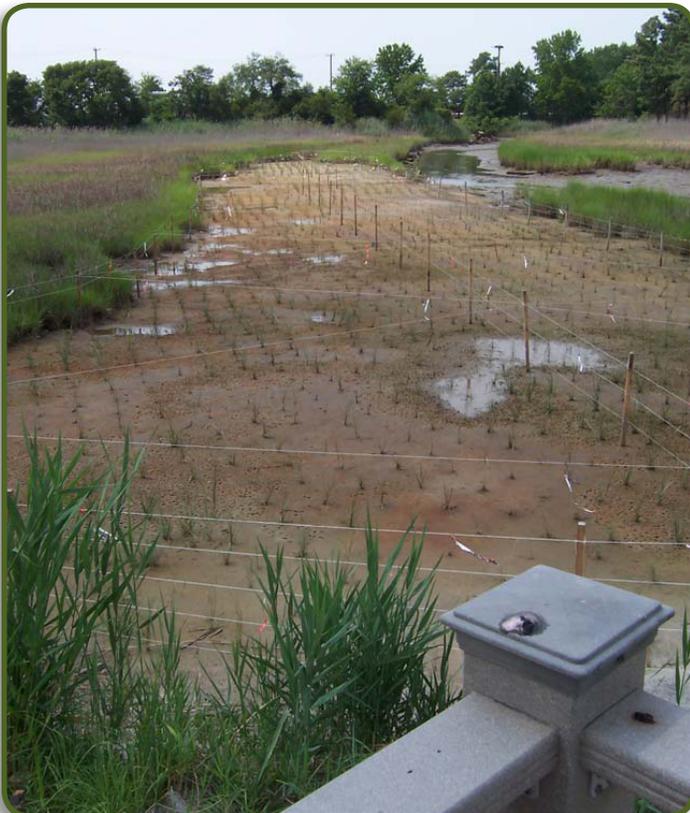
Northwest Quadrant just planted (Summer 2006)

As shown in the figures of the northwest quadrant, native vegetation has thrived after only two years of growth. Site 8 currently consists of both low marsh and high marsh vegetation. Two observation platforms with binoculars allow viewing of the site. People able to access the site are drawn to the platforms to view the wildlife that uses the marsh habitat.

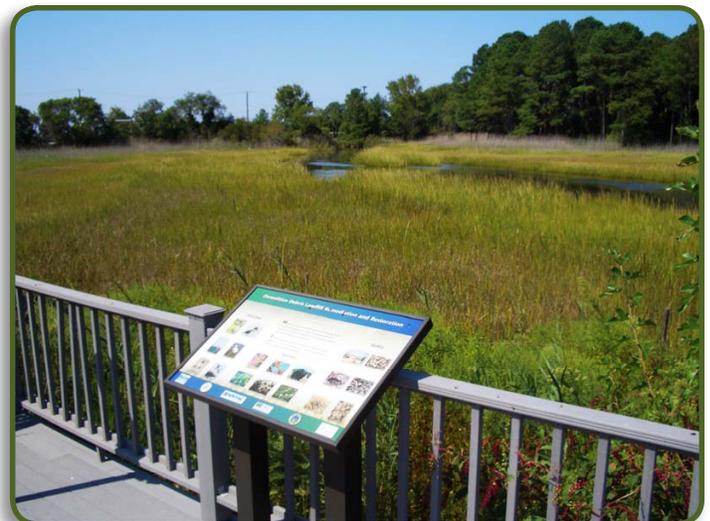
Northwest Quadrant 2 years after planting (Sept. 2008)

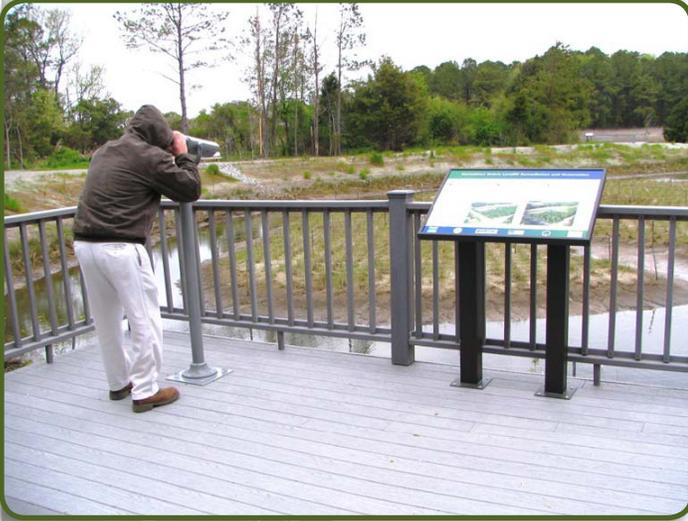
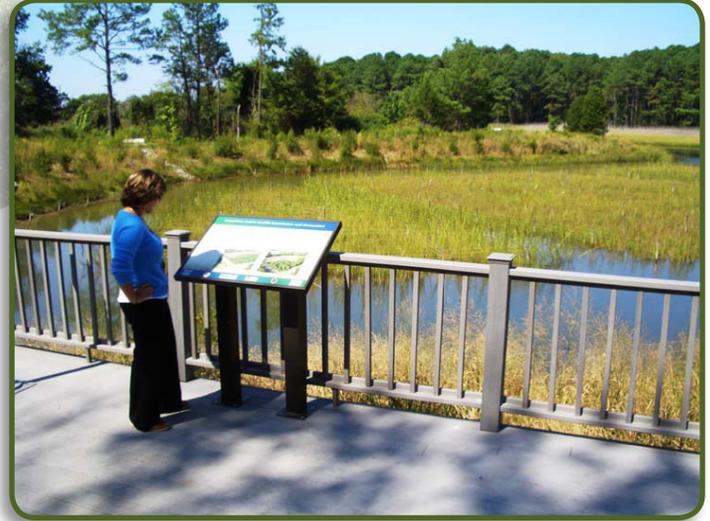
Observation platform 1 year (left, Apr 2007) and 2 years (right, Sept 2008) after planting.

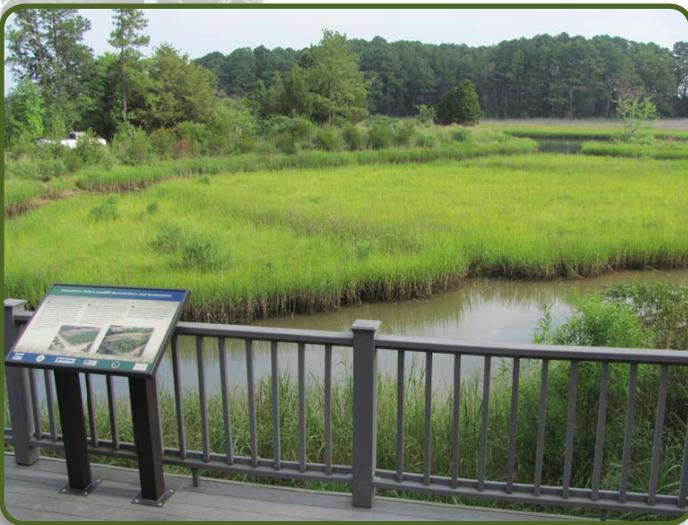
Observation platform 4 years after planting (July 2010).
