# Managing Mine Slimes and Other Lessons Learned

**Jack Waite Mine Removal Action**

April 5, 2012

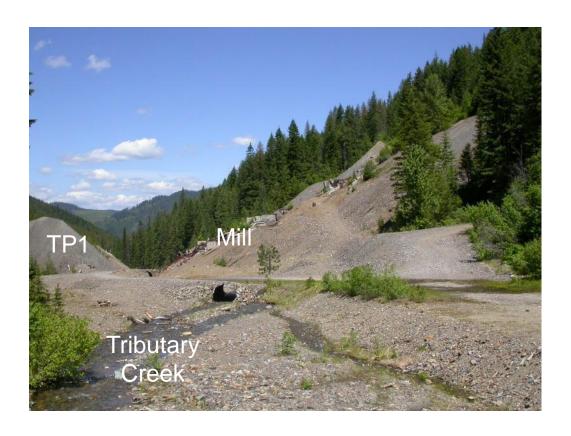
# Tailings Pile 1, Mill Area, & Tributary Creek

TP-1 (110,000 cy); Mill Area (14,000 cy); Alluvium (2,900 cy)

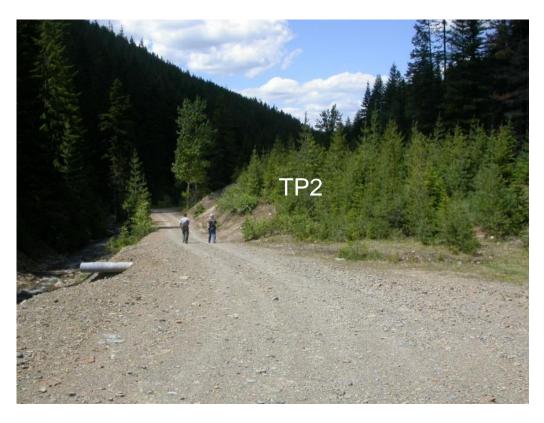
# Tailings Pile 2

TP-2 (15,000 cy Tailings)

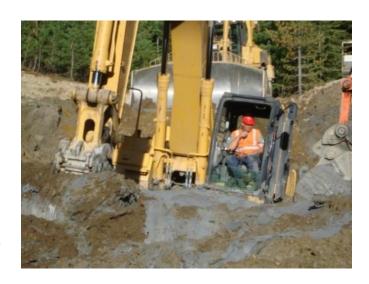
- Design Approach
  - Borings and cone penetrometers completed through tailings piles
- 2011 Construction Issue
  - TP2 slimes encountered in July 2011
  - Difficult to excavate material
  - Difficult to haul material transportation caused separation of solids / liquids & spills
- Solutions / Lessons Learned
  - Temporary stockpile material to dewater, addition of Portland
    Cement (5%); transportable; achieved good compaction
  - For tailings piles, focus on potential volume of this material

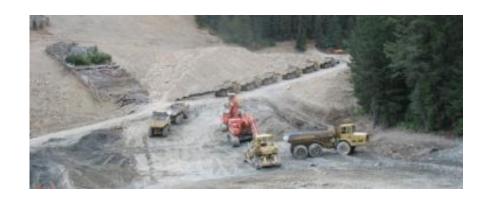
- Repository cover / rehabilitation area growth media and fill primarily developed from Borrow Area 2
- Test pits used to estimate depth of borrow soils
- Field observations /
  geotechnical data used to
  evaluate gradation (oversize
  vs. granular material)
- Borrow soil volumetrics developed using CAD 3D and gradation

- 2011 Construction Issue
  - Significantly more oversize
    material 19,000 cy vs. 11,000 cy
  - Limited stockpiling areas / double handling in steep terrain
- Solutions / Lessons Learned
  - Design approach should use grizzly / screening for oversize rock
