39-Mile Dredging/Capping Approach Used to Treat Fox River PCBs

Pilot Study Shows Effective Cap Design for PCB-Contaminated Sediment

EPA 542-N-08-005
October 2008
Issue No. 38

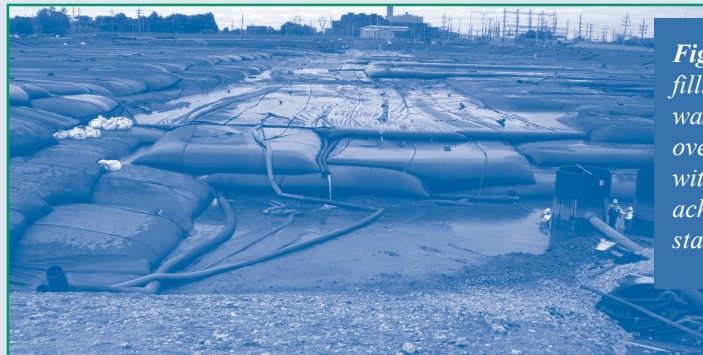
Figure 1. Prior to filling, each tube was placed in an overlaying pattern within the landfill to achieve a 10-layer stack.

Partnership, submitted a request to the GLNPO requesting funds under the newly authorized Great Lakes Legacy Act (GLLA). After extended technical, legal, and financial discussions, active remediation on the \$58 million river project began in 2006, with the GLLA providing \$29 million in funding. The final design called for hydraulic excavation of sediments; hydraulic transport of the dredged slurry to the landfill through a 2.5-mile long, double-walled pipeline; dewatering of the sediment slurry using geotubes; and treatment of the water through a 5,000-gpm water treatment plant. Dewatering was designed to occur at the 1,000,000-yd³ TSCA-permitted landfill, with geo-textile tubes (geotubes) left in place for final disposal (Figure 1).

At the landfill, the sediment slurry was pumped into geotubes that were approximately 300 feet long and 75 feet in diameter. As slurry moved into each tube, a polymer was added to increase coagulation of sediment particles. Coagulated particles remained inside the geotubes while slurry water exited by gravity through pores of the geotube's woven material. Filled tubes were allowed to air dry for approximately 15 days in order to achieve a solids content of approximately 40% before additional tubes were placed on them. The 13.5-acre TSCA-permitted landfill was constructed with two 60-mil synthetic liners, a geosynthetic clay liner, and several drainage layers along with a leachate collection system.

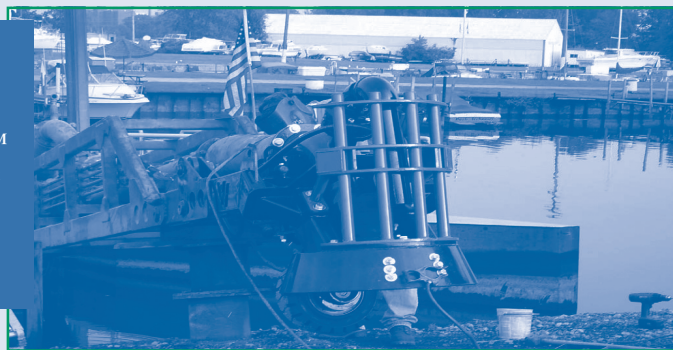
Figure 2. The 8-inch hydraulic dredge with attached Vic-Vac[™] prepares to launch in target portions of the Ashtabula River AOC.

equipped with an innovative Vic-Vac[™] suction dredge-head (Figure 2). The 8-inch dredge operated in parallel with the 12-inch dredge, with both simultaneously discharging to the double-walled pipeline. By operating in parallel, the 12-inch dredge could focus on high production dredging that generated thicker cuts, while the 8-inch dredge focused on cleanup dredging that generated thin residual sediment layers. Typically, cleanup dredging results in hydraulic slurries with just 1-2% percent solids, which can present problems with dewatering and water treatment. By operating parallel dredges and combining the slurry streams, however, operations were able to maintain a consistent and reasonably high solids content (8-15%) in the combined slurry while performing cleanup operations specifically targeted at reducing residual contamination. The 8-inch dredge operated at an average production rate of approximately 1,000 gpm, and the 12-inch dredge operated at an average rate of 3,500 gpm. Cleanup dredging was performed on approximately 10 of the site's total 30 acres where underlying bedrock prevented overdredging of contaminated sediments.

Previous experience at this and other sites suggested that significant amounts of residual contamination would remain in these dredged areas. Confirmation sampling after dredging indicated, however, that in areas where the Vic-Vac was used, the surface-weighted average concentration was 0.1 mg/kg total PCBs, well below the long-term cleanup goal.
