Alternative Cover Assessment Program 2002 Annual Report

October 2002

U.S. Environmental Protection Agency

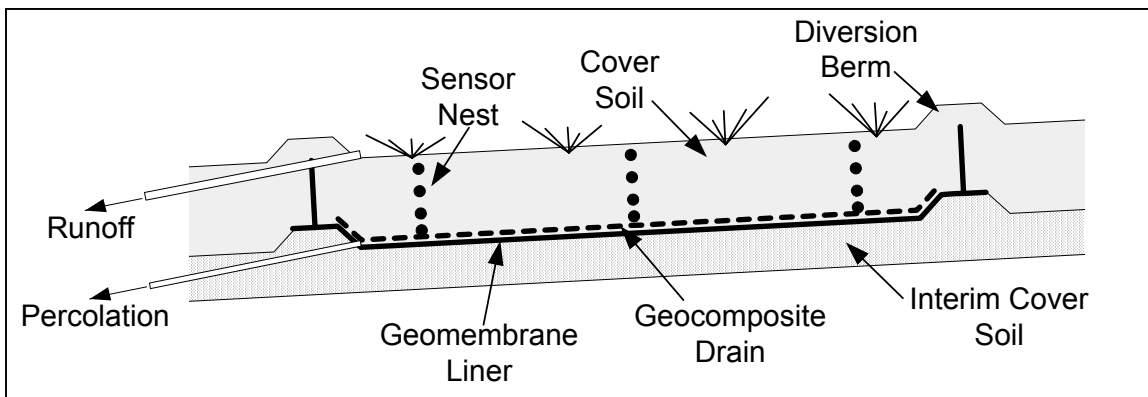
Figure 3. Schematic of ACAP drainage lysimeter.

The primary features of the ACAP program are the large pan-type lysimeters (Benson et al. 1999) located at 10 of the sites (Figure 3). These 10 m x 20 m geomembrane basins allow direct measurement of most variables in the near-surface water budget. The geomembrane is low-density linear polyethylene (LLDPE) and forms the bottom and sides of the lysimeter. Full-scale (in depth) models of the tested cover designs were constructed in the lysimeters. A geocomposite drainage layer was placed between the geomembrane and the cover soils to protect the membrane and allow rapid lateral transmission of intercepted water through the drainage collection system. Surface berms surround the lysimeter to prevent run-on and collect run-off. Collection systems made of PVC pipe carry drainage and surface run-off water to measurement systems. Soils within the lysimeters are instrumented at multiple depths for measurement of soil moisture content and matric potential.

The primary method of measuring deep percolation and surface runoff is by a dosing siphon. The siphons used in the ACAP program are activated by the addition of 85-100 liters of water to the siphon basins (95 liters corresponds to 0.475 mm of flux distributed aerially across the lysimeter). Siphon activation triggers a float switch to send a signal to the data logger. Each basin is individually calibrated. A pressure transducer, located in the bottom of each siphon basin, makes additional verification of siphon events by use of an algorithm in the data logger program that determines the rate and direction of change in the transducer measurements. In each deep percolation basin, where expected flow rates are low, a tipping bucket gauge provides an additional measurement of flux.

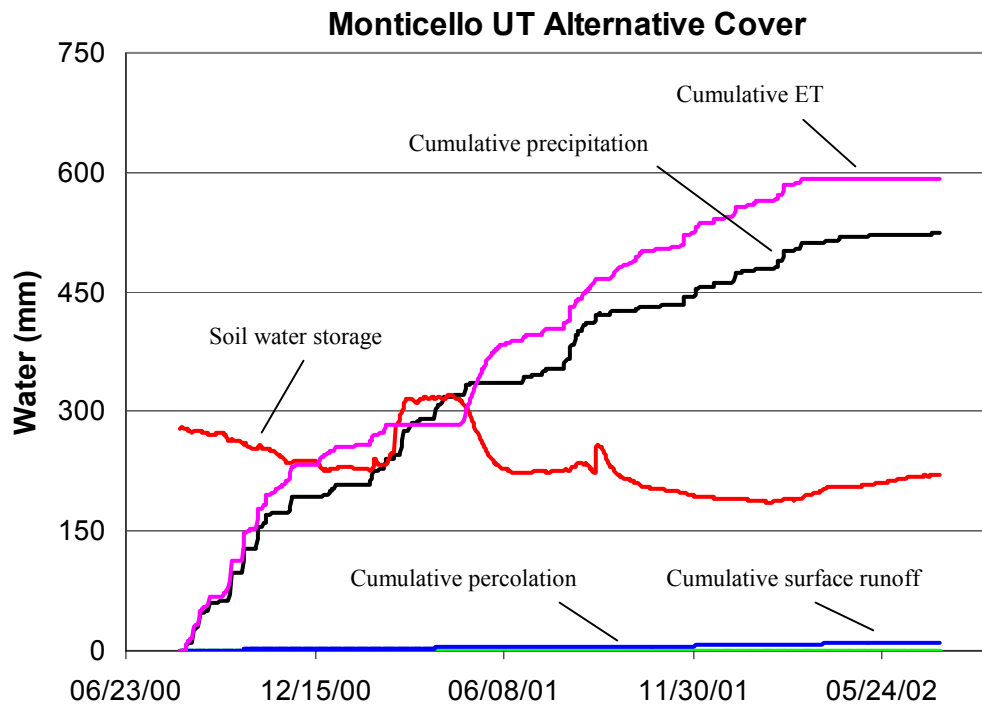
Figure 21. Water balance summary for the alternative cover design at the Monticello UT ACAP site.

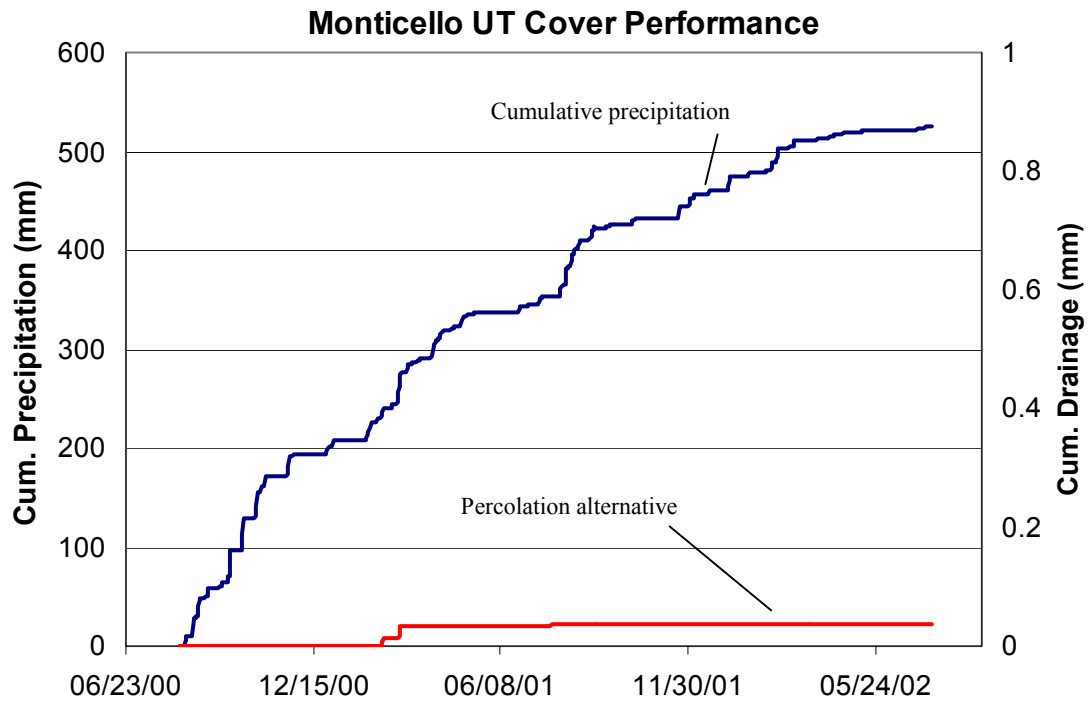
Figure 22. Cover performance at Monticello UT.

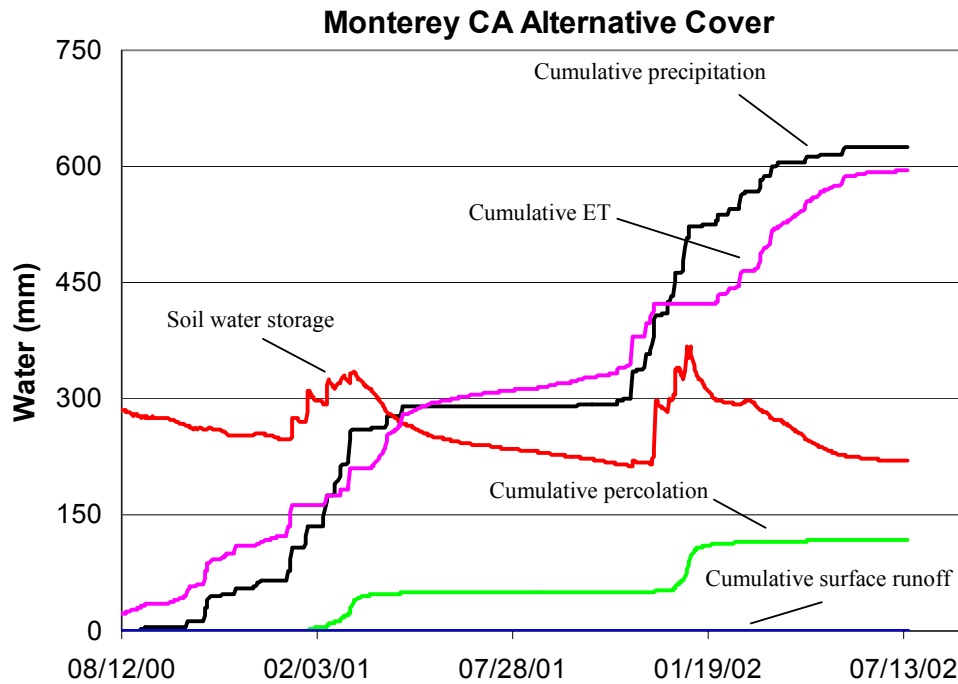
Figure 24. Water balance summary for the alternative cover design at the Monterey CA ACAP site.

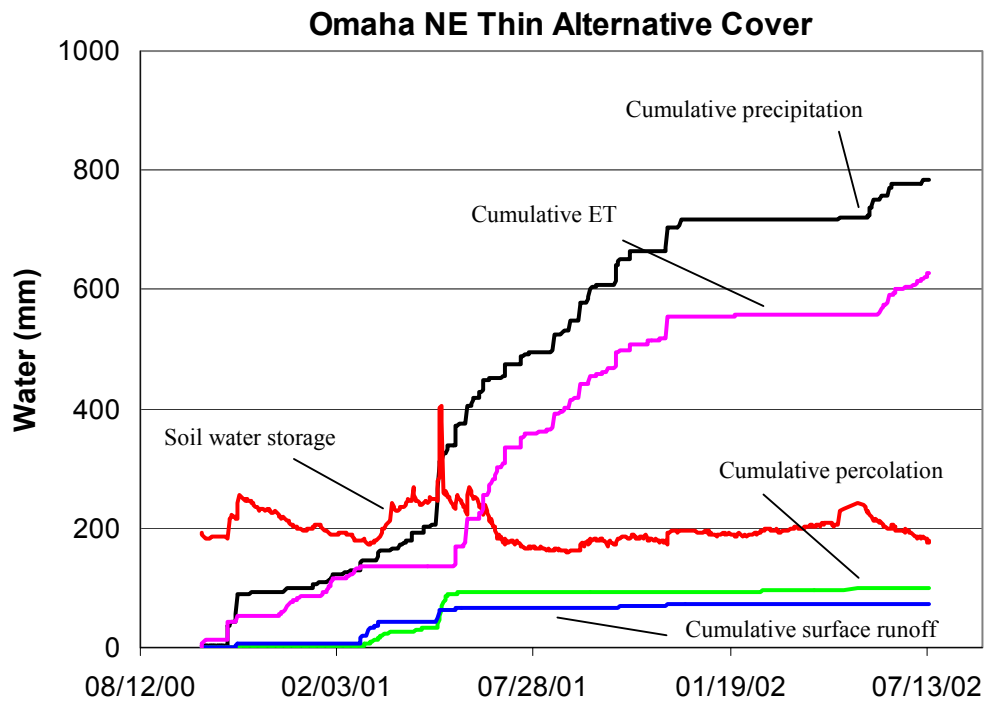
Figure 28. Water balance summary for the thin alternative cover design at the Omaha NE ACAP site.

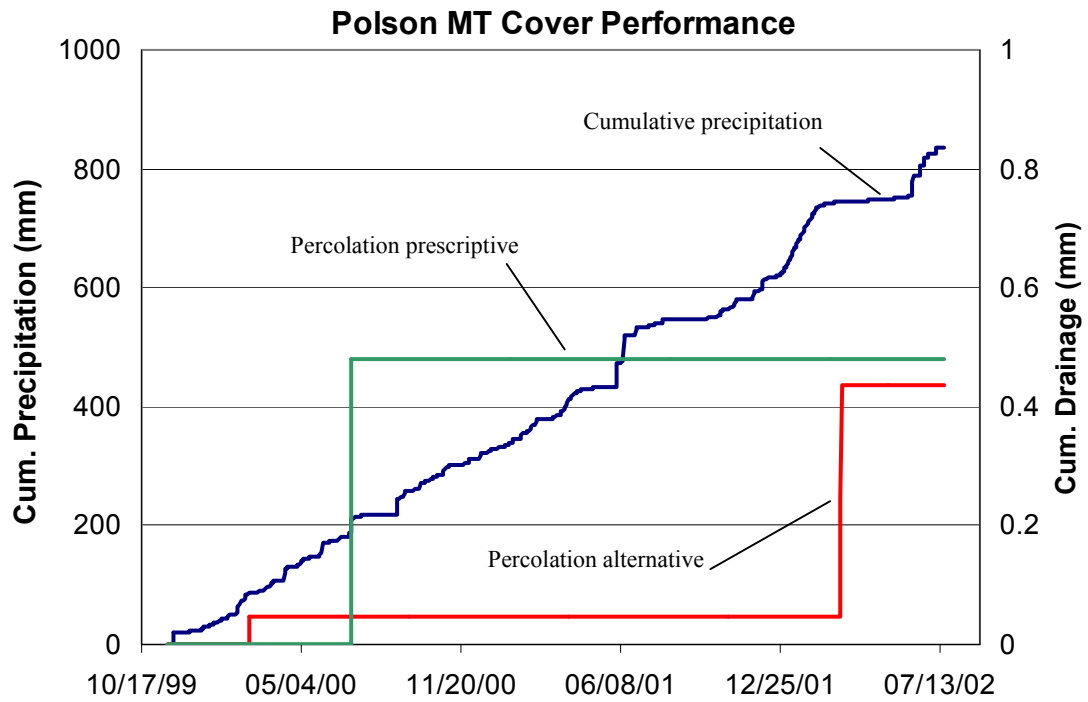
Figure 32. Cover performance at Polson MT.
