Green Remediation Focus

A Profile in Using Green Remediation Strategies

Kerr-McGee Navassa Superfund Site
Navassa, North Carolina

Cleanup Objectives: Remediate surface soil, subsurface soil, groundwater and marsh sediment contaminated by past use of the site for wood treating operations. Contaminants of concern include dense non-aqueous phase liquid (DNAPL), creosote constituents, fuel-related constituents, pentachlorophenol and dioxins. The site comprises about 70 acres formerly occupied by the wood treating facility and approximately 30 acres of a tidal wetland area known as the "southern marsh". The southern marsh is situated at the confluence of Sturgeon Creek and the Brunswick River.

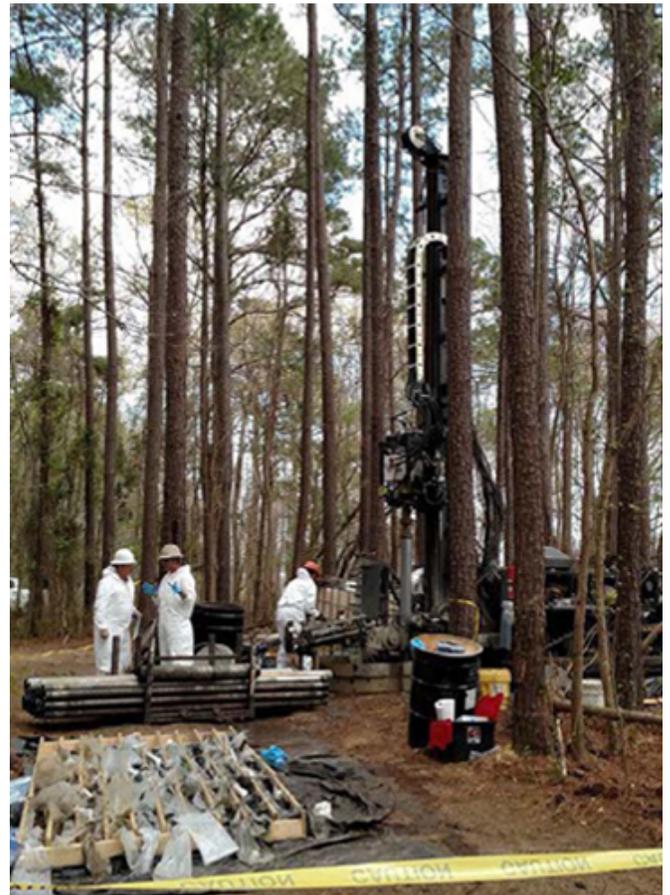
Rotasonic Drilling: Sonic drill rigs are routinely used to drill soil borings and install the monitoring wells.

- Using sonic drilling rather than conventional auger drilling techniques to construct all temporary and permanent monitoring wells.
- Planning use of passive sampling devices to understand the profile of dissolved contaminants along the groundwater- pore water- surface water interface and the mobile fraction of contaminants in wells and piezometers used for water level measurements.
- Using the CSM refinements to focus the additional investigations and target remedial action for the site's operable unit 5, which will address groundwater DNAPL and the dissolved plume.
- Collaborating with the U.S. Army Corps of Engineers to assess potential site-specific vulnerabilities and adaptation measures associated with the impacts of climate change, such as greater tidal influence or future interactions between the site's groundwater and surface water.

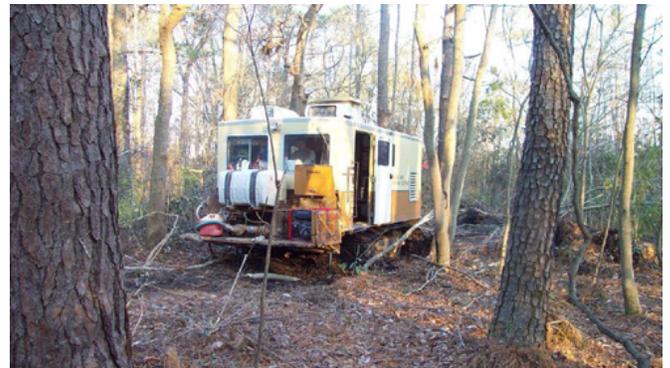
CPT/ROST Rigging: During phase I remedial investigation, the CPT/ROST equipment was transported in a self-contained truck.

- Used a combined CPT/ROST system during an expanded site inspection and phase I remedial investigation to classify soils and identify subsurface areas where DNAPL may be present. The system used a truck-mounted tunable laser connected to a down-hole sensor. Seventy-five CPT/ROST borings were advanced in the process and pond areas, along Navassa Road, and the wood storage areas, and two were advanced in the offsite eastern upland area. The depths ranged from 2 feet below ground surface (bgs) to 50 feet bgs.

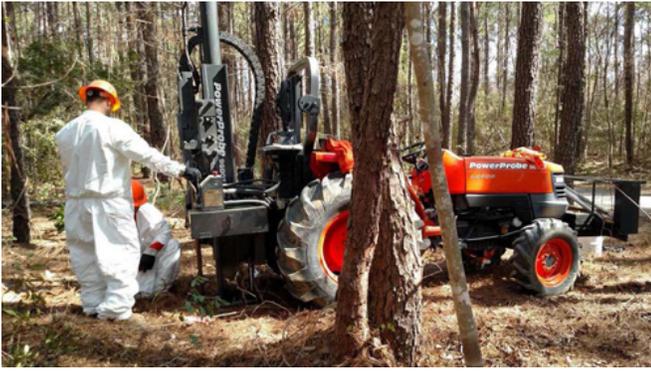
Soil Boring: PowerProbe® equipment was used to advance soil boring in wooded areas and other tight spaces.

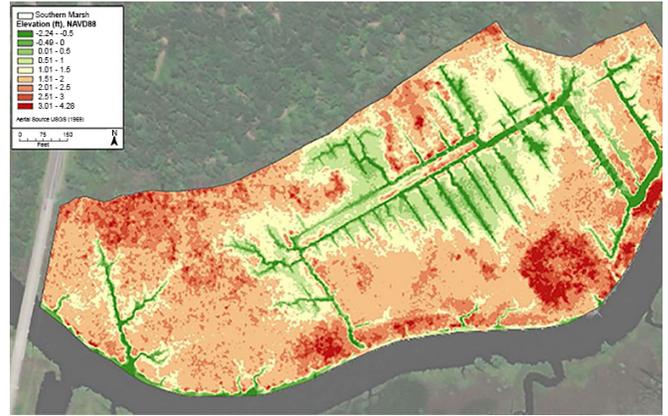
LiDAR-Based Topography Model: A digital elevation model representing bare earth at the southern marsh was generated from a 2014 LiDAR data set compiled by the National Oceanic and Atmospheric Administration (NOAA) and readily available in the NOAA [DigitalCoast](#) tool.

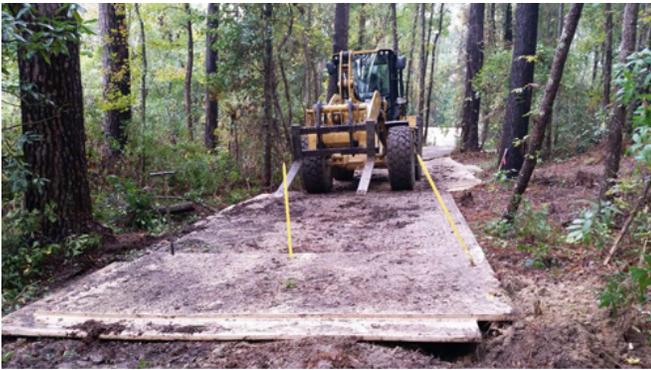
Protective Mats: Plywood sheets were placed along a defined corridor enabling machinery access to the marsh. The matting reduced sub-grade damage.

- Emplaced wood or hollow-HDPE mats to protect the ground and marsh sediments from drill rigs deployed in the southern marsh.

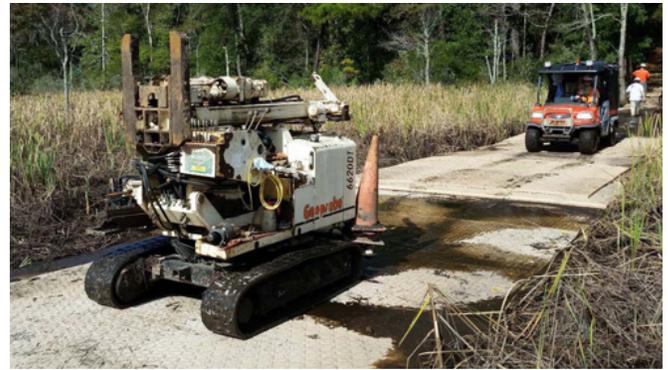
Marsh Sediment Boring: Direct-push Geoprobe equipment resting on hollow HDPE mats was used to obtain marsh sediment samples from shallow depths.

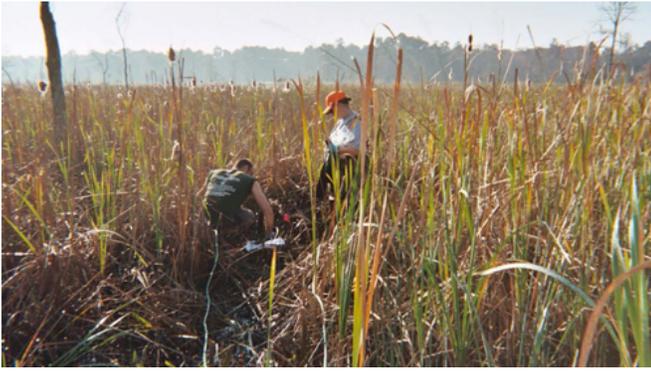
Tidal Marsh Sediment Sampling: A total of 148 sediment samples was collected from 114 locations for laboratory analysis. Thirty-five of the marsh sediment samples were collected at depths greater than 0.5 feet to help delineate the vertical profile of chemicals of potential concern.

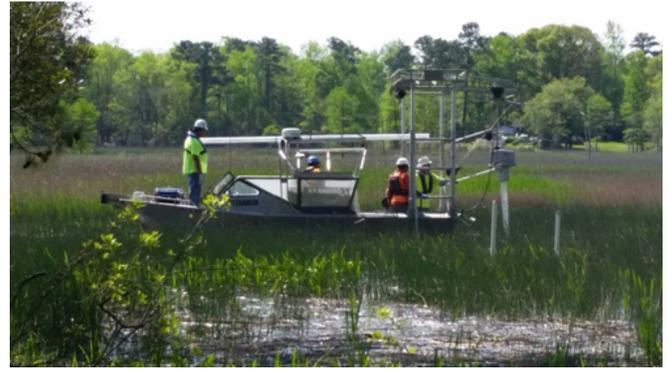
Marsh Sediment Coring: Vibracore equipment was used to obtain sediment cores at greater depths of the marsh.

- Deployed vibracoring equipment to obtain sediment cores in the southern marsh. The sampling tubes were driven with a high-frequency, low-amplitude vibrating device into unconsolidated sediment in saturated or nearly saturated conditions.

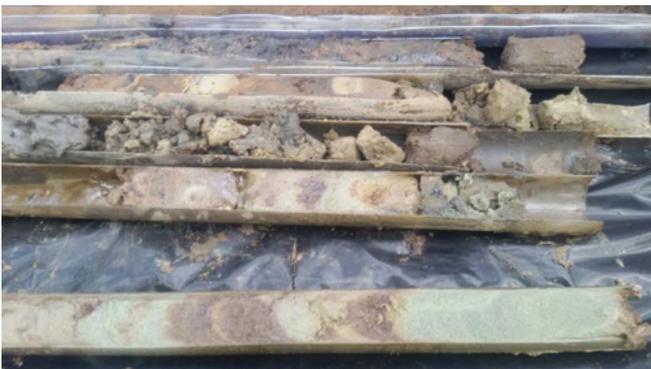
DNAPL: Borings from the pond area and process area contained creosote stringers.

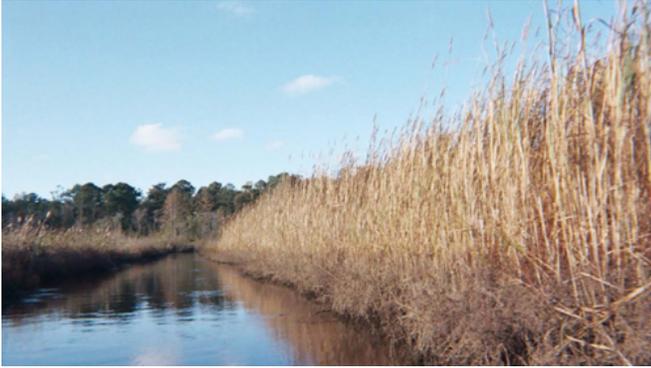
Tidal Wetland Channel: One wetland channel is among the areas where creosote-related constituents were found during site investigation. Semidiurnal tides control the wetland, which fluctuates from fresh to brackish depending on the season. The wetland is dominated by short-leaf cattail and bullrush with bald cypress on the outer fringe.
