Green Remediation Focus

A Profile in Using Green Remediation Strategies

Rainbow Valley Citrus Maintenance Yard Facility
Goodyear, Arizona

RCRA Corrective Action, Leaking Underground Storage Tanks

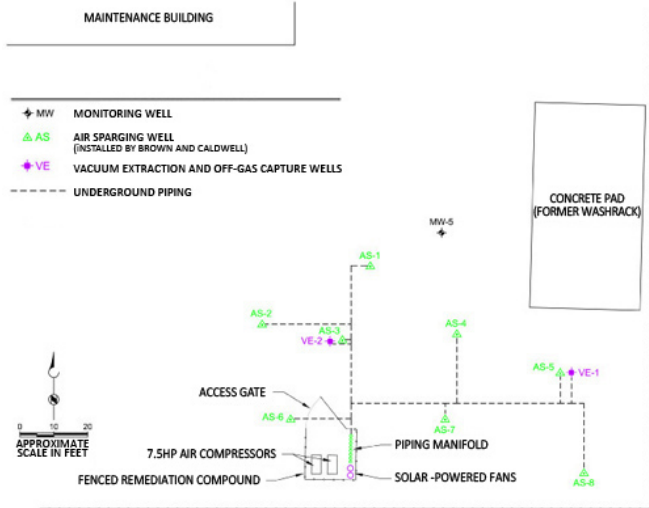
Remediation Schematic: All (eight) air sparging wells and three of the eight monitoring wells (including two used for vapor extraction and off-gas collection) were located within the source area, where two leaking underground storage tanks had been removed. Primary aboveground equipment such as air compressors and the solar-powered venting system were enclosed in a fenced area.

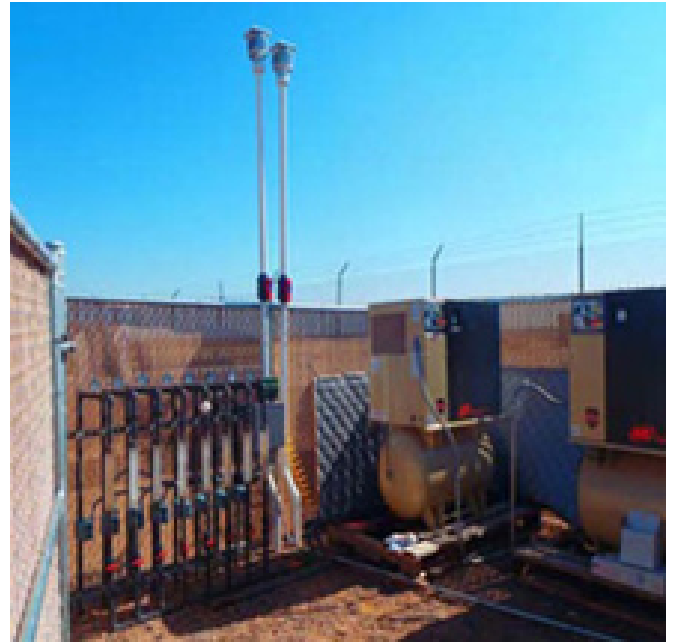
Primary Equipment: Two electricity-driven 7.5 hp air compressors (shown on right) were used to inject air into the subsurface through the eight air sparging wells. Resulting vapors were collected in a single manifold and released into the atmosphere through two air flues. Due to low hydrocarbon concentrations in the vapor, no pre-treatment was required prior to release.

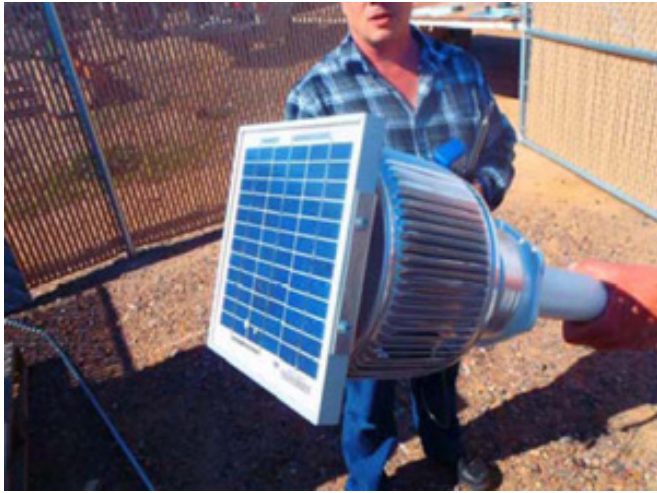
Solar Fan Assembly: Each of the two solar fan assemblies (ASF-4-PVC Aura solar fans) used for off-gas collection consisted of a 2.5 watt solar module, a 1.8 watt fan (inside louvered housing) and a 1.8 watt motor operating on a 12 volt circuit. The integrated unit included a metal adapter enabling placement of the full assembly directly on a single 4-inch diameter PVC vent pipe (flue) extending from the ground surface; no additional wiring was required. Manufacturer testing of the unit at variable wind speeds reports a passive air flow ranging from 26 CFM at 4 miles per hour (mph) to 62 CFM at 11 mph.

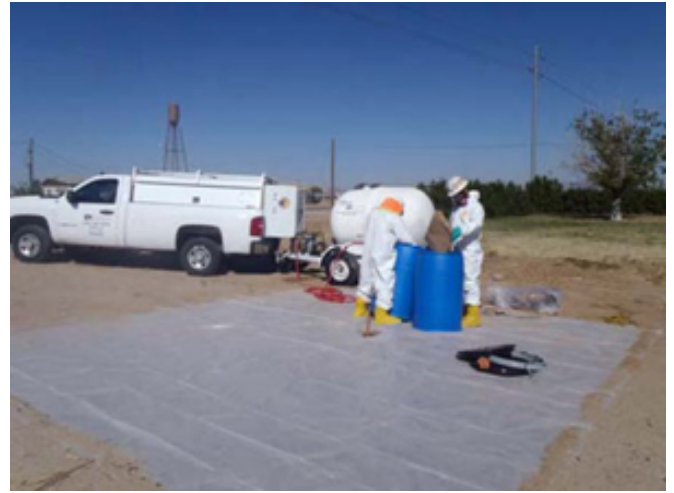
Final Remedial Step: In situ injection of reactive chemical oxidants was conducted five months after air sparging completion to treat a groundwater hotspot. Approximately 220 pounds of catalyzed sodium persulfate (PersulfOx[®]) mixed with 414 gallons of water was injected through a downgradient monitoring well approximately 240 feet southwest of the source area.
