Case Study on Remediation at a Sediment Site in Northern California with Radium-226 and Heavy Metal Contamination, including Use of SCM Technology to Expedite Remediation at the Source

**Seaplane Lagoon Site, former Naval Air Station
Alameda, Alameda, California**

Federal Remediation Technology Roundtable Meeting, November 8, 2017

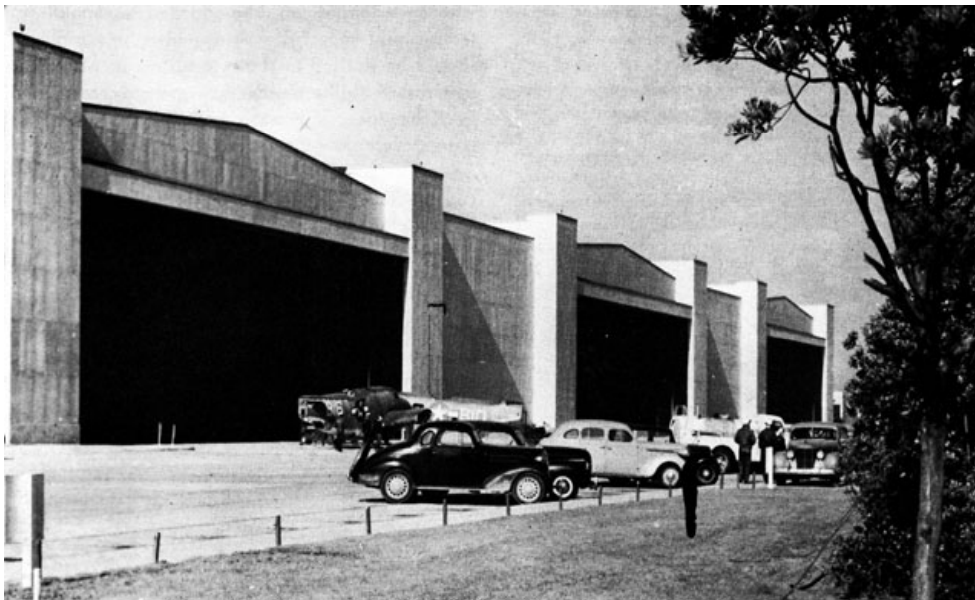
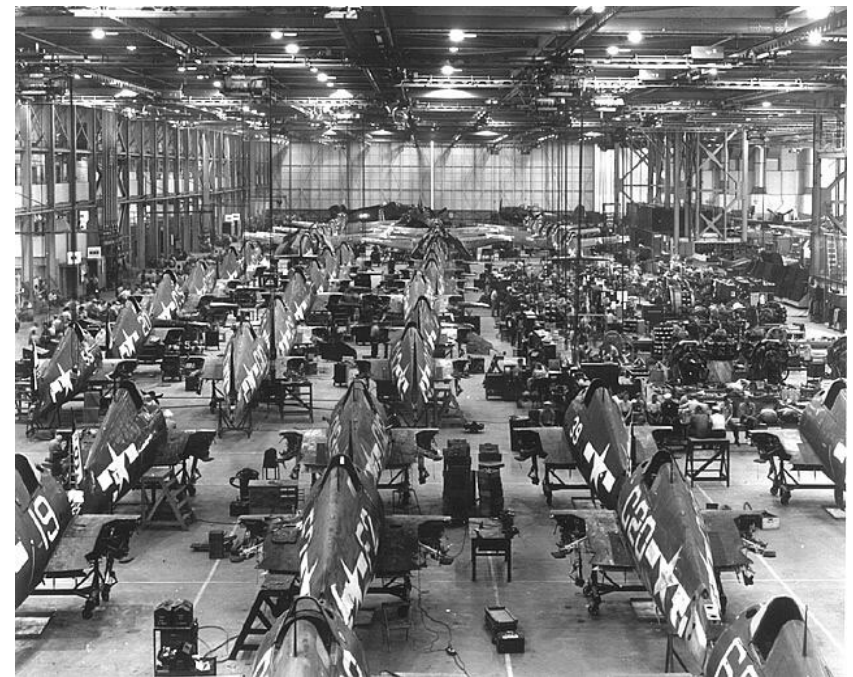
Primary source of the sediment contamination was maintenance activities for aircraft within Building 5 (~16 acres); Ra-226 paint was used on compasses and plane and ship instrument faces.

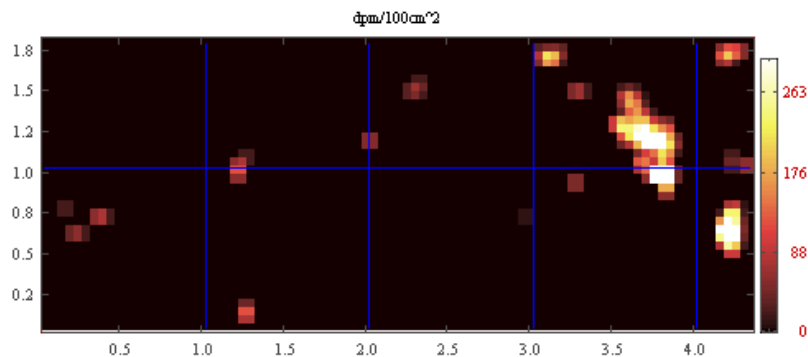
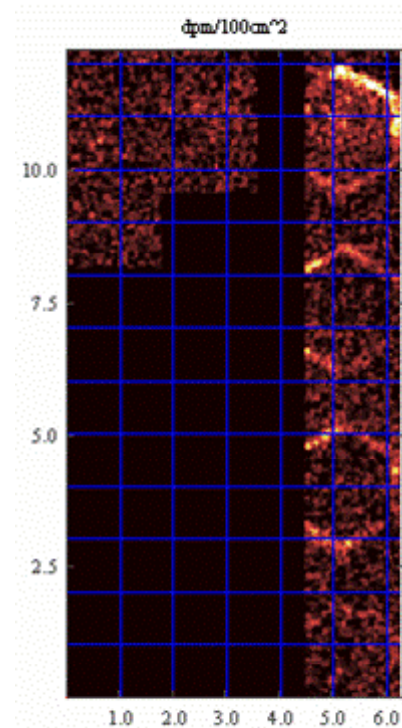
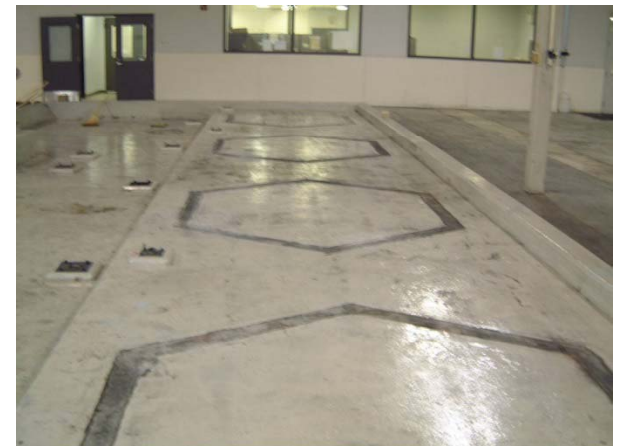
SCM Color Graphic Images of Radiological Contamination:
Left: Building 5 Ra-226 paint room contamination; Right:
Another project showing contamination beneath pads
(SCM image and photo)

Building 5 is an approximately 1 million square foot building with no power; the SCM was able to efficiently survey the first floor and identify contamination very quickly:

- a 180 cm detector will cover an area 6 times faster than a 30 cm detector (all other parameters being equal)
- added benefits come from the equipment's sensitivity and ability to process data and provide color graphic images

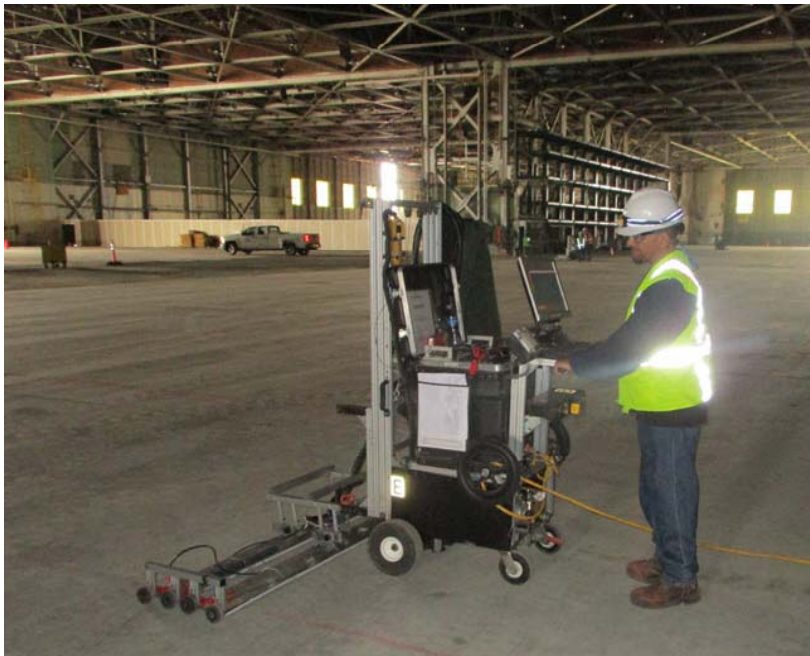
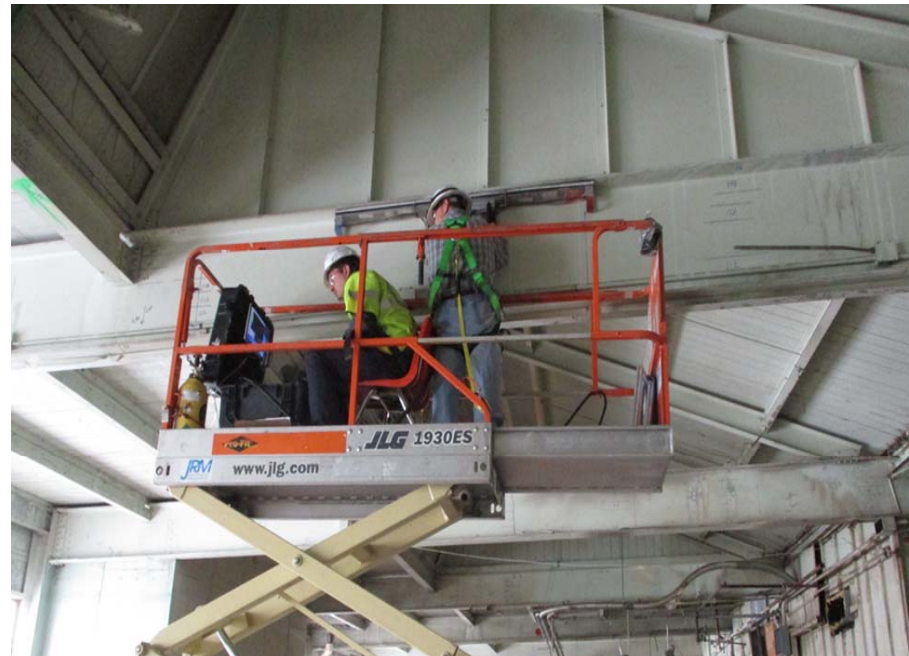
SCM Surveying Hangar Floor (left); SCM ~30 feet from floor, surveying I-beams and ceiling (right)

The Building 5 radiological remediation included use of a recently developed SCM model with:

- electronics package replaced with small computer chips
- computers with faster, more powerful systems (e.g. SurfacePro)
- battery power instead of AC and
- a weight less than one-third the weight of the older model SCM.

This results in significantly greater ease of use in the field; it was very efficient in this 2-story building with no electricity.

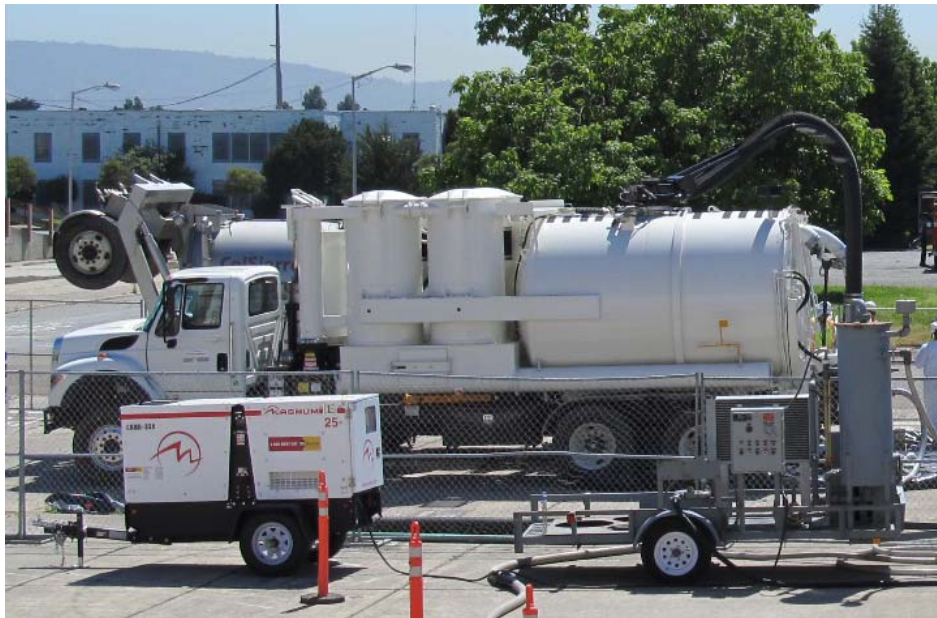
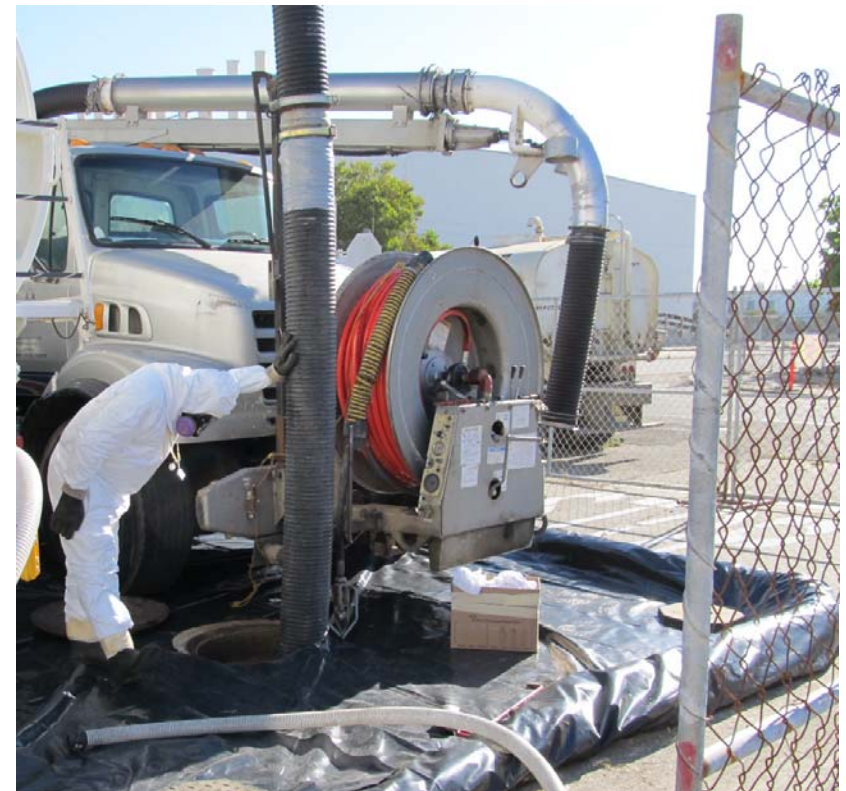
Line G Hydrojetting

- Drain Line G (NE corner of lagoon) hydrojetted and surveyed; video confirmed removal of contamination (innovative); subsequent No Further Action Record of Decision for Line G

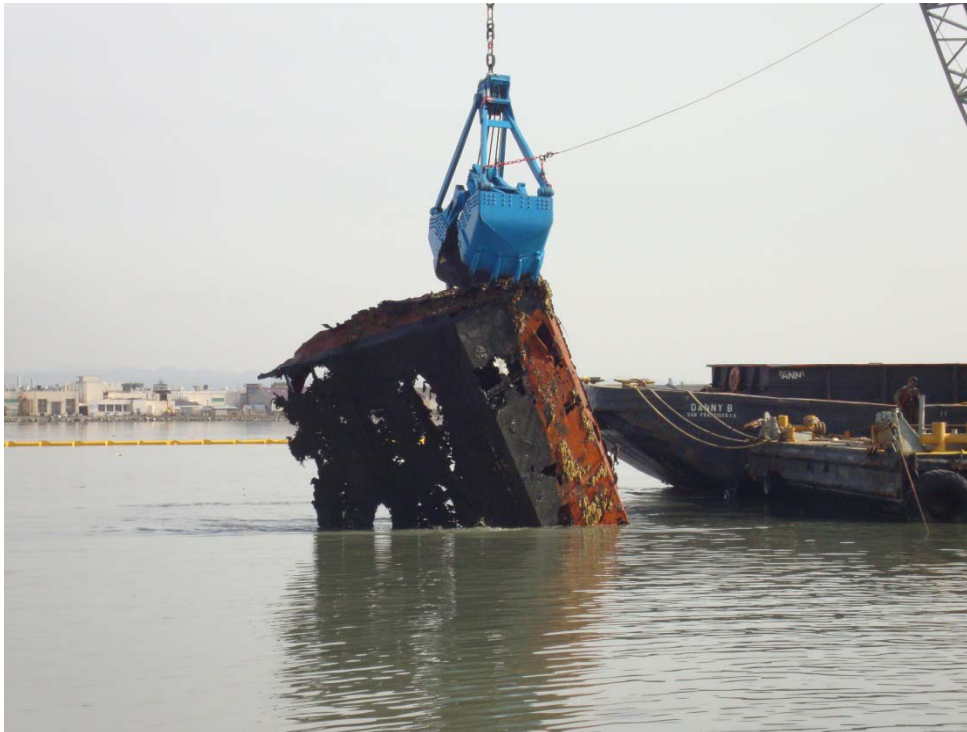
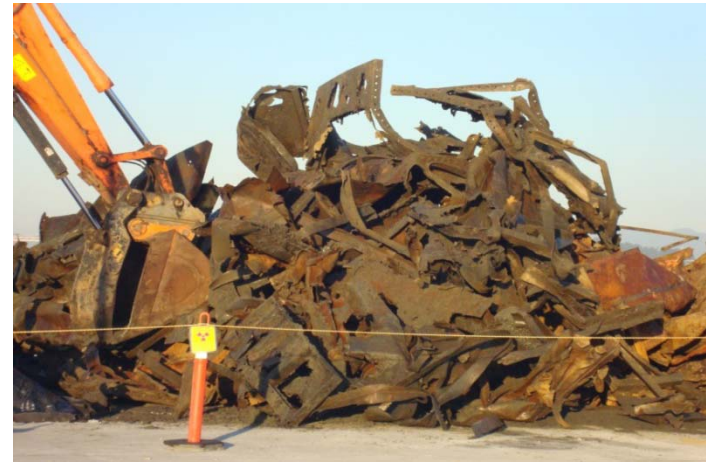
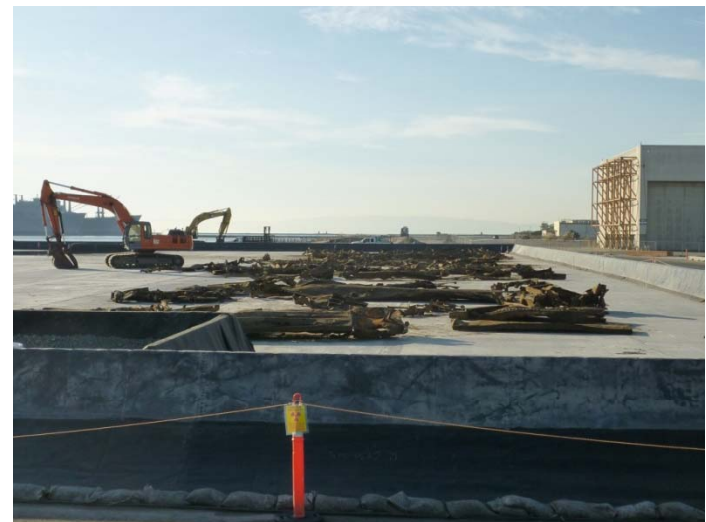
Barge removed; 66 tons of metal scanned and recycled

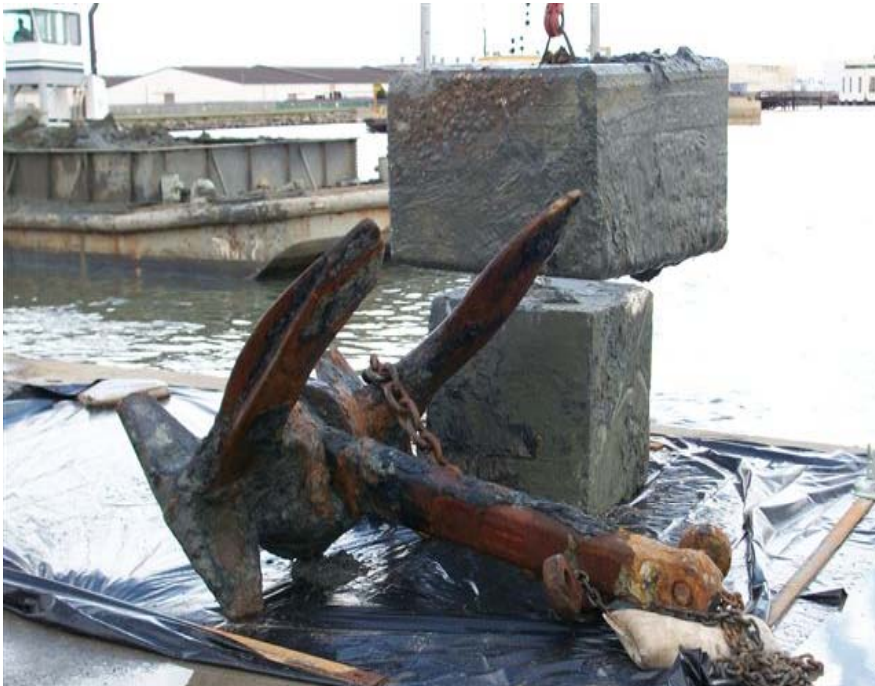
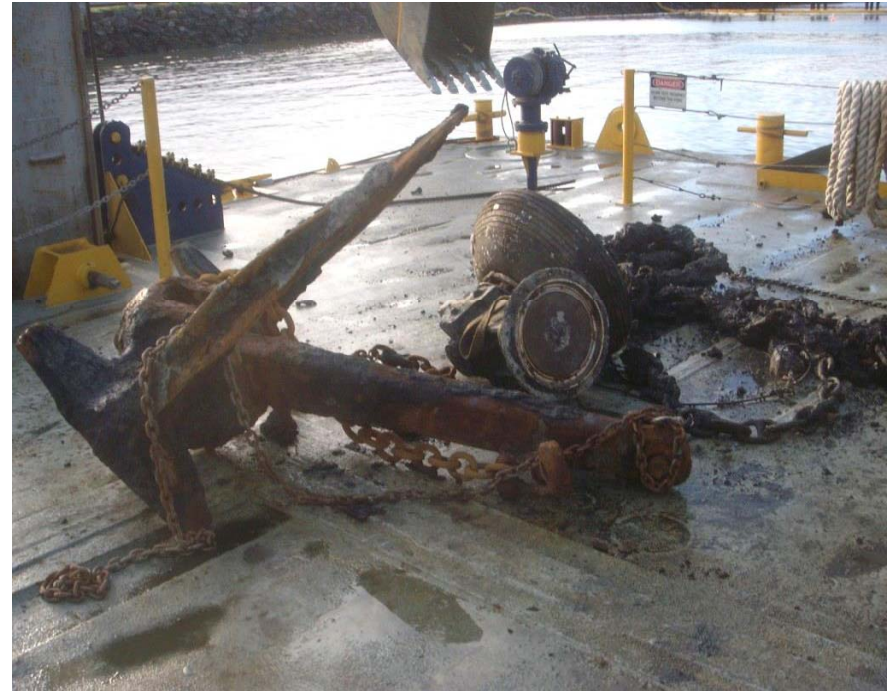
Concrete mooring blocks, 1943 anchor, and landing gear removed from lagoon

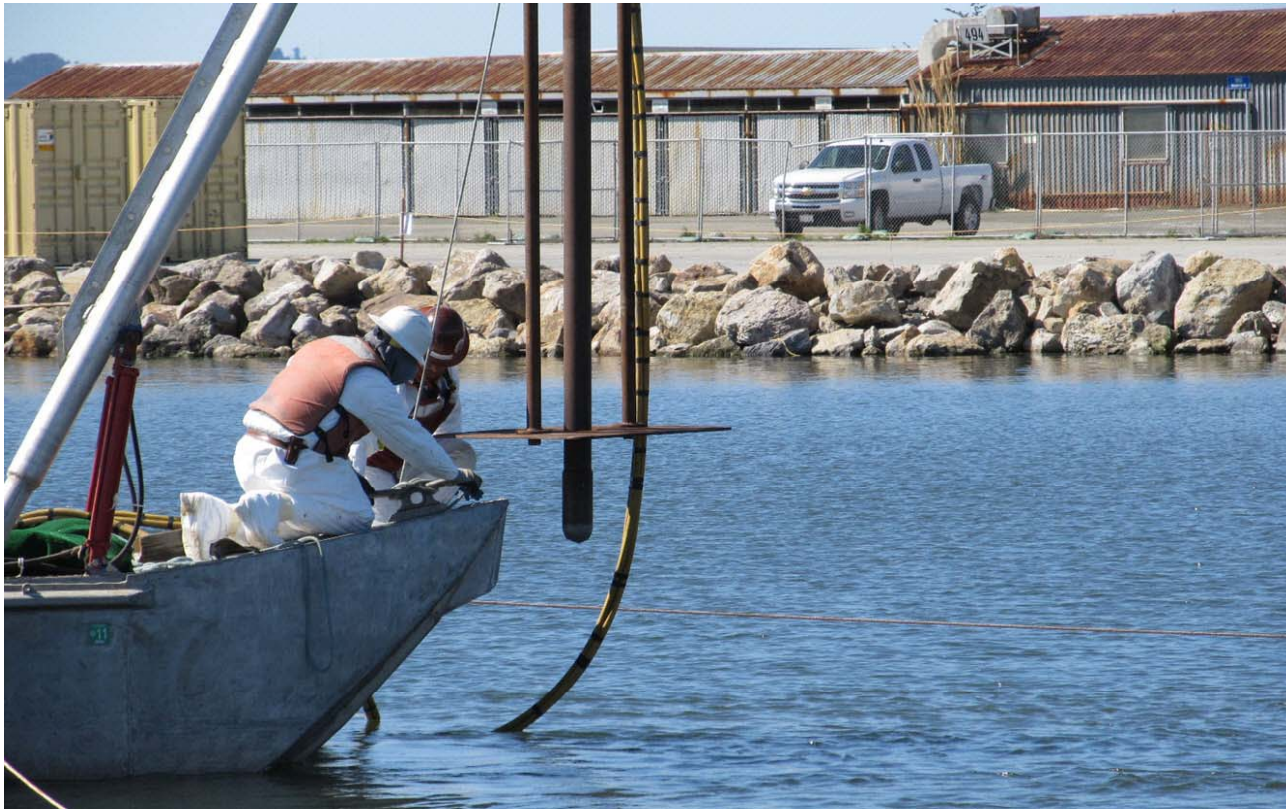
Post-dredge sampling results confirmed completion of the NE area remediation. Results for the NW area indicated that further dredging was necessary in a limited area.

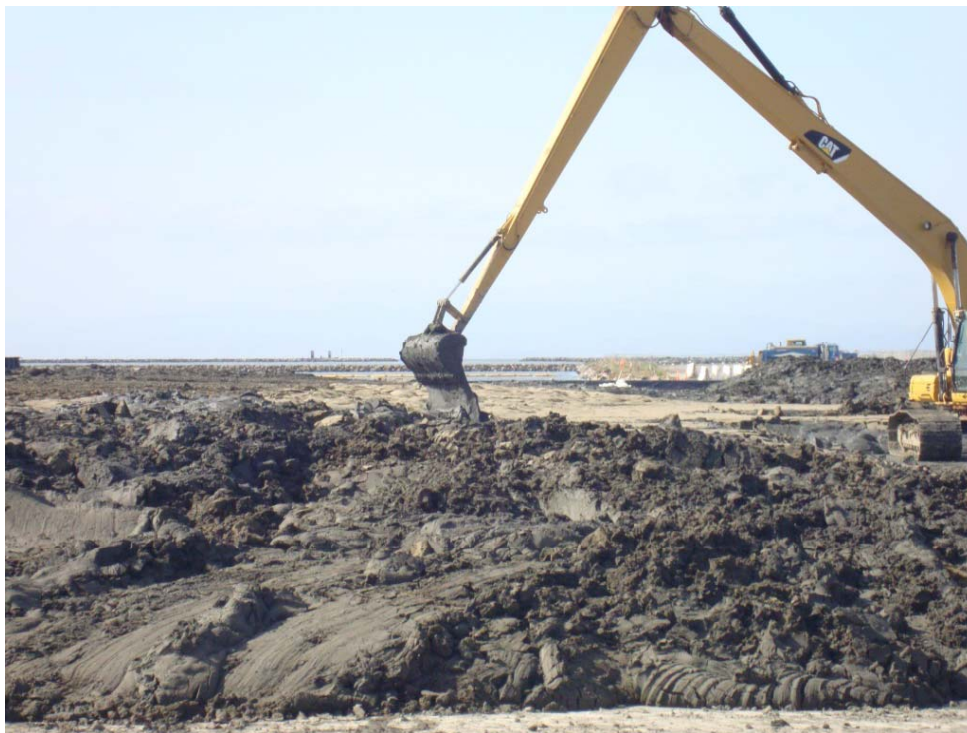
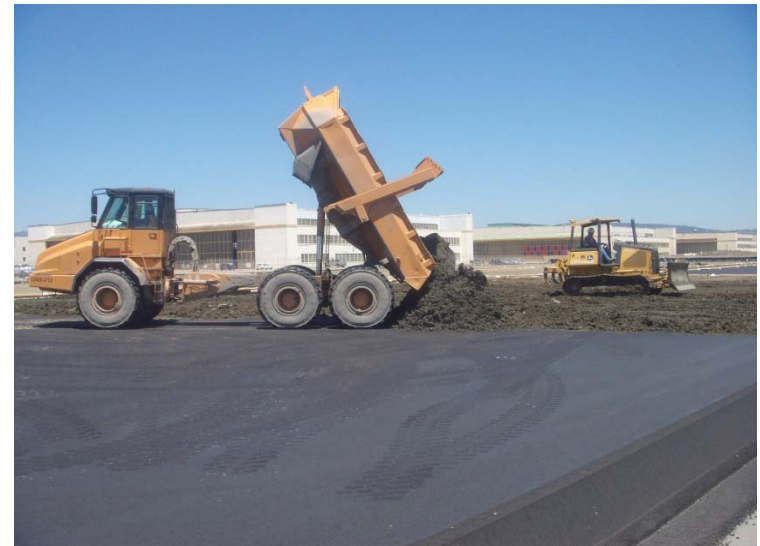
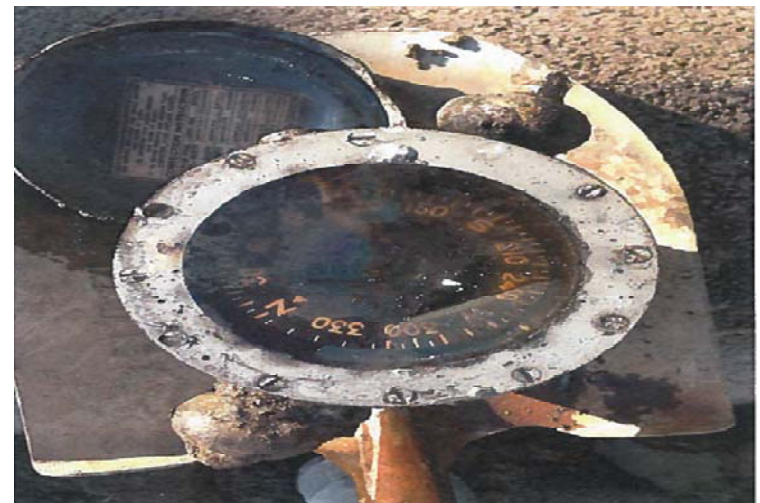
Sediment Processing; bottom right
- Compass recovered from sediment

- Sediment processing included dewatering, radiological surveying, systematic sampling, and re-use or disposal.
- Used SAM940 during Seaplane Lagoon remediation for field isotope identification of point sources; the RadEYE SPRD is an advancement that provides more data, can identify more isotopes, runs on batteries, and is the size of a pager.
- Optimizations included maximizing re-use/recycling for both the removed sediment and wastewater.
