ECOLOGICAL RESTORATION OF BLM ABANDONED MINE SITES

International Phytotechnologies Conference

Karl Ford, BLM National Science and Technology Center
Dennis Neuman, Montana State University
Ed Glenn, University of Arizona

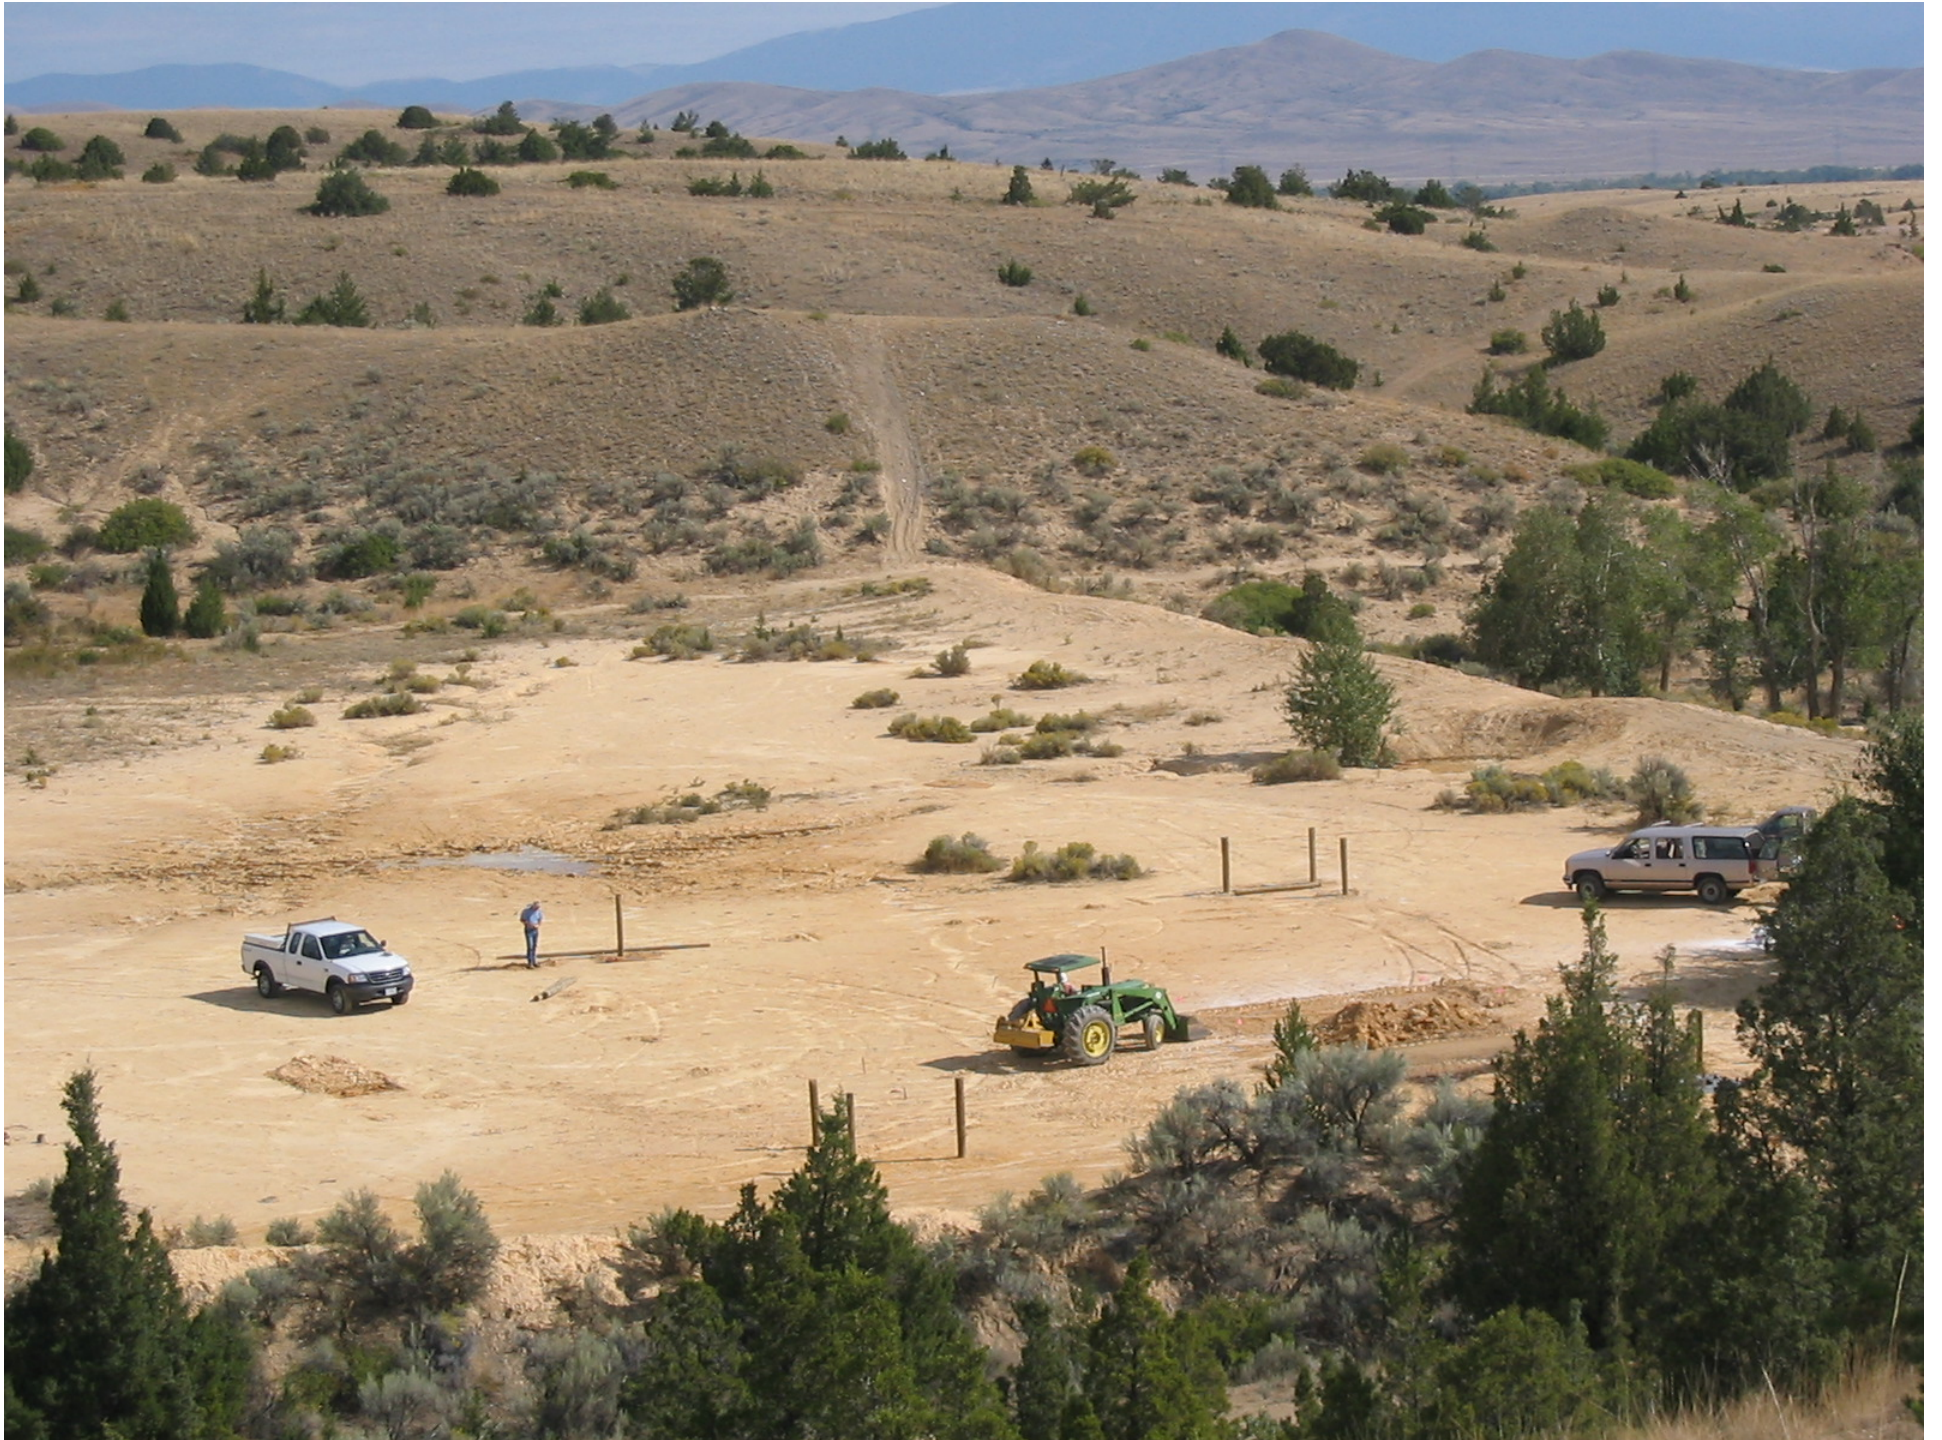
Keating Site Case Study

Keating Test Plots

- Tailings chemistry: pH 4.1-5.6;
 - As, Pb, Cu, Zn in 300-1000 mg/kg total metals range
 - Water extractable Cu, Zn in the 30-300 mg/L range
- Replicated experimental plots 10x20' installed 9/03
 - 4 offsite control
 - 4 onsite control
 - 4 onsite treatment (18") based on sampling
 - 63-150 lbs $\text{Ca}(\text{OH})_2$
 - 300-400 lbs CaCO_3
 - 2250 lbs compost (upper 6")
 - Seeded northern wheatgrasses, fescues, forbs
- Fenced to exclude animals, signed.

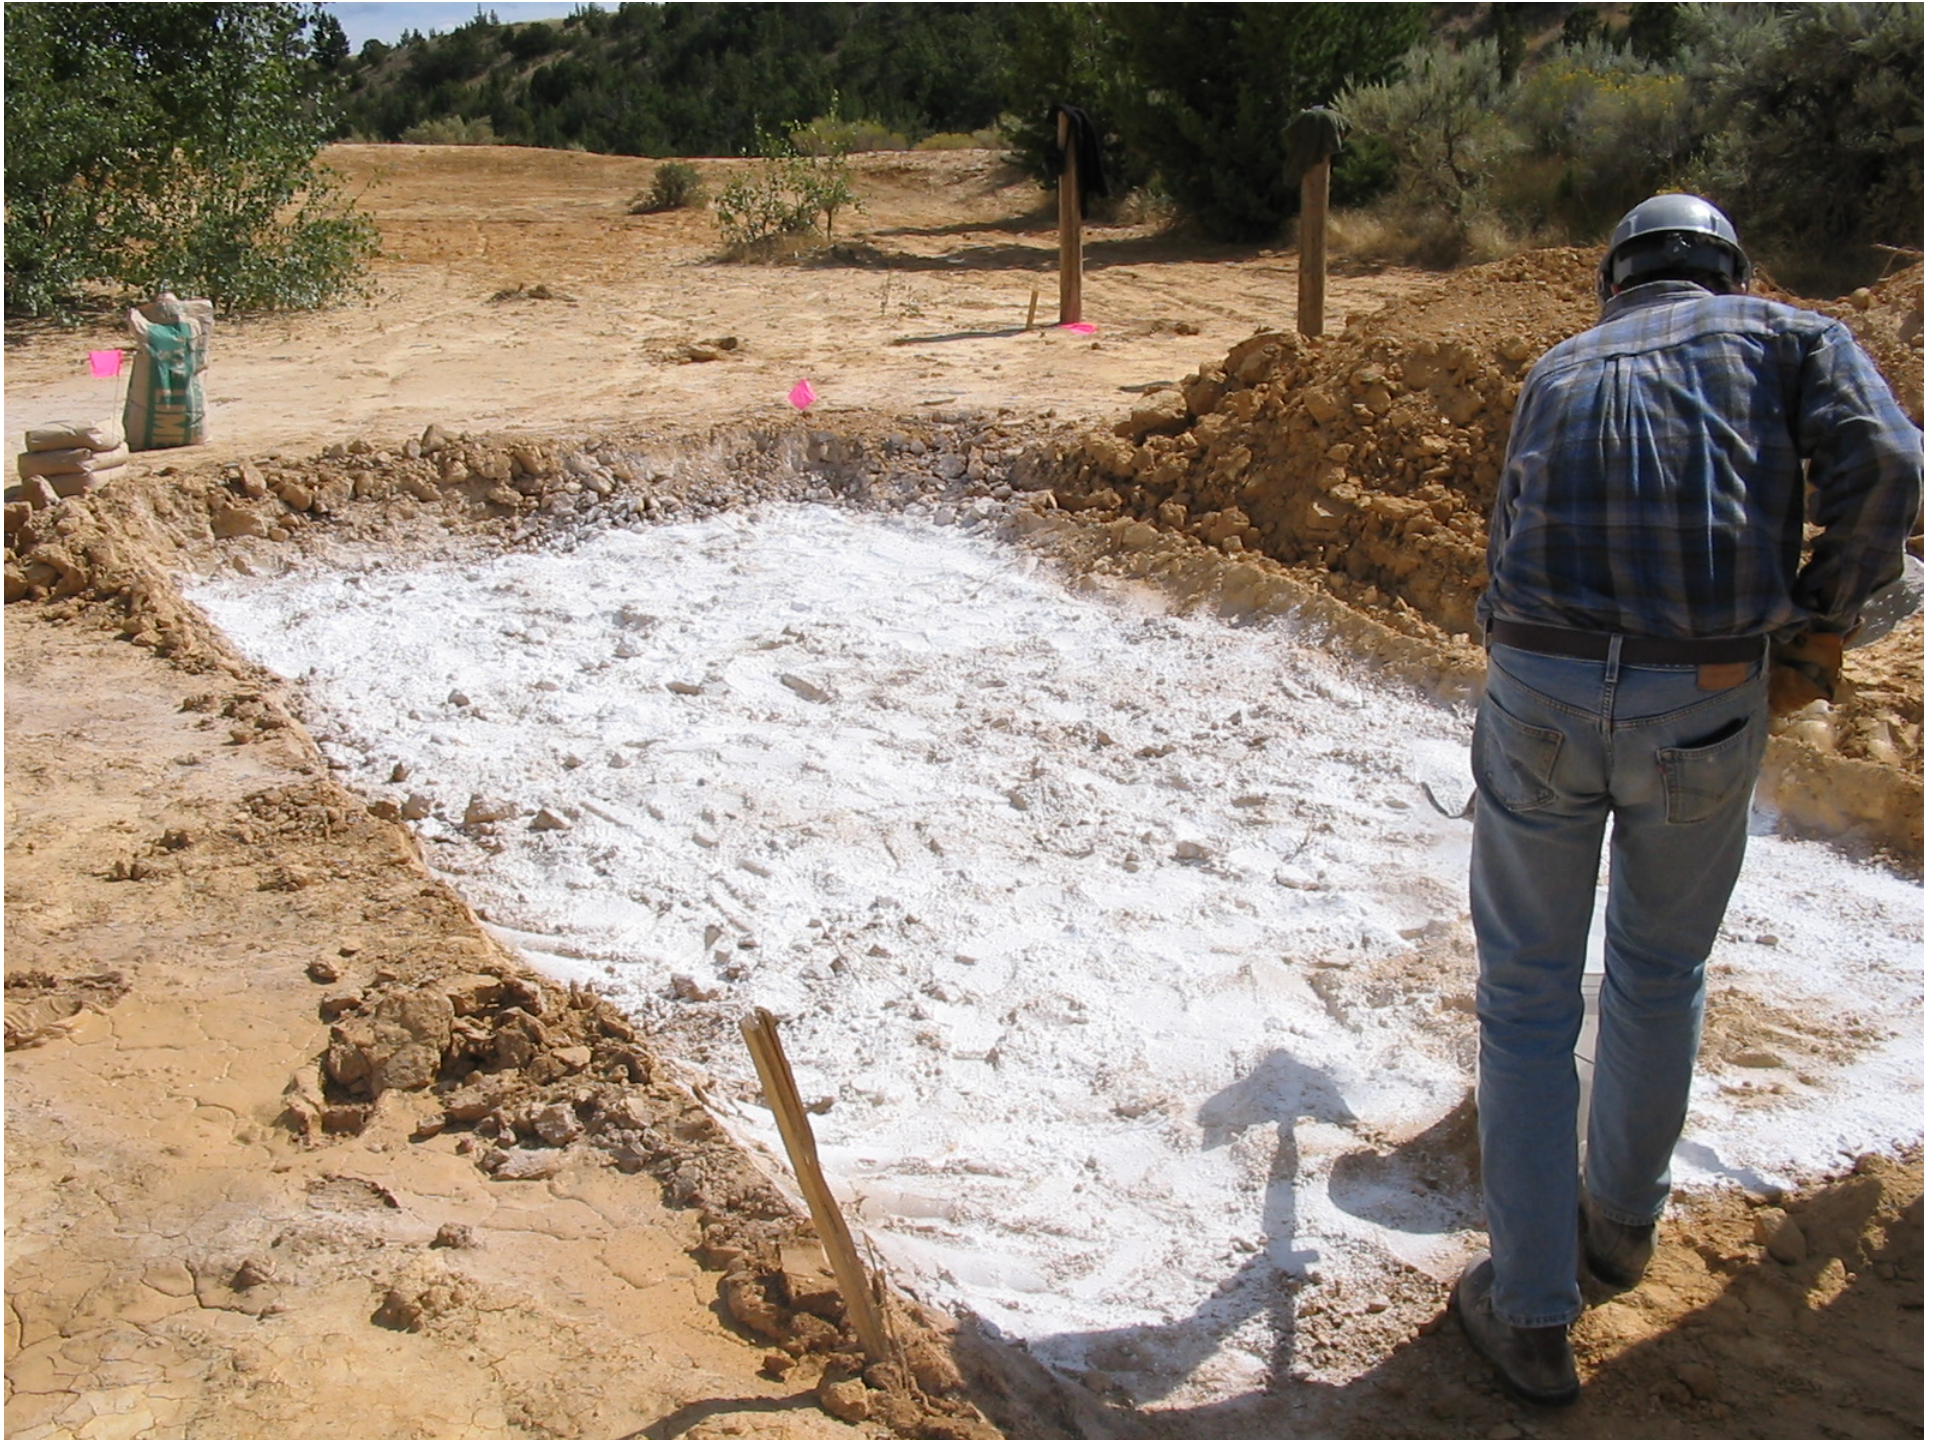
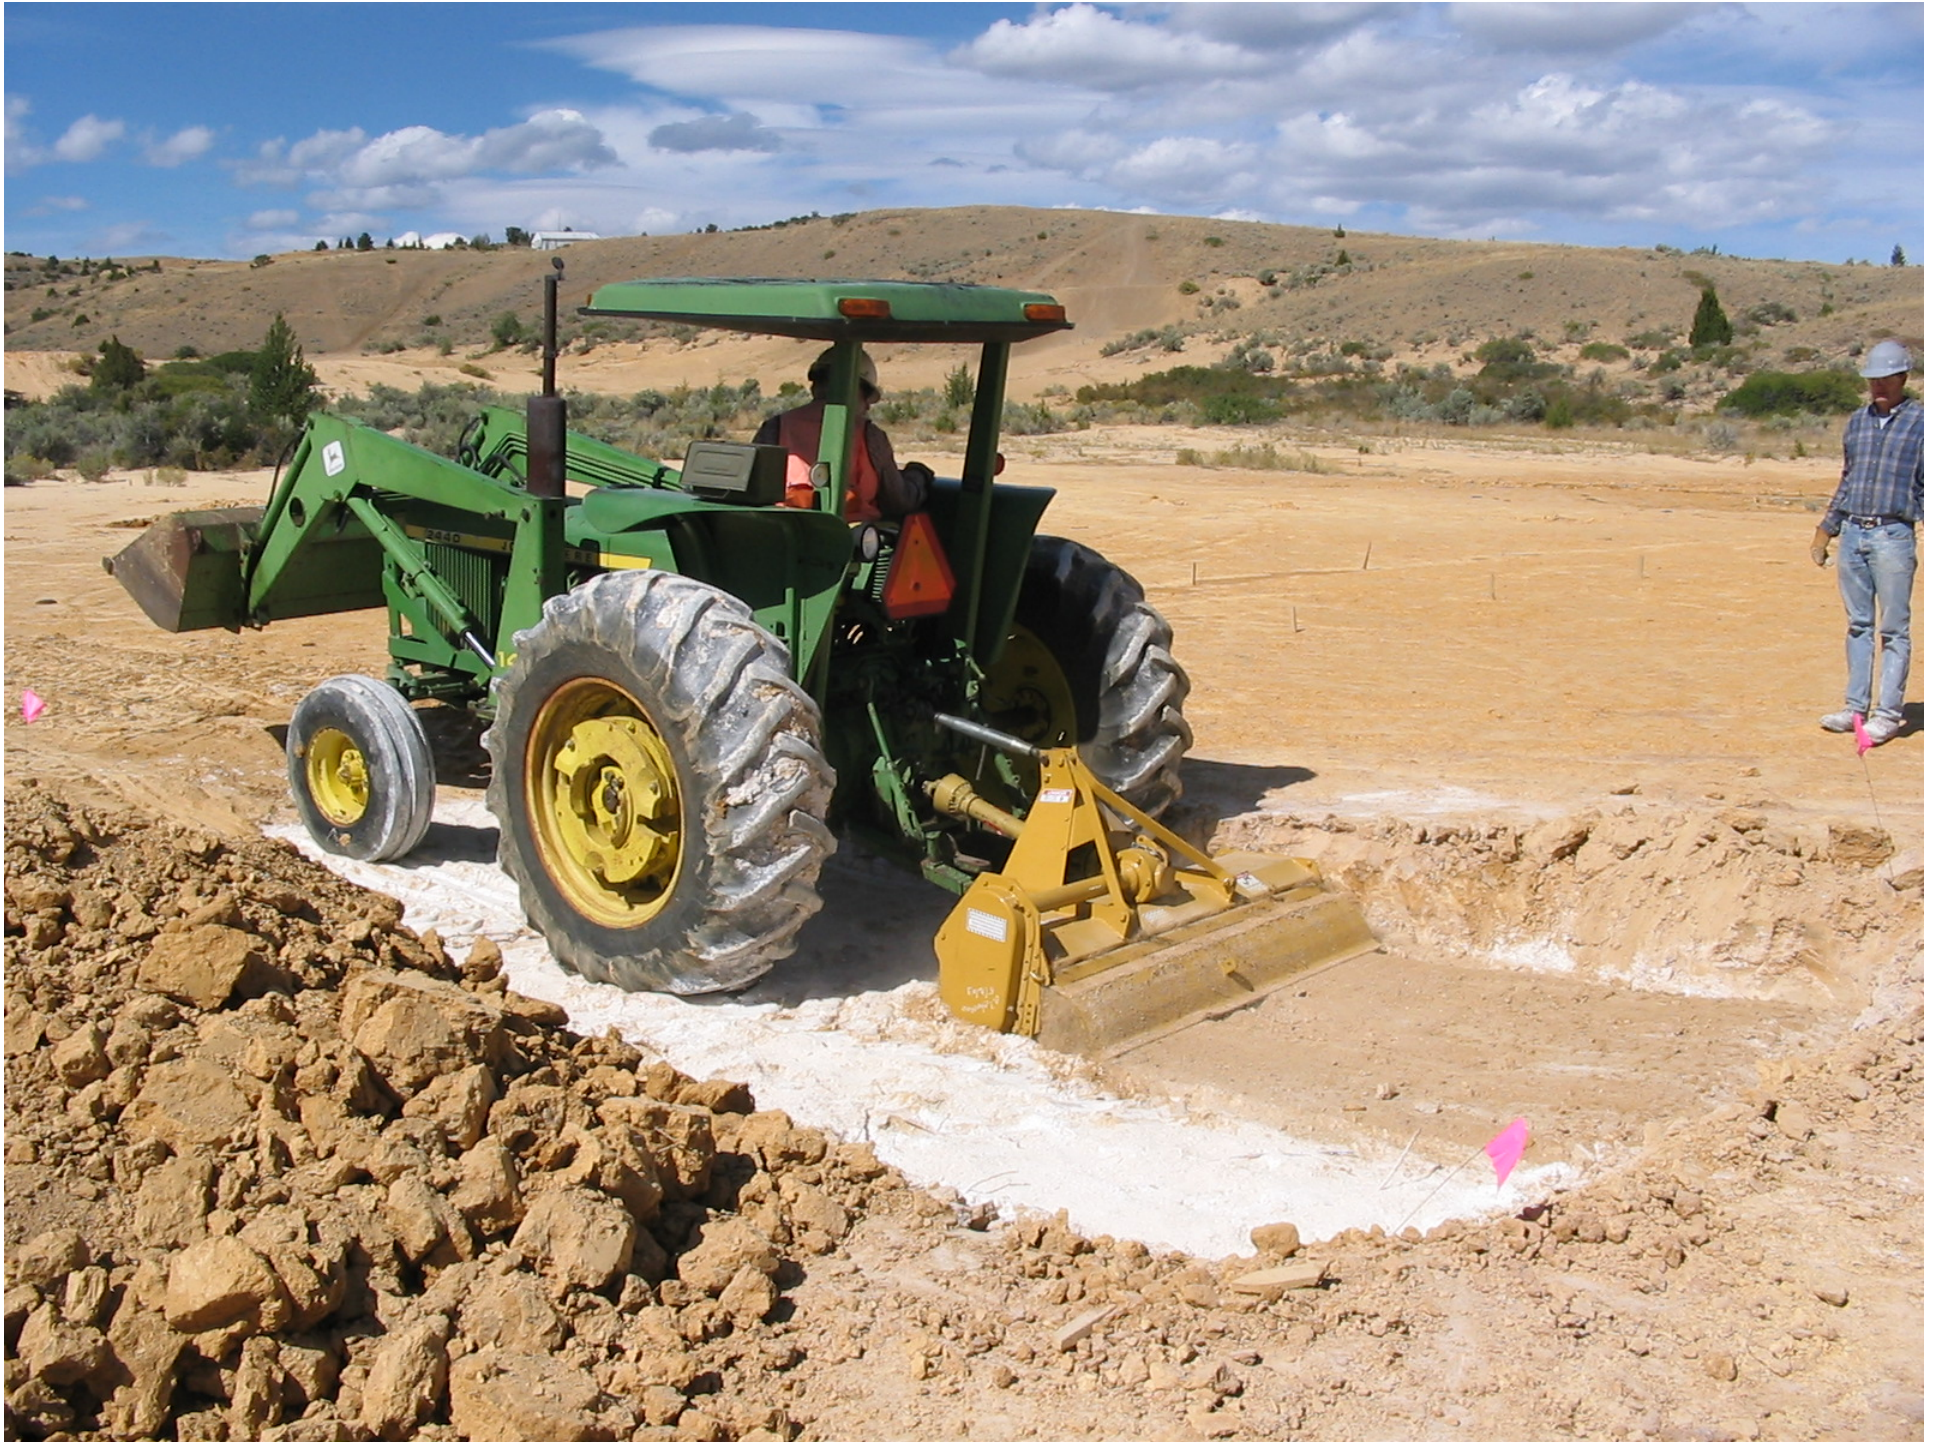
June 2004 Growth

Seedling Density Results, June

Mean Seedling Density (#/m ²)	SD
Offsite Control	460	176
Onsite Control	373	137
Onsite Treated	257	123

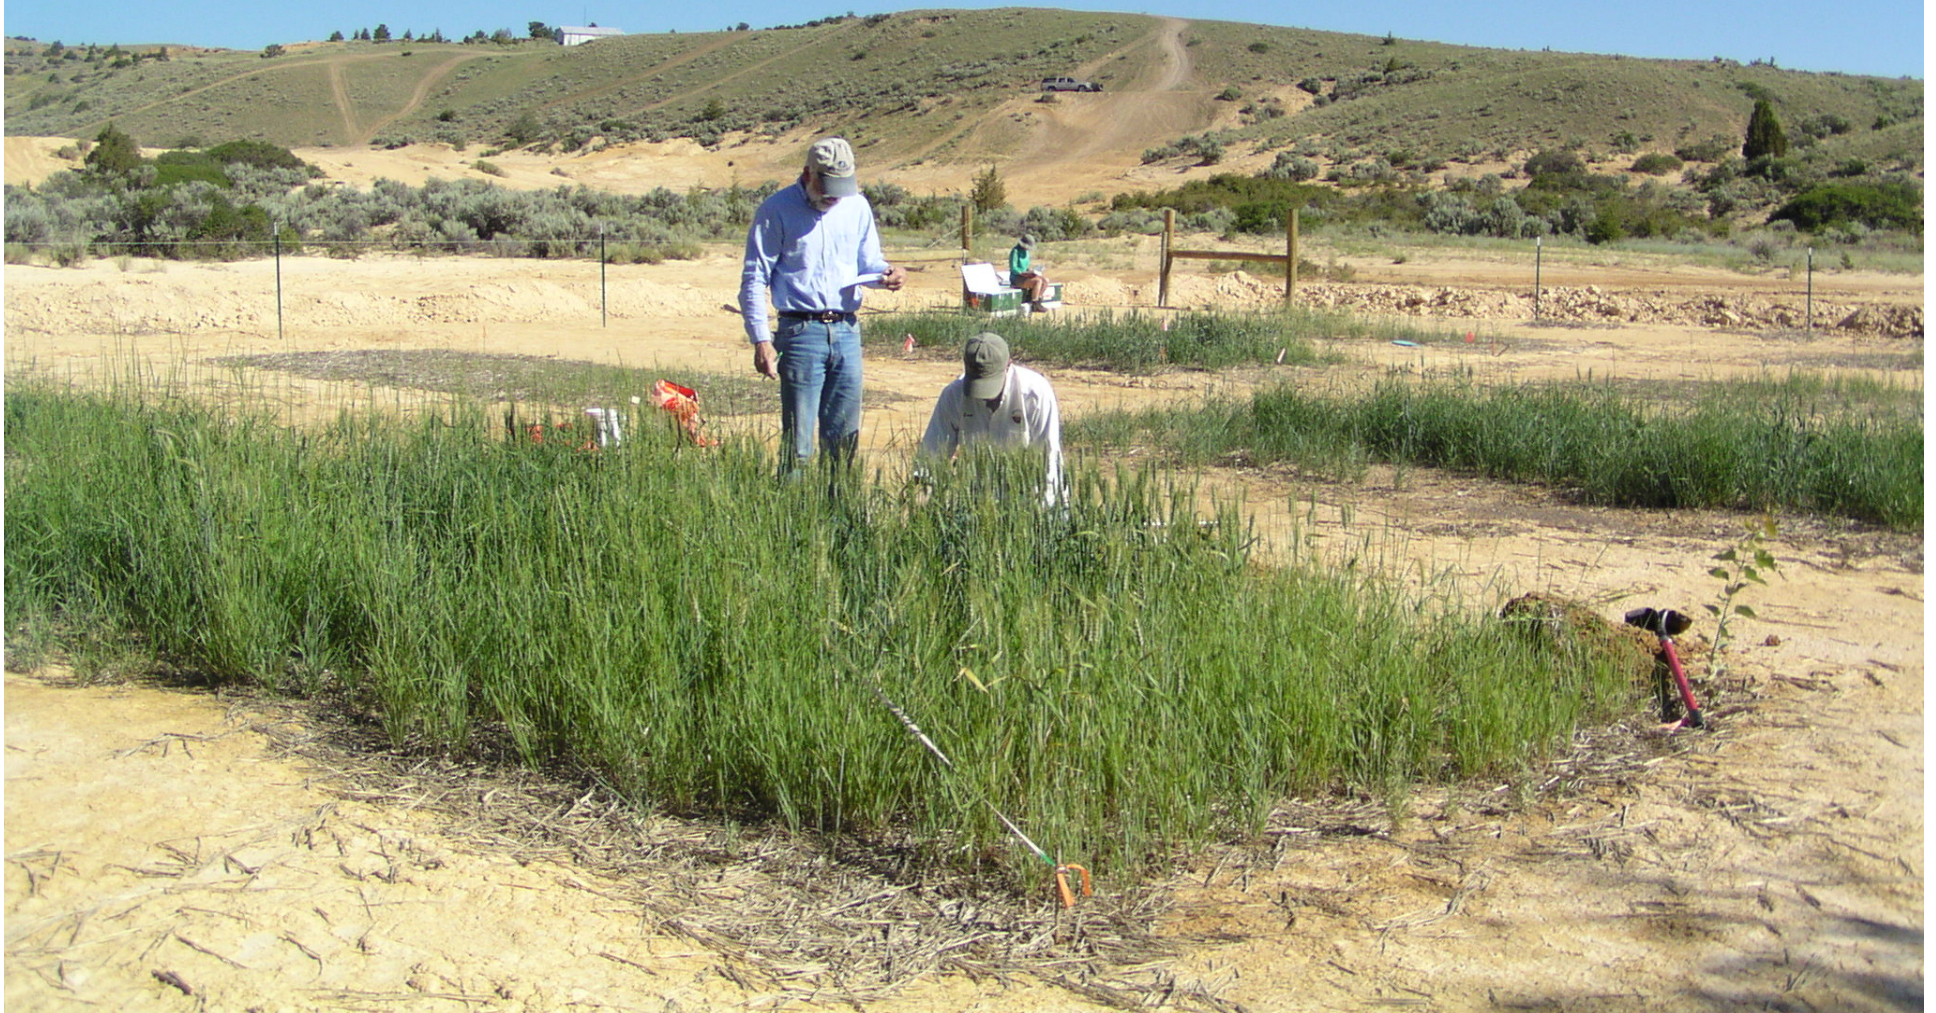
Mean Cover Results, July

Mean % Cover	SD
Offsite Control	52.6	11.9
Onsite Control	16.4	9.4
Onsite Treated	53.8	9.4

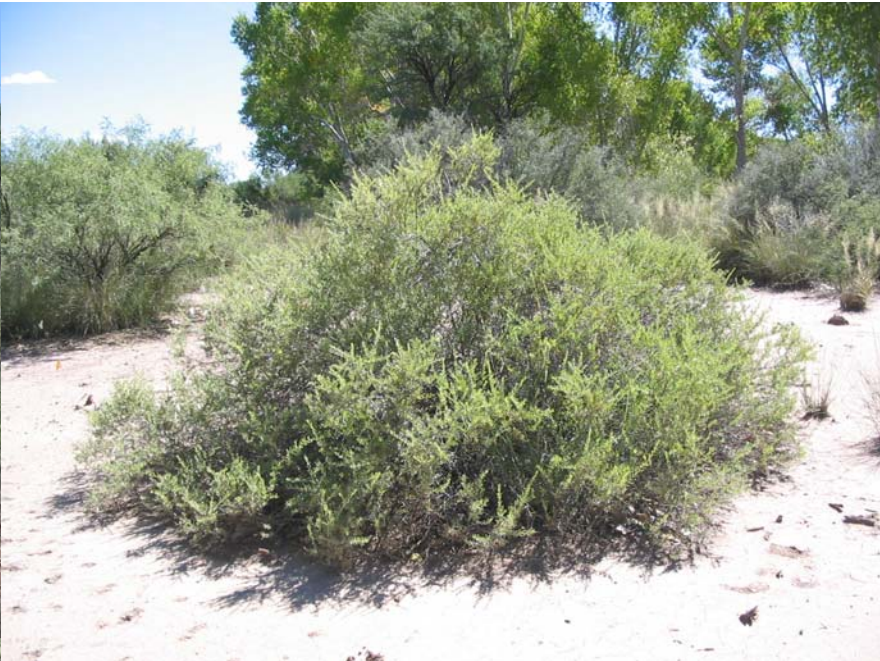
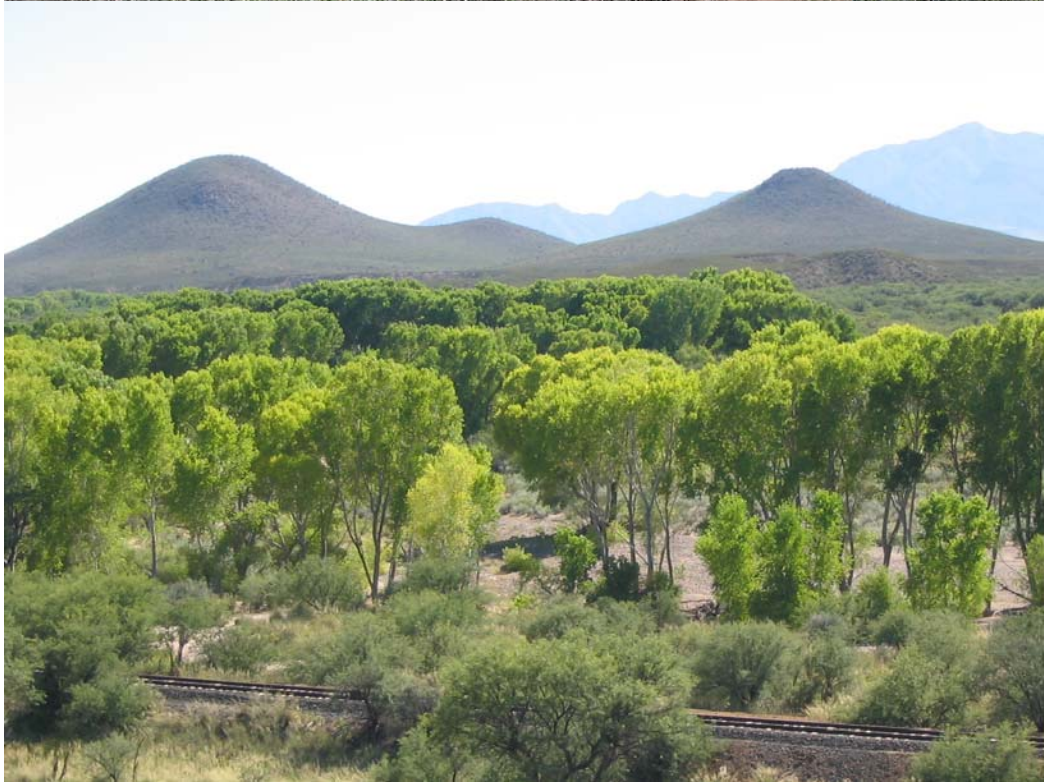
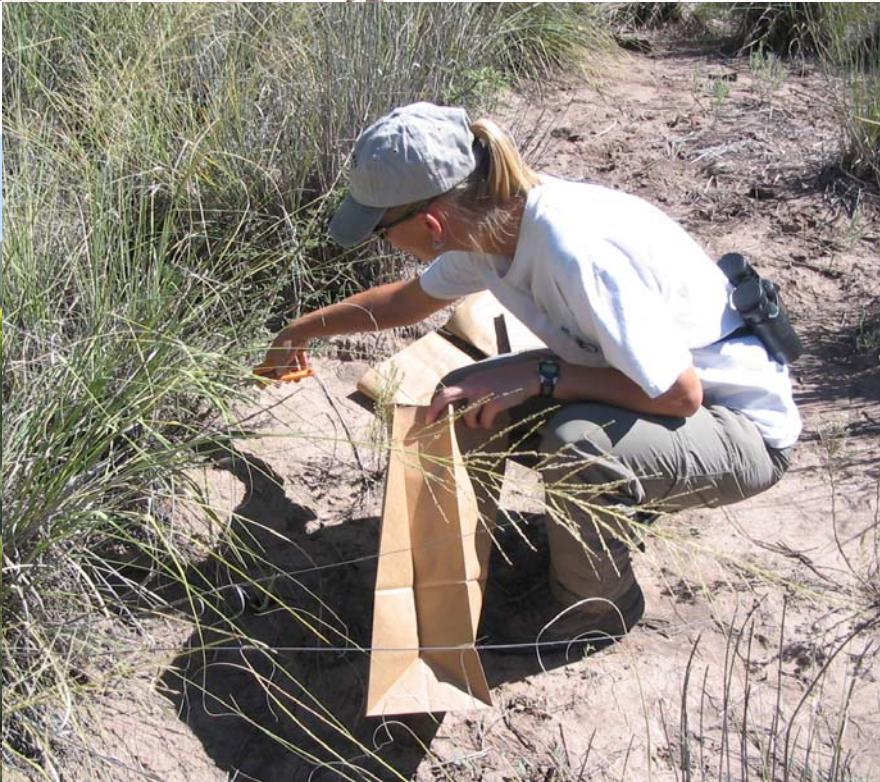
Big sacaton grass, mesquite, four-wing saltbush

Results

- Sacaton seeds failed to germinate
- Atriplex plantings survived and grew
- Sacaton germinated and propagated in greenhouse and replanted onsite
 - 80% survival
- Metals accumulation results:
 - Sacaton grass uptake about 1/10 of shrubs
 - Wildlife protection
 - Food chain accumulation modeled for ecological restoration
 - Indicates cleanup needed for Cu and Pb
