PHYTOREMEDIATION AND WETLAND HABITAT DEVELOPMENT ON A CONTAMINATED SEWAGE SLUDGE DEPOSIT – PRACTICAL EXPERIENCES

**3rd International Phytotechnologies
Conference 2005**

The Site: A Former Sludge Deposit

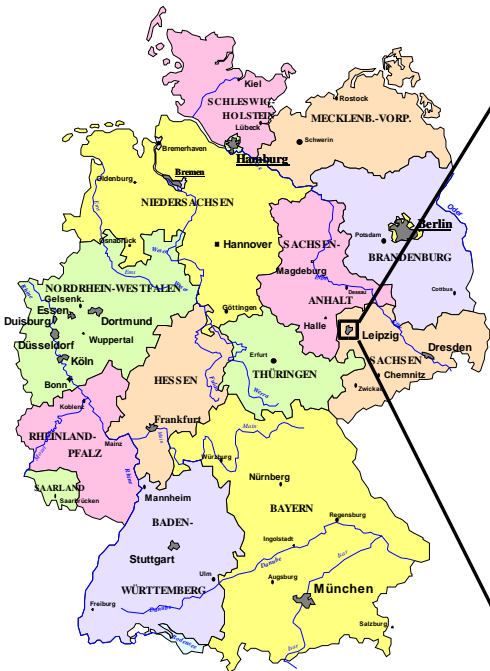
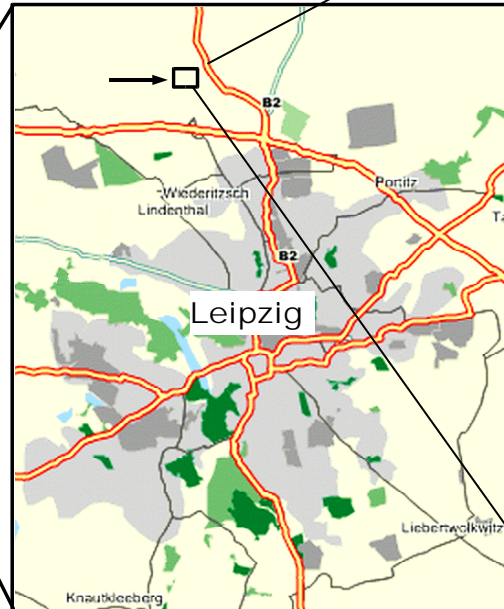
- Since 1955 sludge from the central wastewater treatment plant of Leipzig was pumped to lagoons on the site
- In the 1960s, because of capacity problems, an unlined gravel pit was used to store additional sludge (lagoon 3, the most contaminated part of the site)
- Two additional lagoons (now called 1 and 2) were built in the 1980s
- The sludge dewatering plant was closed in 1990
- At the time of closure, about 300,000 m³ sludge were stored on the site
 - Water content 40 - 60 %
 - Contamination with heavy metals, phenols and hydrocarbons

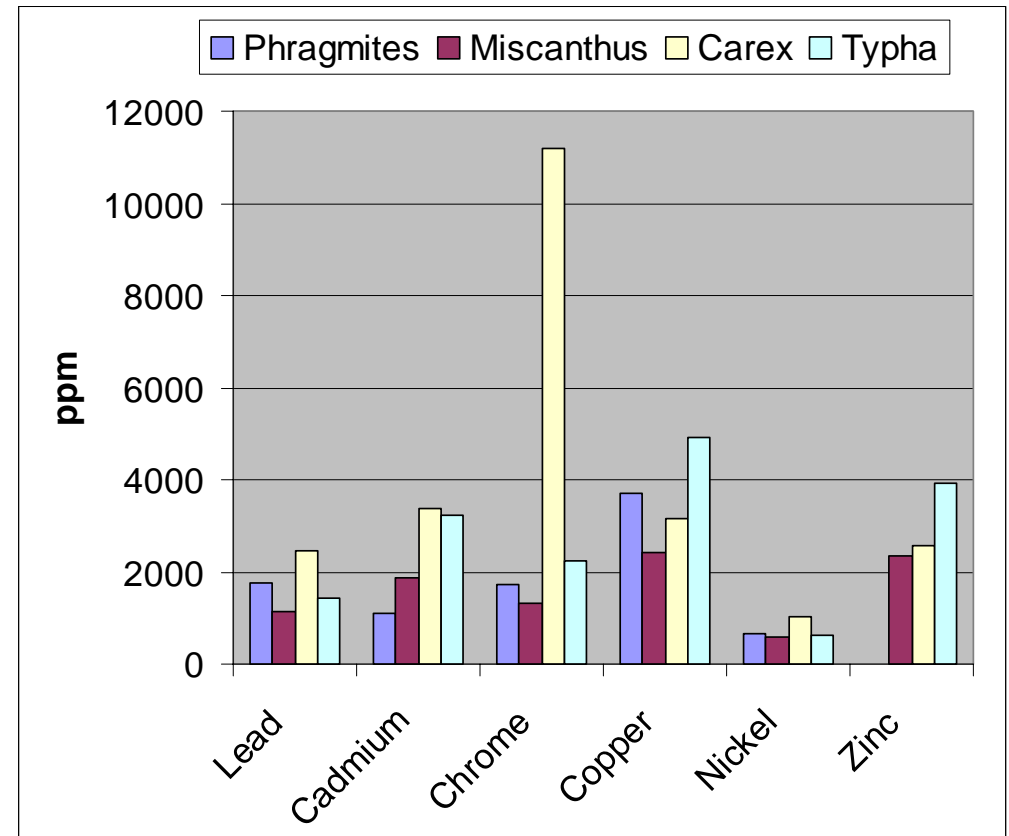
In vitro Experiments

Maximum of metal accumulation in plant biomass *in vitro* for *Miscanthus sinensis*, *Phragmites communis*, *Carex disticha*, *Typha latifolia* after 8 weeks

Metal	Phragmites	Miscanthus	Carex	Typha
	Concentration ppm			
Lead	1770	1130	2470	1420
Cadmium	1101	1878	3387	3244
Chrome	1720	1326	11190	2246
Copper	3705	2422	3167	4916
Nickel	643	602	1034	631
Zinc		2355	2553	3924

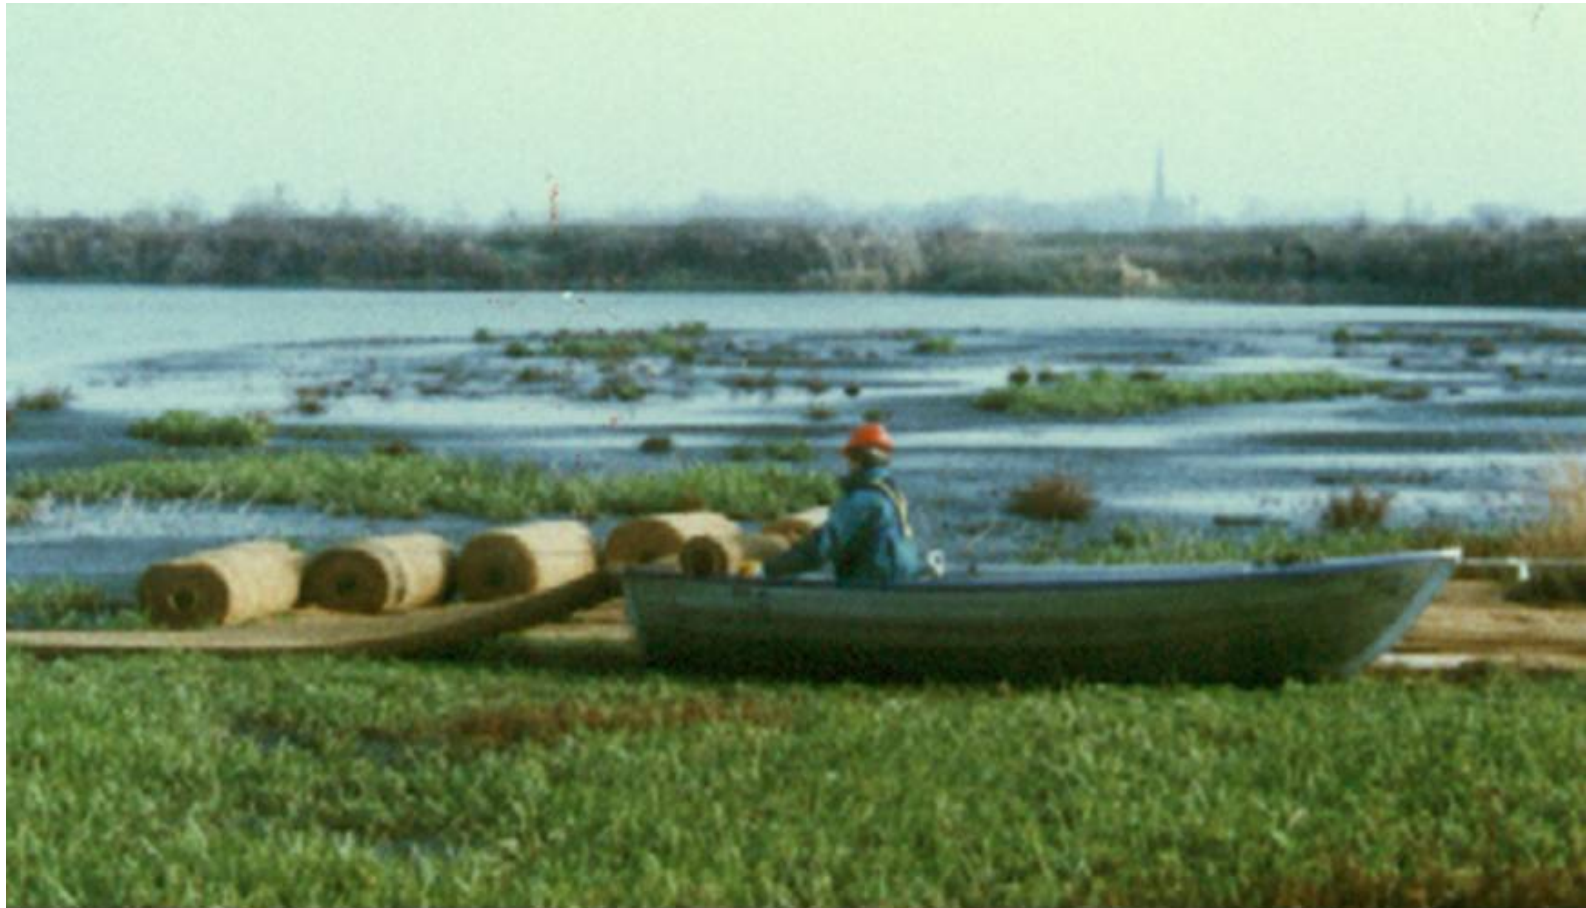
Phytoremediation in Lagoon 3 south: Reed

- A technology for the biological capping of large sludge deposits was developed by BioPlanta.
- Optimized plants are precultivated on coconut fibre mats. A proprietary technology is used to apply the mats onto sludge areas, that are not accessible to people or machines.
- Comparing different remediation options, phytostabilisation combined with an *in situ* phytodecontamination turned out to be the economically and ecologically favorable solution.
- The planted reed is harvested every winter to remove extracted metals.

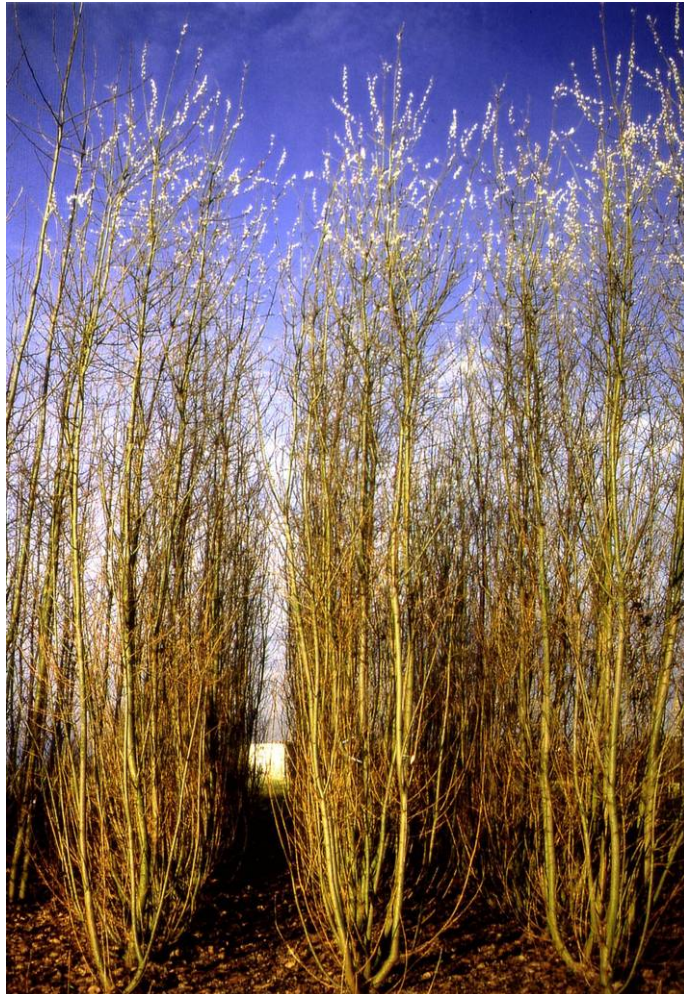
Phytoremediation in Lagoon 3 north: Willows

Salix spp. were planted in the northern part of lagoon 3 in 2002

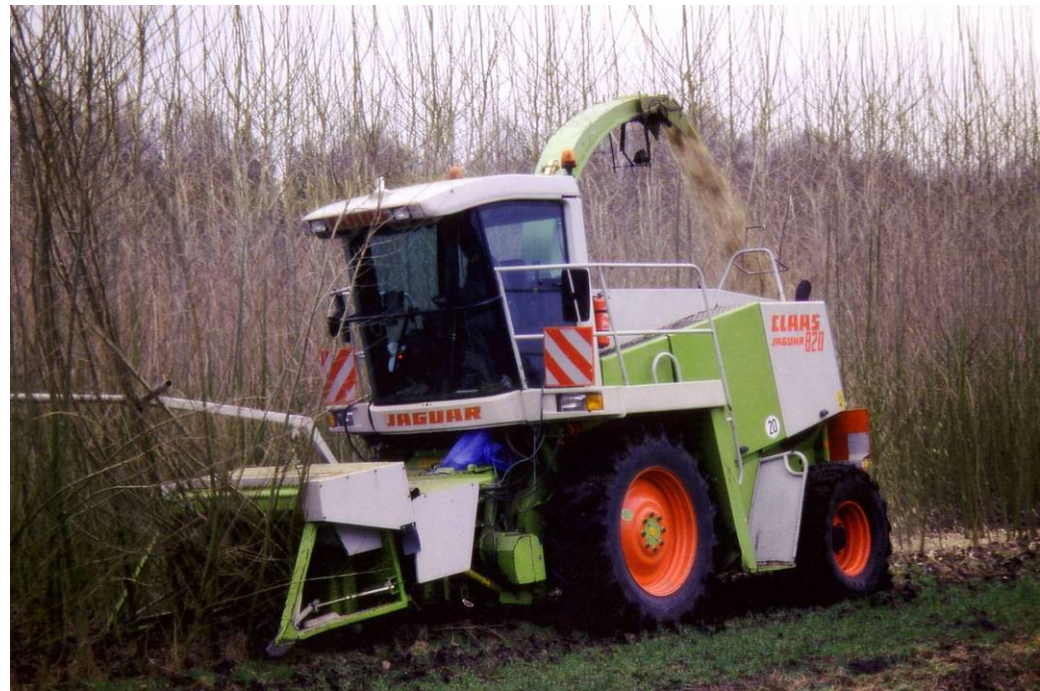
Outlook on growth and harvest

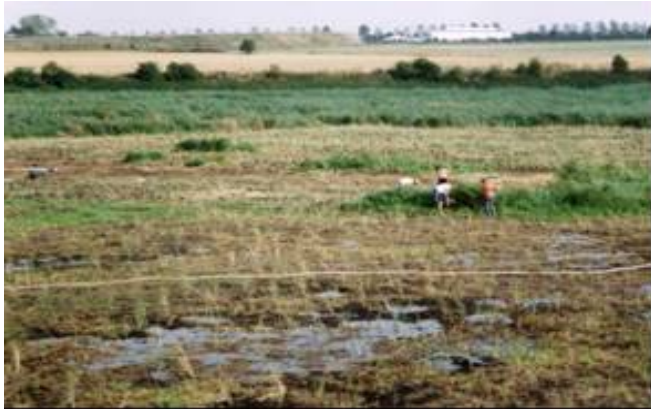
Reed planting

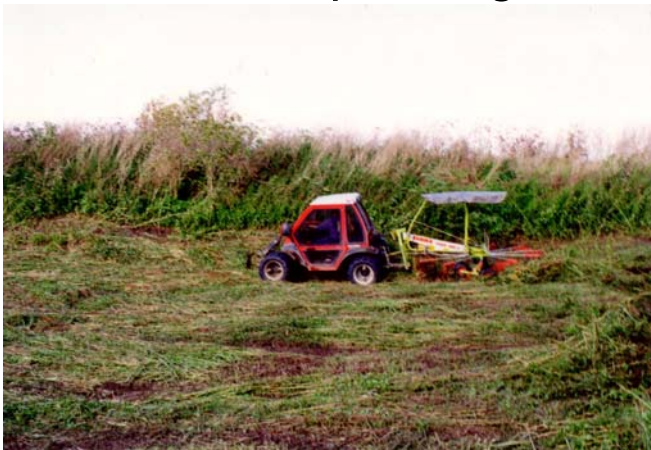
Harvesting

year	yield in tons	dry matter
1996	12	4
1997	12	10
1998	16	11
1999	18	15
2000	32	18
2001	29	20
2002	36	24
2003	79	51
2004	62	(~ 40)

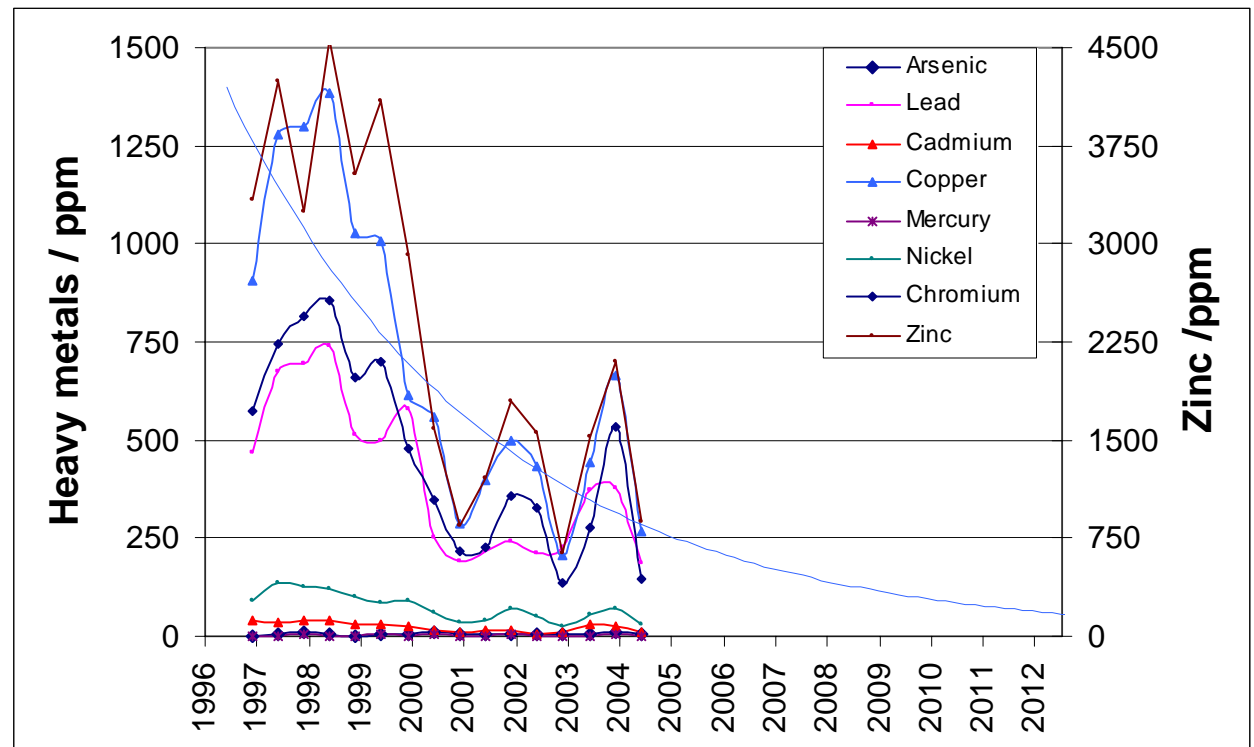
Phytoremediation in Lagoon 3 south: Reed

Until Dec. 2003 these amounts of heavy metals have been removed

Lead	140 g
Cadmium	79 g
Chromium	158 g
Copper	1,401 g
Nickel	215 g
Zinc	34,674 g

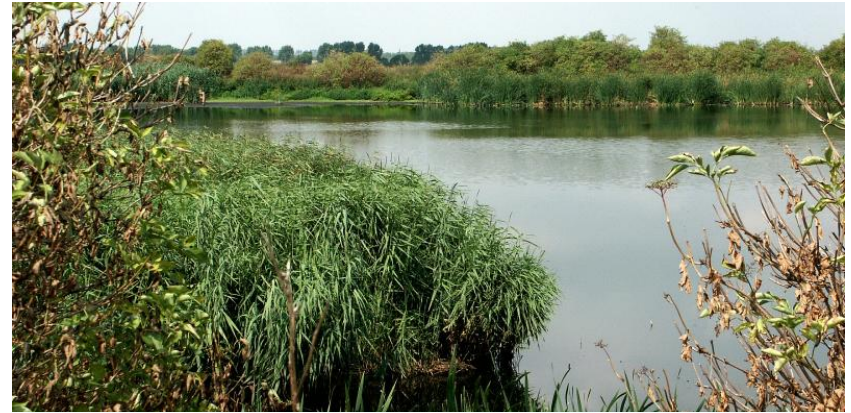
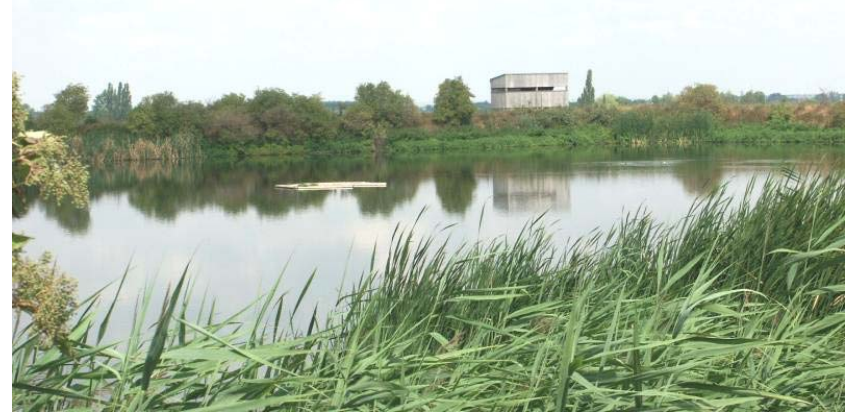
Current Contaminant Situation

- Contaminant concentrations are continuously decreasing
- Threshold values will be reached by 2012
- Legal restrictions
 - no fishery, bathing, usage as drinking or irrigation water
 - no agricultural use in the core zone
 - only partial, supervised public accessibility
