***Conference on Accelerating Site Closeout,  
Improving Performance, and Reducing Costs  
Through Optimization***

**Accelerated VOC Source Investigation  
Pairing SCAPS/MIP with EPA Triad,  
Marine Corps Base Camp Pendleton,  
California**

**Karen Collins, San Diego Navy Public Works Center**

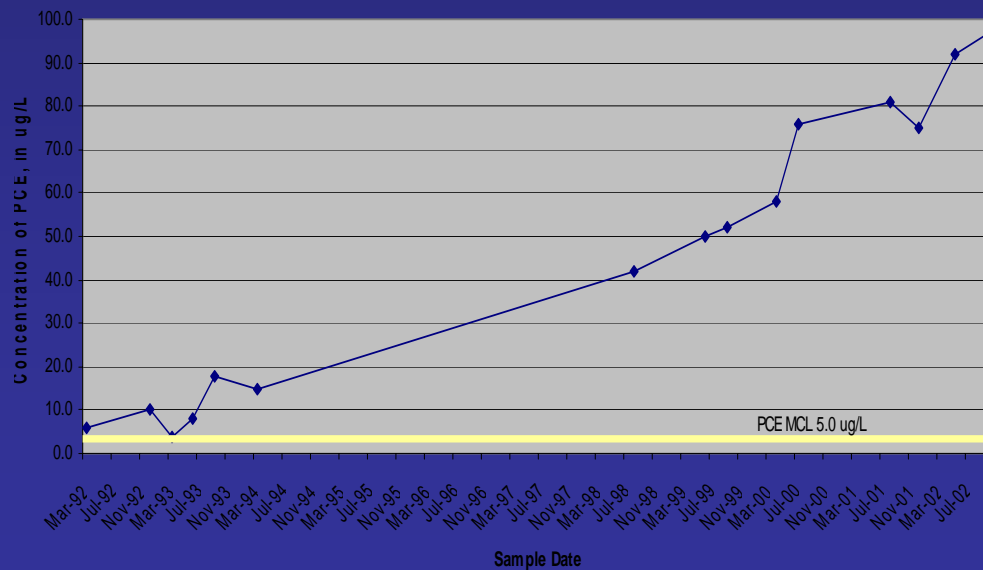
Figure 2-1. Water Quality Hydrograph,  
PCE in 9W-07A Groundwater  
IR Site 9 MCB Camp Pendleton, California

- Site 1114 identified in 2003 because PCE concentrations in well at adjacent site increased from 4 ug/L to 97 ug/L between 1993 when LTM ROD was signed and 2002
- MW 9W-07A is a cross-gradient perimeter well for Site 9, the former Waste Stabilization Pond

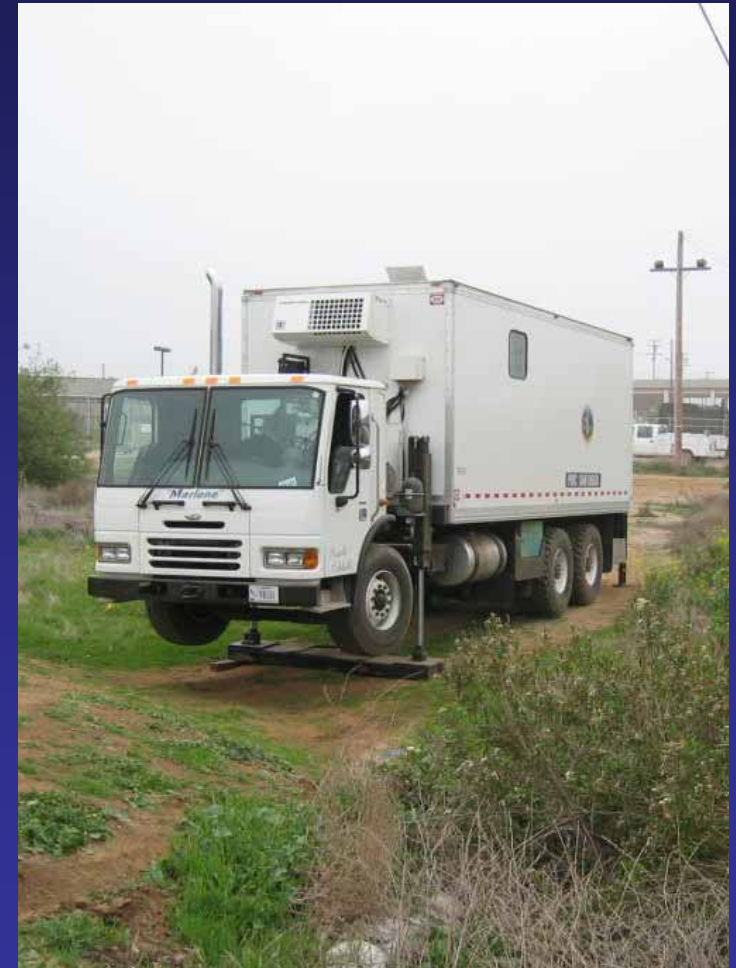
- West of Bldg. 41312
- Military tanks serviced from mid-1950s through 1990s.
- Cleaning chemicals reportedly used, type undetermined
- No VOCs reported in groundwater samples from UST wells at B41312

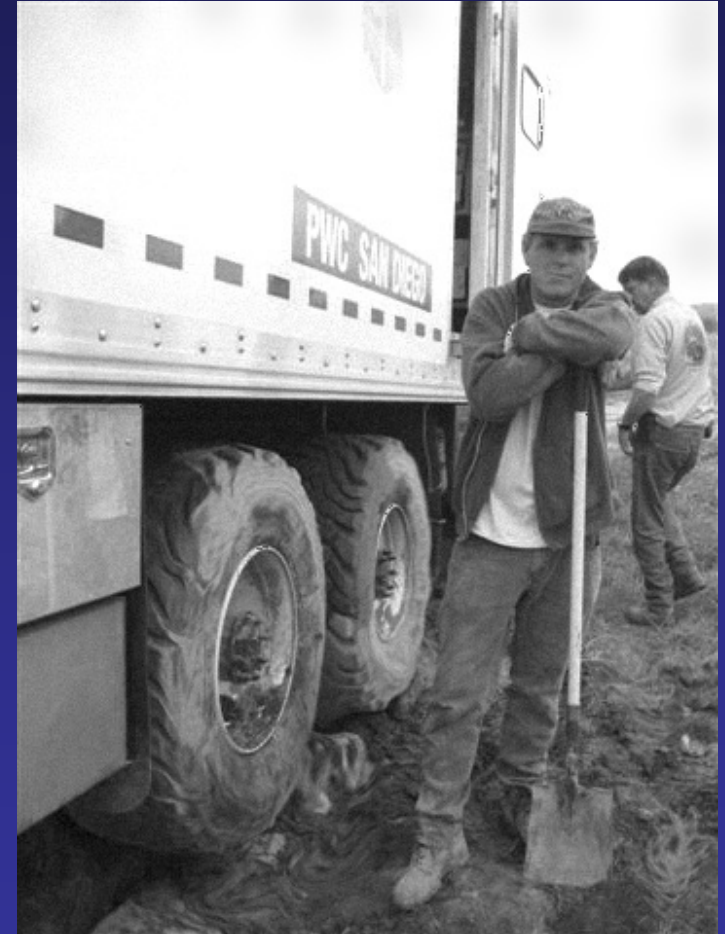
- Lithologic and groundwater quality data collected adjacent to and upgradient of 9W-07A
- CPT data collected at 12 locations provided continuous lithologic characterization
- Discrete groundwater samples collected from 12 temporary microwells at 10 locations.

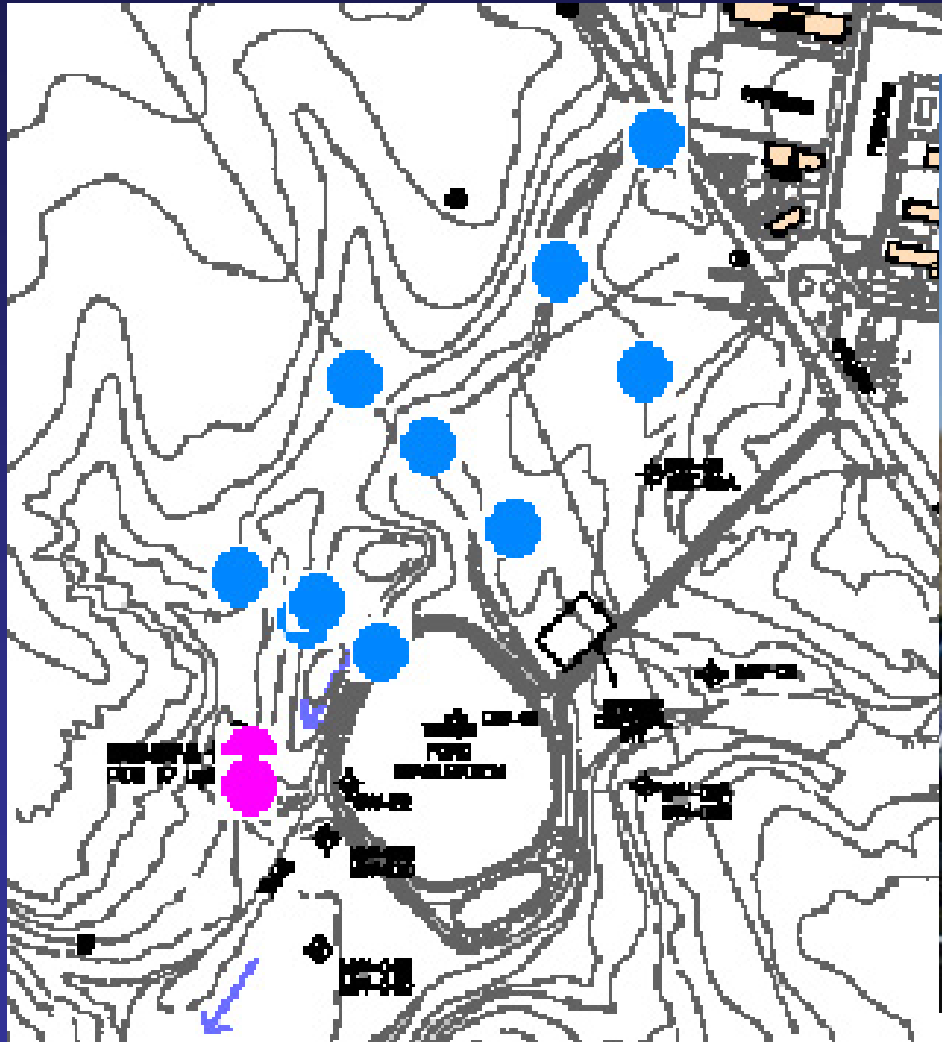
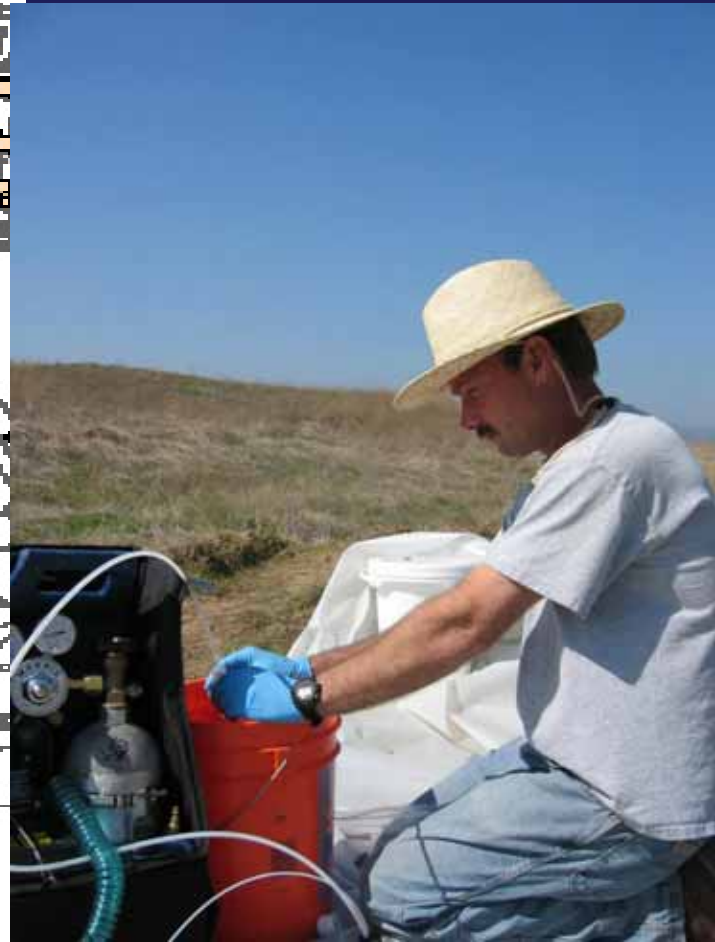
# Temporary Microwell Data

- 12 temporary microwells constructed and sampled at 10 locations
- Each well constructed with a 5 foot screen
- Groundwater samples analyzed by HP Labs with MDL of 1.0 ug/L
- Target VOCs not detected in microwells 2, 5, 6, 7, 8, 10, 11A, 11B, and 12.
- PCE and TCE reported in 13A and 13B.

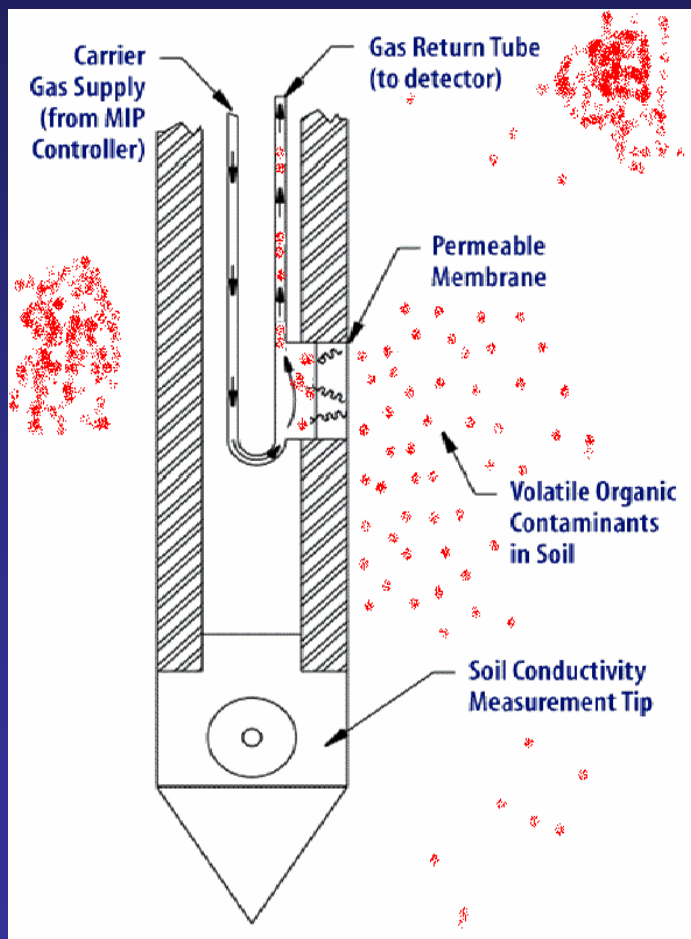
## Geoprobe® Systems Membrane Interface Probe (MIP)

- An inert ultrapure helium carrier gas is sent down to the probe, sweeps behind the membrane, and returns to the surface to be analyzed.
- A temperature controller allows the membrane to be heated, which may optimize membrane performance.
- When the membrane is heated, VOCs advect away from the membrane. However, some of the VOCs pass through the membrane and are brought to the surface with the carrier gas to be analyzed.
- SCAPS analyzes the gas stream with a Direct Sample Ion Trap Mass Spectrometer (DSITMS)

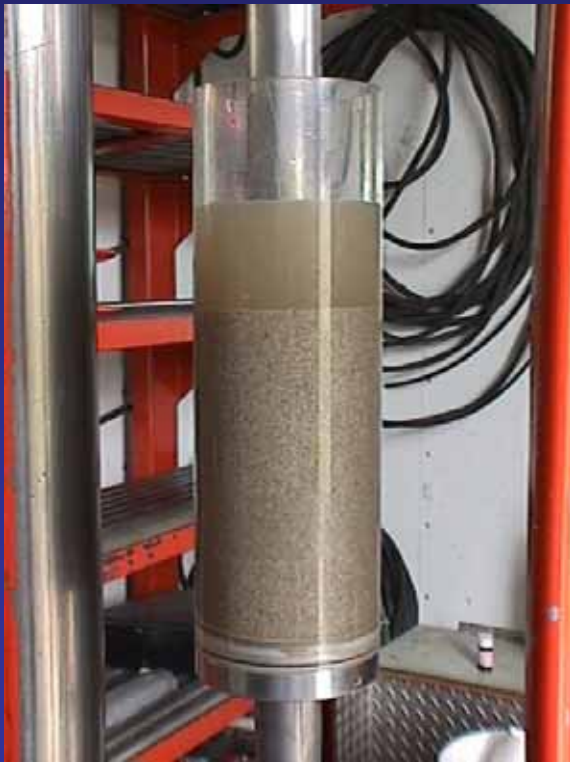
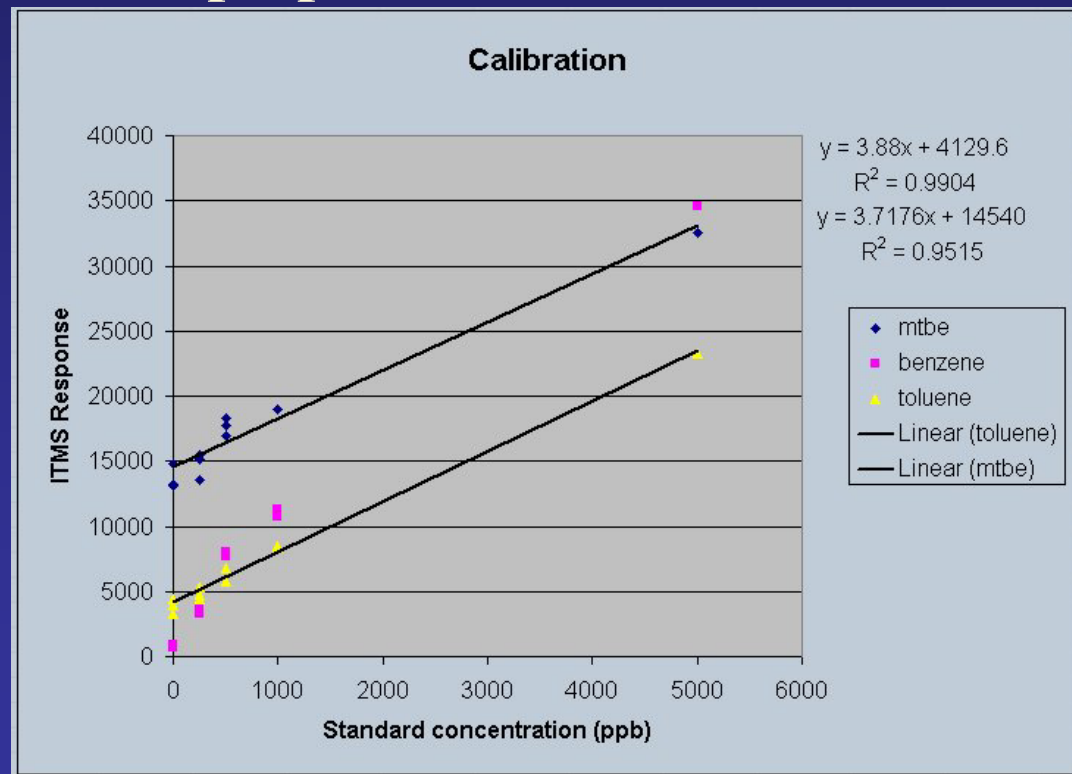
# Calibrating the system.

- Samples of water containing a known concentration of contaminant are added to sand in a calibration jig and measured with the MIP/DSITMS.
- The results are used to prepare a calibration curve.

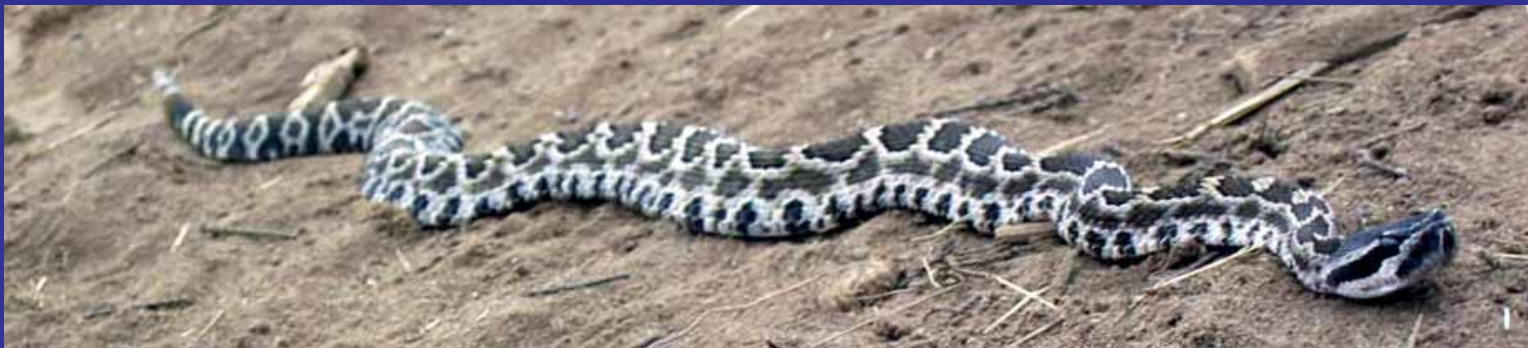
- Thirteen SCAPS/MIP borings advanced
- 12 sample locations positioned along three transects upgradient from 9W-07A, southwest of Stuart Mesa Road
- 1 location northeast of Stuart Mesa Road near former tank maintenance facility by Bldg. 41312

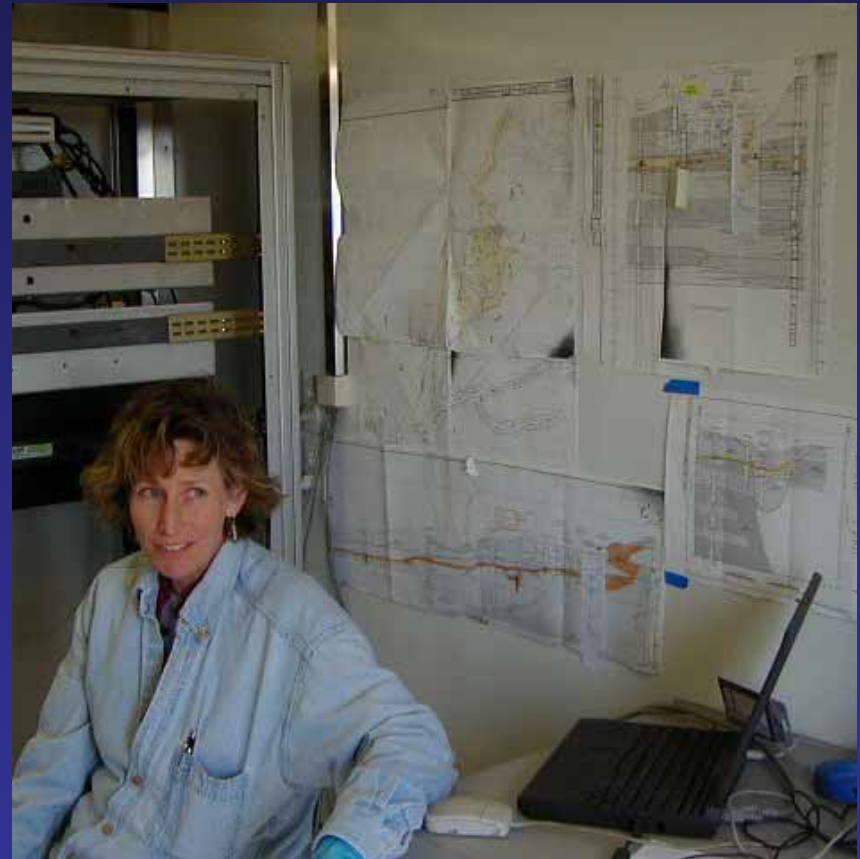
- Over 690 linear feet of site area assessed for VOCs
- MIP-11 was the single location where target VOCs were detected

- Detailed conceptual site model produced identifying:
  - Site 1114 lithologic conditions
  - Well-delimited VOC presence
- Greatest PCE concentration was 1,000 ppb at MIP-11 between 42.5 and 44.4' bgs
- PCE concentration at MIP-11 declines sharply with depth, dropping order of magnitude within 2 feet

- VOC source area is well bounded
  - Laterally within ~200 feet
  - Vertically within 10 feet
  - Groundwater samples from microwells confirm vertical boundary
- DNAPL conditions and product-level concentrations were not encountered
- Data suggests small volume of initial release.

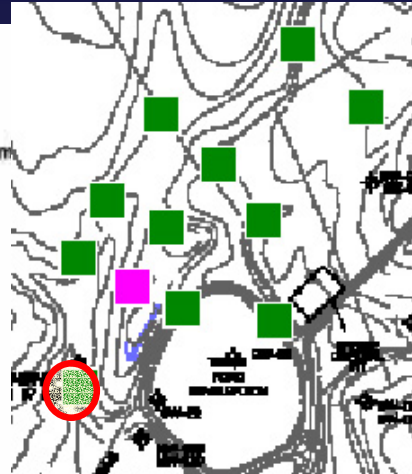
CP-1114-13

Depth	PCE by MIP/DSITMS (ppm)
5.5	<0.25
8.6	<0.25
11.8	<0.25
14.8	<0.25
18.4	<0.25
21.5	<0.25
22.4	<0.25
23.5	<0.25
24.5	<0.25
25.5	<0.25
26.5	<0.25
27.6	<0.25
28.6	<0.25
29.6	<0.25
30.5	<0.25
31.5	<0.25
32.5	<0.25
33.6	<0.25
34.7	<0.25
35.7	<0.25
36.7	<0.25
37.6	<0.25
38.6	<0.25
39.6	<0.25
40.6	<0.25
41.6	<0.25
42.6	<0.25
43.6	<0.25
44.6	<0.25
45.6	<0.25
46.5	<0.25
47.6	<0.25
48.6	<0.25
49.5	<0.25
50.5	<0.25
51.4	<0.25
52.5	<0.25

Well ID	Groundwater Analytical (µ/L)		
	PCE	TCE	DCE
13A	54	4.6	<1
13B	61	5.3	<1

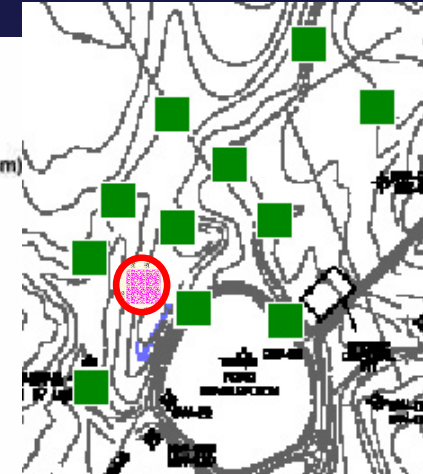
CP-1114-11

Depth	PCE by MIP/DSITMS (ppm)
2.6	<0.25
5.8	<0.25
9	<0.25
12.1	<0.25
15.2	<0.25
18.1	<0.25
21.1	<0.25
24.2	<0.25
27.2	<0.25
30.4	<0.25
33.5	<0.25
36.5	<0.25
39.4	<0.25
42.5	<0.25
44.4	1
45.5	0.5
46.4	0.1J
47.4	<0.25
48.5	<0.25
49.4	<0.25
50.4	<0.25
51.3	<0.25
52.4	<0.25
53.4	<0.25
54.4	<0.25
55.5	<0.25
58.1	<0.25
61.3	<0.25
64.4	<0.25

Well ID	Groundwater Analytical (µ/L)		
	PCE	TCE	DCE
11A	<1	<1	<1
11B	<1	<1	<1

PCE @ about 1ppm  
 PCE @ about 0.5 ppm  
 PCE <0.5 ppm present

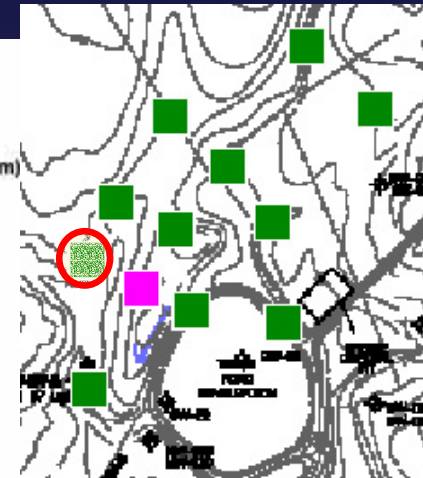
CP-1114-10

Depth	PCE by MIP/DSITMS (ppm)
3	<0.25
6	<0.25
9.1	<0.25
12	<0.25
15	<0.25
17.9	<0.25
21	<0.25
23.9	<0.25
27	<0.25
30	<0.25
33.2	<0.25
34	<0.25
35	<0.25
36.1	<0.25
37	<0.25
38	<0.25
39	<0.25
40	<0.25
41	<0.25
42.1	<0.25
43.1	<0.25
46	<0.25
49.1	<0.25

Well ID	Groundwater Analytical (µ/L)		
	PCE	TCE	DCE
10	<1	<1	<1

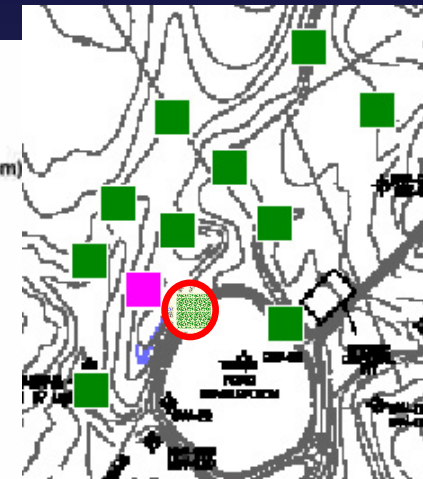
CP-1114-12

Depth	PCE by MIP/DSITMS (ppm)
3	<0.25
5.8	<0.25
9.1	<0.25
12	<0.25
15	<0.25
18	<0.25
21	<0.25
24	<0.25
27	<0.25
28	<0.25
29	<0.25
29.9	<0.25
31	<0.25
32	<0.25
33	<0.25
34	<0.25
35	<0.25
36	<0.25
37.1	<0.25
38	<0.25
39	<0.25
40	<0.25
41	<0.25
42	<0.25
43	<0.25
44.1	<0.25
45	<0.25
46	<0.25
46.9	<0.25
48	<0.25
49	<0.25
51.9	<0.25
55	<0.25

Well ID	Groundwater Analytical (µ/L)		
	PCE	TCE	DCE
12	<1	<1	<1

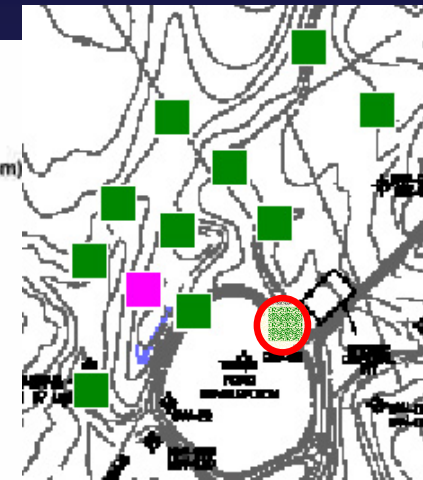
CP-1114-15

Depth	PCE by MIP/DSITMS (ppm)
6	<0.25
9	<0.25
12	<0.25
15	<0.25
18	<0.25
21.1	<0.25
24.1	<0.25
27	<0.25
28	<0.25
29	<0.25
30	<0.25
31	<0.25
32	<0.25
33	<0.25
34	<0.25
35	<0.25
36	<0.25
37	<0.25
40	<0.25
43	<0.25
46.1	<0.25
49.1	<0.25

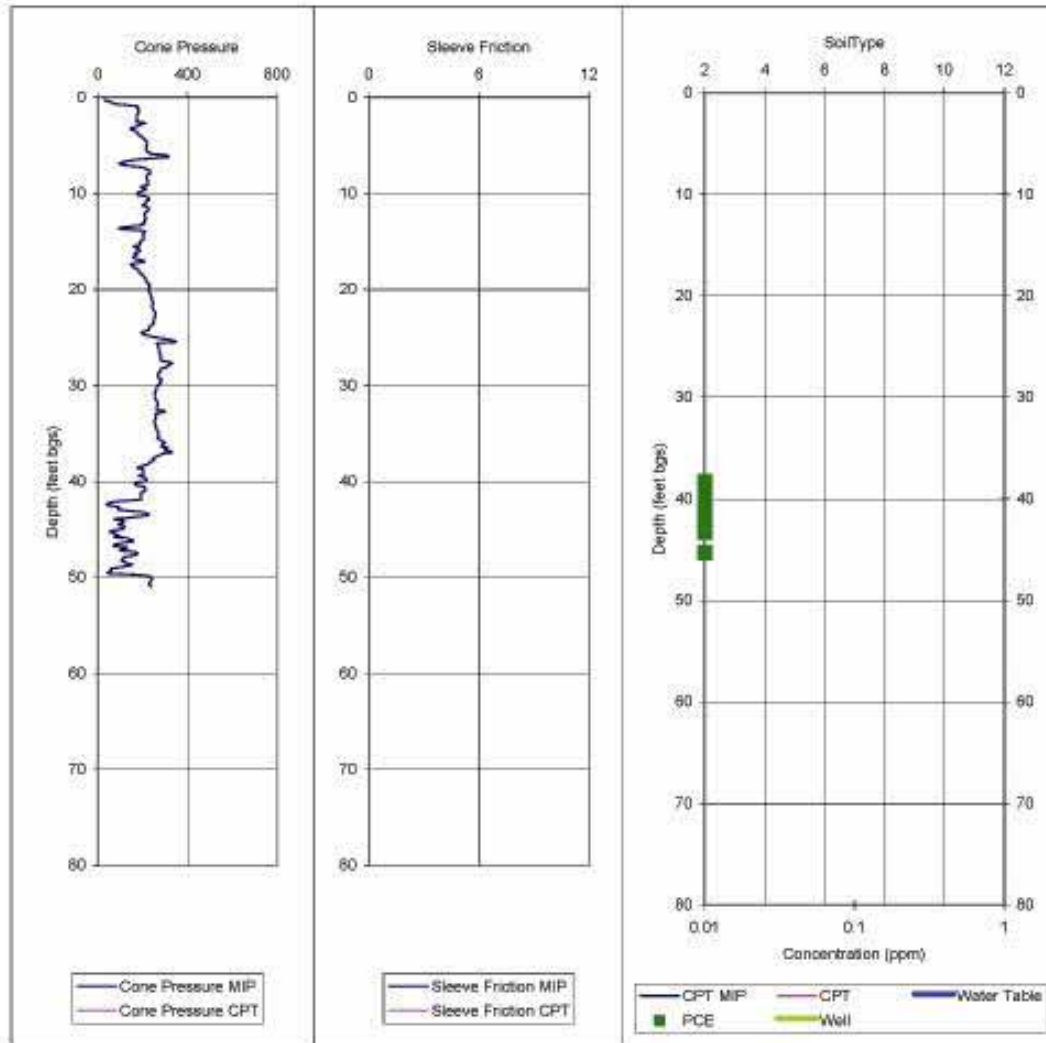
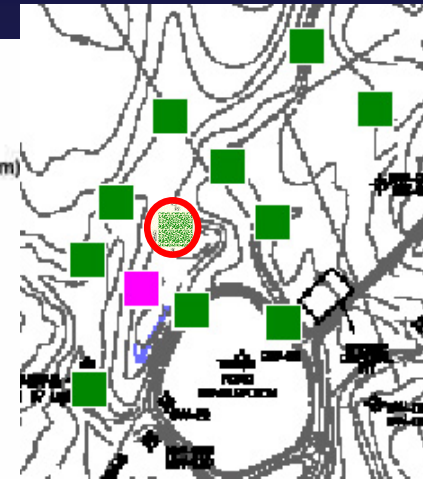
CP-1114-16

Depth	PCE by MIP/DSITMS (ppm)
38.3	<0.25
39.3	<0.25
40.3	<0.25
41.3	<0.25
42.3	<0.25
43.3	<0.25
45.3	<0.25

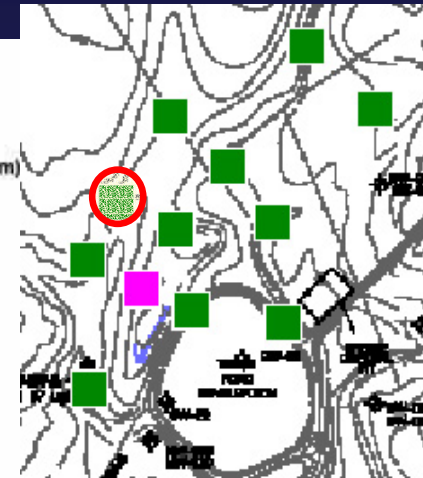
CP-1114-17

Depth	PCE by MIP/DSITMS (ppm)
25.7	<0.25
41.5	<0.25
42.5	<0.25
43.5	<0.25
45.4	<0.25
50	<0.25
