***Conference on Accelerating Site Closeout,
Improving Performance, and Reducing Costs
Through Optimization***

**Accelerated VOC Source Investigation
Pairing SCAPS/MIP with EPA Triad,
Marine Corps Base Camp Pendleton,
California**

Karen Collins, San Diego Navy Public Works Center

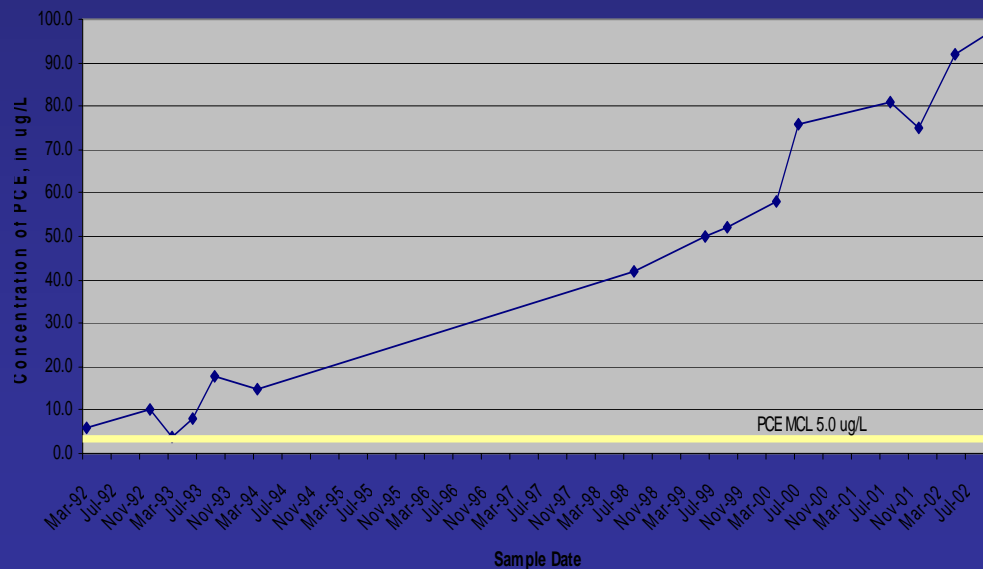
Figure 2-1. Water Quality Hydrograph,
PCE in 9W-07A Groundwater
IR Site 9 MCB Camp Pendleton, California

- Site 1114 identified in 2003 because PCE concentrations in well at adjacent site increased from 4 ug/L to 97 ug/L between 1993 when LTM ROD was signed and 2002
- MW 9W-07A is a cross-gradient perimeter well for Site 9, the former Waste Stabilization Pond

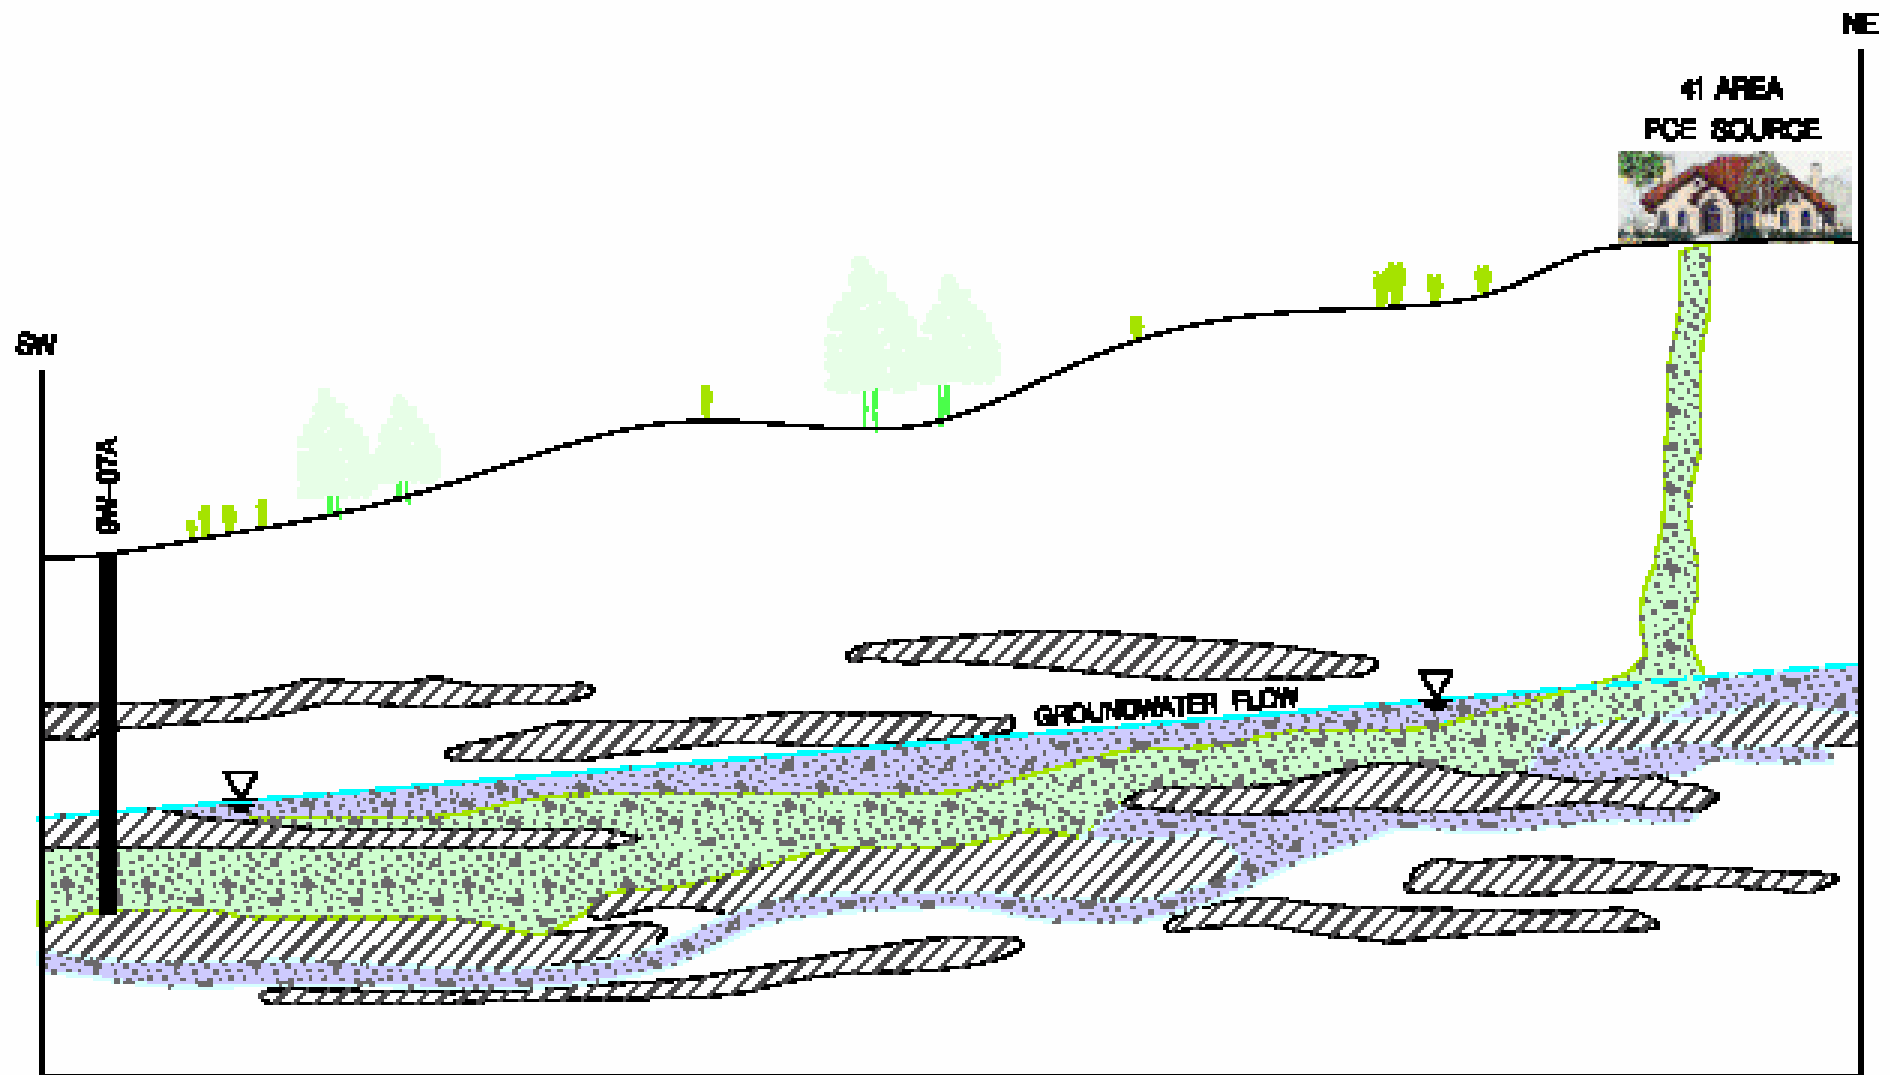
Working Conceptual Site Model

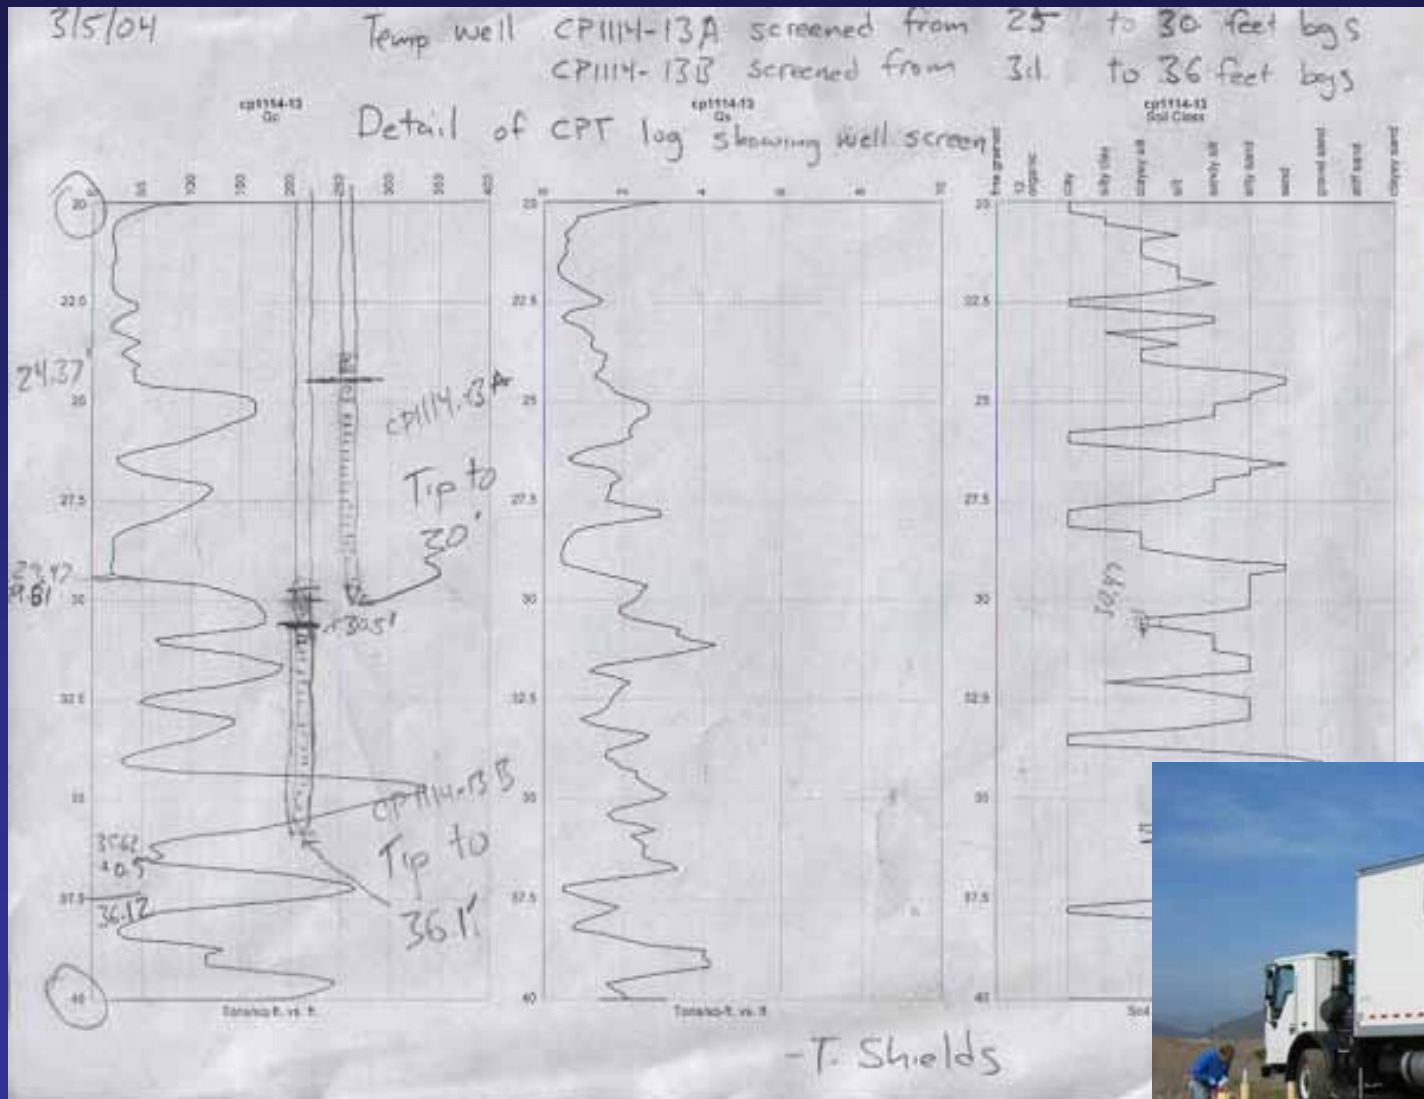
CPT Log CP1114-13

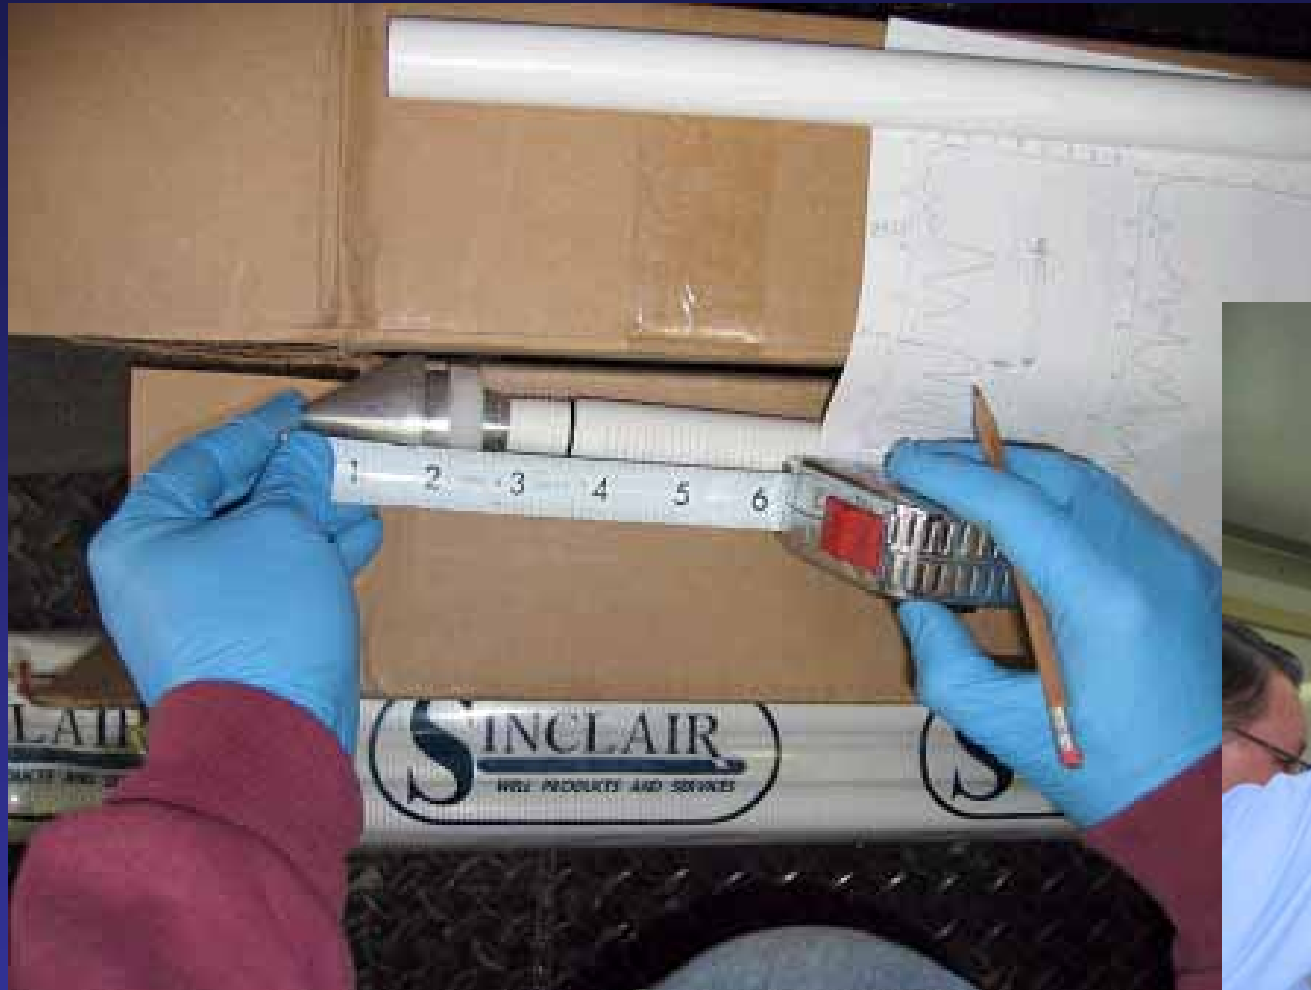
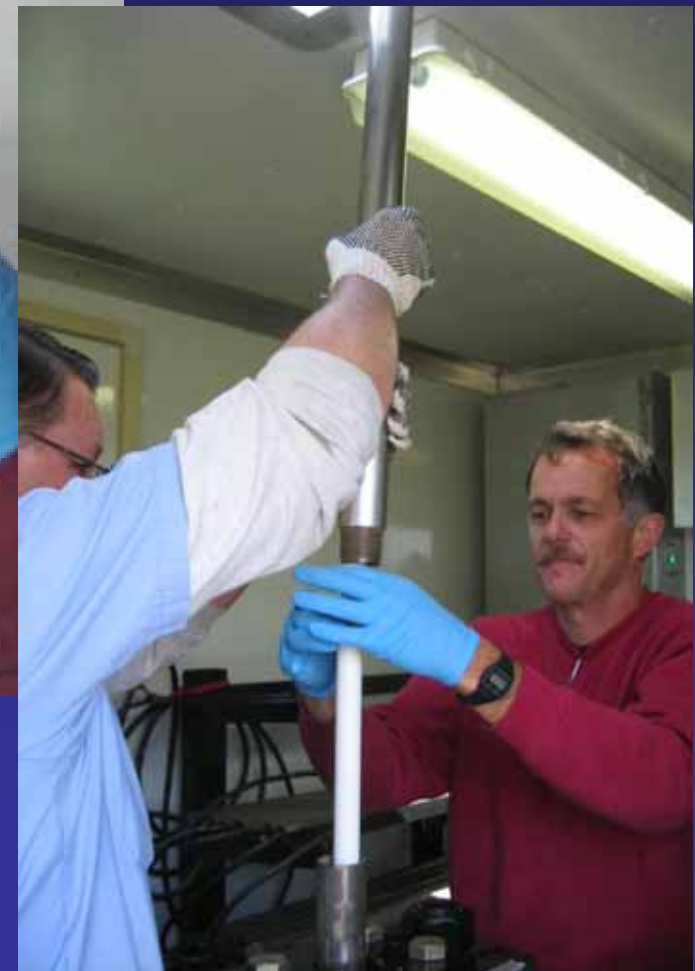
Designing Well Screen

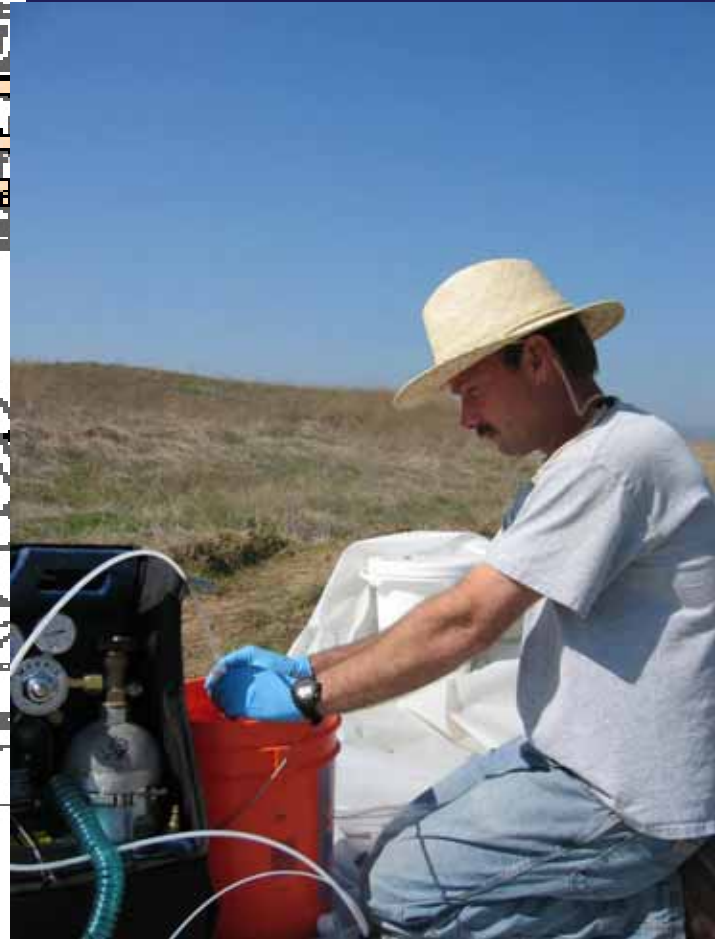
Temporary Microwell Data

- 12 temporary microwells constructed and sampled at 10 locations
- Each well constructed with a 5 foot screen
- Groundwater samples analyzed by HP Labs with MDL of 1.0 ug/L
- Target VOCs not detected in microwells 2, 5, 6, 7, 8, 10, 11A, 11B, and 12.
- PCE and TCE reported in 13A and 13B.

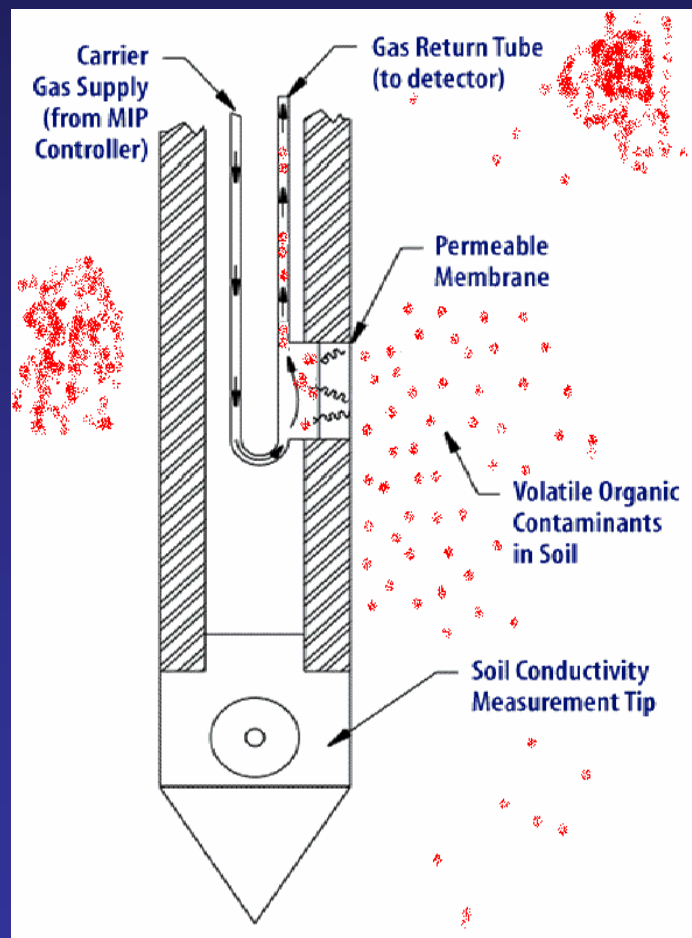
Geoprobe® Systems Membrane Interface Probe (MIP)

- An inert ultrapure helium carrier gas is sent down to the probe, sweeps behind the membrane, and returns to the surface to be analyzed.
- A temperature controller allows the membrane to be heated, which may optimize membrane performance.
- When the membrane is heated, VOCs advect away from the membrane. However, some of the VOCs pass through the membrane and are brought to the surface with the carrier gas to be analyzed.
- SCAPS analyzes the gas stream with a Direct Sample Ion Trap Mass Spectrometer (DSITMS)

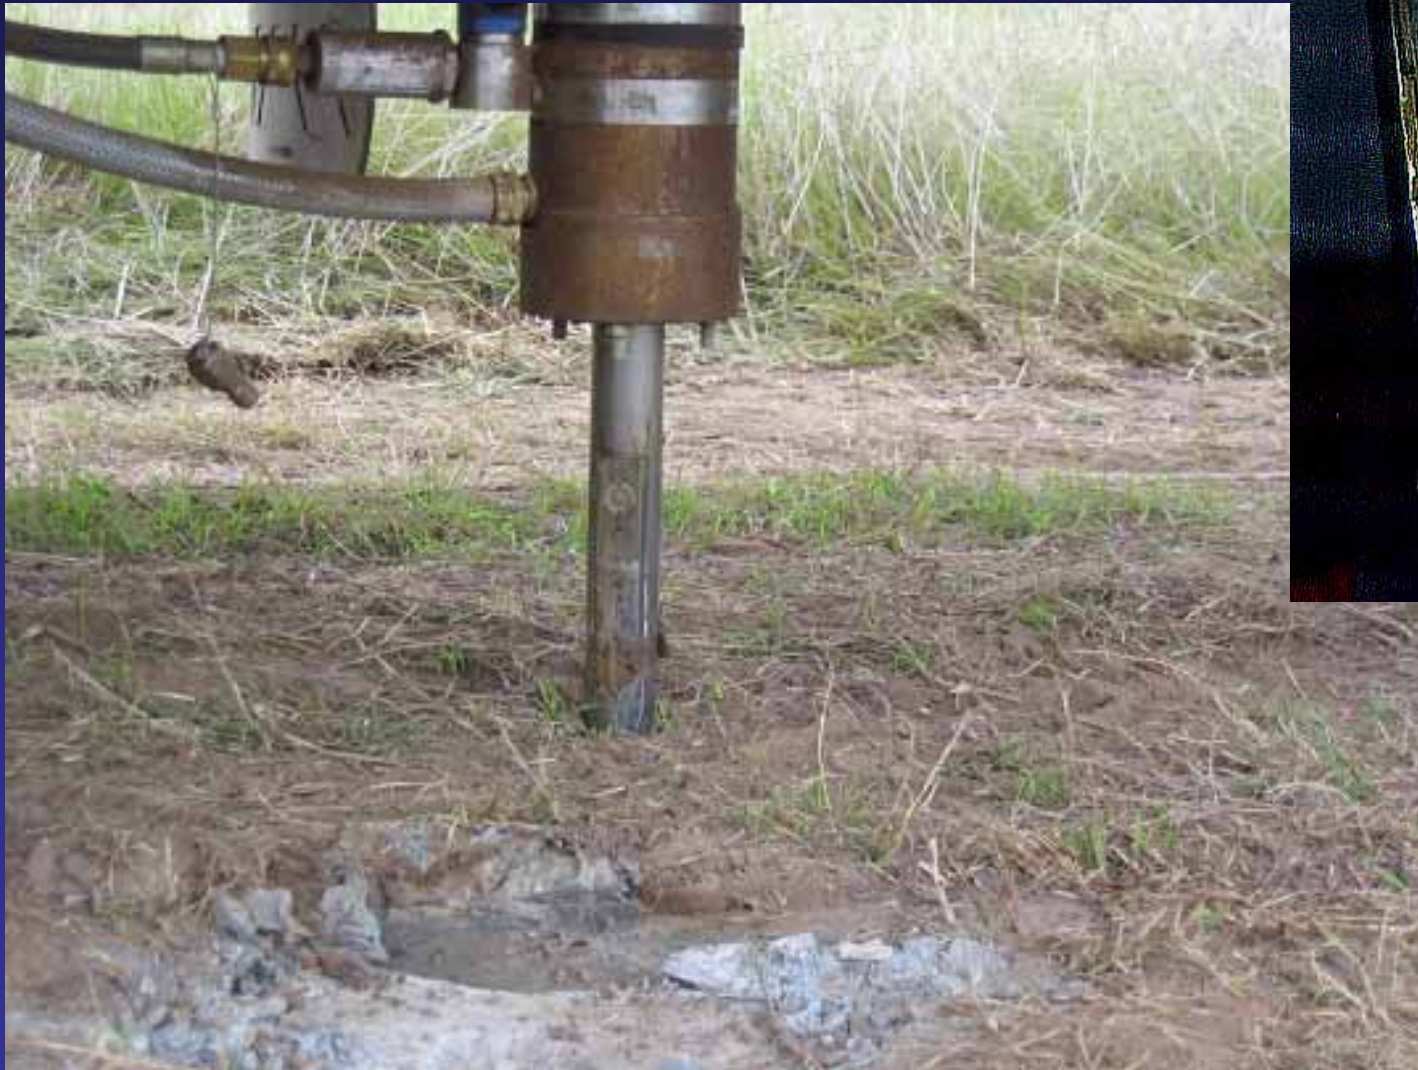
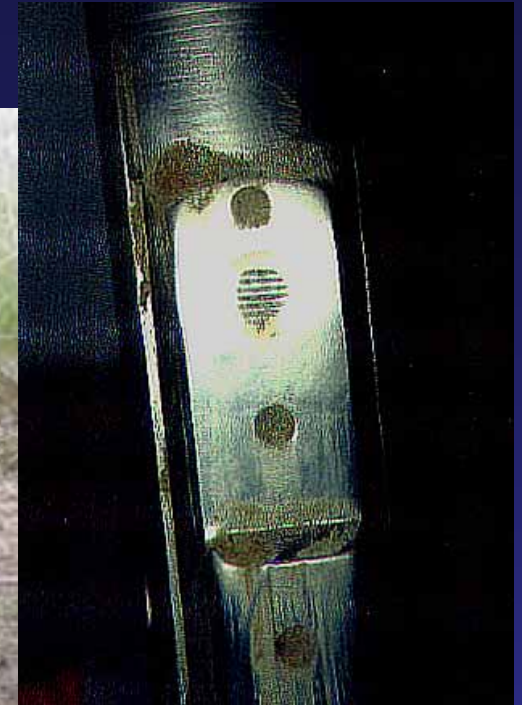
MIP Probe

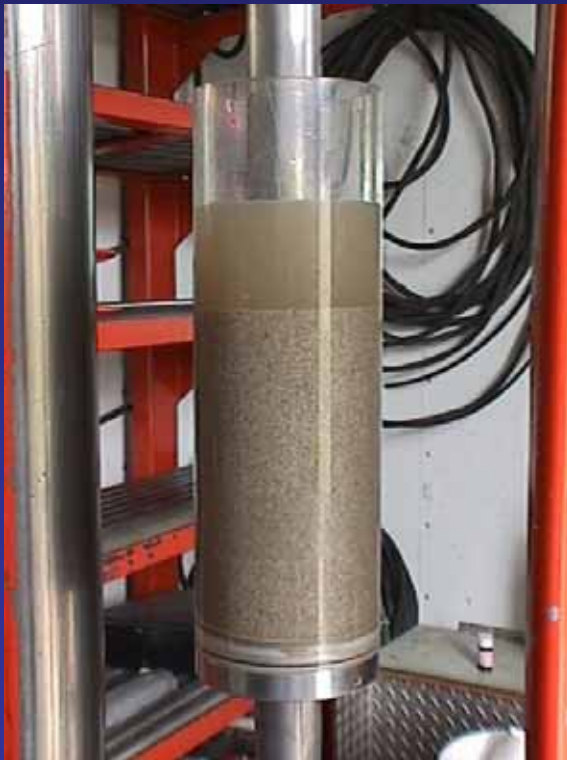
Calibrating the system.

- Samples of water containing a known concentration of contaminant are added to sand in a calibration jig and measured with the MIP/DSITMS.
- The results are used to prepare a calibration curve.

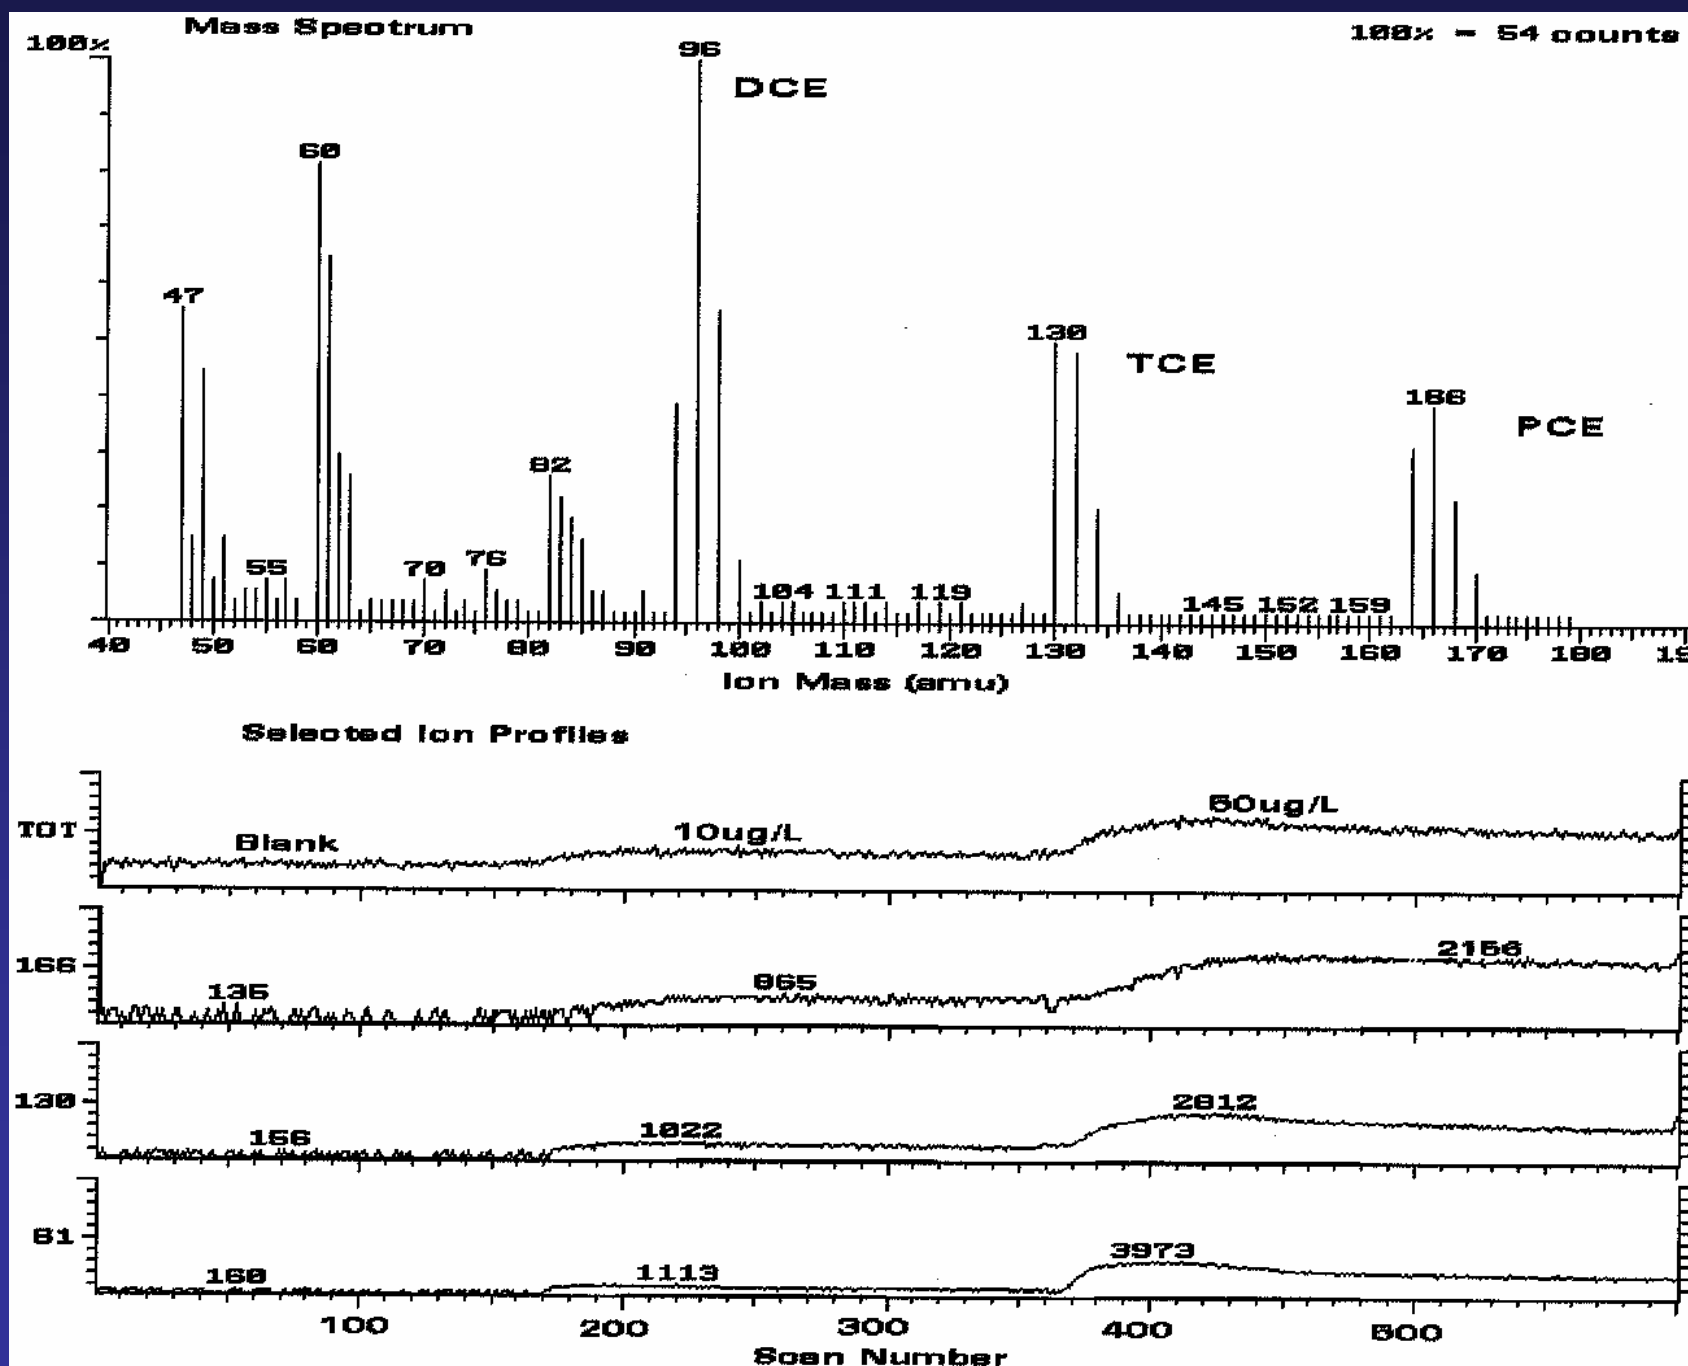
Typical DSITMS Response

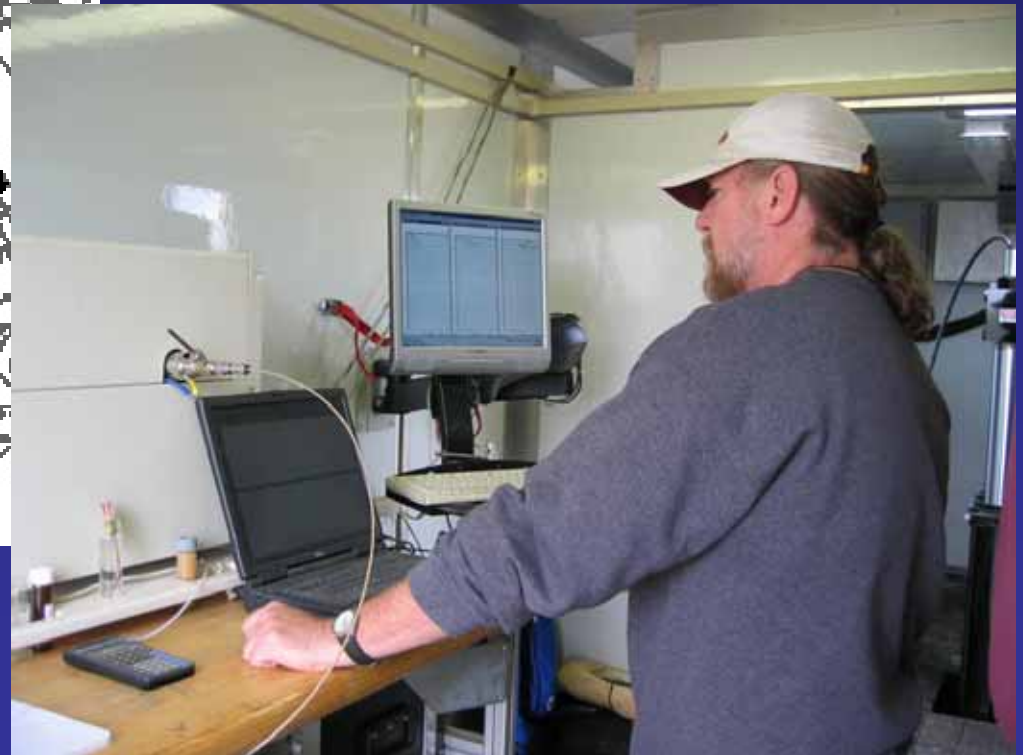
MIP Results

- Thirteen SCAPS/MIP borings advanced
- 12 sample locations positioned along three transects upgradient from 9W-07A, southwest of Stuart Mesa Road
- 1 location northeast of Stuart Mesa Road near former tank maintenance facility by Bldg. 41312

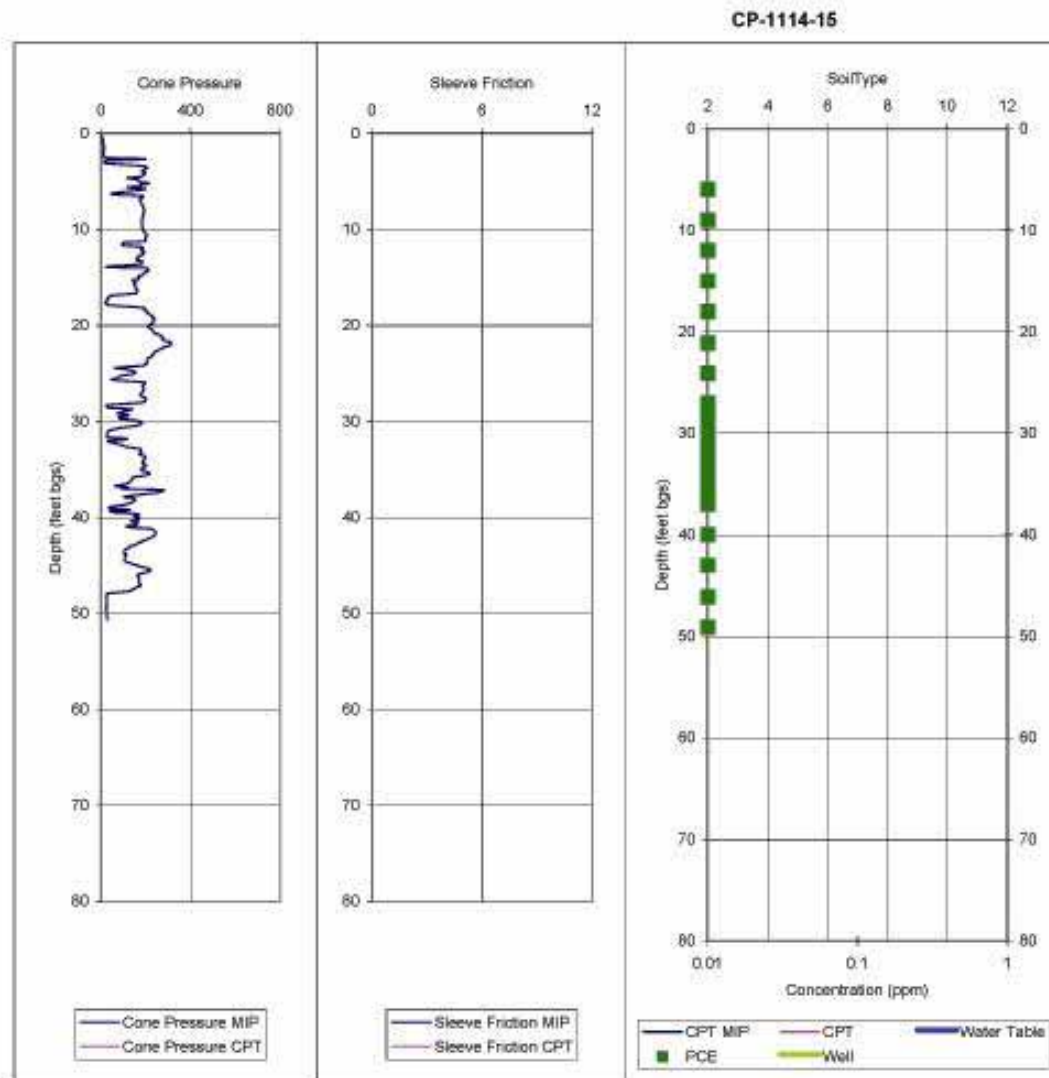
MCBCP IR Site 1114

Depth	PCE by MIP/DSITMS (ppm)
6	<0.25
9	<0.25
12	<0.25
15	<0.25
18	<0.25
21.1	<0.25
24.1	<0.25
27	<0.25
28	<0.25
29	<0.25
30	<0.25
31	<0.25
32	<0.25
33	<0.25
34	<0.25
35	<0.25
36	<0.25
37	<0.25
40	<0.25
43	<0.25
46.1	<0.25
49.1	<0.25

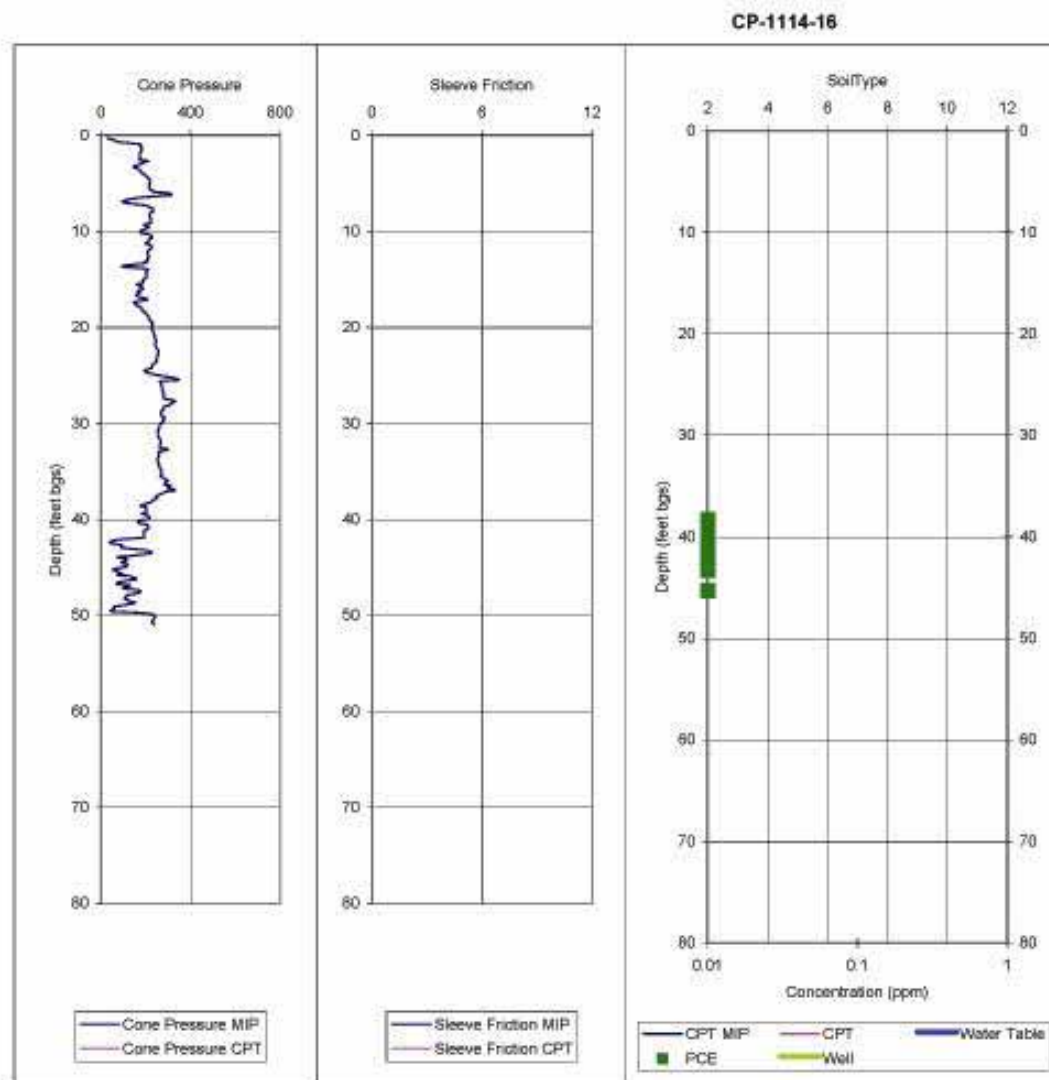
MCBCP IR Site 1114

Depth	PCE by MIP/DSITMS (ppm)
38.3	<0.25
39.3	<0.25
40.3	<0.25
41.3	<0.25
42.3	<0.25
43.3	<0.25
45.3	<0.25
