Remediation of Cretaceous Sediments affected by uranium in-situ leaching (ISL) in the Czech Republic

NATO SPS Study "<u>Prevention and Remediation Issues in Selected Industrial Sectors</u>" Ljubljana, 17 – 22 July 2007

MINISTRY OF ENVIRONMENT, CZECH REPUBLIC
Prague 2007

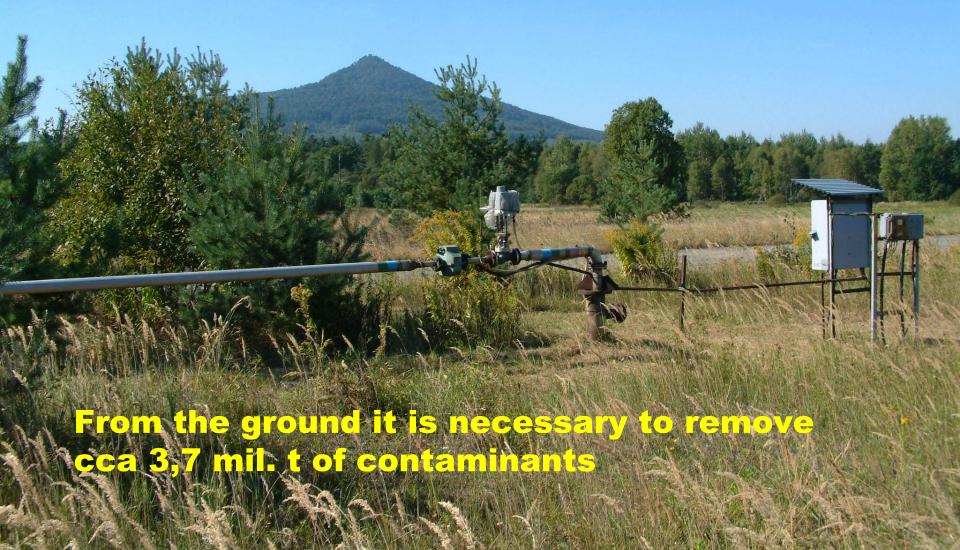
Scheme of present remedial technologies

Capacity of present remedial technologies

for withdrawing of contamination Production and reprocessing of alum: up to 35 000 t TDS per year **Neutralization:** up to 30 000 t TDS per year Present remediation well net **End of remediation 2100**

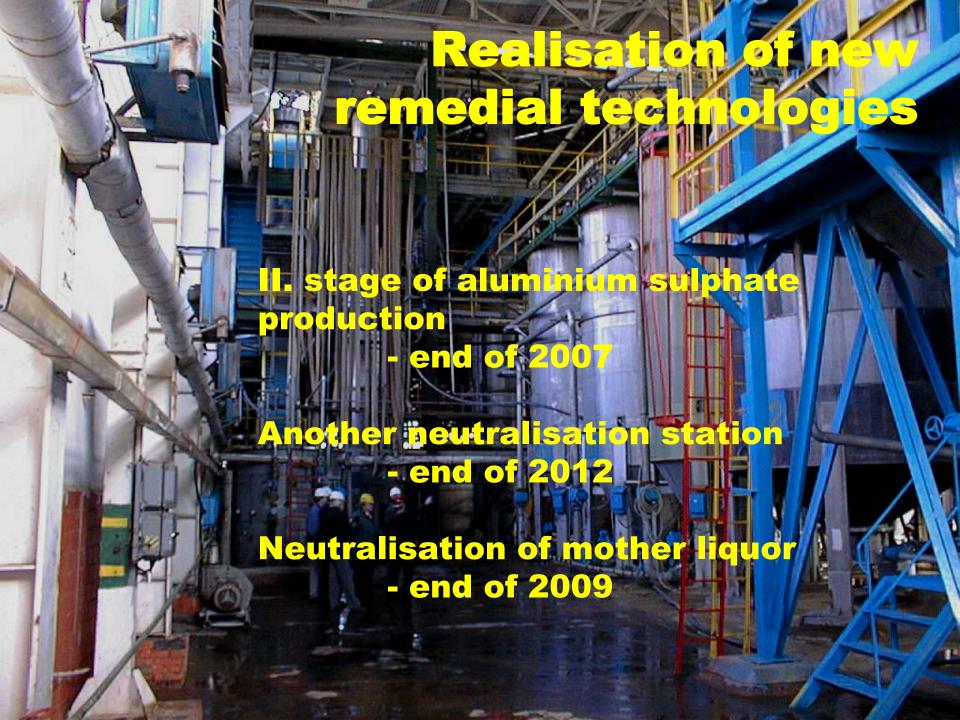
Complete scheme of remedial technologies
