**Thermal Remediation  
Services, Inc.**

***Electrical Resistance Heating  
for  
In-Situ Remediation of Soil &  
Groundwater***

December 10, 2002

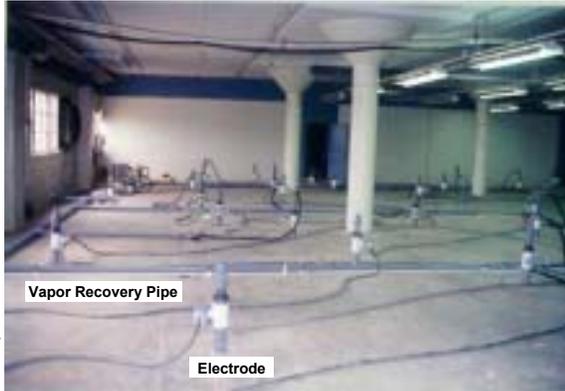
## ERH Remediation Beneath a Building

Limited  
overhead  
access

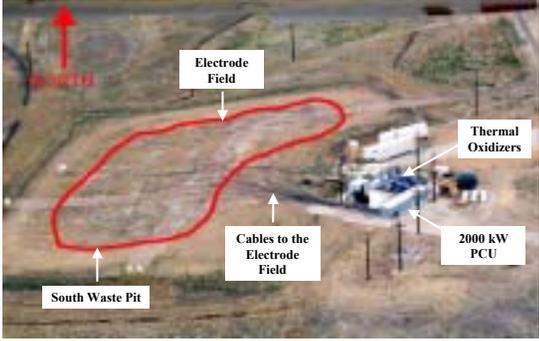
# Lowry Landfill System Layout

Electrode  
Field

Thermal  
Oxidizers

2000 kW  
PCU

Cables to the  
Electrode  
Field

South Waste Pit
