Final Report

TREATMENT OF PCB CONTAMINATED PAINTS AT BADGER MUNITIONS DEPOT

**Part of the ESTCP project titled, “APPLICATON
OF A BIMETALLIC TREATMENT
SYSTEM (BTS) FOR PCB REMOVAL FROM
OLDER STRUCTURES ON DOD FACILITIES.”**

**Cherie L. Geiger, Ph.D. and Christian A. Clausen, Ph.D.
Chemistry Department
University of Central Florida**

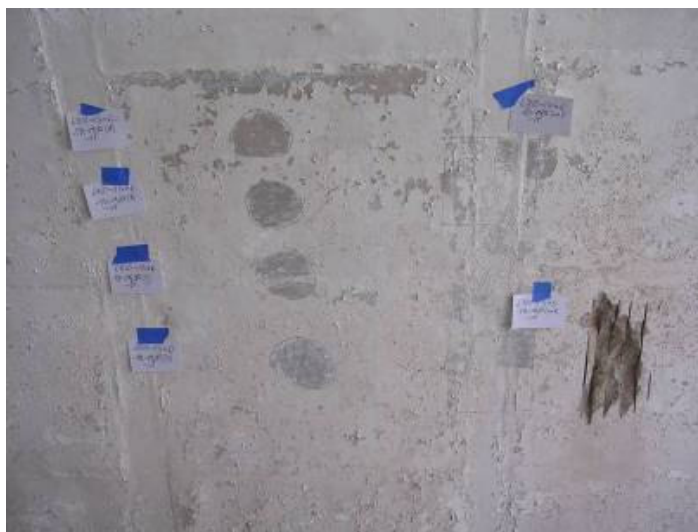
Figure 2. Location of pre-treatment samples in 6810-11.

Figure 2 shows where the pre-treatment samples were taken for the section that was to be treated with the BTS containing active Mg/Pd particles and sealed with a vinyl polymer. These samples have the prefix identification of 6810-11 MgPd-VP. What can also be seen in this figure in the lower right corner is where sections of concrete were cut out from the wall for preliminary treatment tests back in November of 2006. The other two treatment sections in 6810-11 were sampled in a similar manner. Samples of concrete to a depth of 3/8 inch were also taken from each treatment location before and after BTS treatment.

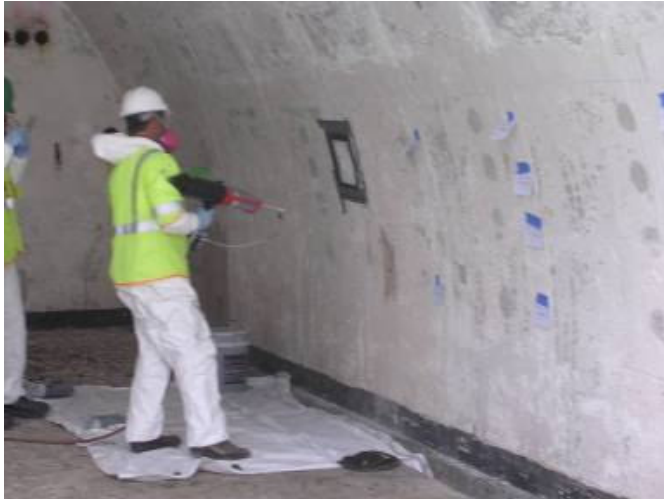
Figure 3. Spraying BTS with cartridge-type spray gun.

After all of the pretreatment samples were taken, the next step involved applying the BTS paste to the wall. The original plan was to spray the BTS onto the test section using a cartridge type sprayer gun as shown in Figure 3. However, the temperature dropped so low as evidenced by the snow falling outside the bunker as shown in Figure 4, that the paste became too viscous to spray. Therefore, it became necessary to apply the paste to the test section by troweling it on. This technique was used to apply the BTS

paste to all other test locations. After the BTS paste was applied to the test section, the sealant was then sprayed onto the paste to cover it. The vinyl polymer sealant was sprayed on by using a cartridge spray gun as can be seen in Figure 5. The silicon sealant was applied by using a typical commercial spray gun as shown in Figure 6.

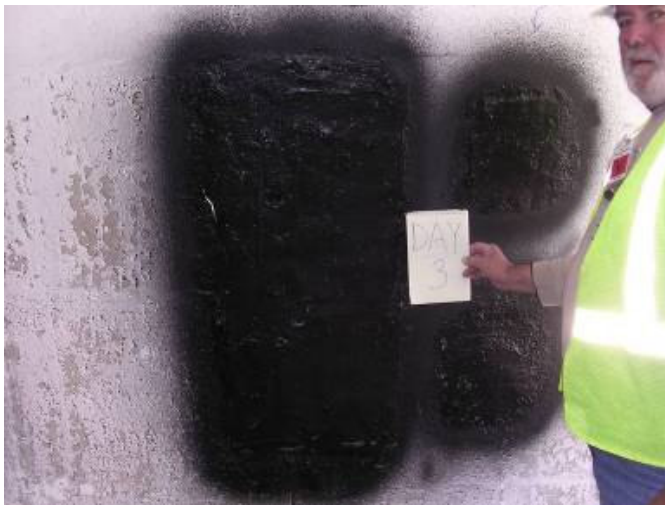
Figure 7. Three days post BTS application, NM-VP in 6810-11.

The status of the treated sections at the 6810-11 test site can be assessed from the following three figures which show them three days after treatment. Figure 7 shows the NM-VP site, Figure 8 shows the Mg/Pd-silicon site and Figure 9 shows the Mg/Pd-VP site. As the figures show, all of the sealants are intact with no cracks.

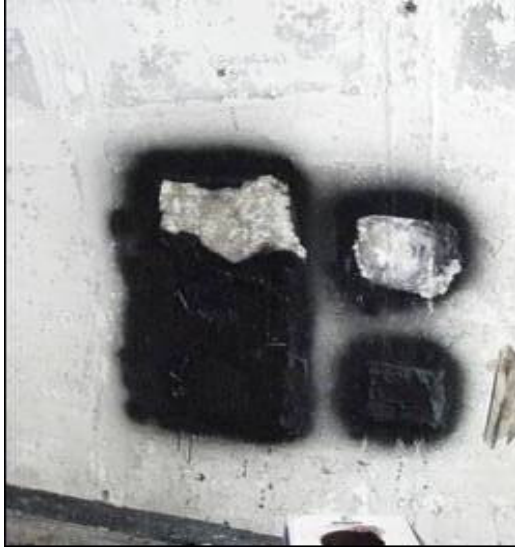
Figure 16. MgPd-VP, two weeks after application, 6810-11.

Figure 16 shows the 6810-11 MgPd-VP treatment two weeks after treatment. It can be seen that part of the vinyl polymer sealant had failed. Thus it was decided to take the two week sample from the three-square foot section and the three-week sample from a one-square foot section (originally identified for sampling at two weeks).

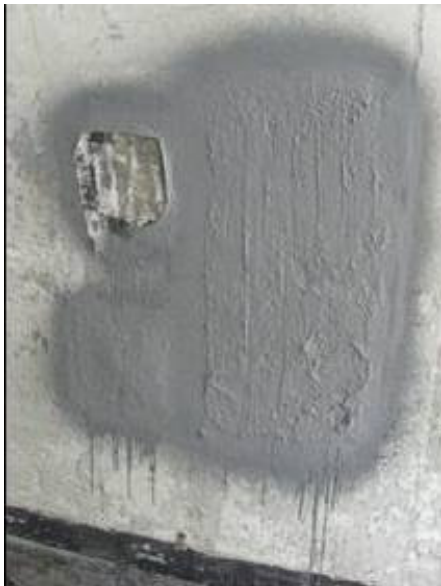
Figure 17. MgPd-silicon prior to two week sampling event, 6810-11.

Figure 17 shows the MgPd silicon site prior to taking week two samples. It can be seen that the sealant has not failed. Figure 18 shows the MgPd-silicon site after the two week sample was taken.

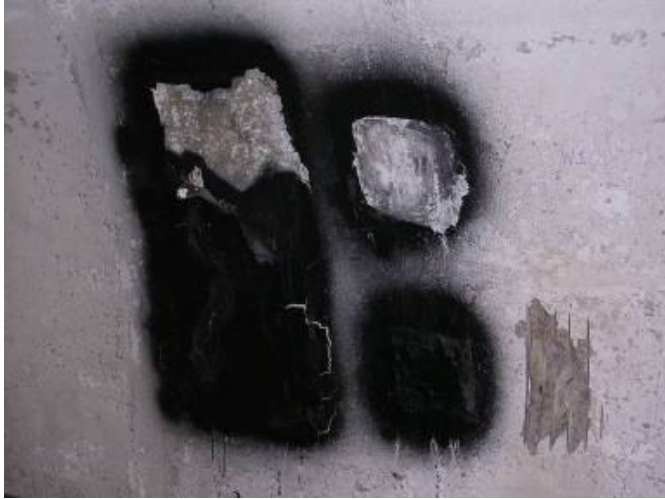
Figure 19. MgPd-VP prior to three week sampling event, 6810-11.

Figure 19 shows the status of the 6810-11 Mg/Pd-VP treatment site prior to sampling after three weeks of treatment. It can be seen that the condition of the sealant did not change very much between weeks two and three. The three week sample for this treatment location was taken from the one-square foot area that was still intact. Figure 20 shows the NM-VP treatment location, prior to taking the three week sample. It can be seen that a portion of the vinyl polymer broke loose between week two and week three sampling. Figure 21 shows the Mg/Pd-silicon treatment area. It can be seen that the three-square foot section is still intact. Figure 22 shows the Mg/Pd-silicon site after sampling. Figure 23 shows a sample of concrete being taken from the Mg/Pd-silicon site after three weeks of treatment. Table 1 gives the PCB concentrations in the paint located at the different treatment sites in the 6810-11 building at times of pre-treatment, and after one, two and three weeks of treatment. The foot-note at the bottom of the table explains the legends that are used in the table.

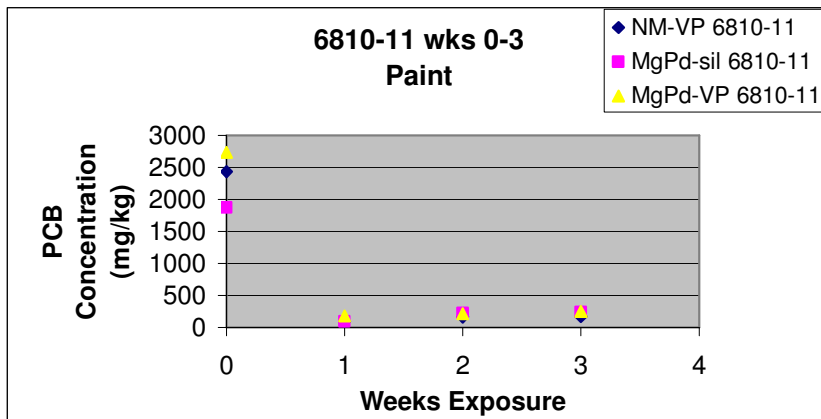
Figure 24. Concentrations of PCBs in paint at 6810-11 during treatment times of 0-3 weeks.

The PCB concentrations in the paint for each of the test locations as a function of time is shown in Figure 24. As can be seen from the data, the major drop in PCB concentration is after one week. After one week, the concentration does not change significantly. The paint on the wall at each sample site was so heterogeneous that small differences in PCB concentrations at each test site between weeks 1, 2, and 3 samples are not statistically meaningful.

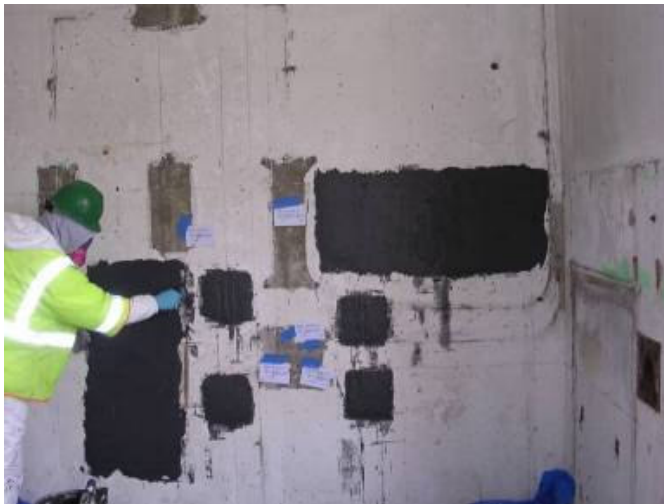
Figure 27. Application of MgPd BTS prior to sealing with vinyl polymer or silicon sealant, 6810-36.

Figure 27 shows the application of the BTS-MgPd to the locations that were respectively sealed with the vinyl polymer and silicon polymer. Figure 28 shows the NM-VP test location in 6810-36 three days after treatment and Figure 29 shows the MgPd-VP test location after three days of treatment. The one-square foot section three days after BTS application and sealed with silicon polymer is shown in Figure 30. The three-square foot section, three days after treatment is shown in Figure 31. As can be seen, the three-square foot MgPd-silicon section began to fail immediately and could not be saved for testing after three weeks. Thus it was decided to test it after one week. The 6810-36 test site was visited each day for one week and when any cracks appeared in the sealant, attempts were made to repair them as described in what was done at the 6810-11 site.

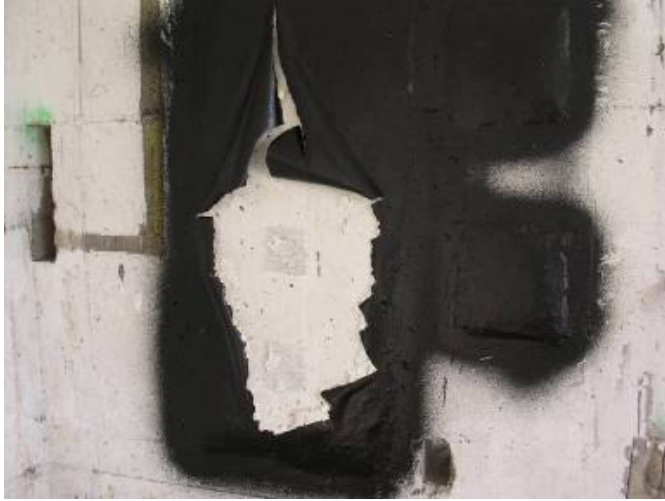
Figure 32. NM-VP after one week of treatment, 6810-36.

Figure 32 shows the NM-VP test location after one week. As can be seen, the three foot section began to fail after one week. Figure 33 shows the integrity of the MgPd-VP test site after one week of treatment and that the sealant is still intact. Figure 34 shows the MgPd-sil test location. It can be seen that the three-square foot test sections for the MgPd-silicon and the NM-VP that were to be sampled after three weeks failed after one week. Thus, it was decided for those test locations to take the one week samples from the three-square foot section that was still covered with sealant.

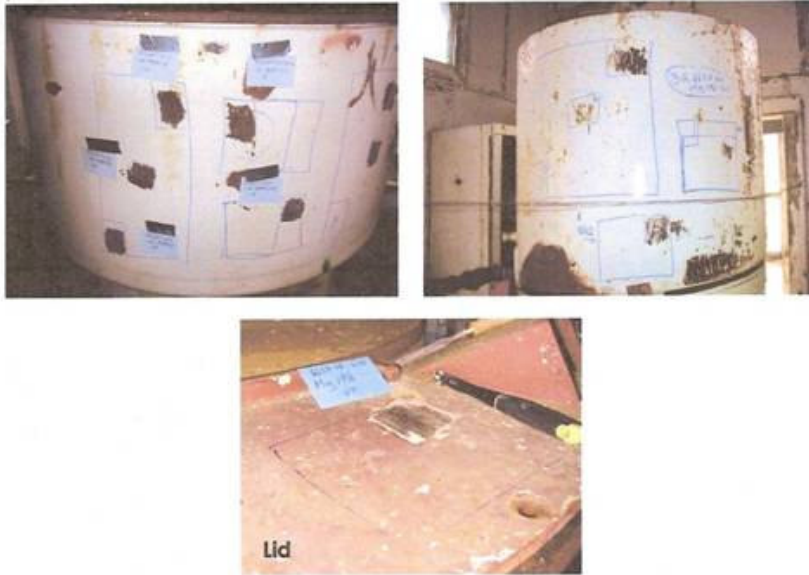
FIG 3: Nitrating House 6657-02
BTS Paste Application

After treating the concrete press houses, the nitrating house, 6657-02 was treated. Figure 43 shows the location of the treatment zones. There were two nitrating tanks located in this building, one large tank and one smaller tank. The large tank was treated with MgPd and the nonmetal pastes, both of these test sections were coated with vinyl polymer sealant. The small tank was treated with MgPd paste and then sealed with the silicon polymer. Figures 44, 45, and 46 show the large tank after it was treated and sealed with the silicon polymer. Figures 47 and 48 show the large tank two days after treatment. As can be seen from the figures, the sealant and BTS is still intact and has not failed.

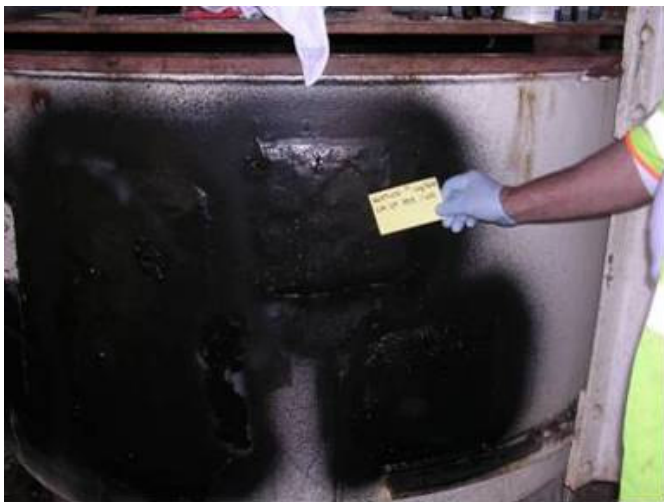
Figure 49. Large tank treated with MgPd-VP and NM-VP one week after application.

Figure 49 shows the large tank after one week. As can be seen, the treated sections are still intact. Figure 50 shows the one week NM-VP sample being taken and Figure 51 shows the one week MgPd-VP sample being taken. Figure 52 shows that the three-square foot section on the small tank that was treated with the silicon polymer failed after one week. This section was to be sampled after three weeks of treatment, however, it was decided to take the one week sample from it and then take the two and three week samples from the one-square foot sections that were still intact.
