Hudson River
PCBs SUPERFUND SITE

Engineering Performance Standards

**Appendix: Case Studies
of Environmental
Dredging Projects**

April 2004

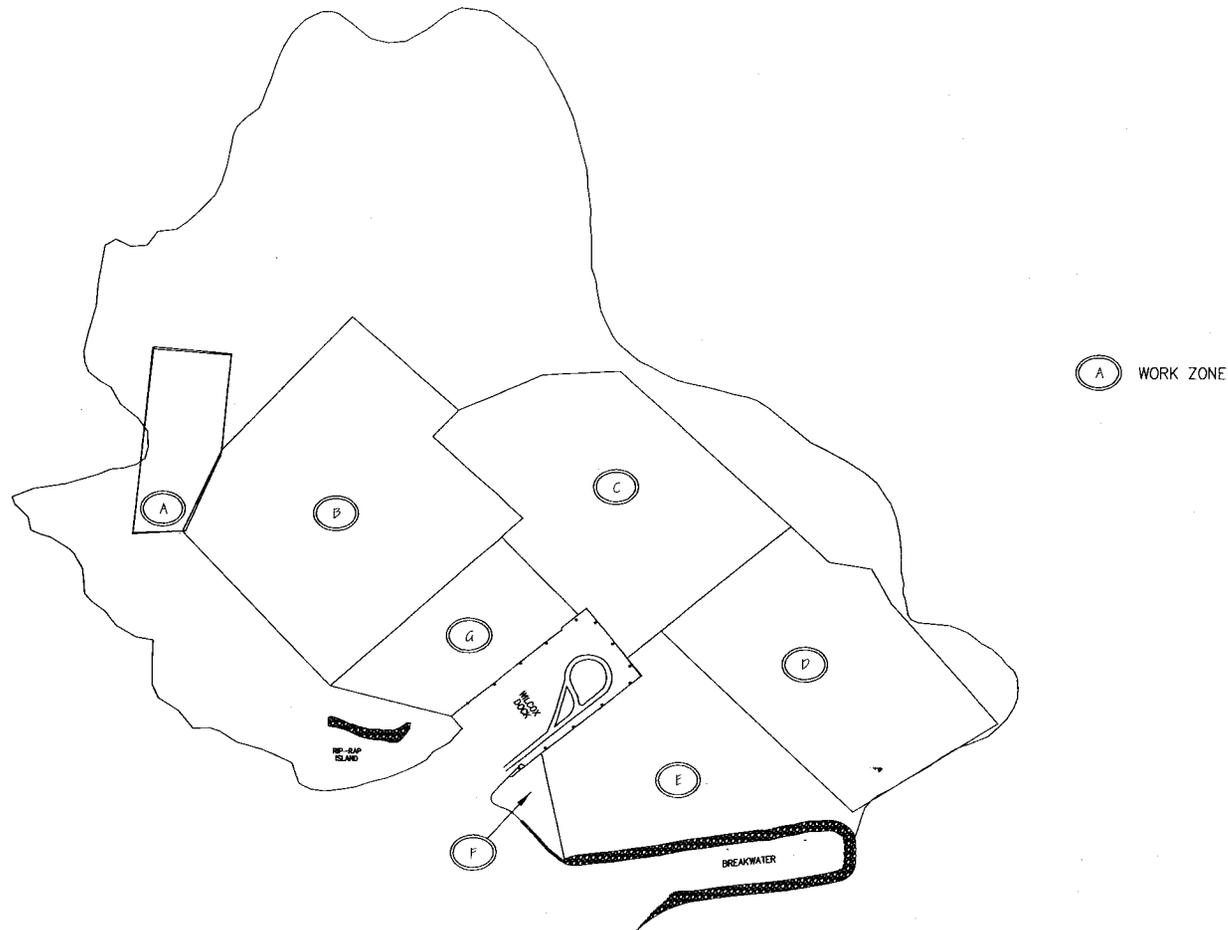
**Figure 4-5
Cumberland Bay Work Areas and 2000 Work Zones**

- Mudflat Area - 1A, 1B, 3A, 3B, 4A, 4B, 5
- Wilcox Dock - 2A, 2B
- Breakwater Area - 6, 7
- 1.9 - Concentration of PCBs in ppm
- S - Natural lake Bottom Sands that contain very low (< 1ppm) Concentrations
Or Concentrations of PCBs less than Detection Limit
- SE - Shoreline Excavation (<1 ppm)
