# Blue Ledge Mine Superfund Site Presentation Overview

- Location
- Mine Development
- Site Features
- Acid Mine Drainage
- Distribution of Metals Contamination
- Impacts to Ecosystem
- 2010-11 USFS Non-Time-Critical Removal Action
- Q&A

US Forest Service  
Non-Time-Critical  
Removal Action

# Emphasis on AMD Source Control by Removing Waste Rock Piles

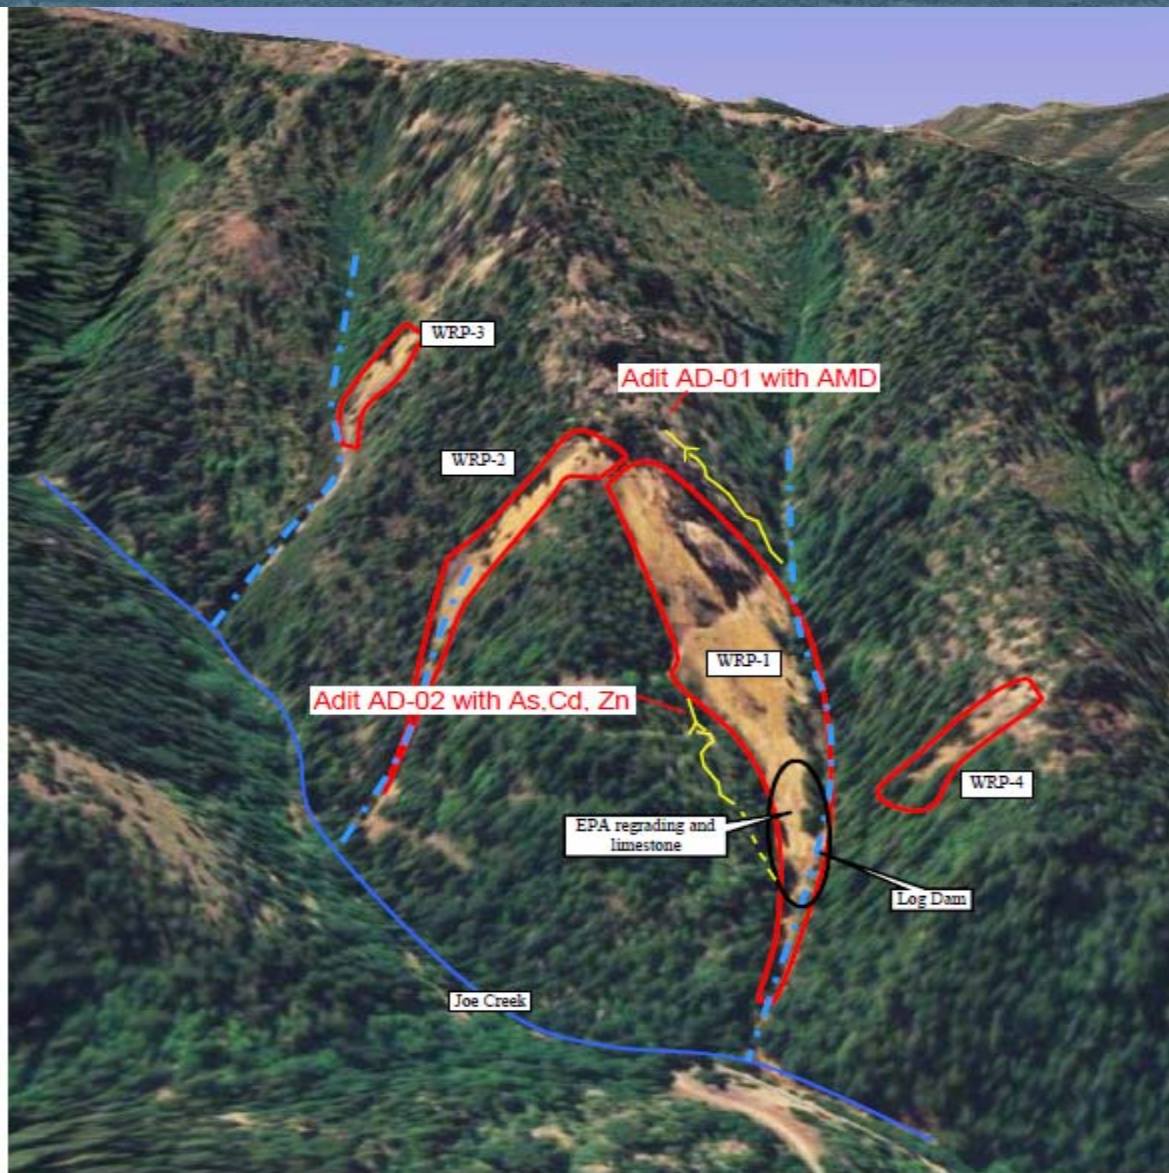
**Waste Rock Areas**

WRP Waste Rock Pile

WRP 3

WRP 2

WRP 1

WRP 4

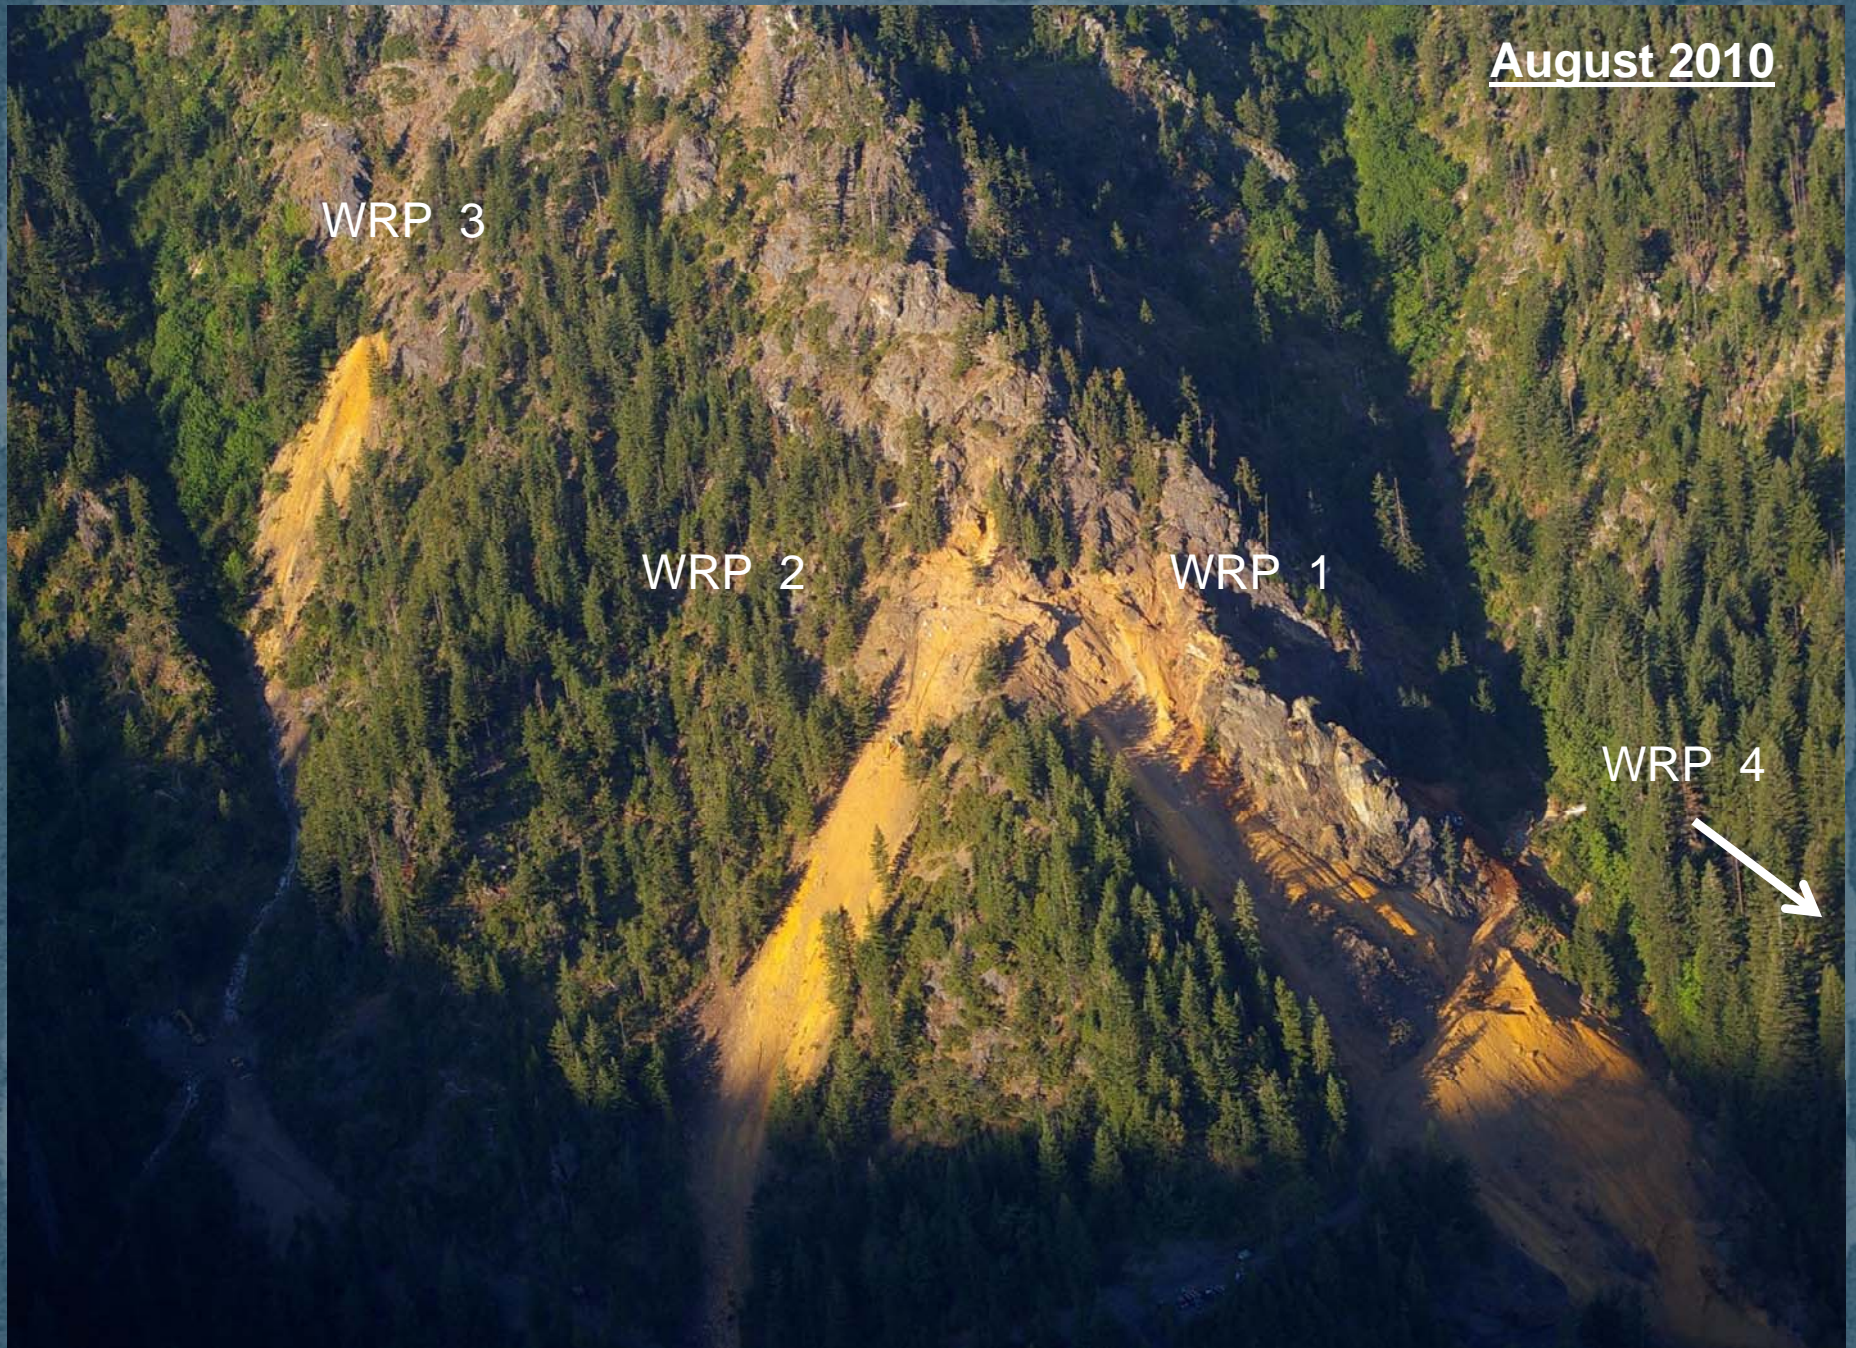
Blue Ledge Mine  
Acid Mine Drainage  
Discharged to the Environment

500k g/p/d  
AMD Entered  
Joe Creek in  
Spring

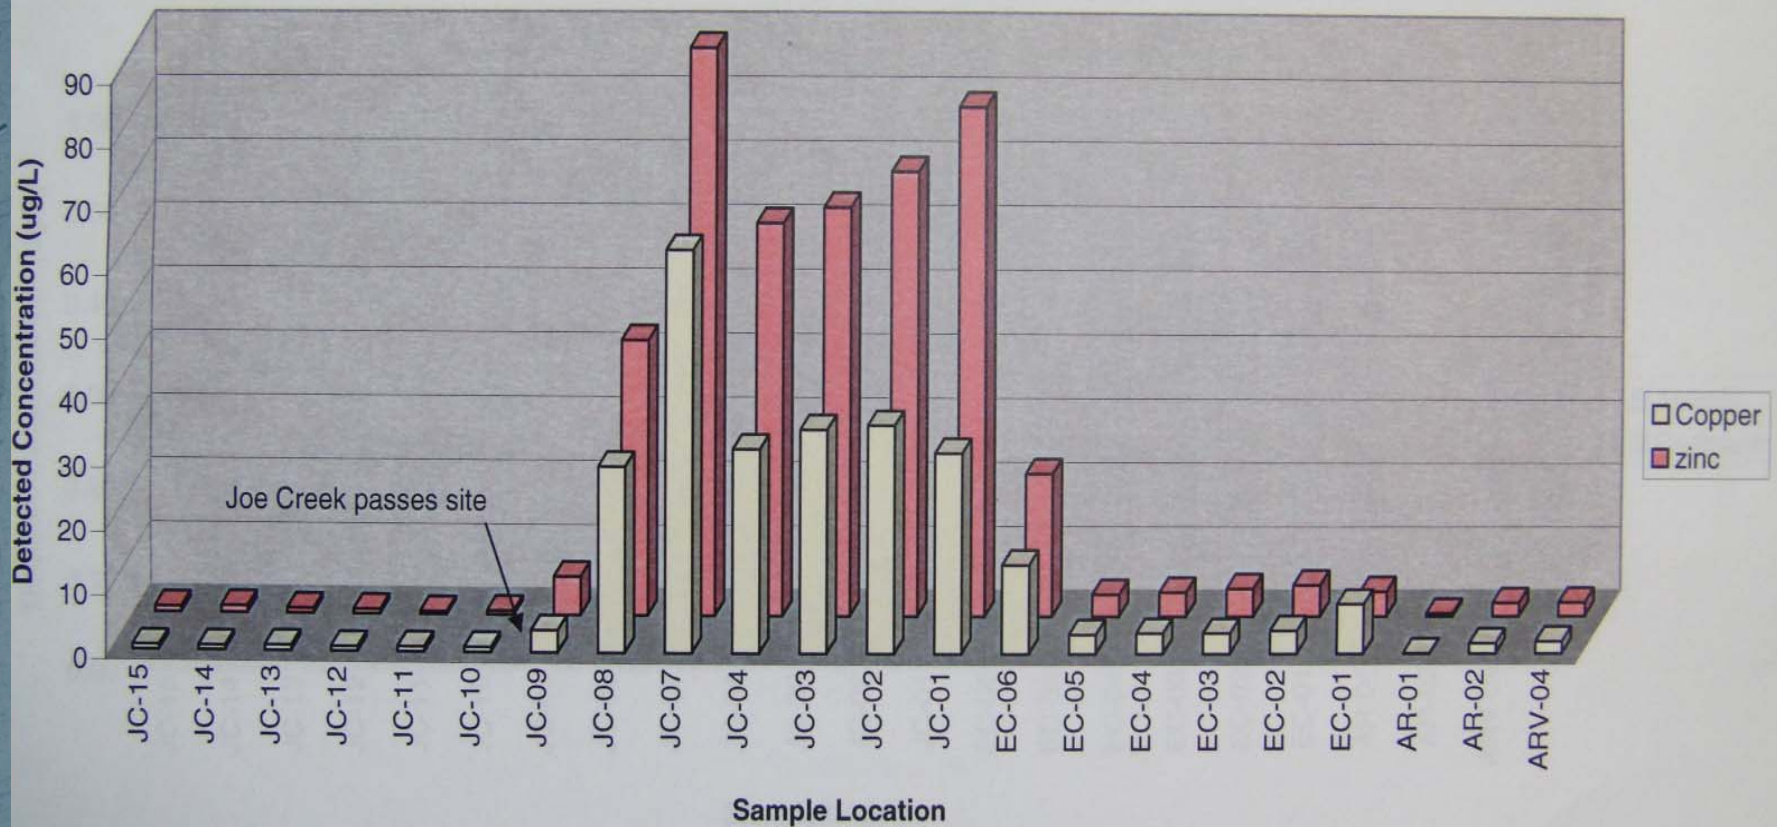
# Dissolved Copper & Zinc in Surface Water

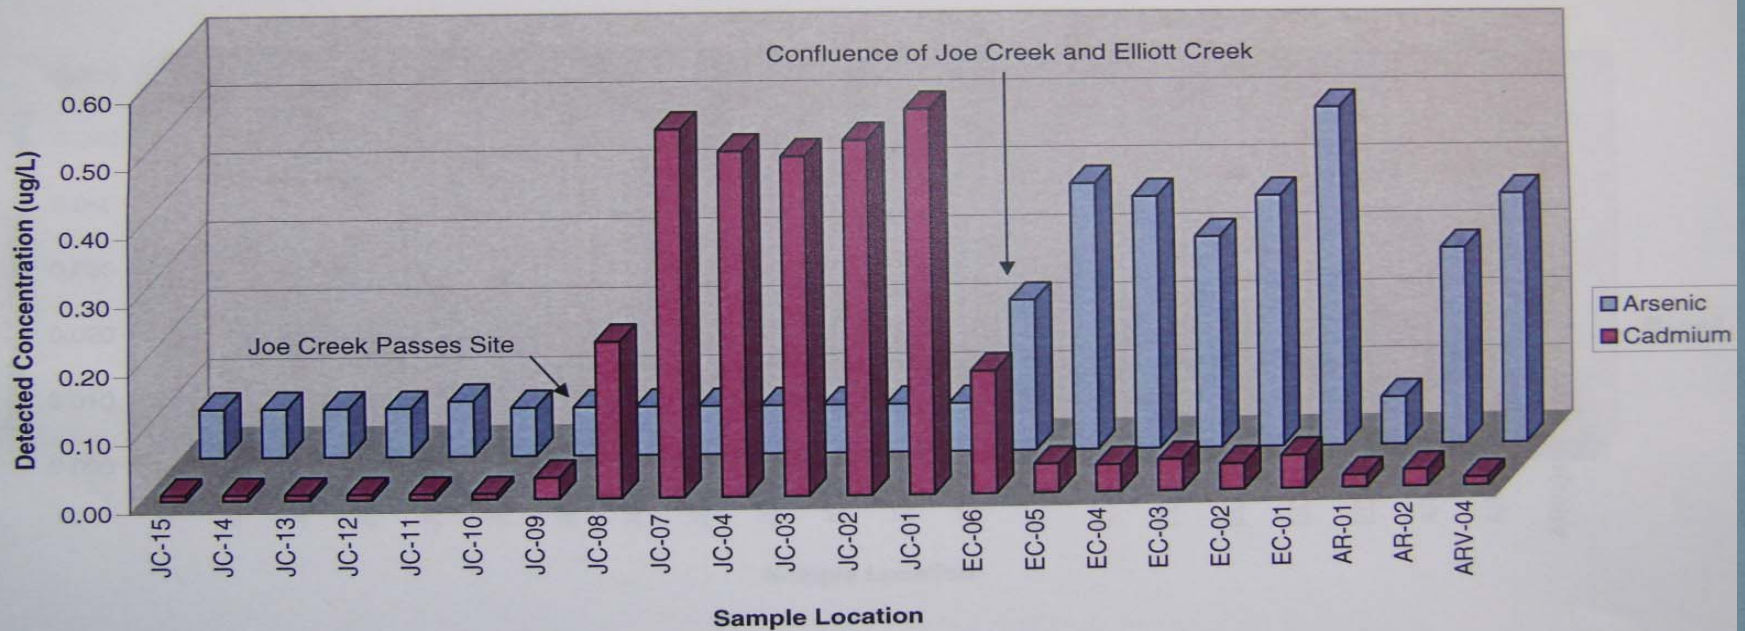
Chart 2  
Dissolved Arsenic and Cadmium in Surface Water

# Arsenic & Cadmium in Water

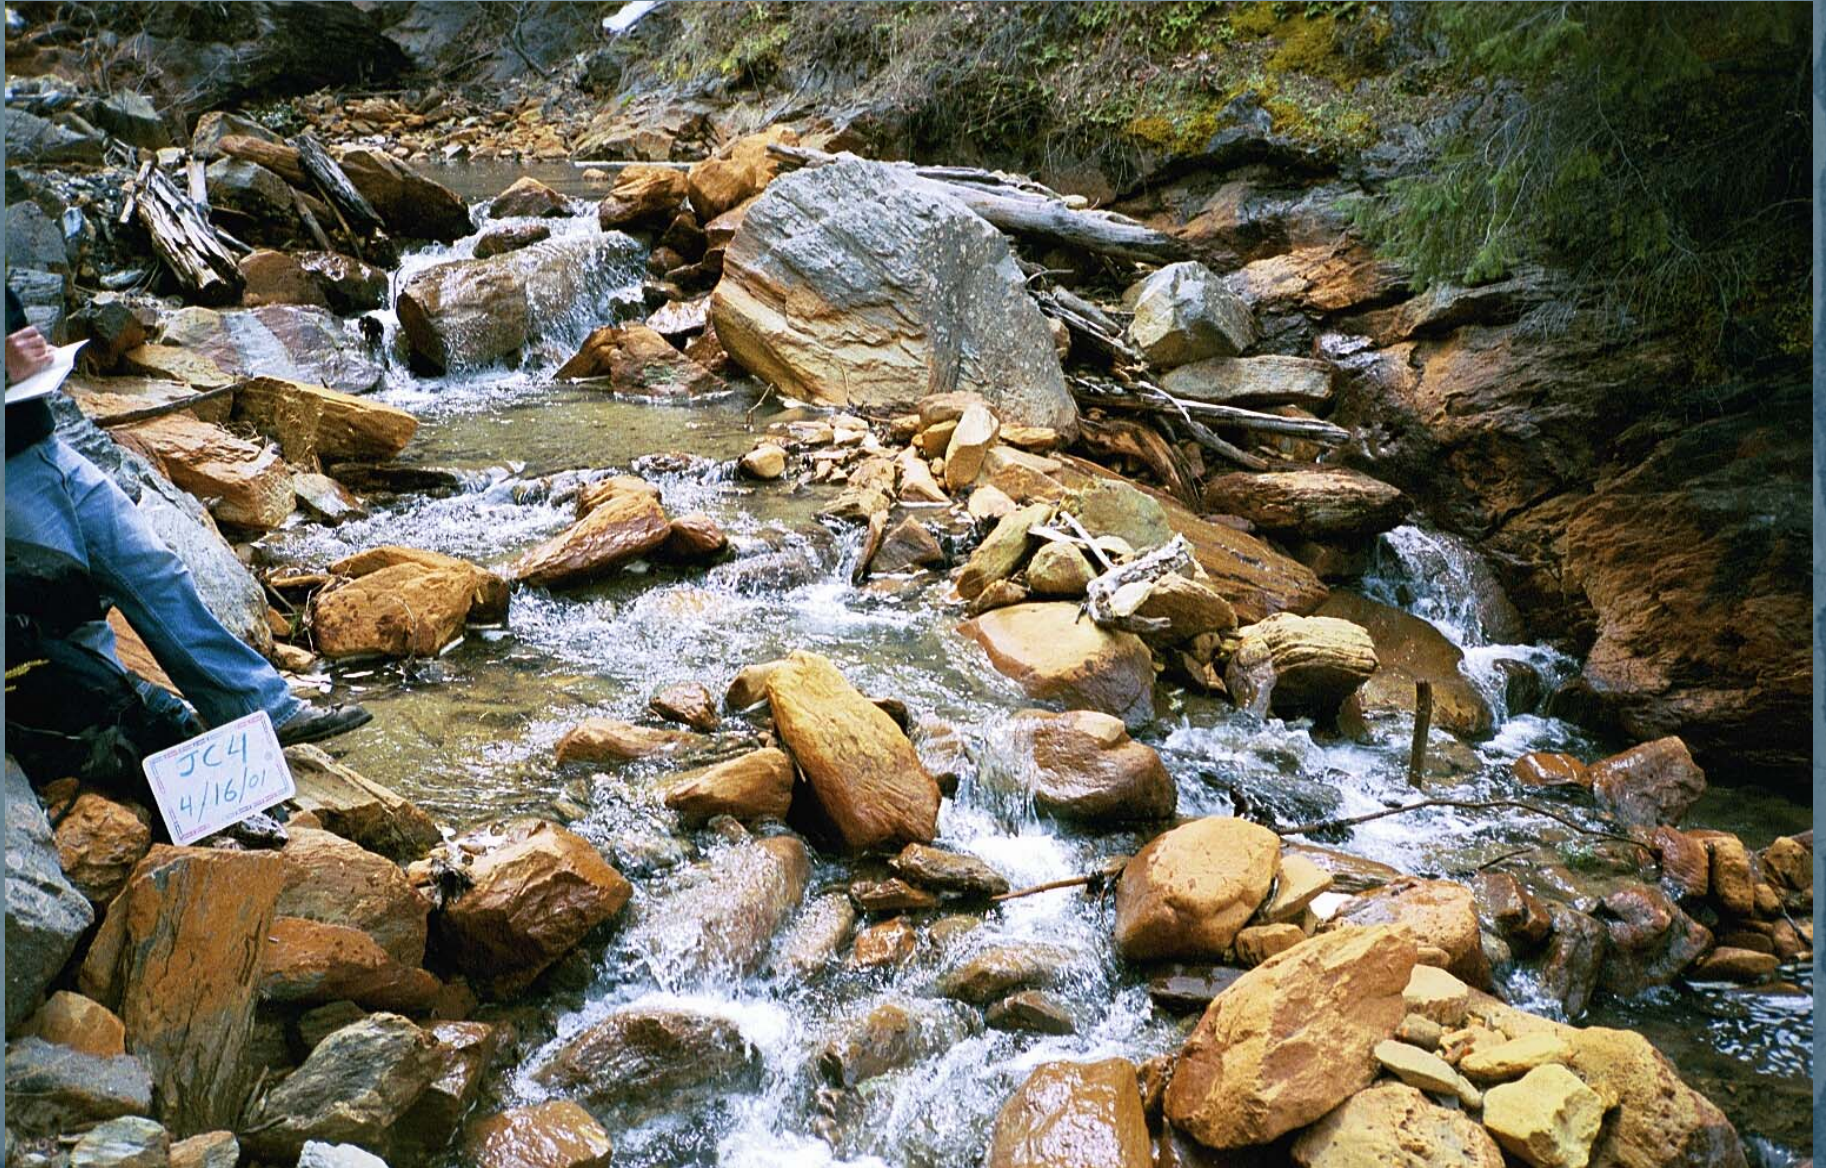
# 4 Miles of Sterile Stream Below Waste Rock Piles

One Mile Below Mine  
Brown Algal Mat is Only Living Organism

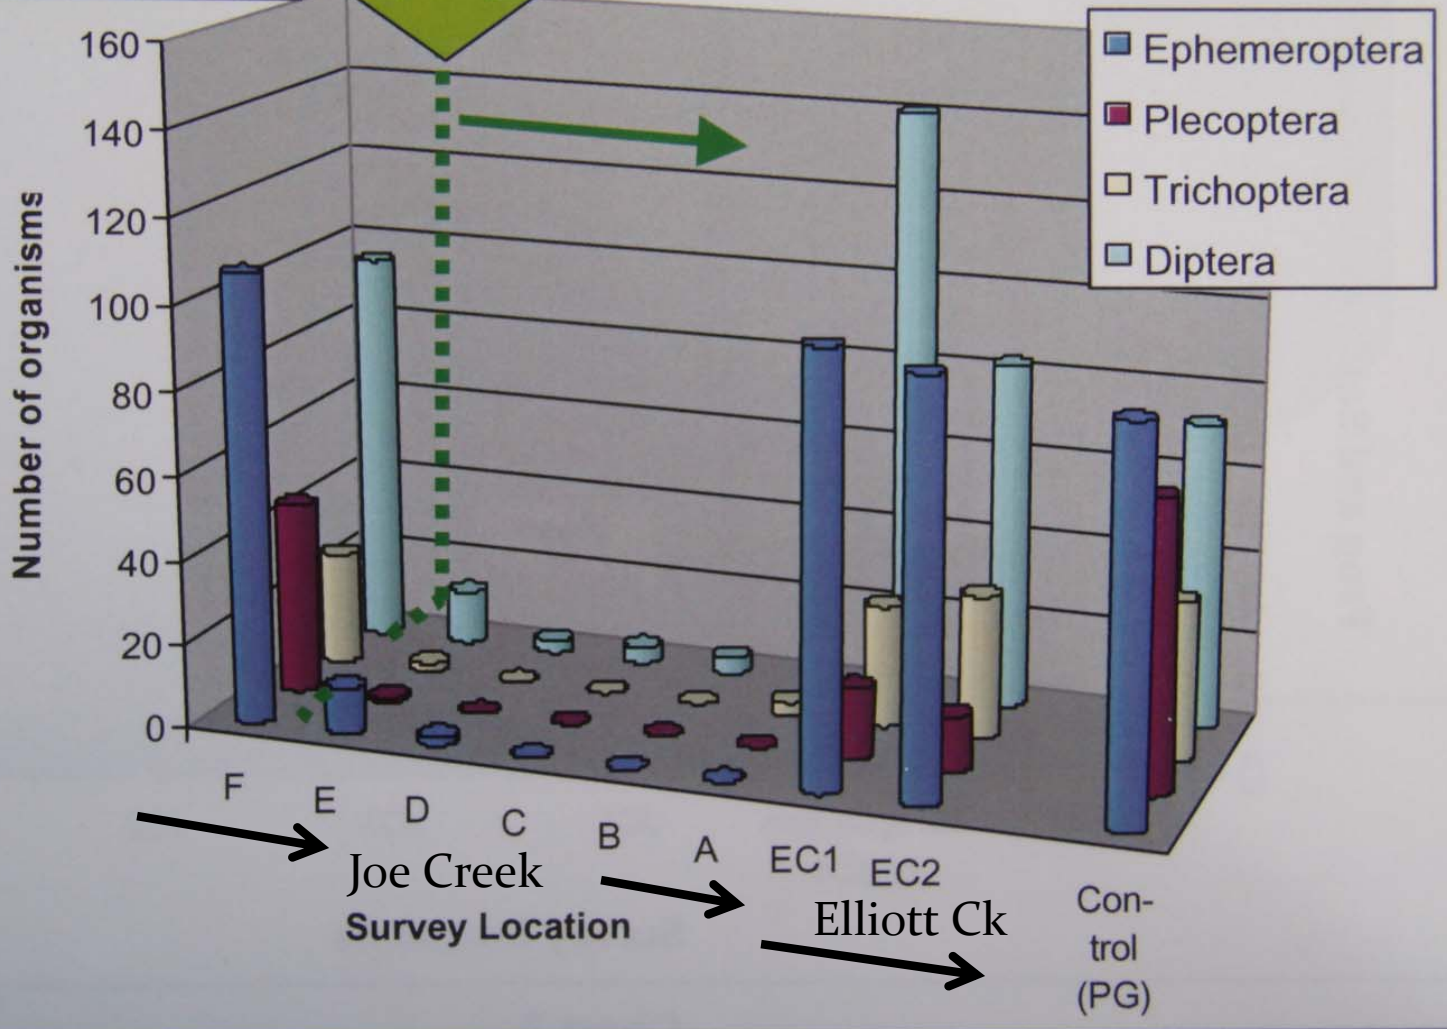
Tributary flowing through Blue Ledge Mine Waste Pile (AMD Input)

### Macroinvertebrates May 2001 (Wet Season)

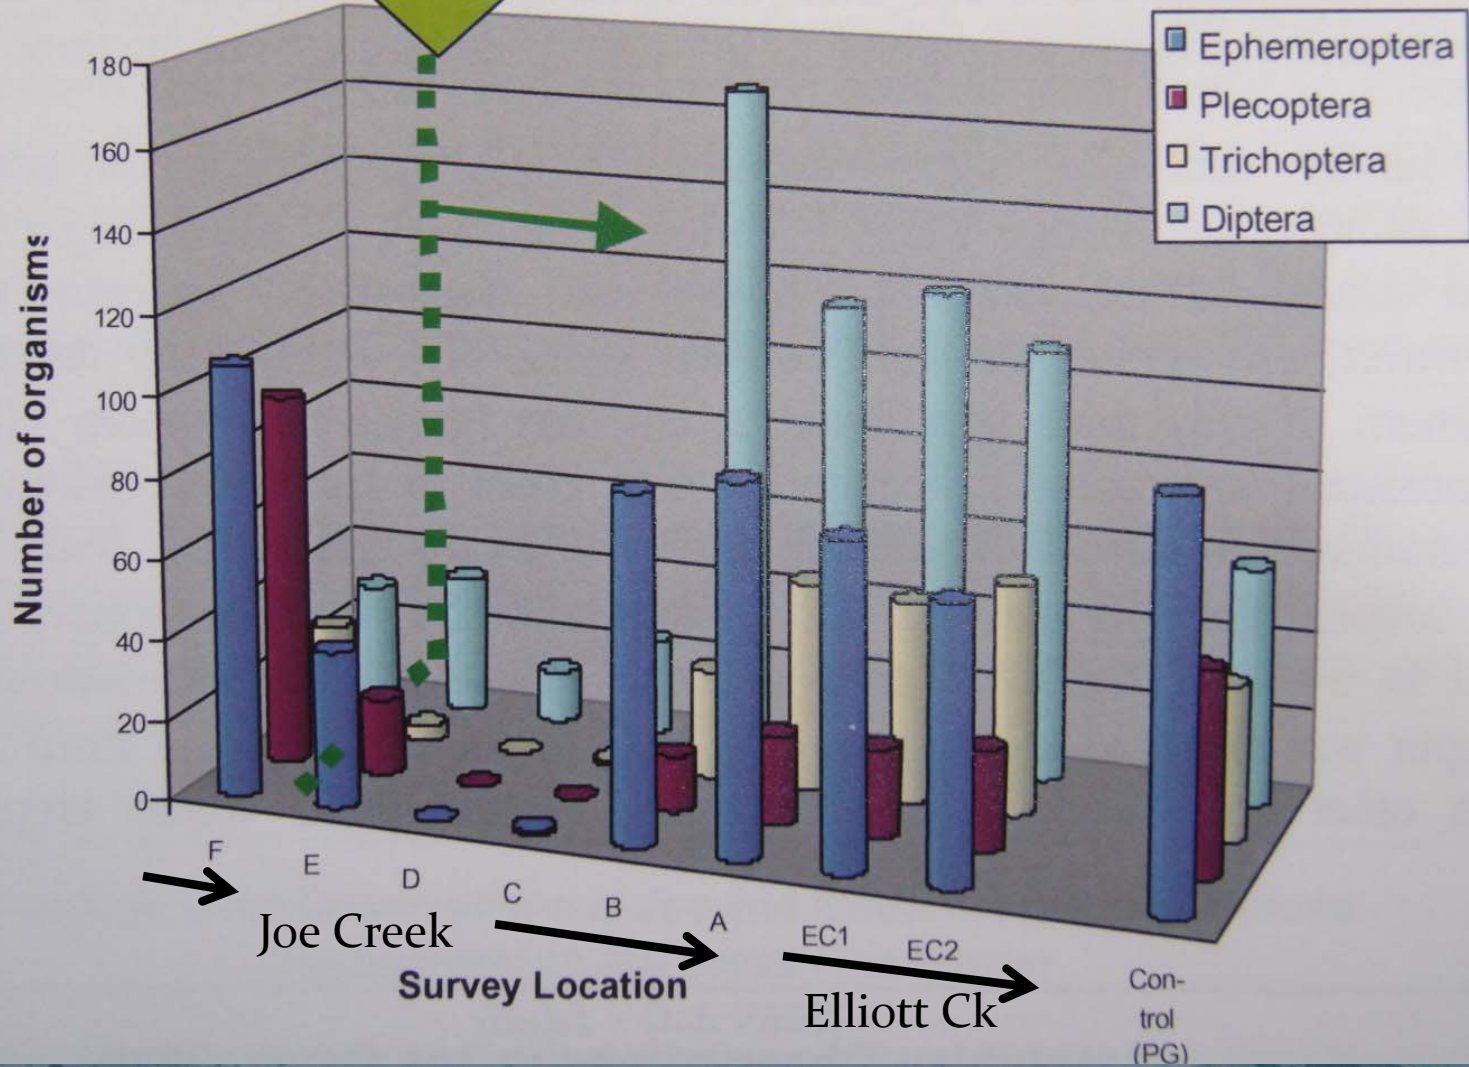
Tributary flowing through Blue Ledge Mine Waste Pile (AMD Input)

### Macroinvertebrates Sept. 2000 (Dry Season)

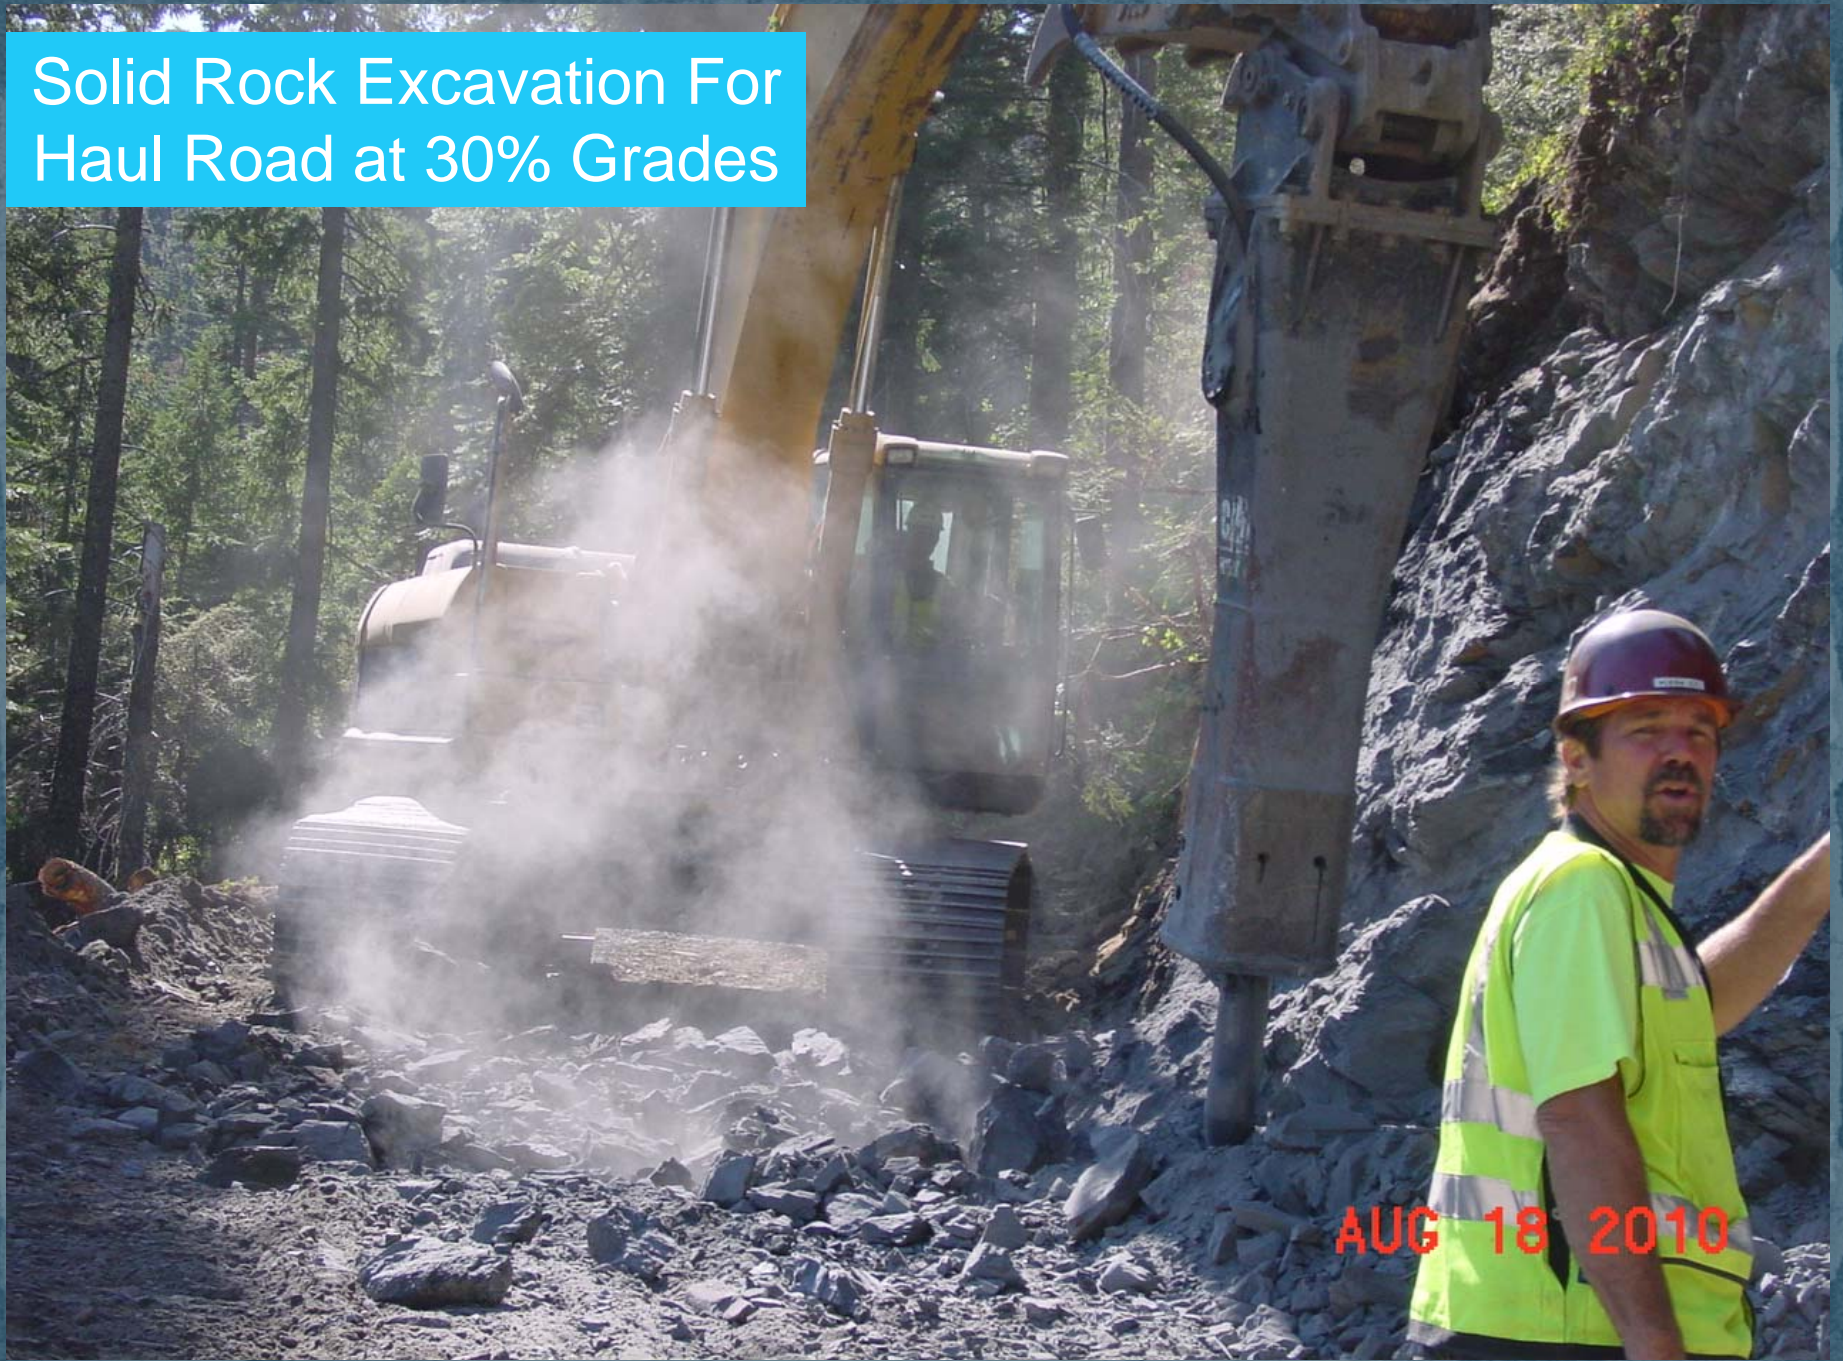
Solid Rock Excavation For  
Haul Road at 30% Grades

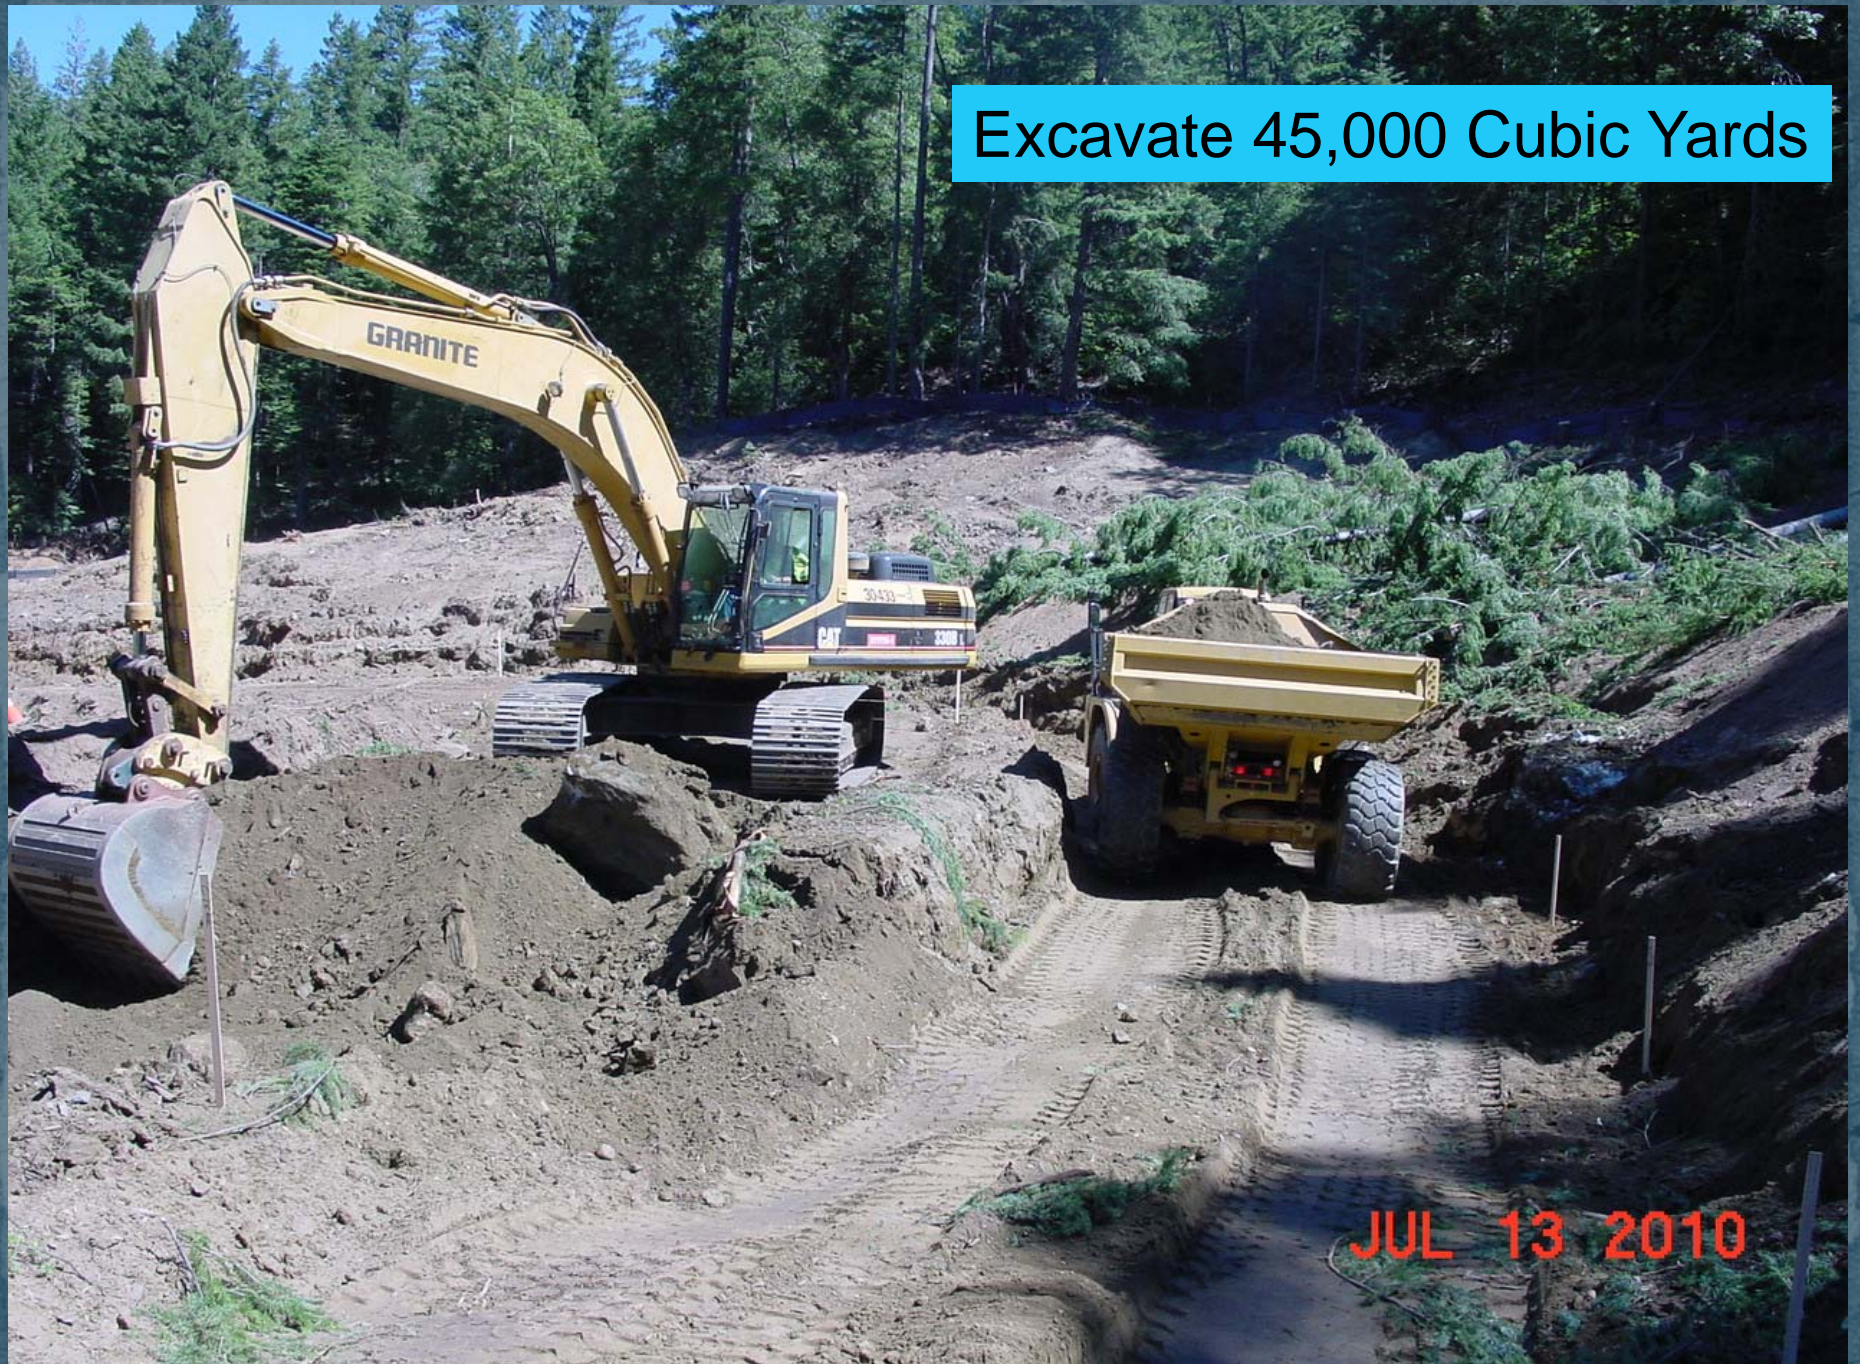
Excavate 45,000 Cubic Yards

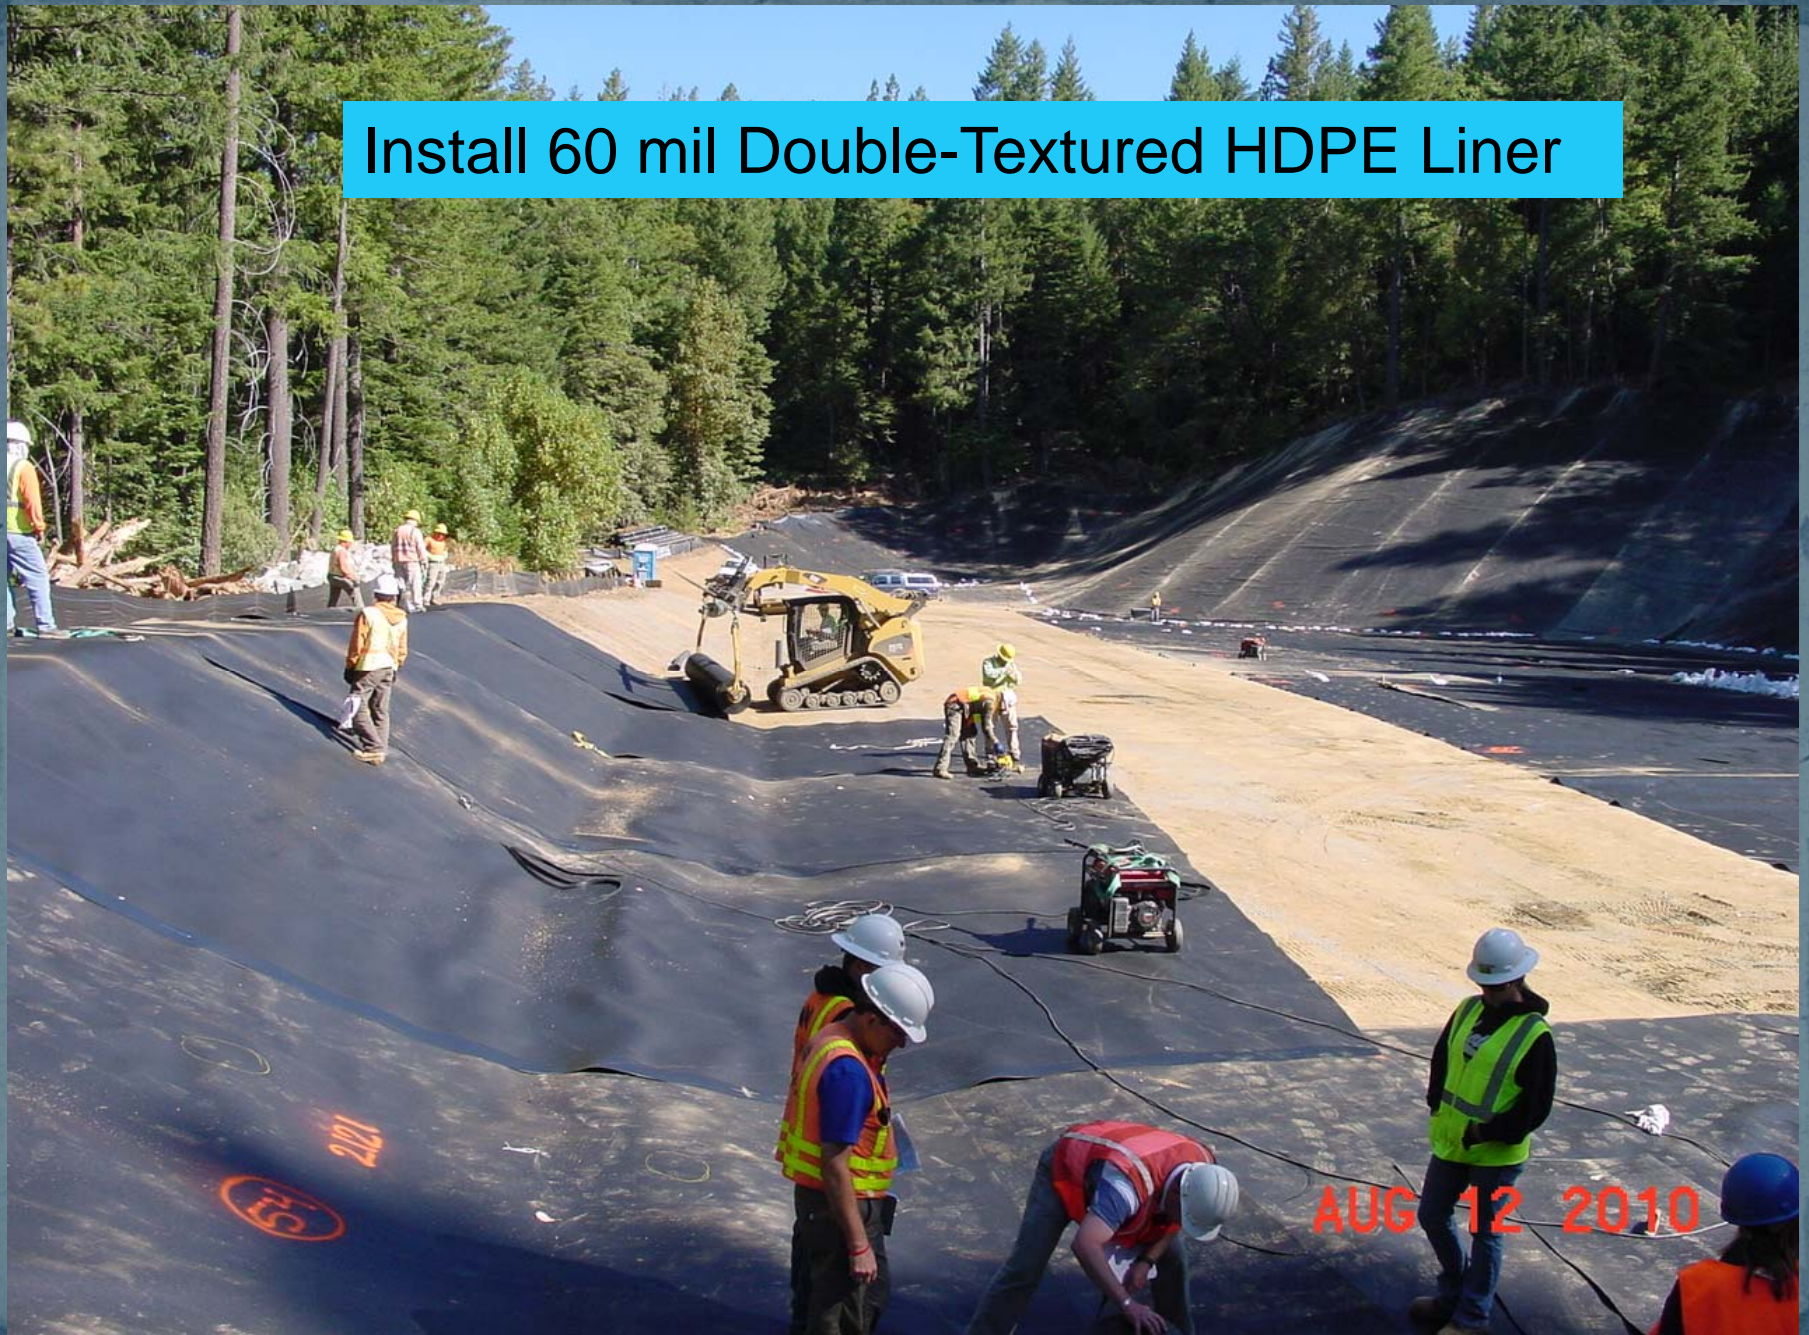
## Install 60 mil Double-Textured HDPE Liner

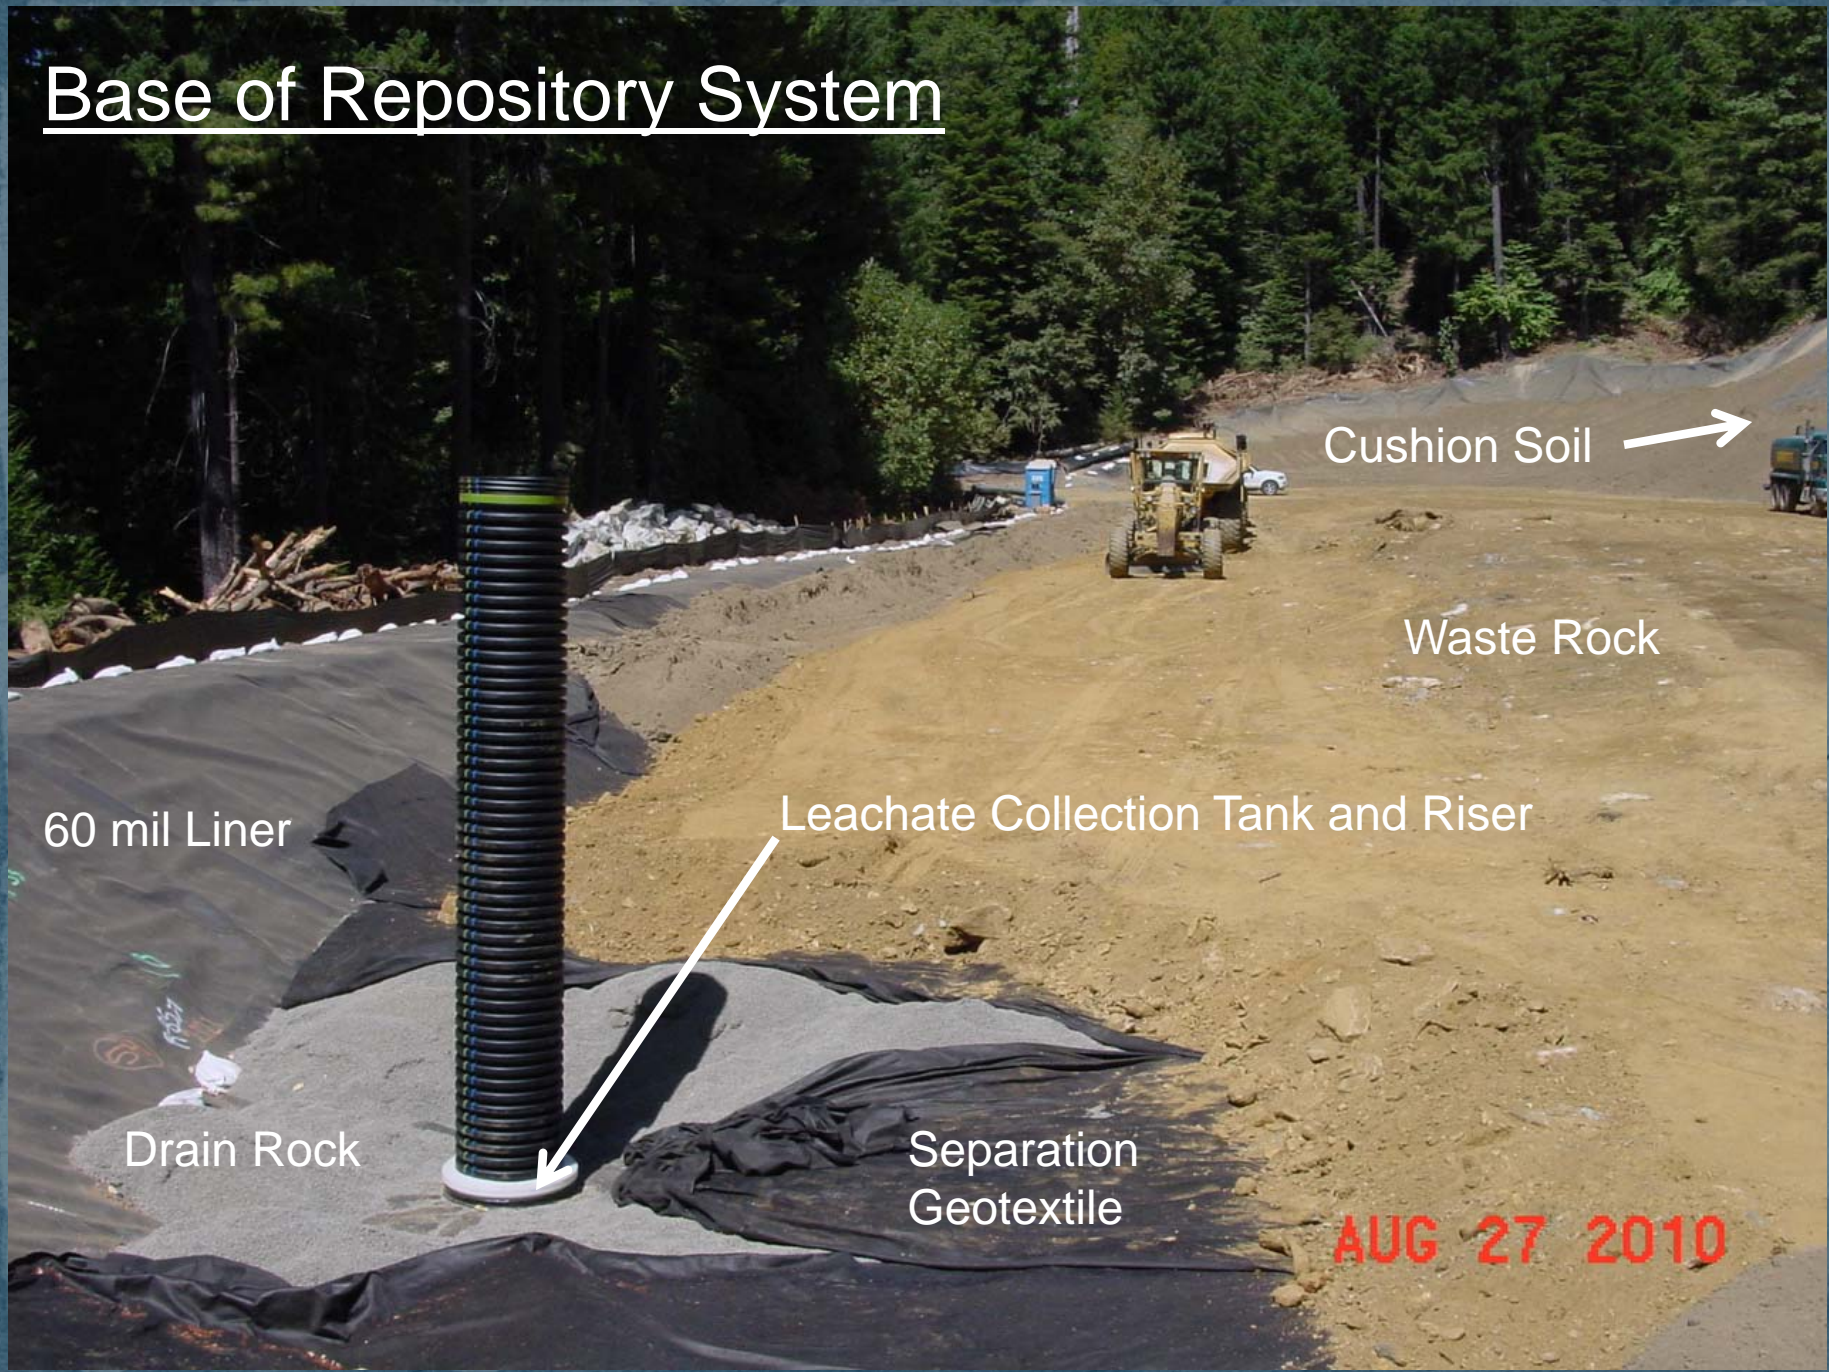
# Base of Repository System

Cushion Soil →

Waste Rock

60 mil Liner

Leachate Collection Tank and Riser

Drain Rock

Separation Geotextile
