# Blue Ledge Mine Superfund Site Presentation Overview

- Location
- Mine Development
- Site Features
- Acid Mine Drainage
- Distribution of Metals Contamination
- Impacts to Ecosystem
- 2010-11 USFS Non-Time-Critical Removal Action
- Q&A

US Forest Service  
Non-Time-Critical  
Removal Action

# Emphasis on AMD Source Control by Removing Waste Rock Piles

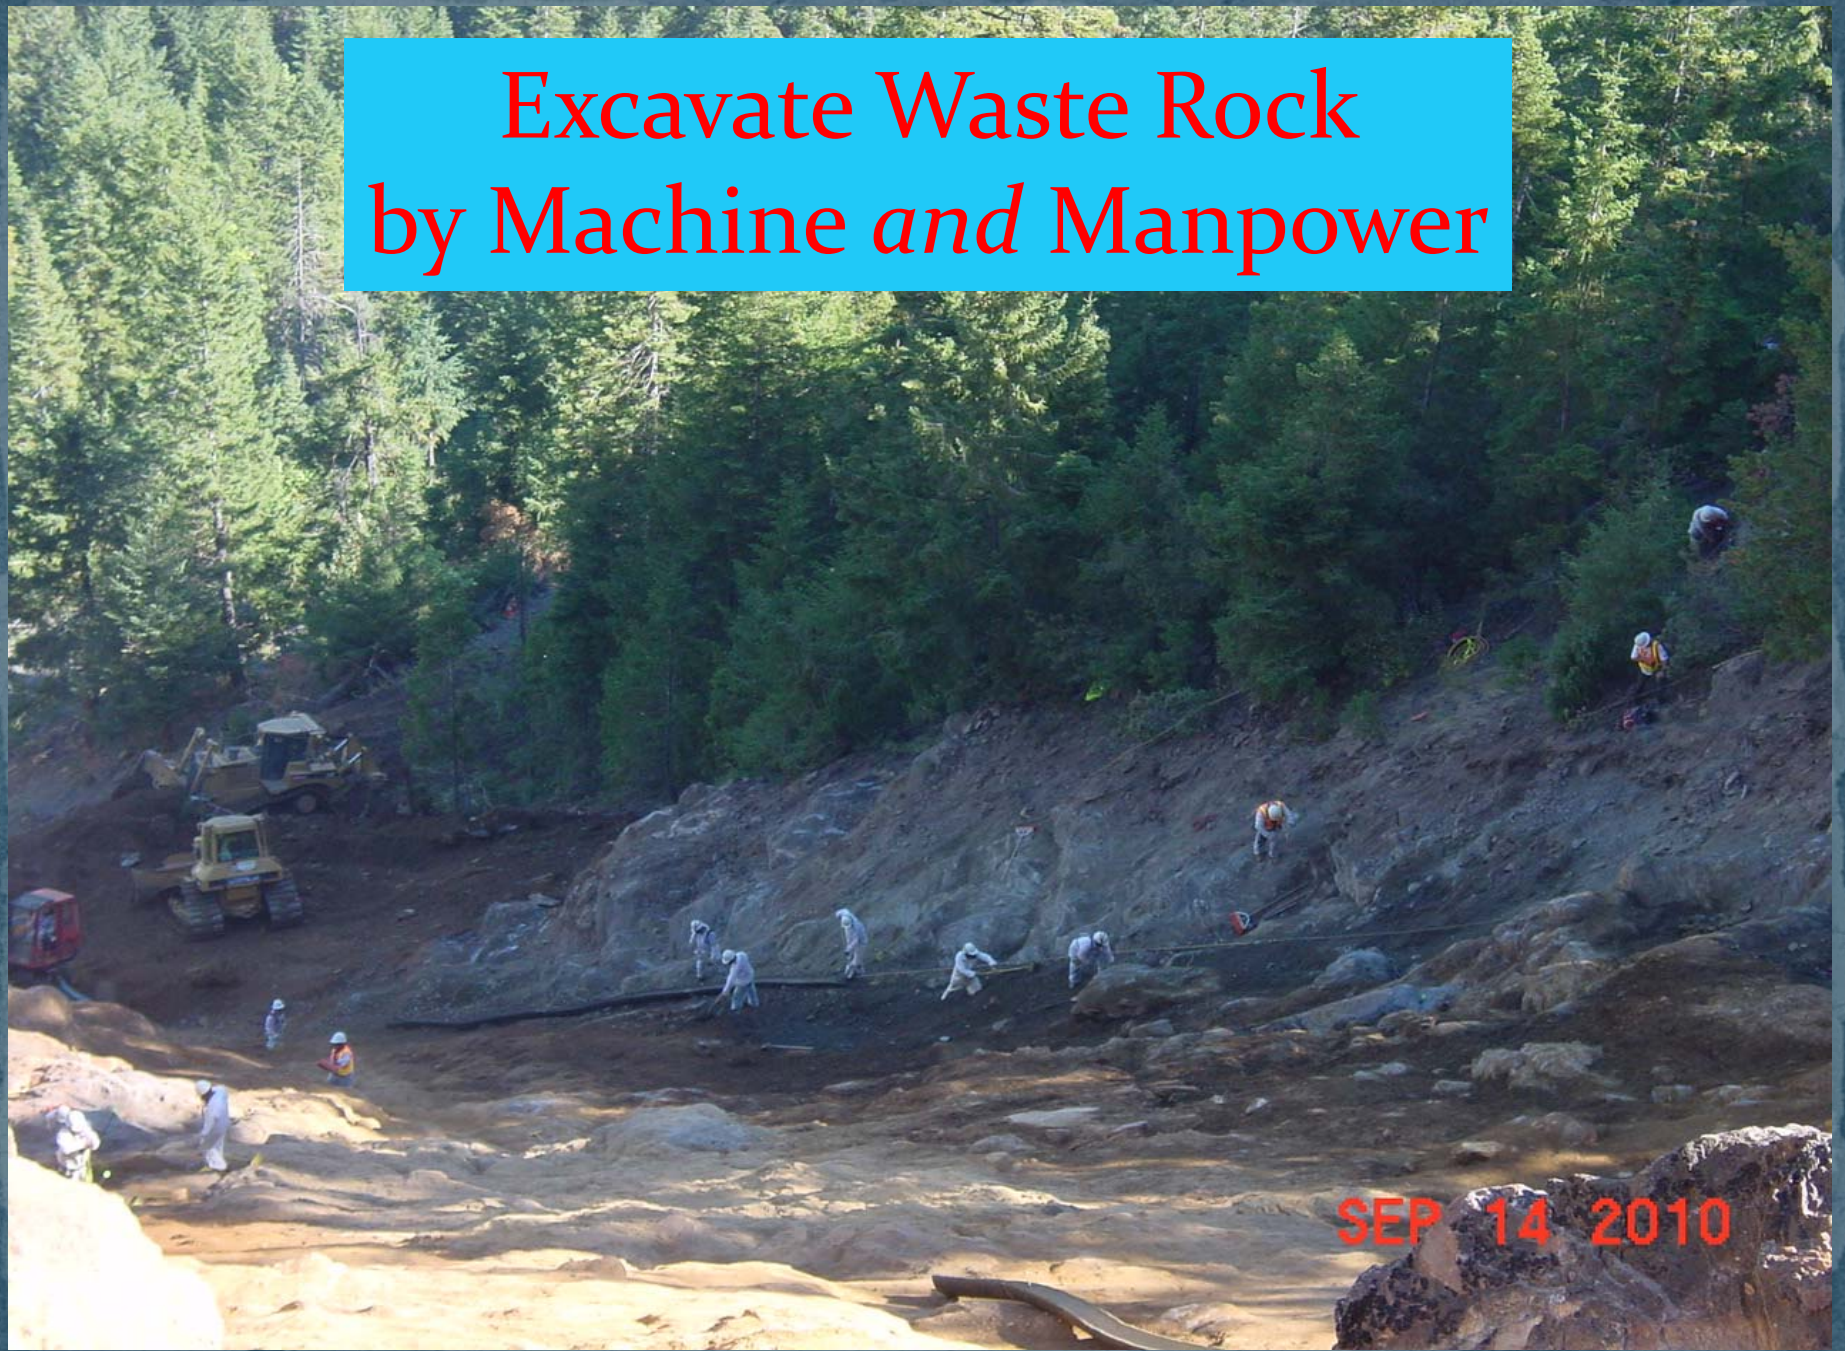
# Excavate Waste Rock by Machine *and* Manpower

Mini-Excavator Flown  
From Repository to  
Top by Helicopter

3 Spider Excavators Climb to Top of Piles

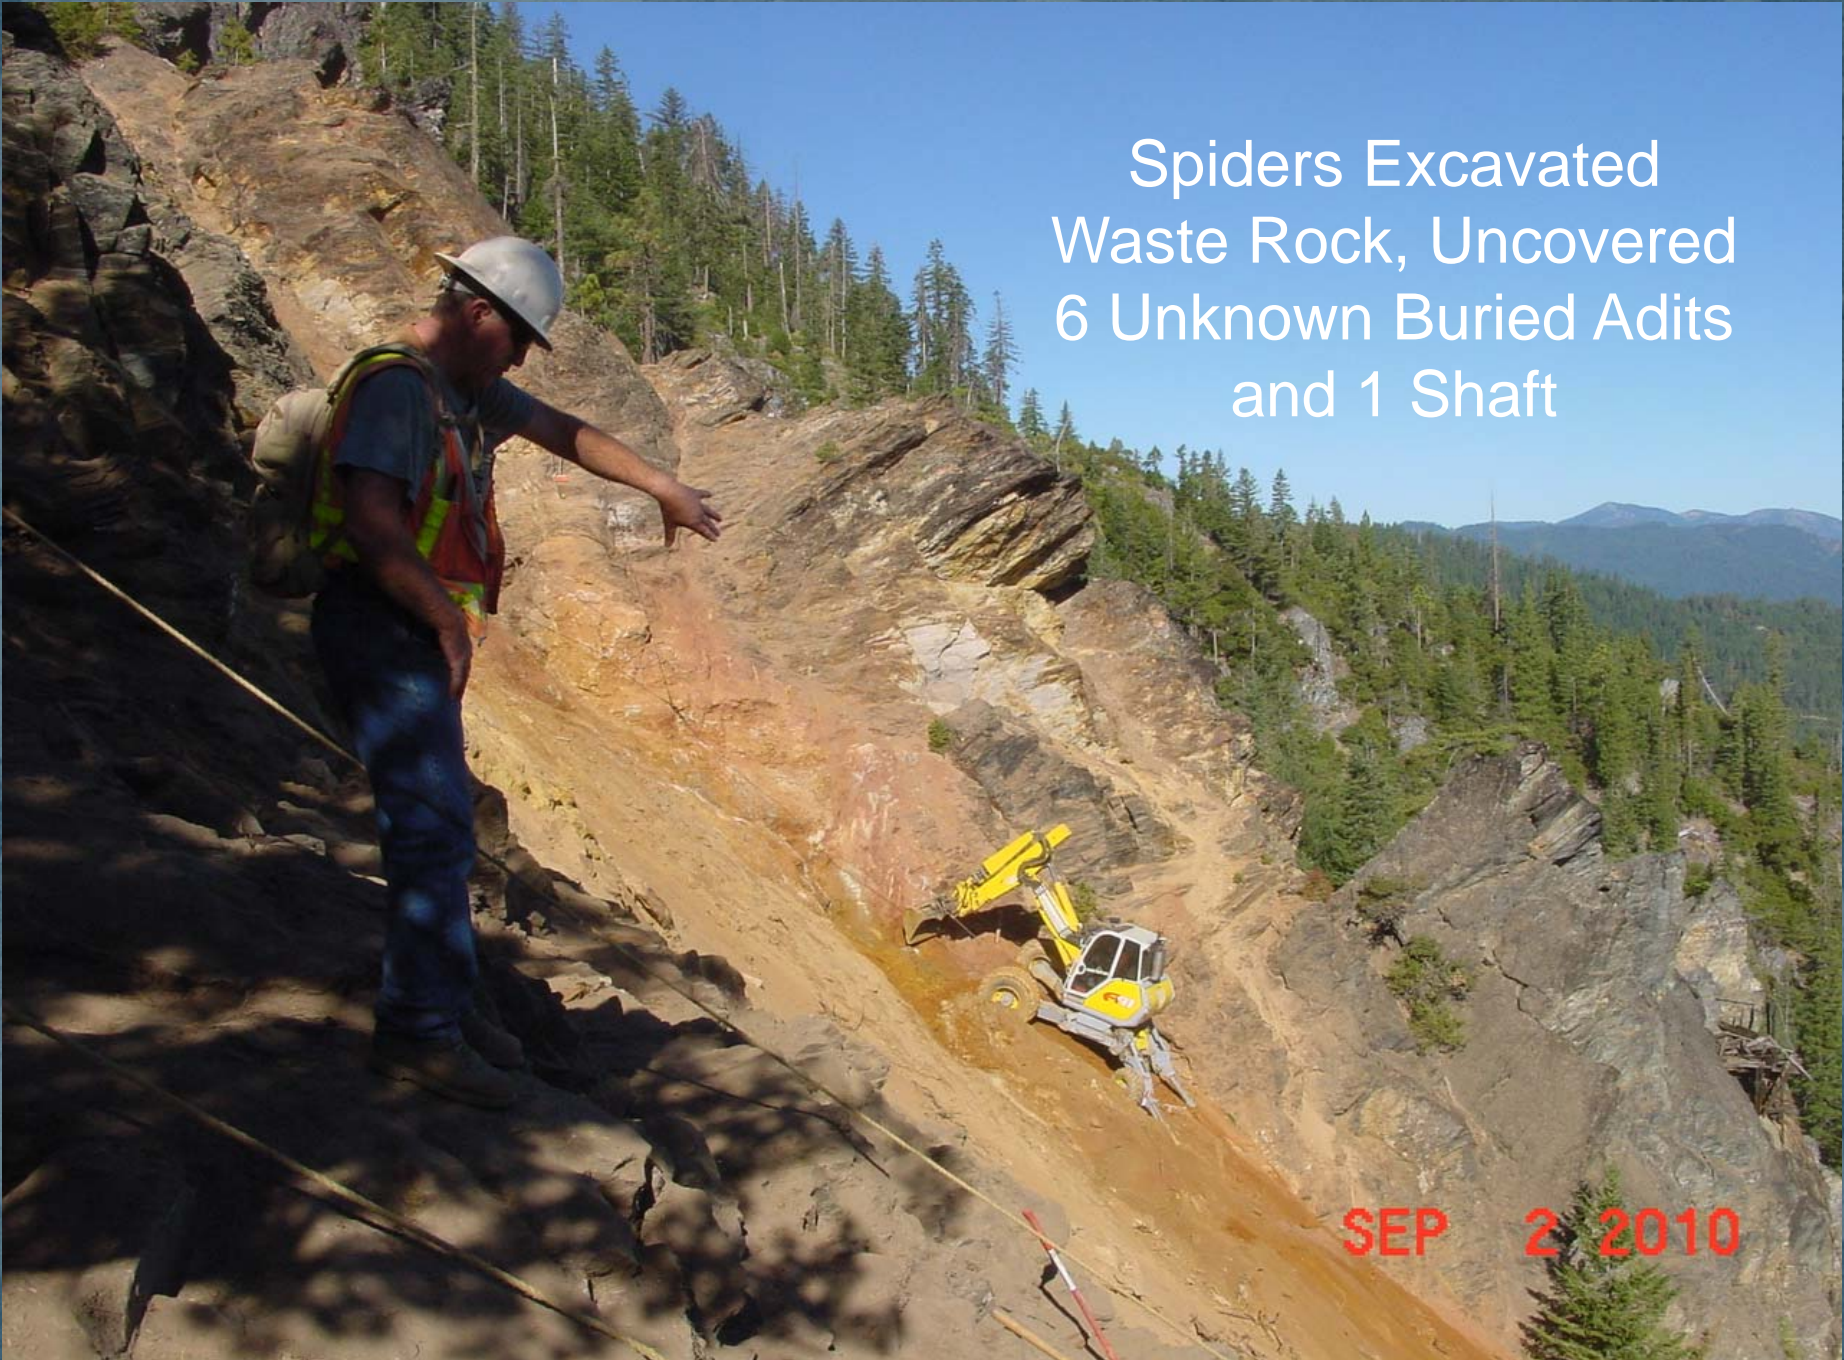
Spiders Excavated  
Waste Rock, Uncovered  
6 Unknown Buried Adits  
and 1 Shaft

Laborers  
Remove Waste  
Rock Down to  
Clean Soil or  
Bedrock

Chutes Convey Hand-Excavated  
Waste Rock to Spiders Below

Scalers Remove Rock Above  
Before Waste Excavation Below

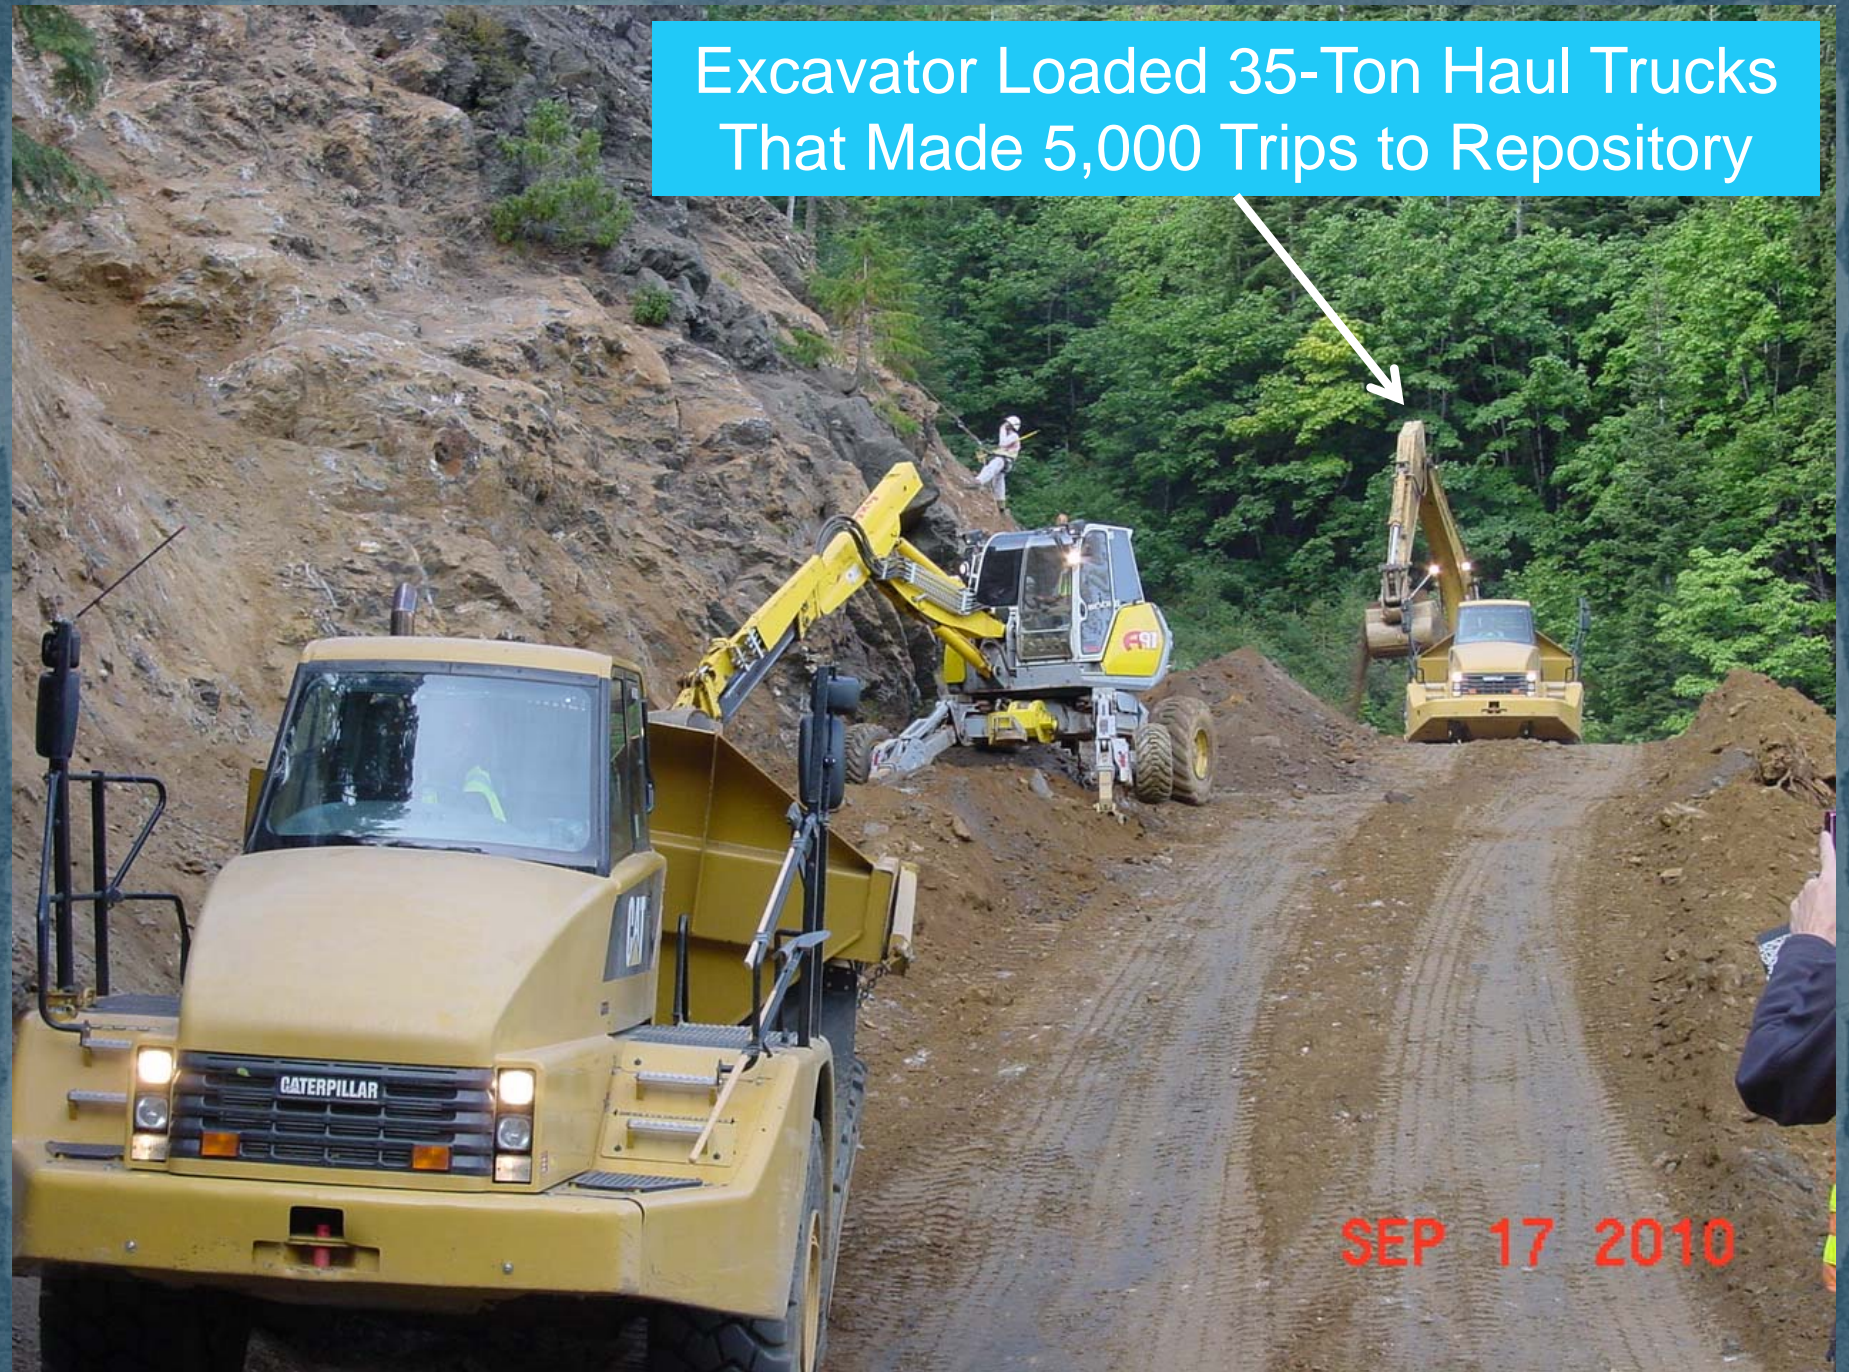
Excavator Loaded 35-Ton Haul Trucks  
That Made 5,000 Trips to Repository

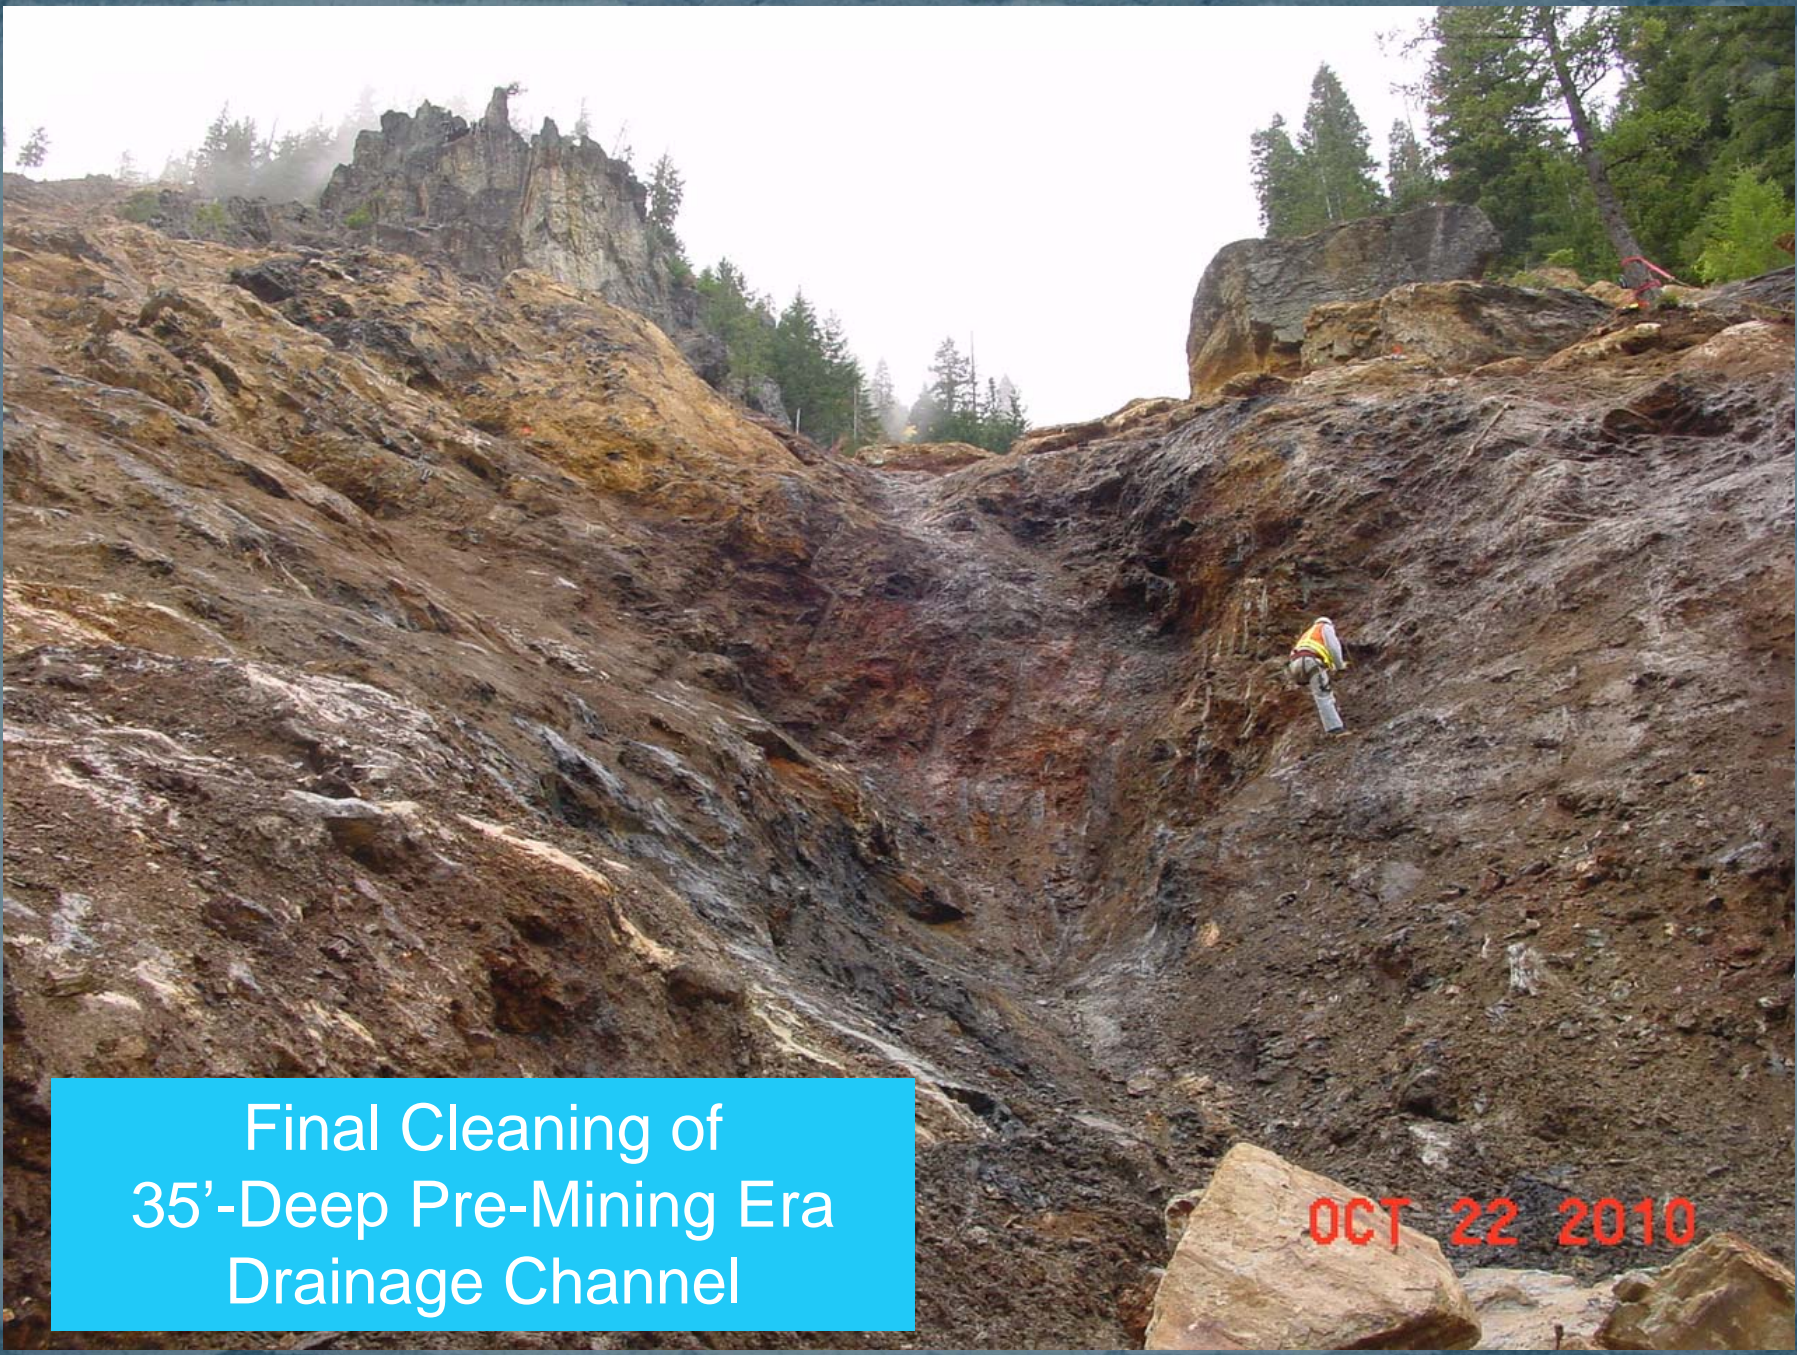
Final Cleaning of  
35'-Deep Pre-Mining Era  
Drainage Channel

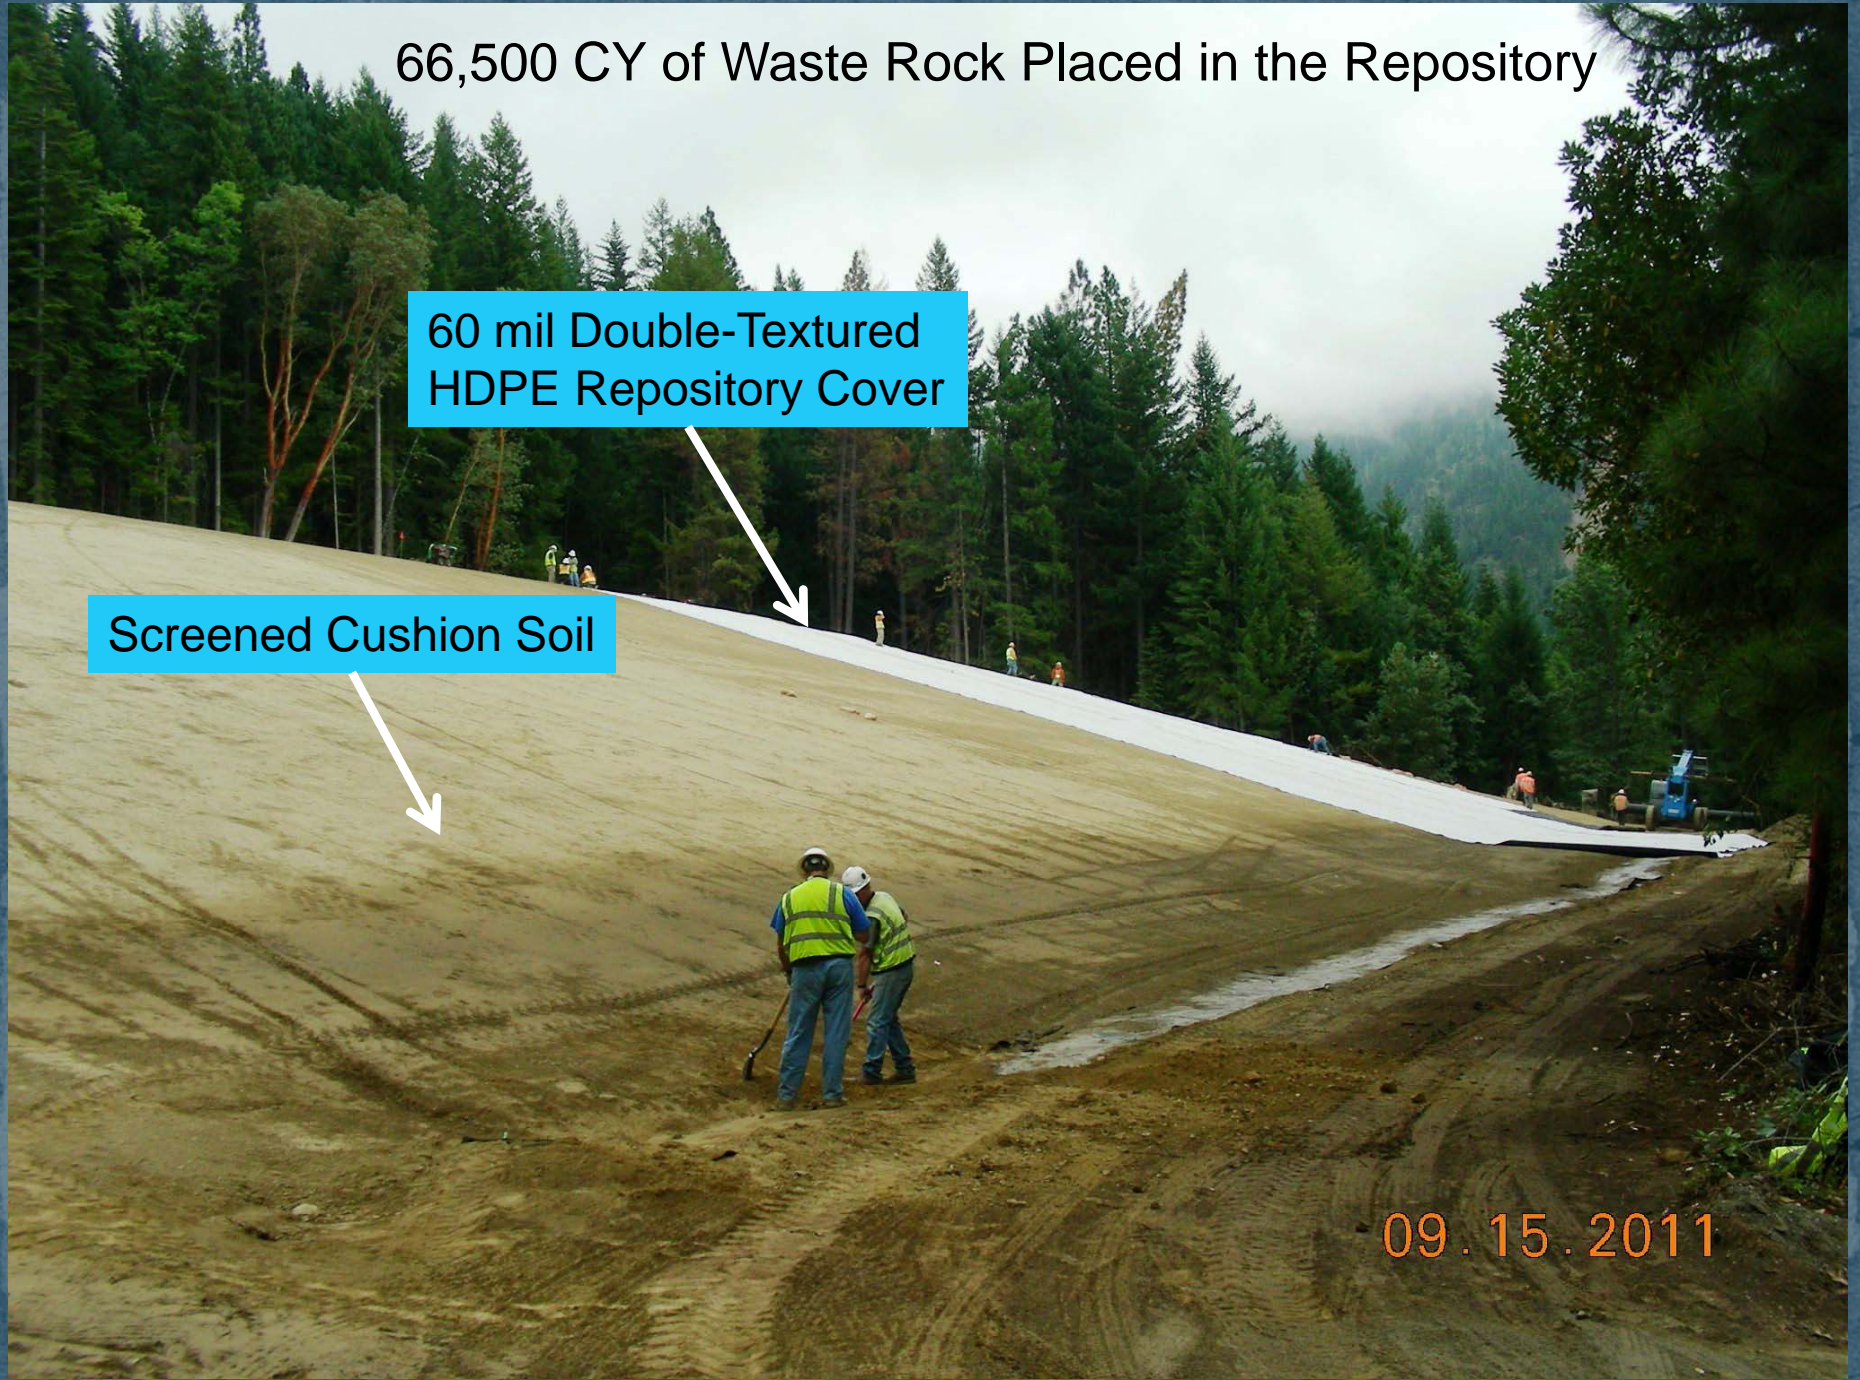
66,500 CY of Waste Rock Placed in the Repository

60 mil Double-Textured  
HDPE Repository Cover

Screened Cushion Soil

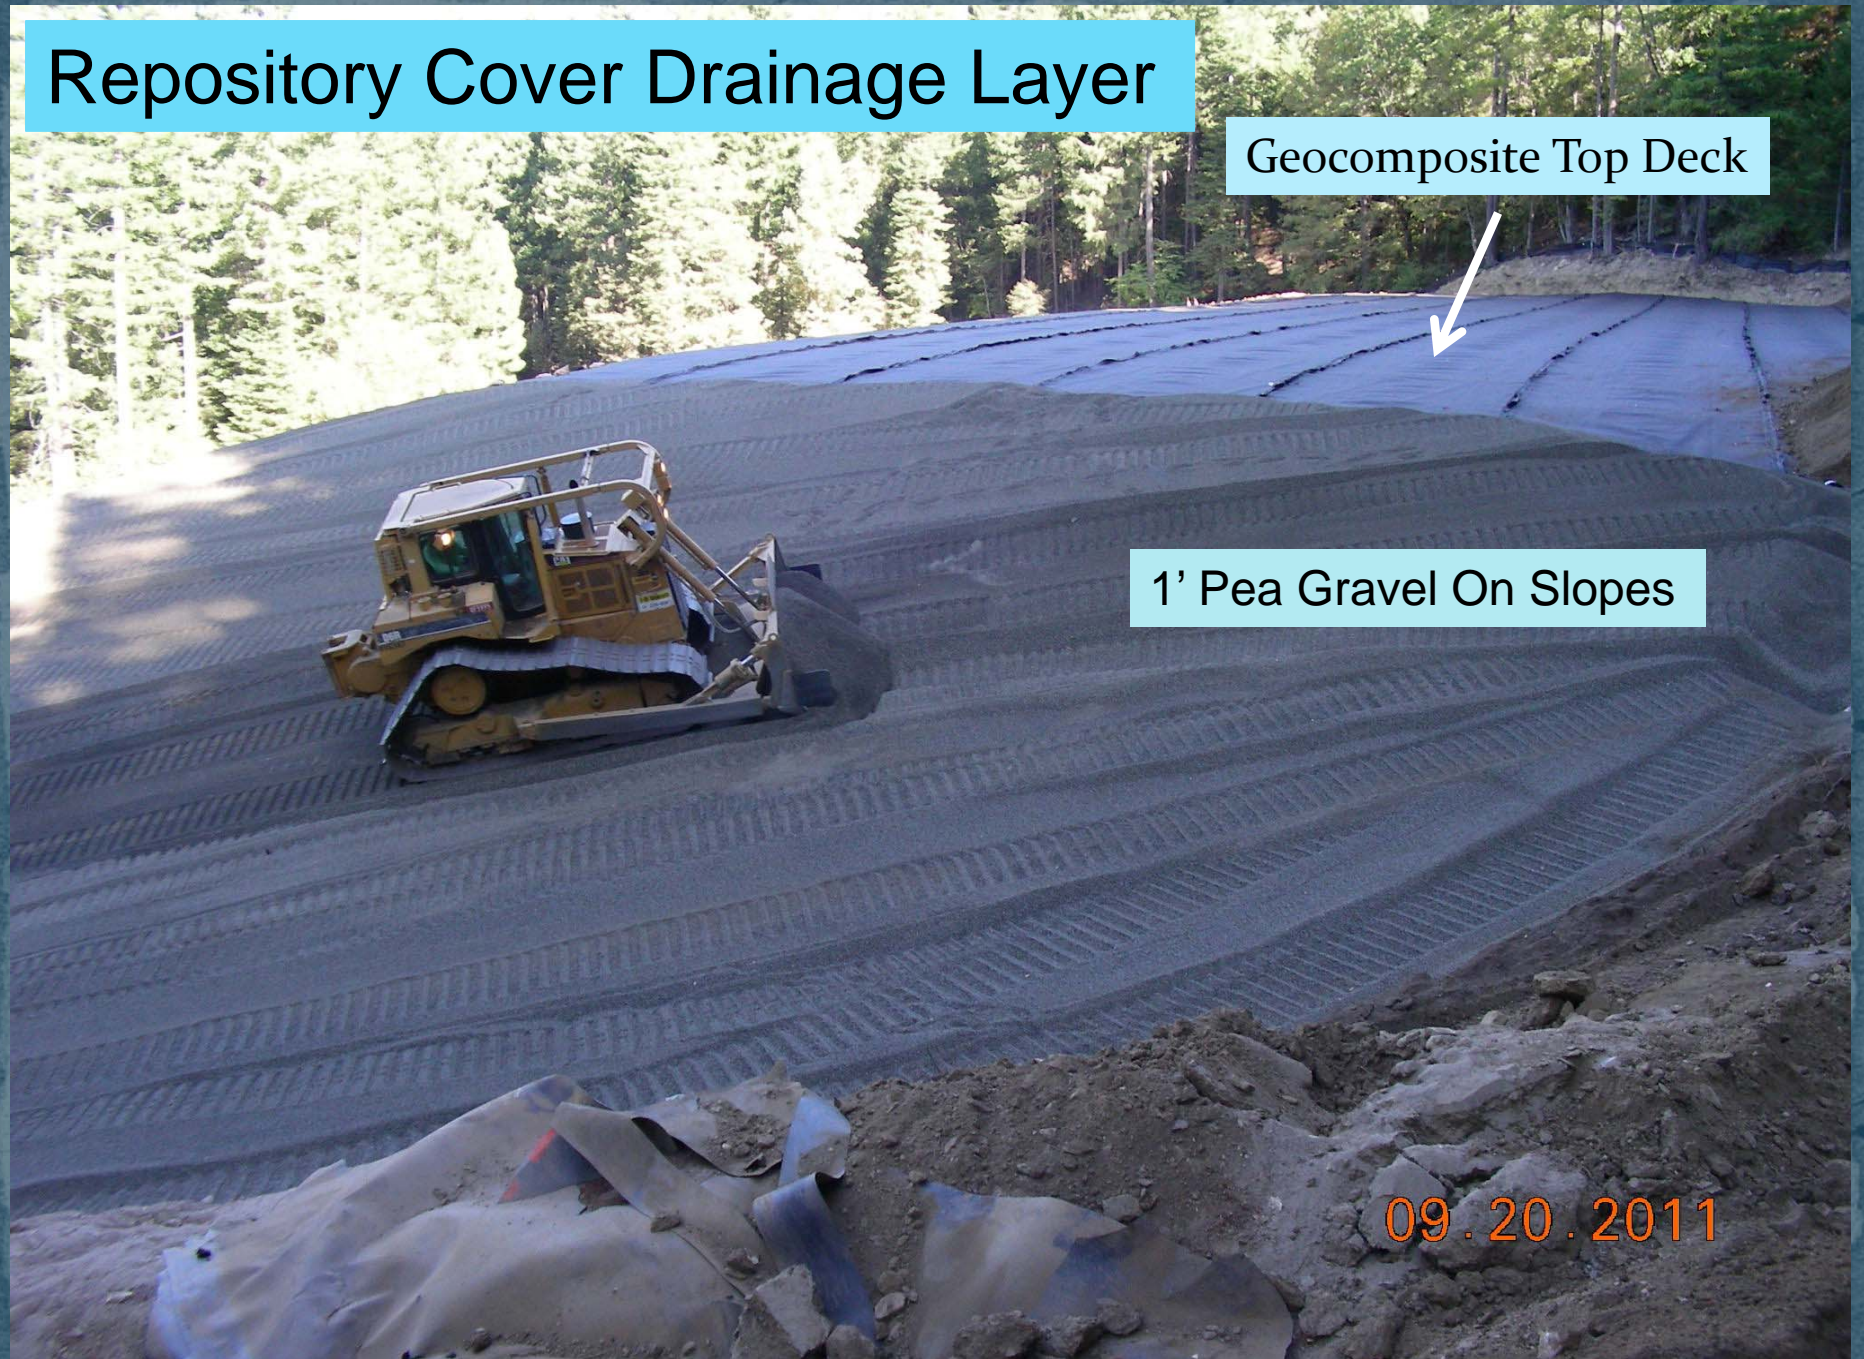
# Repository Cover Drainage Layer

Geocomposite Top Deck

1' Pea Gravel On Slopes

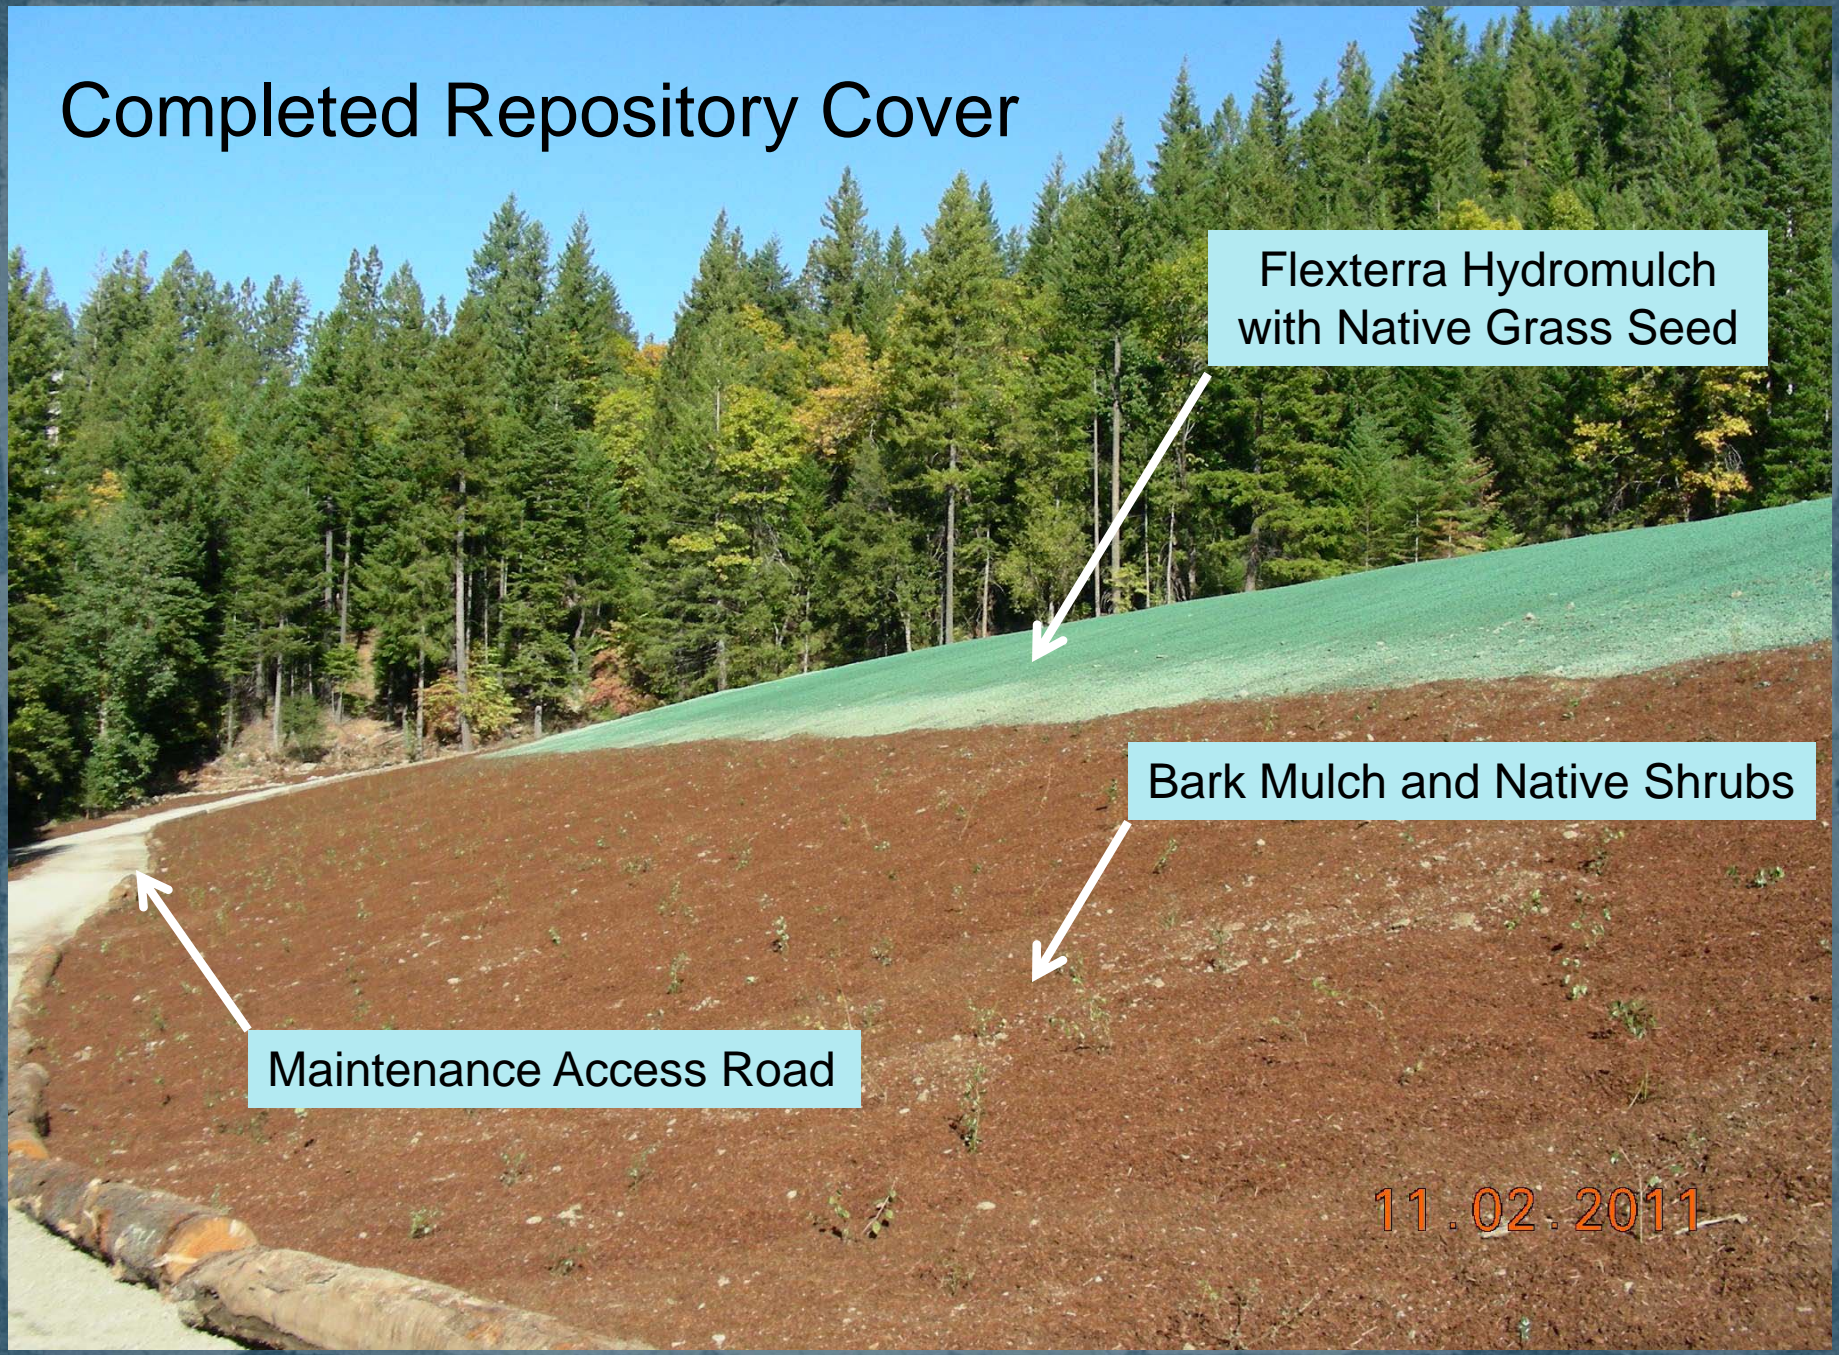
# Completed Repository Cover

Flexterra Hydromulch  
with Native Grass Seed

Bark Mulch and Native Shrubs

Maintenance Access Road

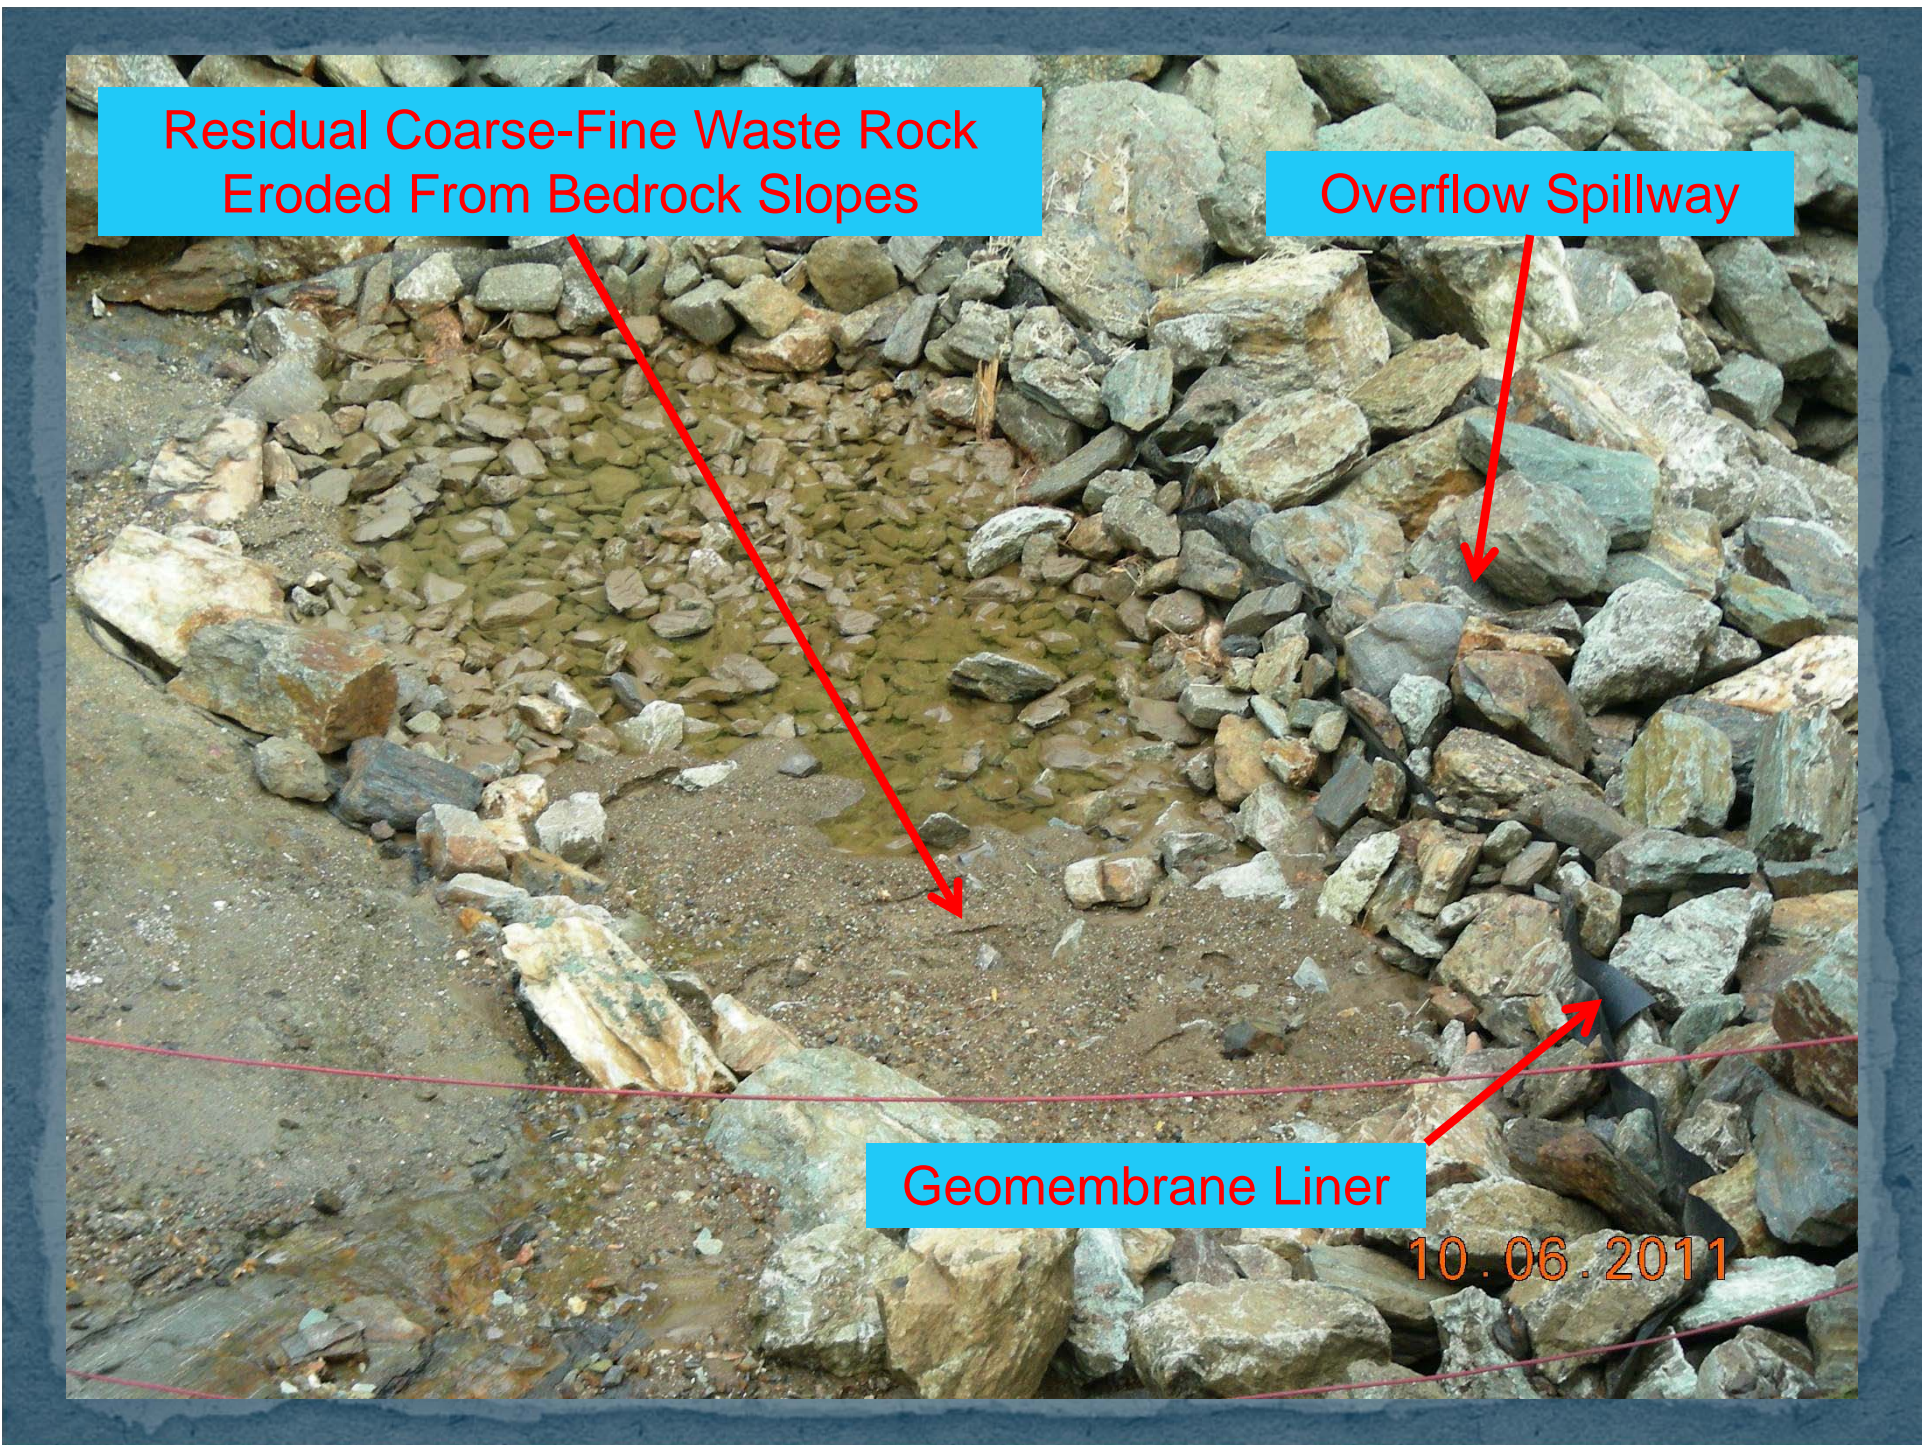
Geomembrane Liner w/Drain Holes

Rock  
Buttress

Limestone  
Sand

Geotextile Cover  
Over Lime Sand

Residual Coarse-Fine Waste Rock  
Eroded From Bedrock Slopes

Overflow Spillway

Geomembrane Liner

During Low  
Flows  
Seepage  
Through  
Limestone  
Sand in  
Basins  
Raises pH  
From 4 to 7

Copper and  
Other Metals  
Precipitate

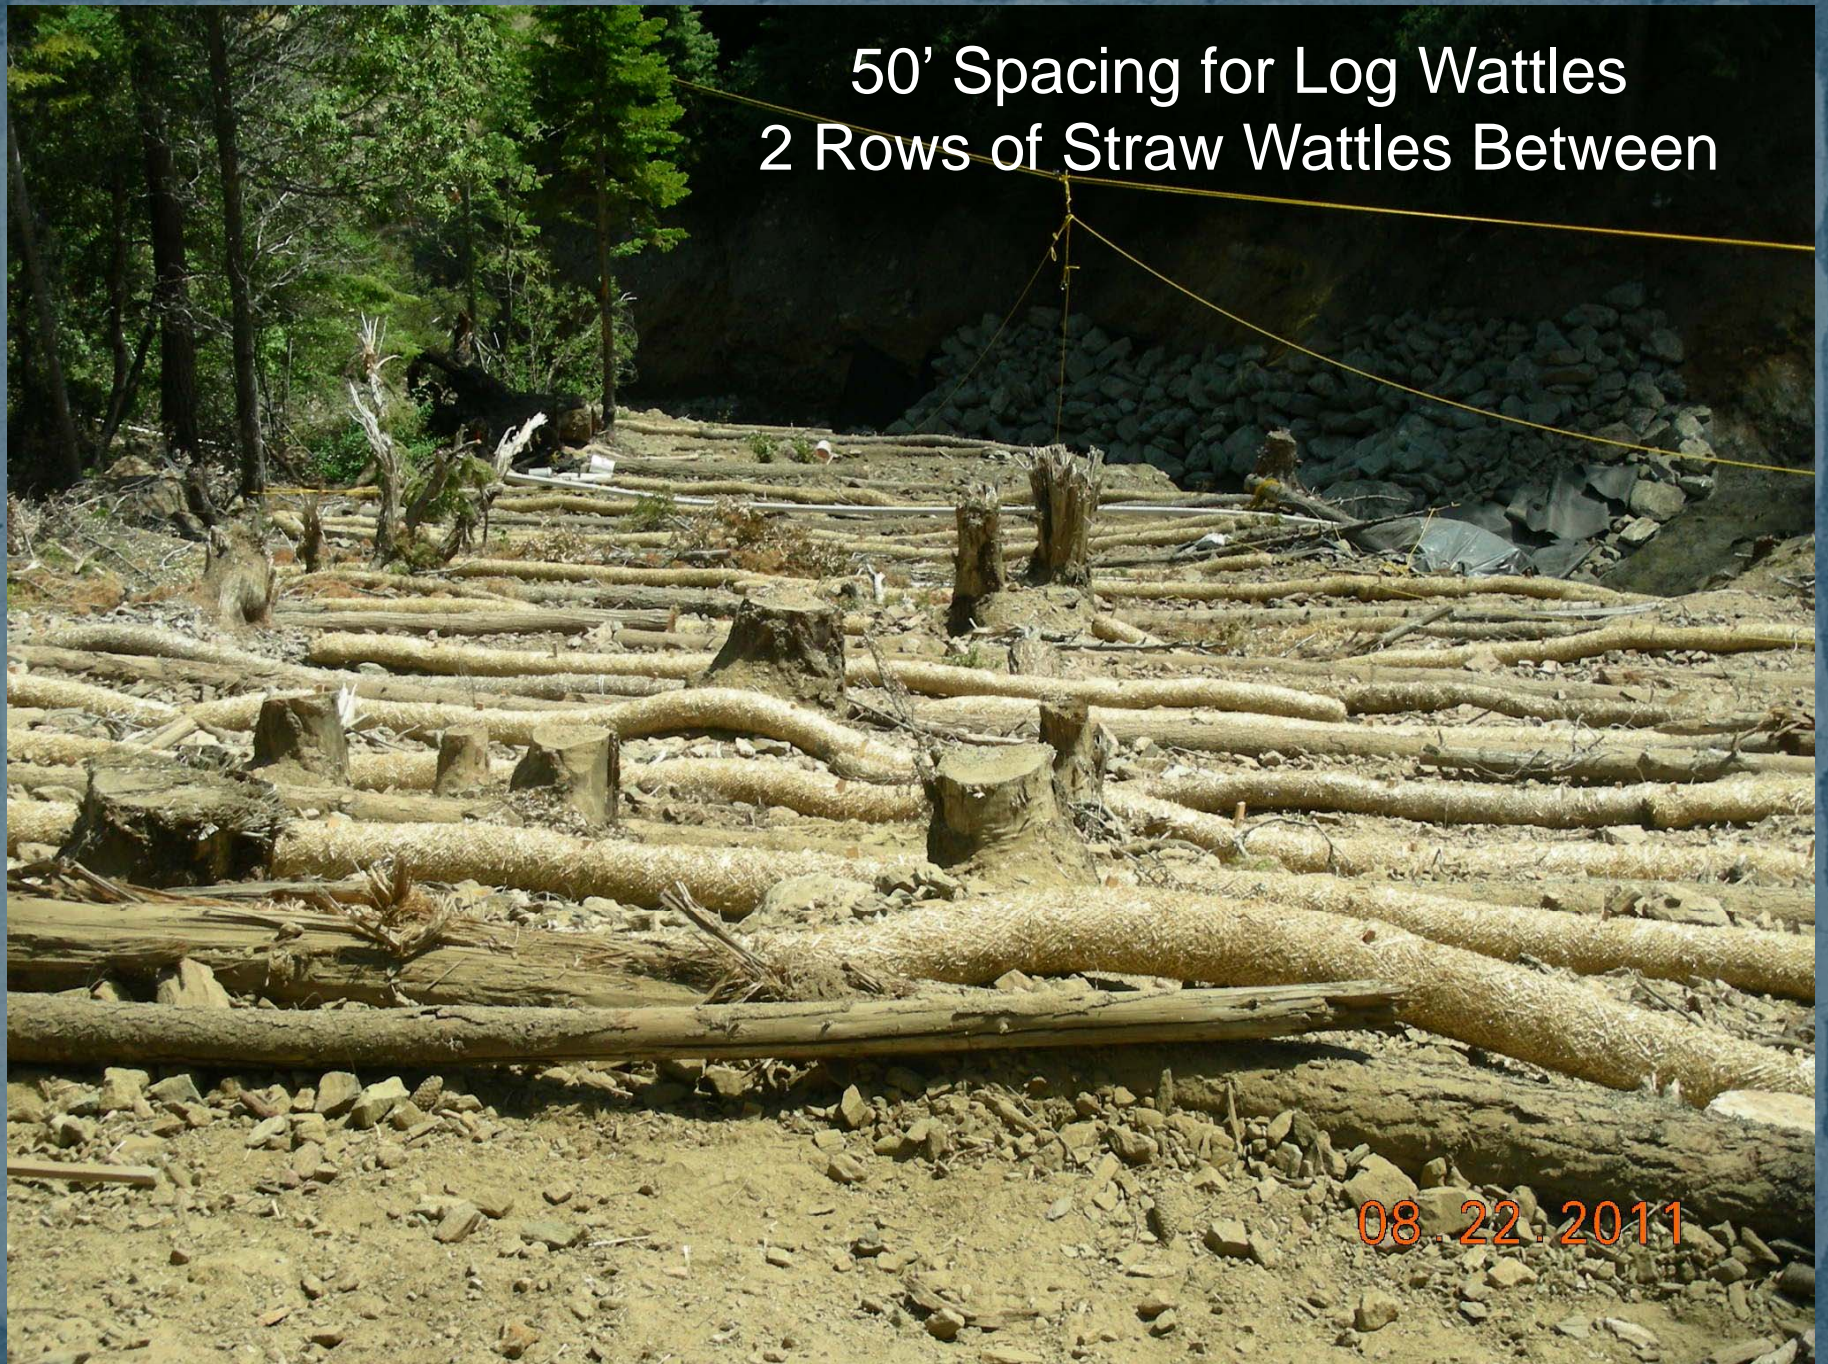
50' Spacing for Log Wattles  
2 Rows of Straw Wattles Between
