# Blue Ledge Mine Superfund Site Presentation Overview

- Location
- Mine Development
- Site Features
- Acid Mine Drainage
- Distribution of Metals Contamination
- Impacts to Ecosystem
- 2010-11 USFS Non-Time-Critical Removal Action
- Q&A

US Forest Service  
Non-Time-Critical  
Removal Action

# Emphasis on AMD Source Control by Removing Waste Rock Piles

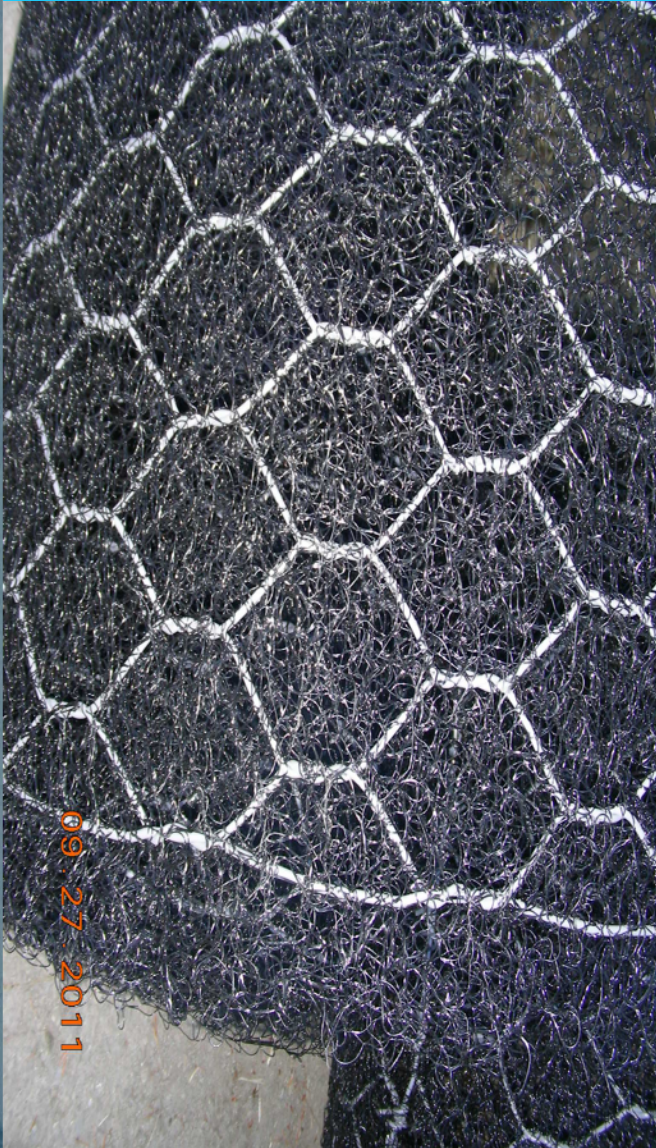
Double-Twisted PVC-Coated  
Steel Mesh With Lofted  
Polypropylene Netting

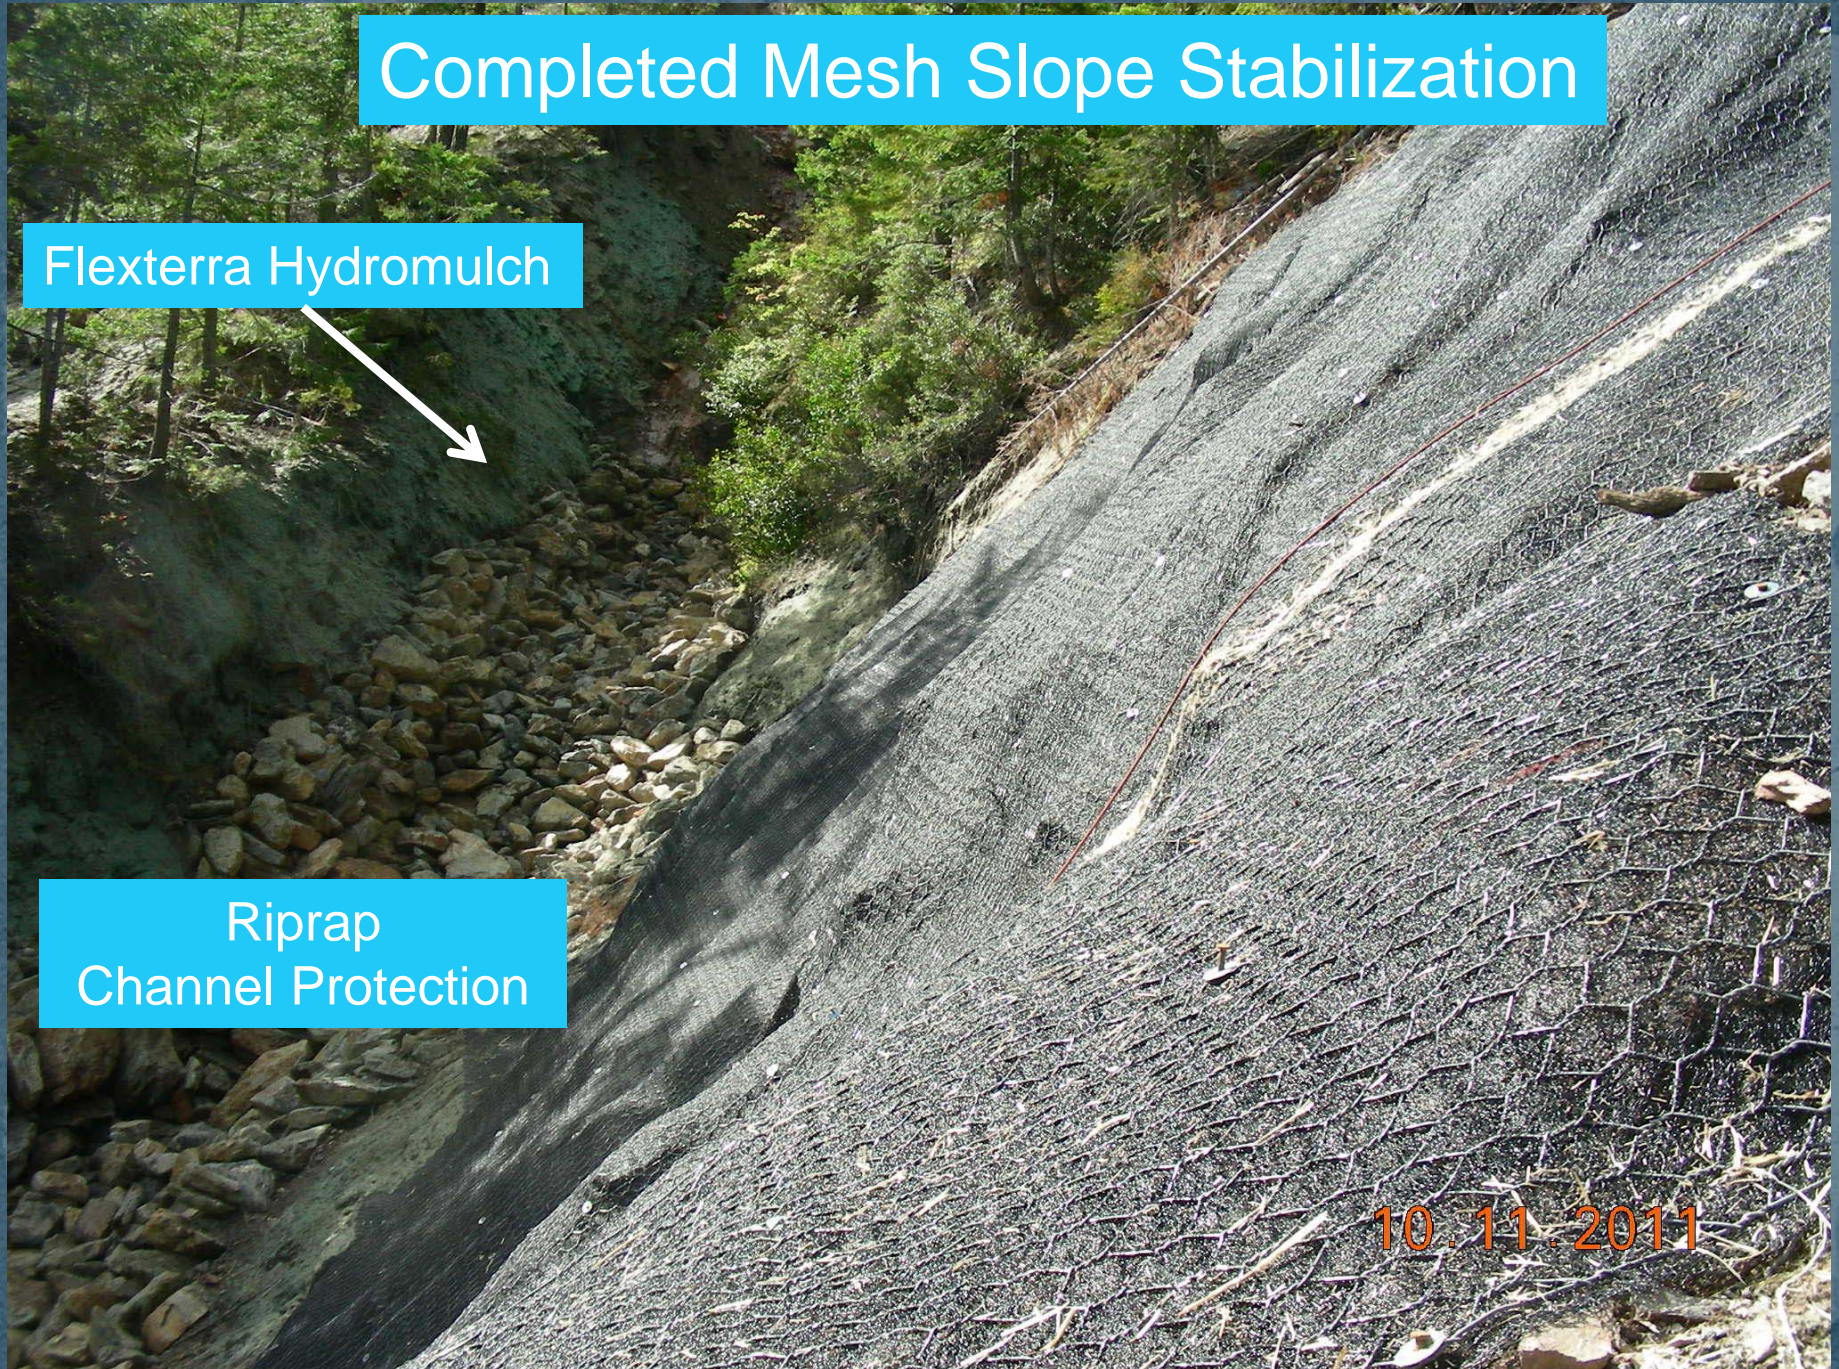
# Completed Mesh Slope Stabilization

Flexterra Hydromulch

Riprap  
Channel Protection

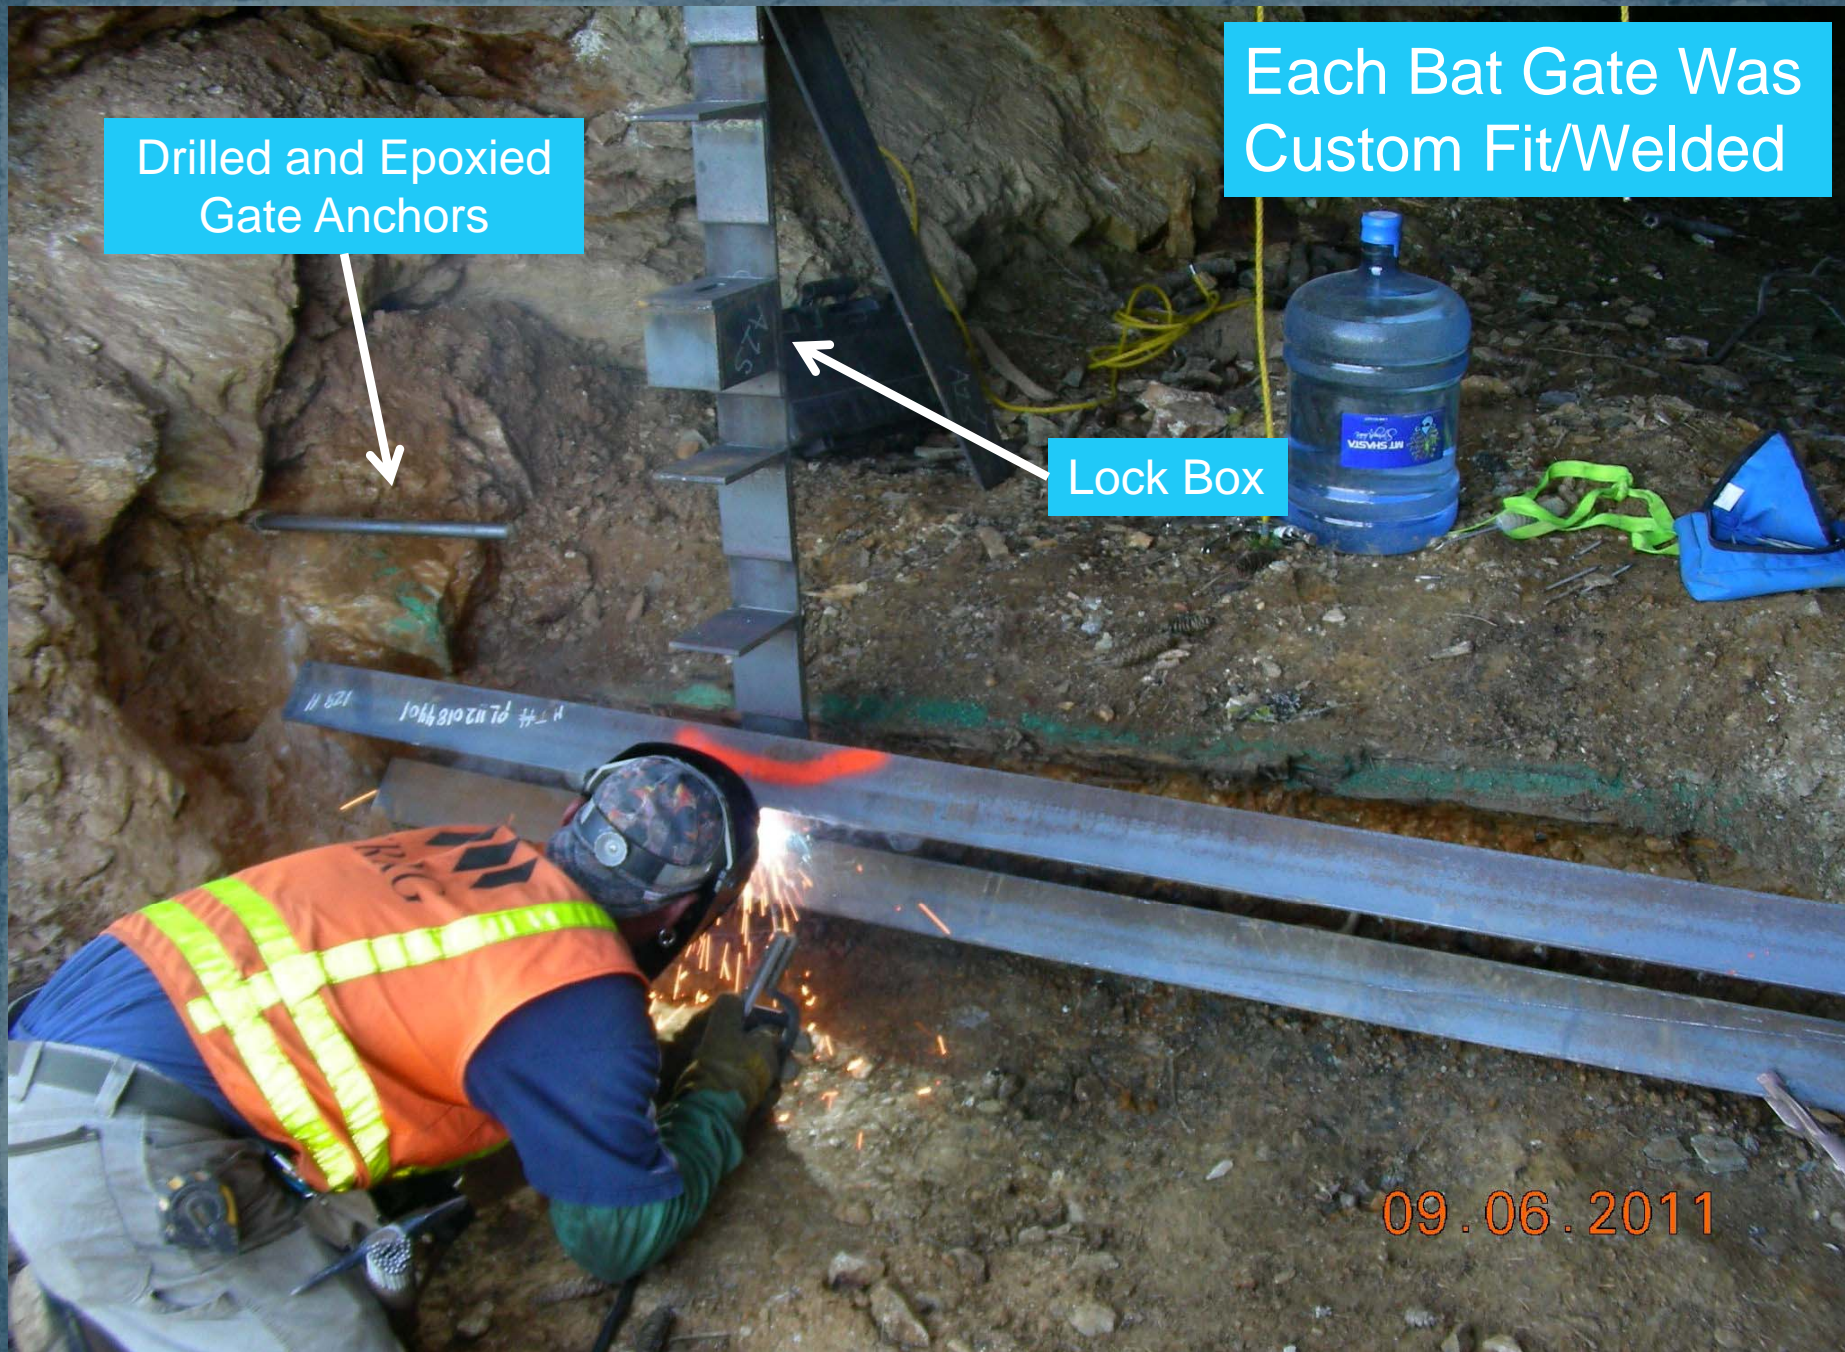
Drilled and Epoxied  
Gate Anchors

Each Bat Gate Was  
Custom Fit/Welded

Lock Box
