Henry's Knob Site Case Study

Revitalizing Mine Tailings in Clover, South Carolina

This case study highlights ecological revitalization outcomes at the Henry's Knob Superfund Alternative Approach¹ site in York County, South Carolina. Working with state and federal regulatory agencies, ABB Inc., (ABB), a proactive responsible party is using an adaptive management approach to address environmental impacts from decades of kyanite mining.

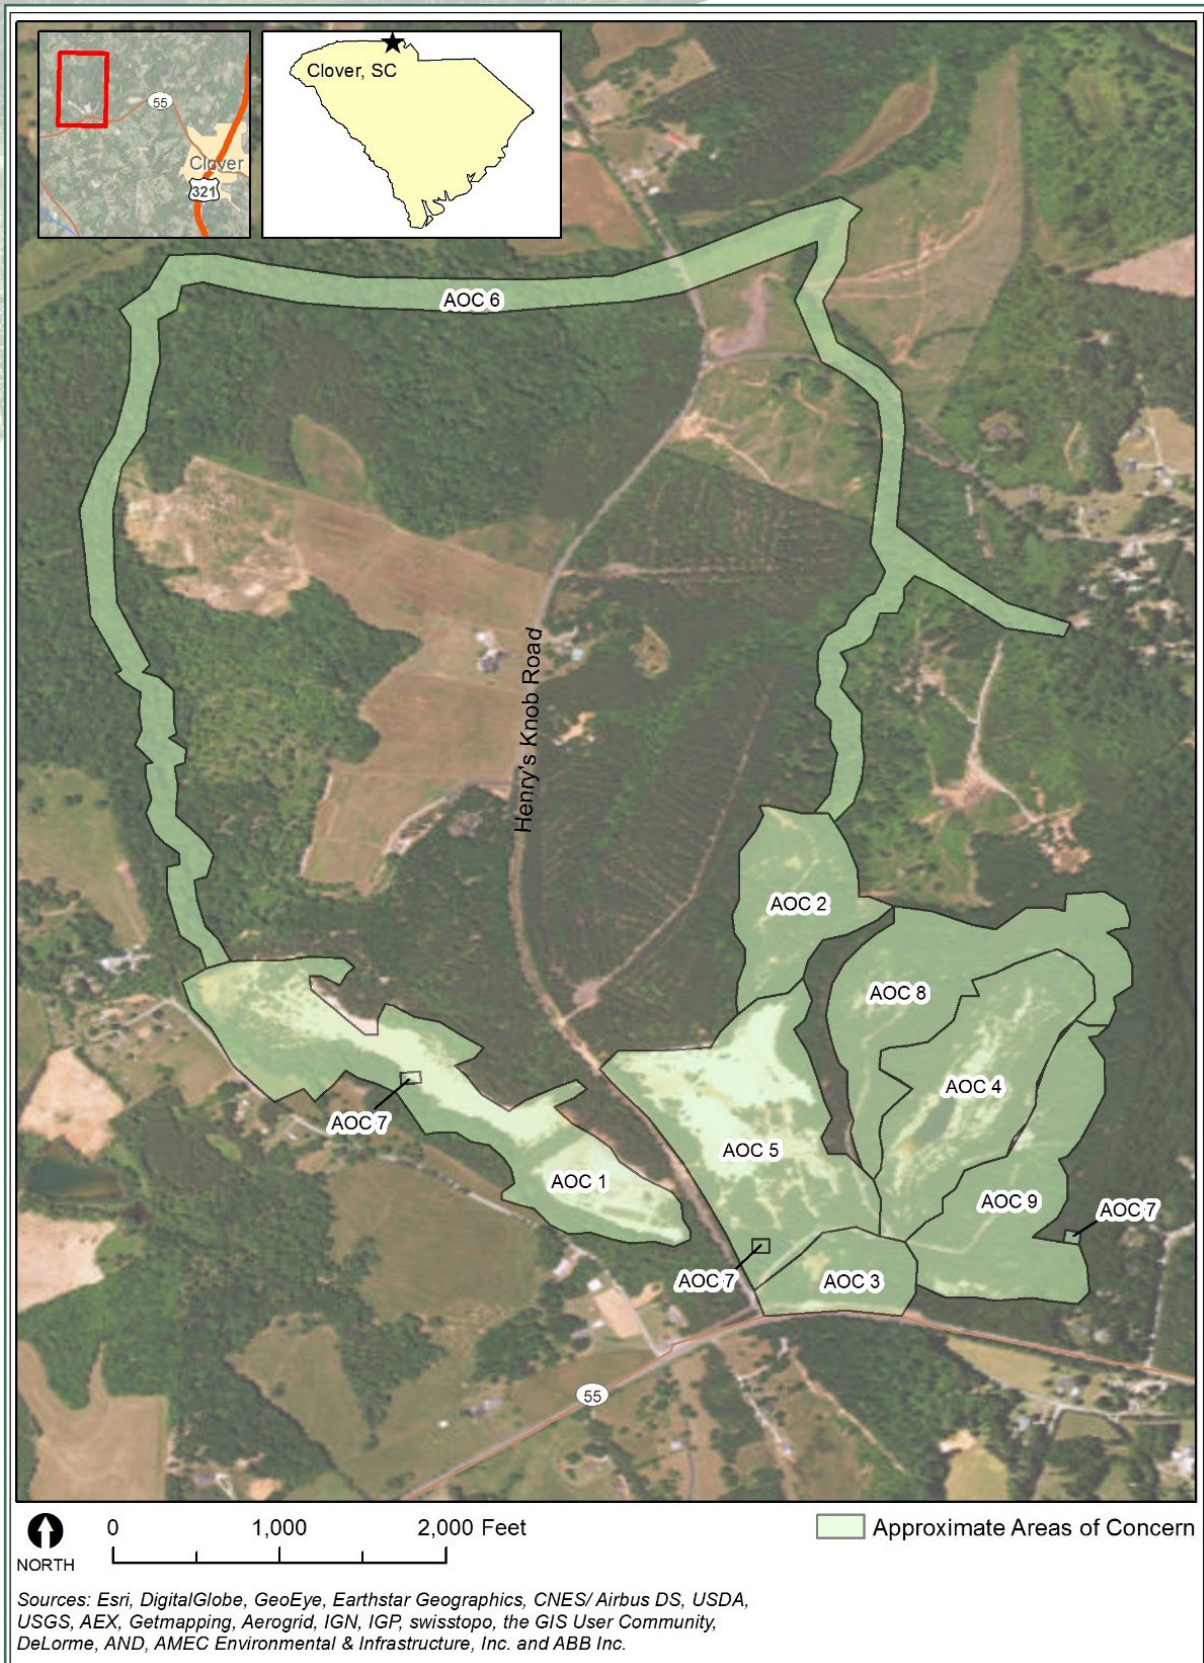
Figure 3: Henry's Knob Site Map

EPA identified 10 Areas of Concern (AOCs) at the site as well as several off-site residences where contamination (primarily manganese and/or cobalt) was found in wells. The 10 AOCs are shown in Figure 3 and listed below:

- AOC 1** - West Tailing Pond (industrial waste lagoon on western side of Henry's Knob Road)
- AOC 2** - North Tailings Pond (infiltration beds/settling ponds on eastern side of Henry's Knob Road)
- AOC 3** - Former Mill Operation Buildings (eastern side of Henry's Knob Road)
- AOC 4** - Mine Pit Pond
- AOC 5** - East Tailings Pond (also known as Mine Tailings Area)
- AOC 6** - South Fork of Crowder's Creek
- AOC 7** - Dumping Area (eastern side of Henry's Knob Road)
- AOC 8** - Northern Waste Rock Area
- AOC 9** - Southern Waste Rock Area
- AOC 10** - Site Groundwater

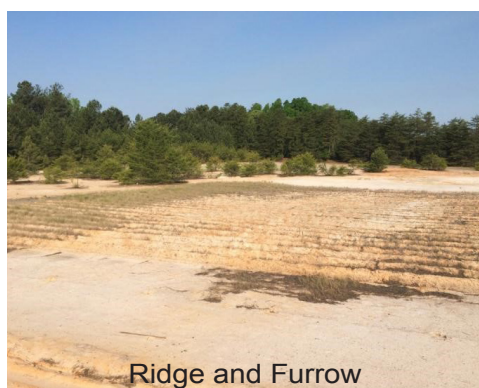
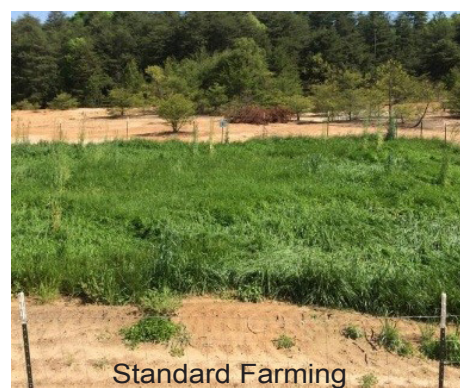
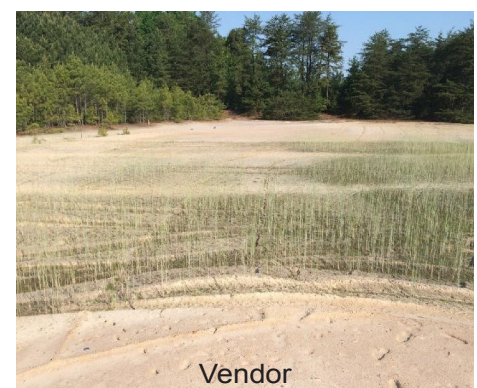
Figure 4. Differences in vegetation growth across the Ridge and Furrow test plot (left), the Standard Farming test plot (middle) and the vendor test plot (right) in April 2015. (Source: ABB Inc.)

Following approval from EPA and SCDHEC, ABB consulted with local farmers as well as companies and experts that specialize in revegetation for guidance and recommendations. The responsible party also led several studies to create a soil profile with a sufficient organic content and pH that could support plant growth across the site's mine tailing areas. These studies included three test plots within AOC 1 – the Ridge and Furrow test plot, the Standard Farming test plot, and a test plot that tested some specific vendor provided amendments. The Standard Farming test plot was based on basic farming practices that incorporates organic materials and fertilizer into the upper portion of the mine tailings to create a soil material suitable for the establishment and sustainable growth of vegetation. Figure 4 shows differences in growth among the three tests plots. They demonstrate that the addition of organic material increases vegetation success.

During the two-year study (from 2013 until 2015), substantial growth was observed on the Standard Farming test plot. The community welcomed the study findings. Some community members stopped in the field office to compliment the appearance of the vegetated tailing.
