# Conquering a Busy Intersection to Install Horizontal Remediation Wells and Protect Indoor Air

# Site Location Tallahassee, FL

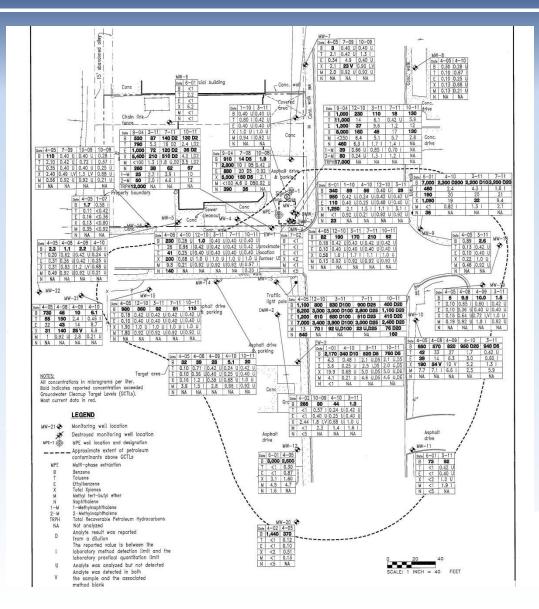
#### Baseline Groundwater Plume

- Depth to water 26 ft bls
- Sandy clay and clayey sand
- Confining clay layer at 35 ft bls
- Groundwater plume 102,000 ft²

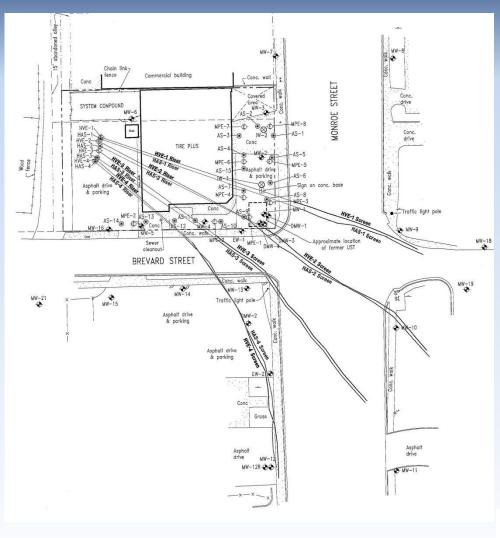
- 4 horizontal AS wells with screens at 33 ft bls.
  - Screen lengths: 100, 170, 170, and 200 ft
- 4 horizontal SVE wells with screens at 20 ft bls
  - Screen lengths: 100, 170, 170, and 200 ft
- Source area: select on-site vertical AS/SVE wells remain active
- Horizontal wells run in cycles

- Horizontal wells accurately followed their compound curves by combining downhole sonde locating equipment with continuous calculation of wellbore depths and topographic survey points of the uneven ground surface
- Wells were placed along the top of a clay aquitard unit with the horizontal SVE wells being placed with the companion AS well.
   This allowed for total vapor recovery, thereby satisfying FDEP requirements for AS-SVE pairs
- Blind wells were installed without exit pits, keeping in compliance with the property owners requests
