The Conditions

Technologies, Inc. Horizontal Remediation Wells

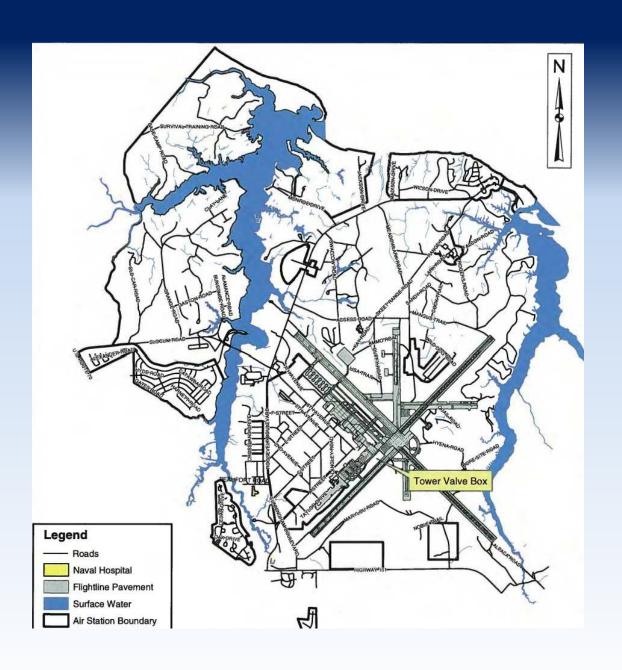
- A large free-product plume of JP-4 and 5 existed under the active aircraft maintenance facility.
- The plume was nearly 250 feet long by 100 feet wide with a maximum thickness of 5 to 6 feet. The amount of fuel in the subsurface was estimated at 250,000 gallons.
- Aircraft maintenance activities could not be disrupted.
- An emergency water force main was located under the building.

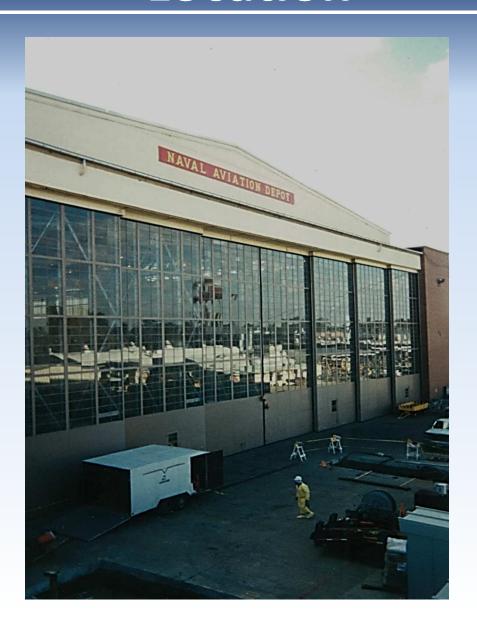
- Three 450-ft horizontal wells constructed of 8-inch HDPE with 200-ft of slotted well screen.
- Three 2-inch collection pipes installed in each horizontal well to remove product from different areas.
- Hydrophobic pumps transfer free-product to treatment equipment for collection.

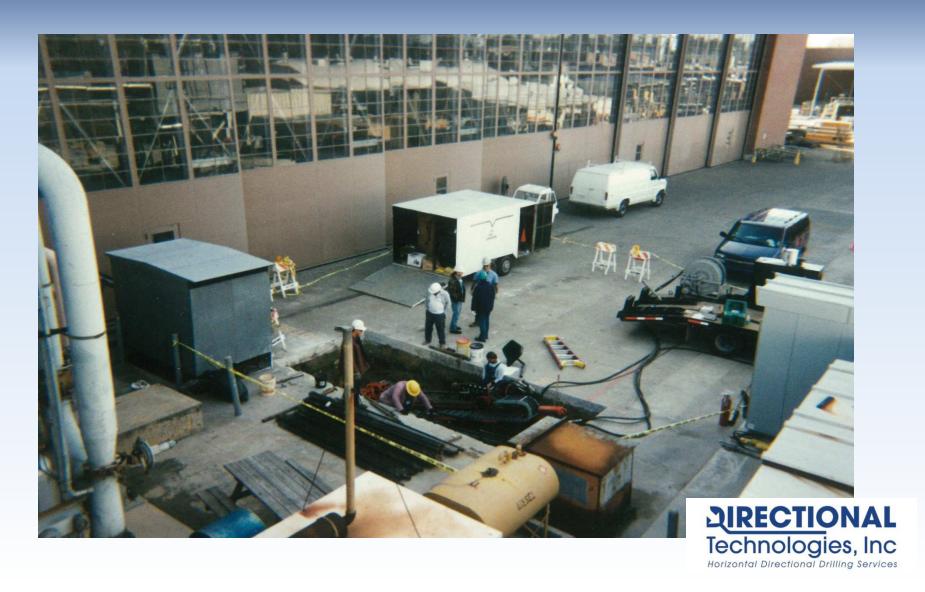
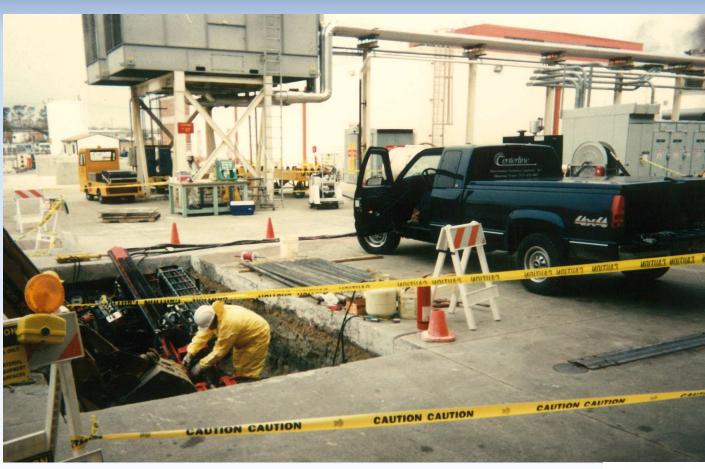
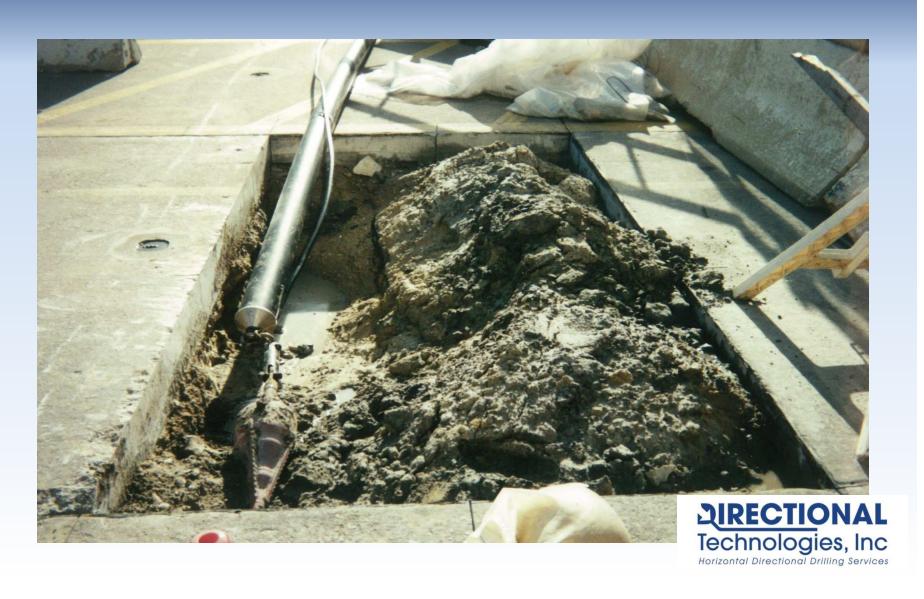
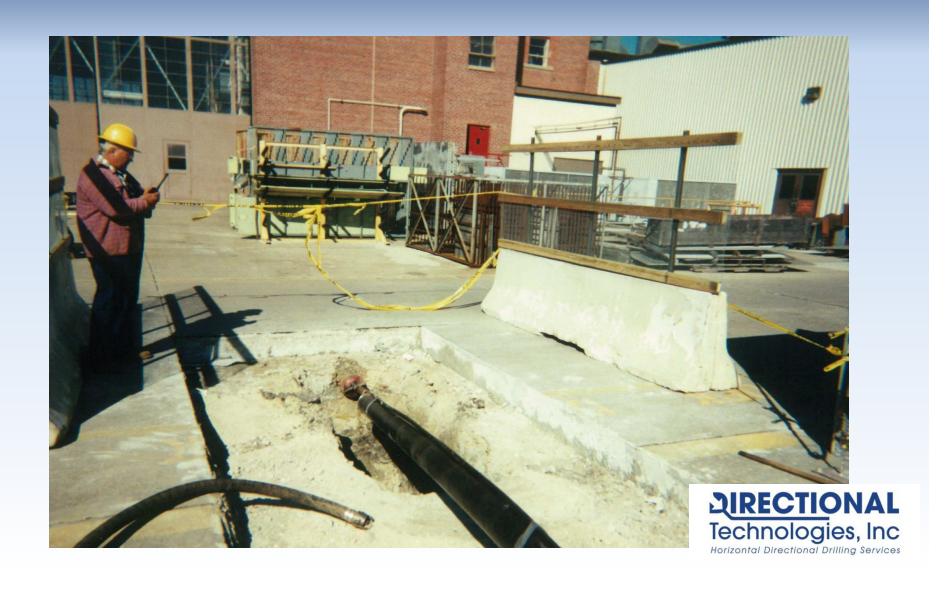
- Achieving the designed entry angle.
- Unexpected conditions cypress stumps.
- Missing the water line and moving from a walk-over location method to a wire-line location method.

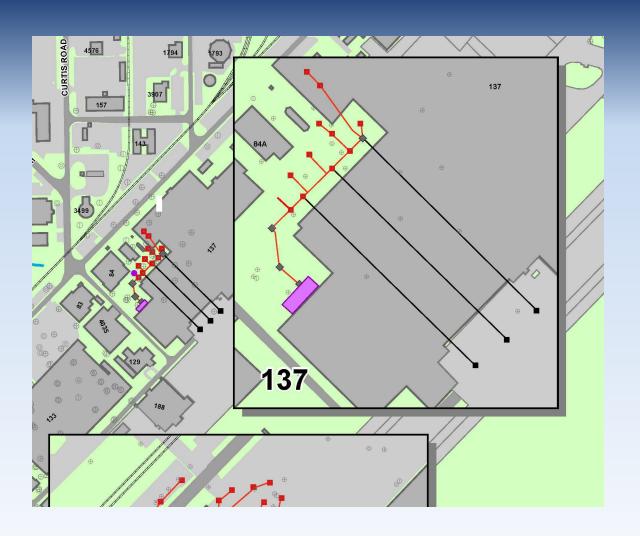
- The system became operational in August 1997.
- The system recovered an average of approximately 280 gallons of free-product per day and over 52,000 gallons of free-product the first year.
- Recovered fuel was transported to the Air Station's central heating plant where it was blended and used to operate the plant's steam boilers.
- The system was regarded as a success and received recognition from the DOD as the free product recovery system of the year.
