Demonstration of Phytostabilization of Shallow Contaminated Groundwater Using Tree Plantings at Travis Air Force Base, California

Addendum Report No.3
to the
Interim Technical Report
Interim Cost and Performance Report

**FINAL
ADDENDUM REPORT NO. 3
TO THE
INTERIM TECHNICAL REPORT
FOR THE DEMONSTRATION OF PHYTOSTABILIZATION
OF SHALLOW CONTAMINATED GROUNDWATER
USING TREE PLANTINGS AT
TRAVIS AIR FORCE BASE, CALIFORNIA**

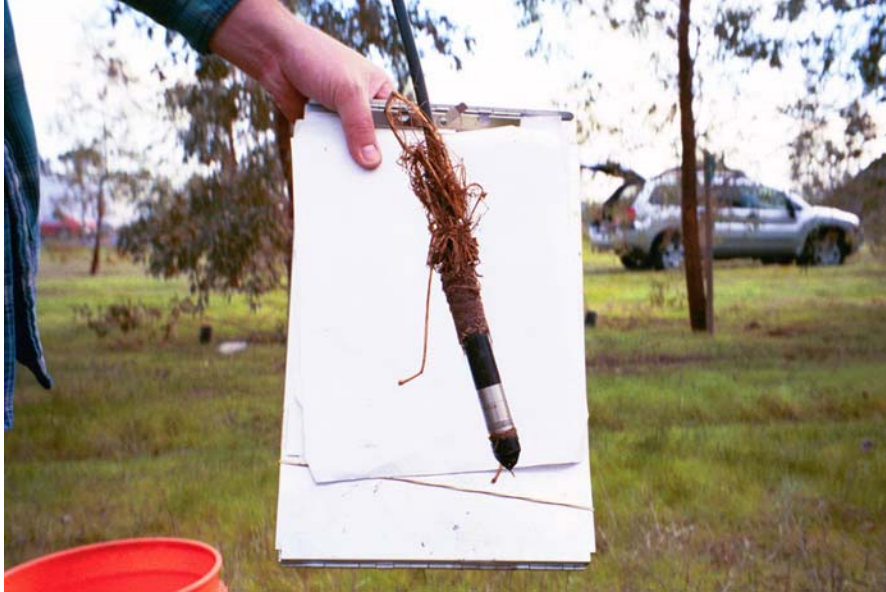
Photograph taken February 2004 at monitoring well 755PHYTO32, which contains a Druck[®] pressure transducer. This shows the roots that were pulled up when the sensor was removed from the well.

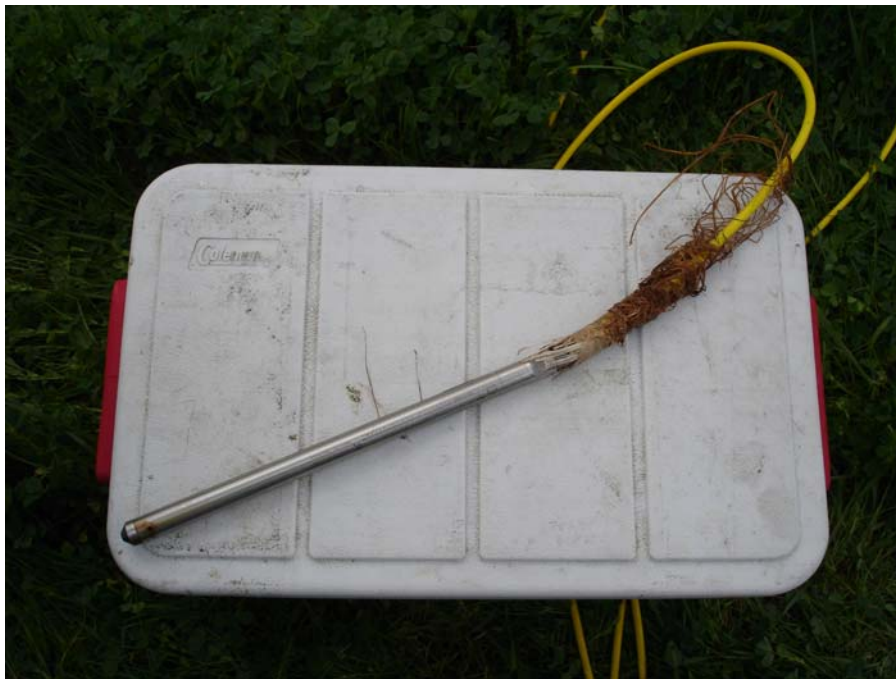
Photograph taken February 2005 at monitoring well 755PHYTO25, which contains an In-Situ[®] pressure transducer. This shows the roots that were pulled up when the sensor was removed from the well. The roots consisted of tough/woody red roots at the top (above the water table) and wet/smooth white roots that were in the groundwater.

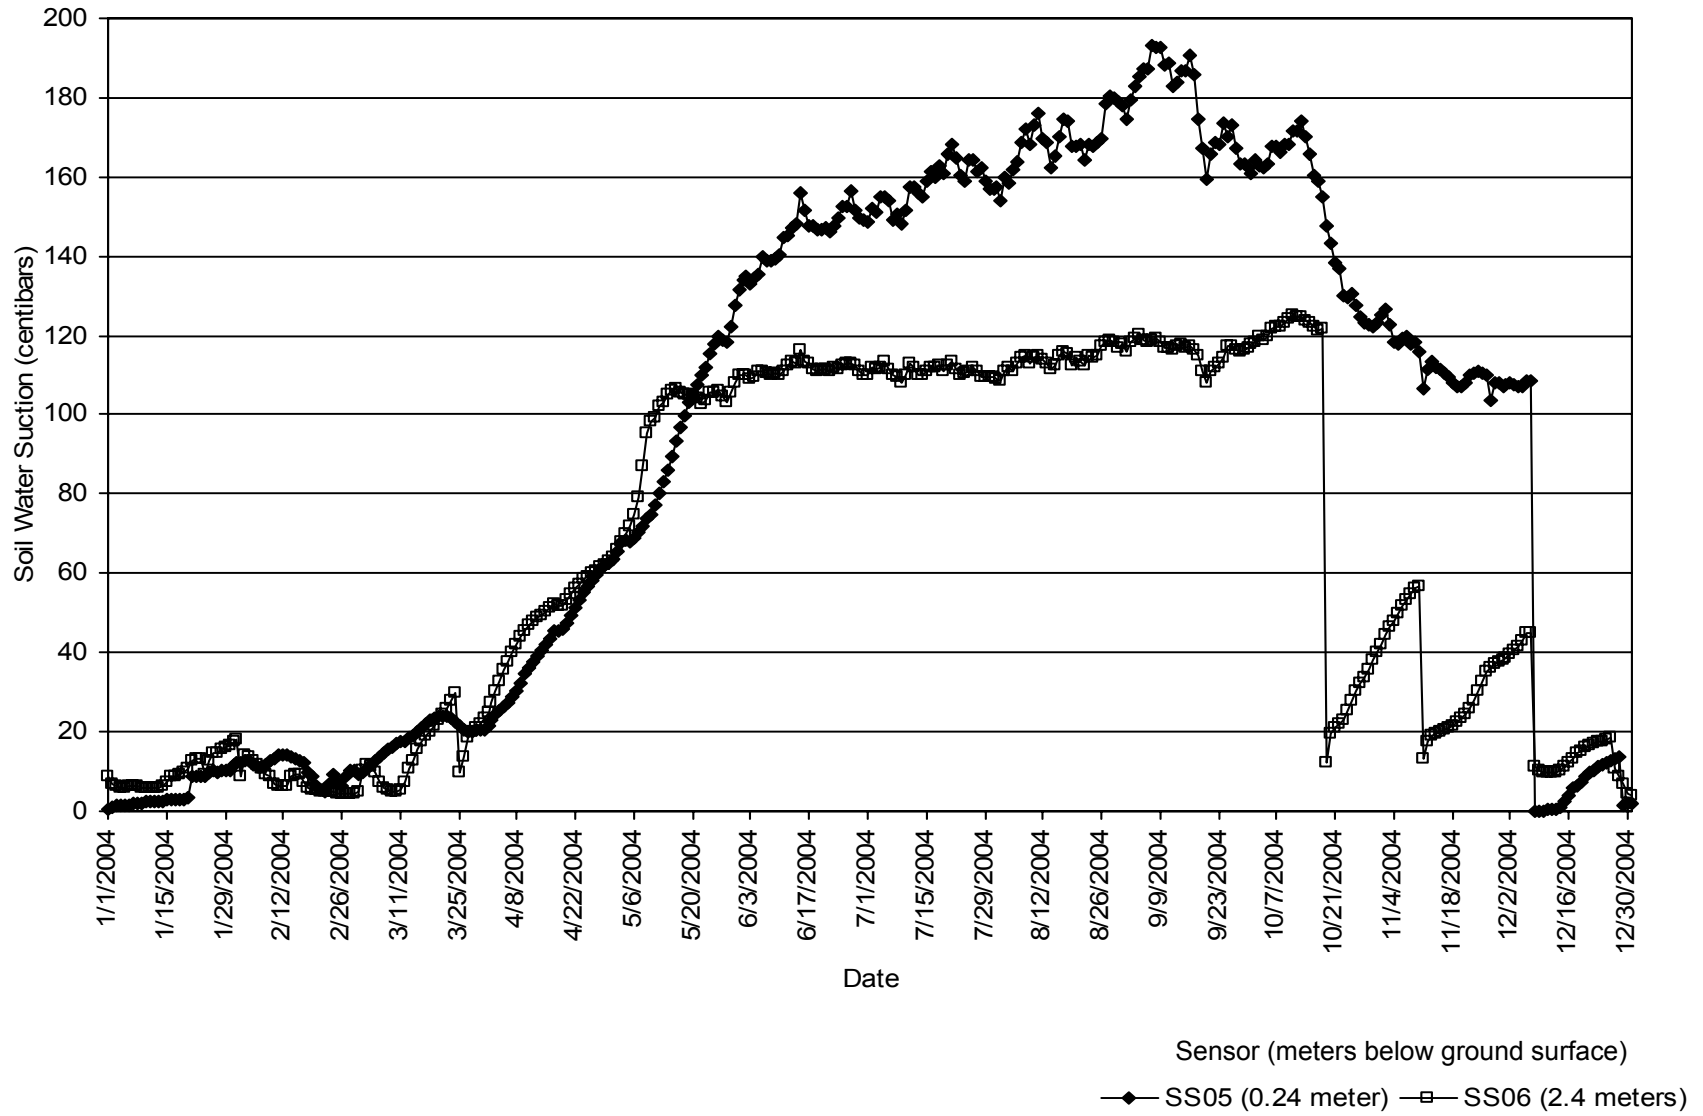
FIGURE B.7
DAILY WATERMARK SOIL SENSOR READINGS (SS5 AND SS6)
 PHYTOSTABILIZATION DEMONSTRATION
 BUILDING 755
 TRAVIS AIR FORCE BASE, CALIFORNIA

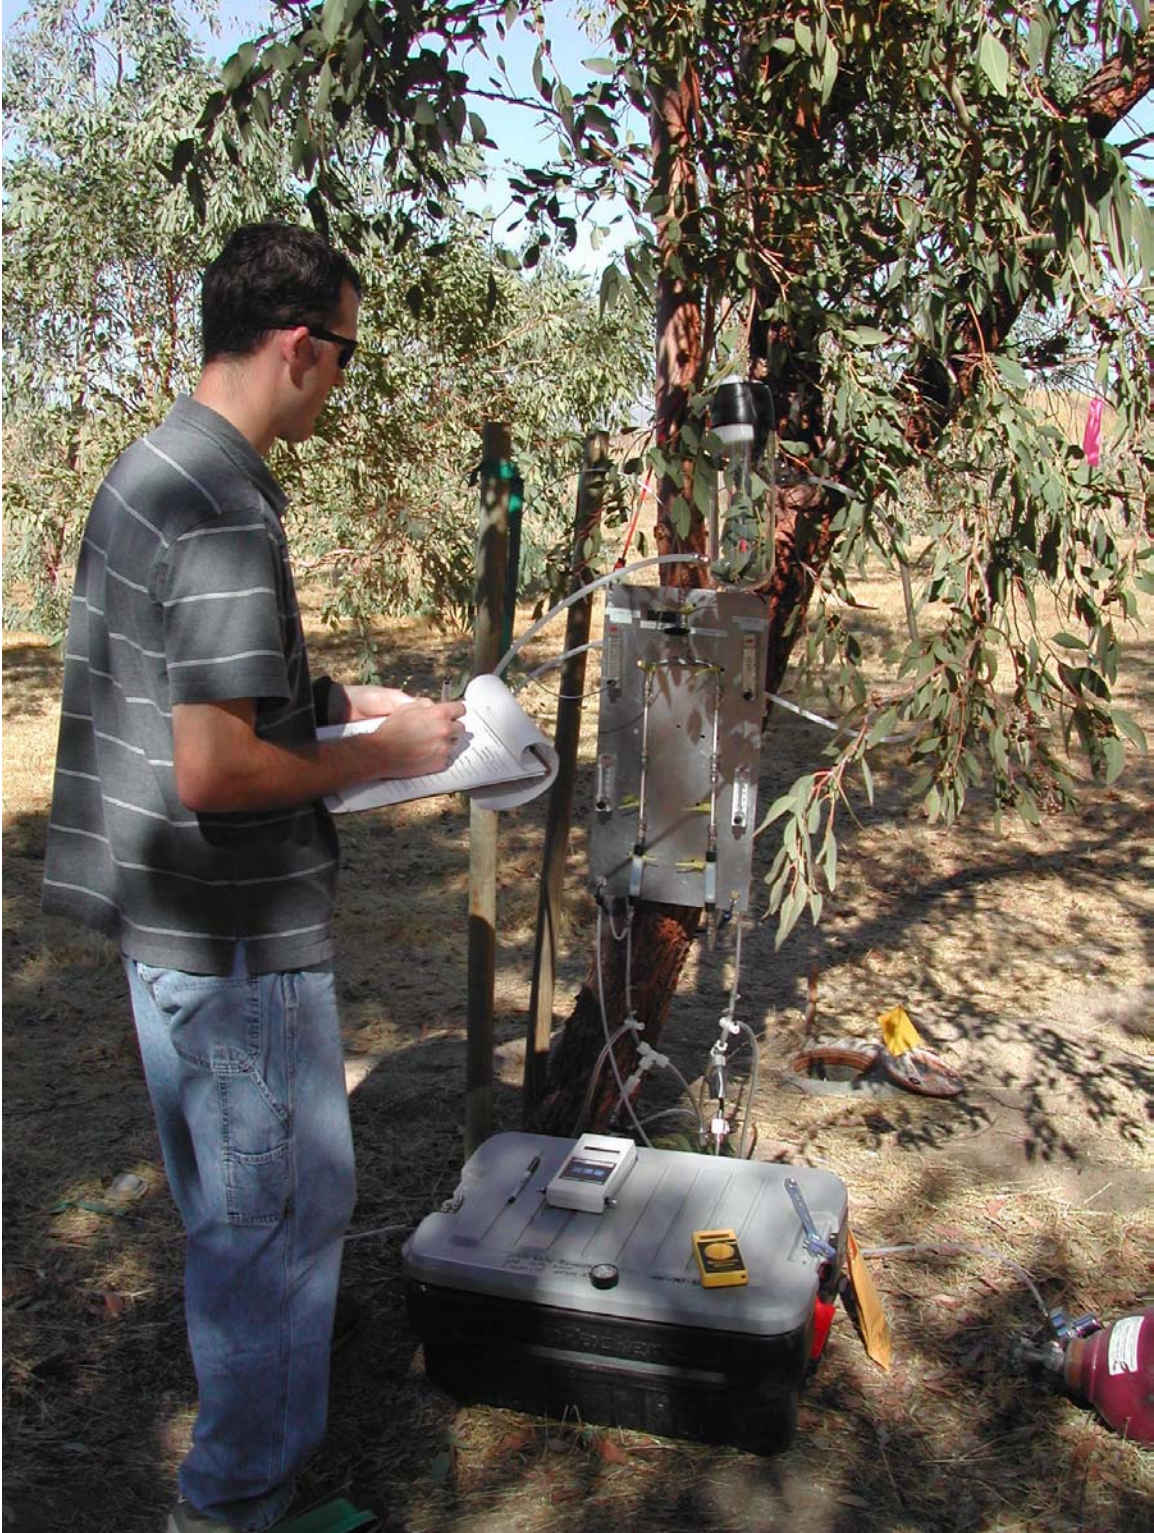
Figure A1. Photo of Phytovolatilization Sampling at Travis AFB.
