**Subject: Solvents Recovery Service of New England Inc. Superfund Site  
Southington, Connecticut  
Revised In-Situ Thermal Remediation  
Construction Completion Report**

## Responses to Comments Dated September 10, 2015 on Draft In-Situ Thermal Remediation Construction Completion Report

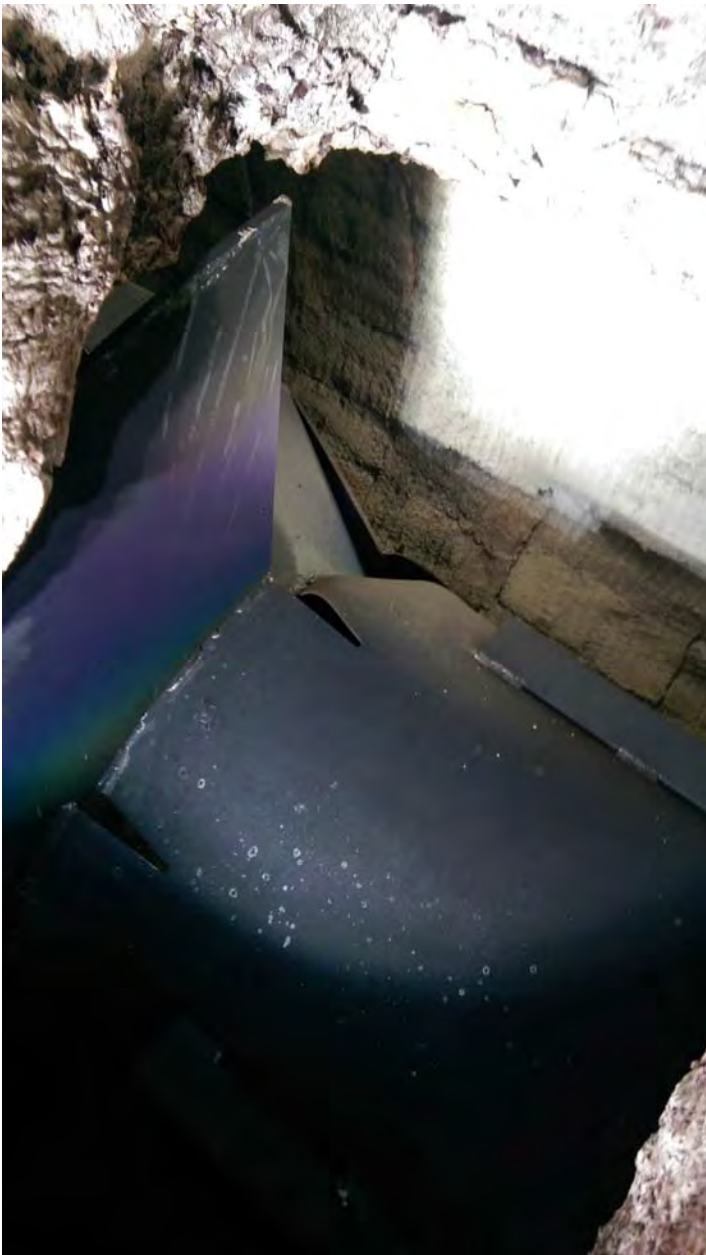
- The photo below shows the daisy wheel process flow distributor mounted on the end plate. The bent “petals” were oriented between 11:00 and 3:00 positions when viewed from the burner end plate. The impacted petals were discolored, further suggesting localized over-heating from influent vapors. A new daisy wheel assembly was designed, fabricated, and installed after this unit was removed for inspection. The replacement unit included a reinforcing ring welded to the petals of the wheel to minimize the chance of the assembly becoming distorted again due to high influent operating temperatures.

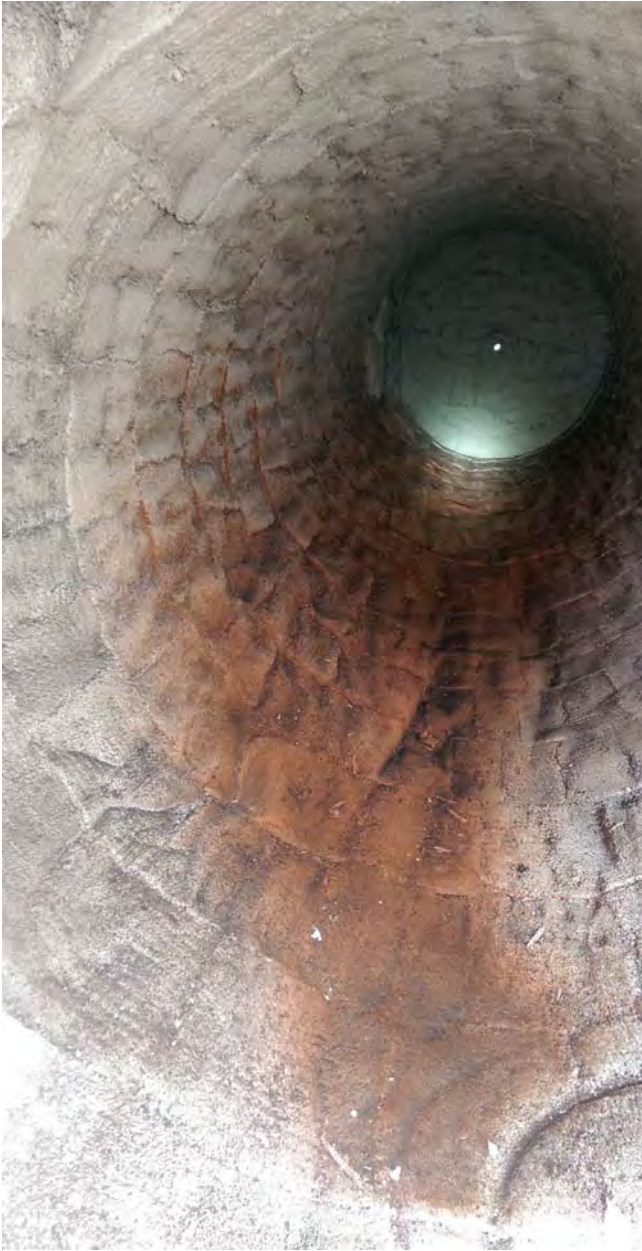
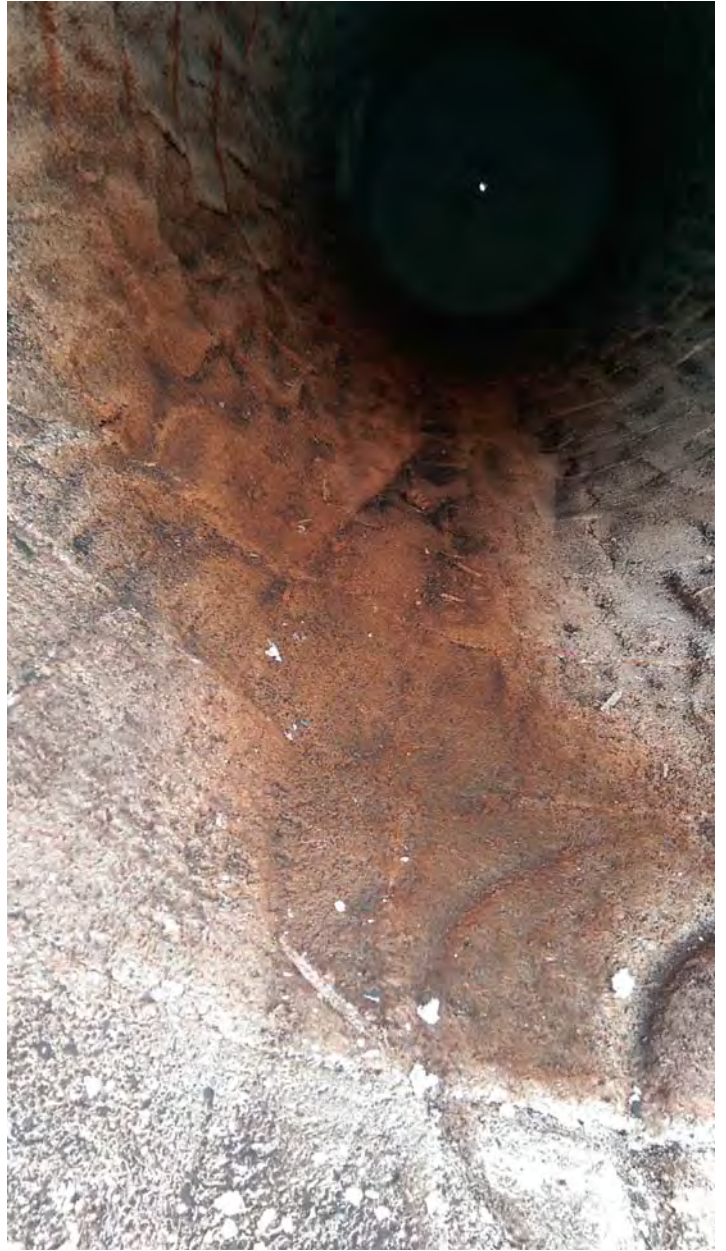
- In the photos below, the combustion chamber & roof show discoloration, likely due to impingement from a re-directed burner flame from the distorted shape of the daisy wheel.

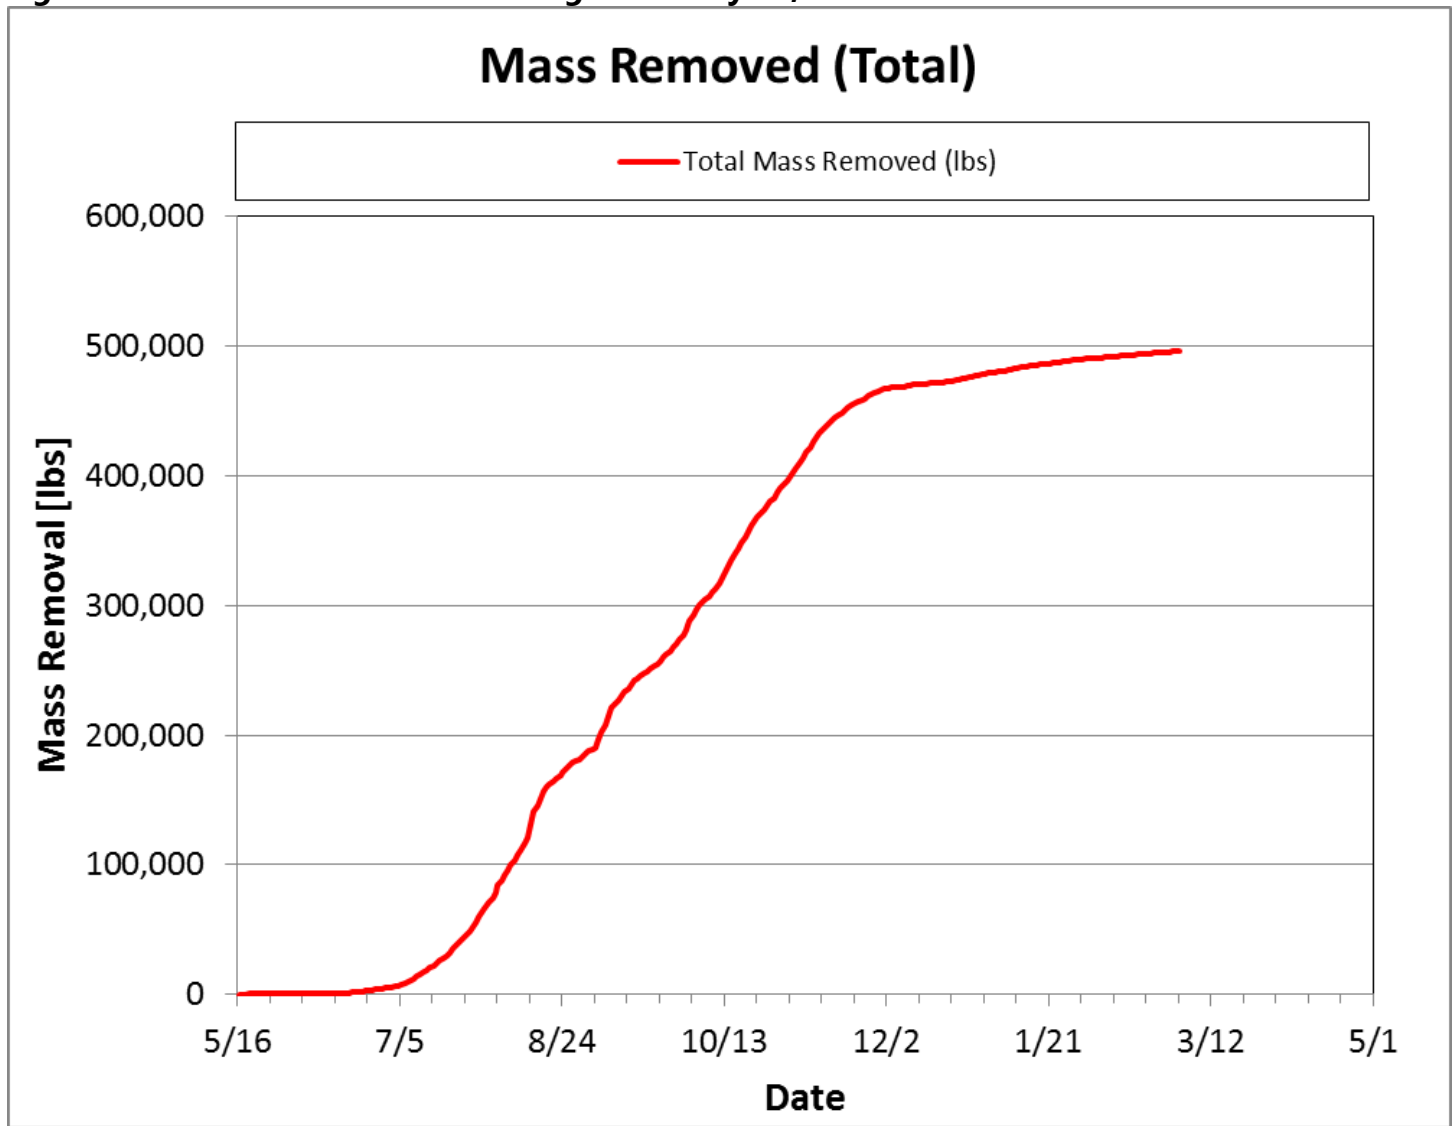
Figure 4 - Total Mass Removed through February 20, 2015

Total mass: 496,400 lbs.

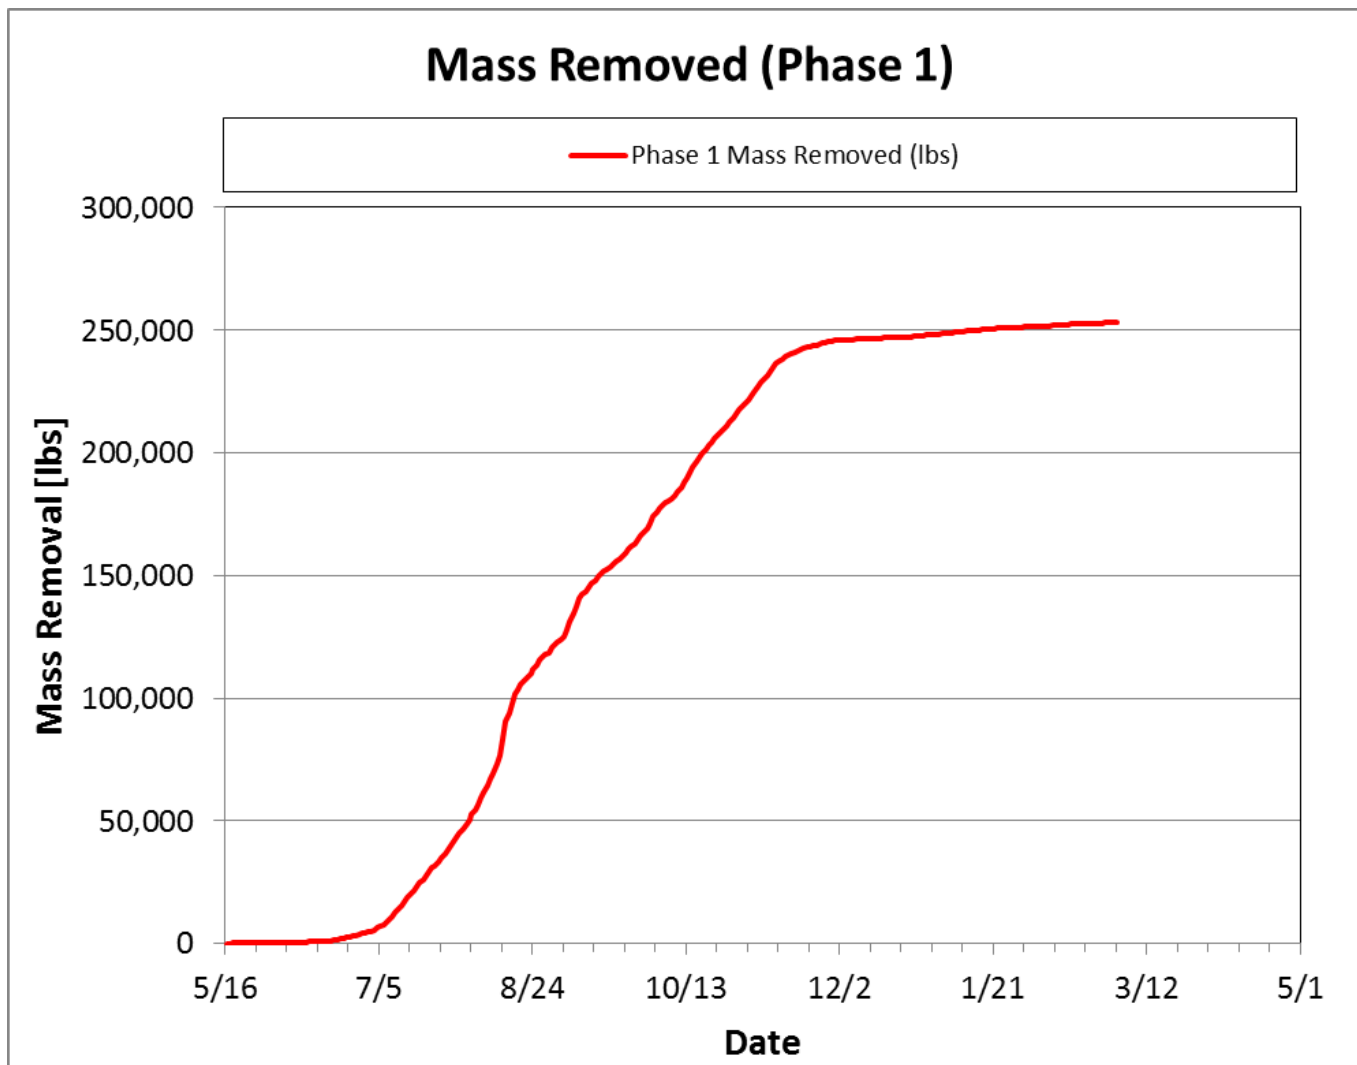
Figure 5 - Phase 1 mass removed through February 20, 2015

Phase 1 total: 253,000 lbs

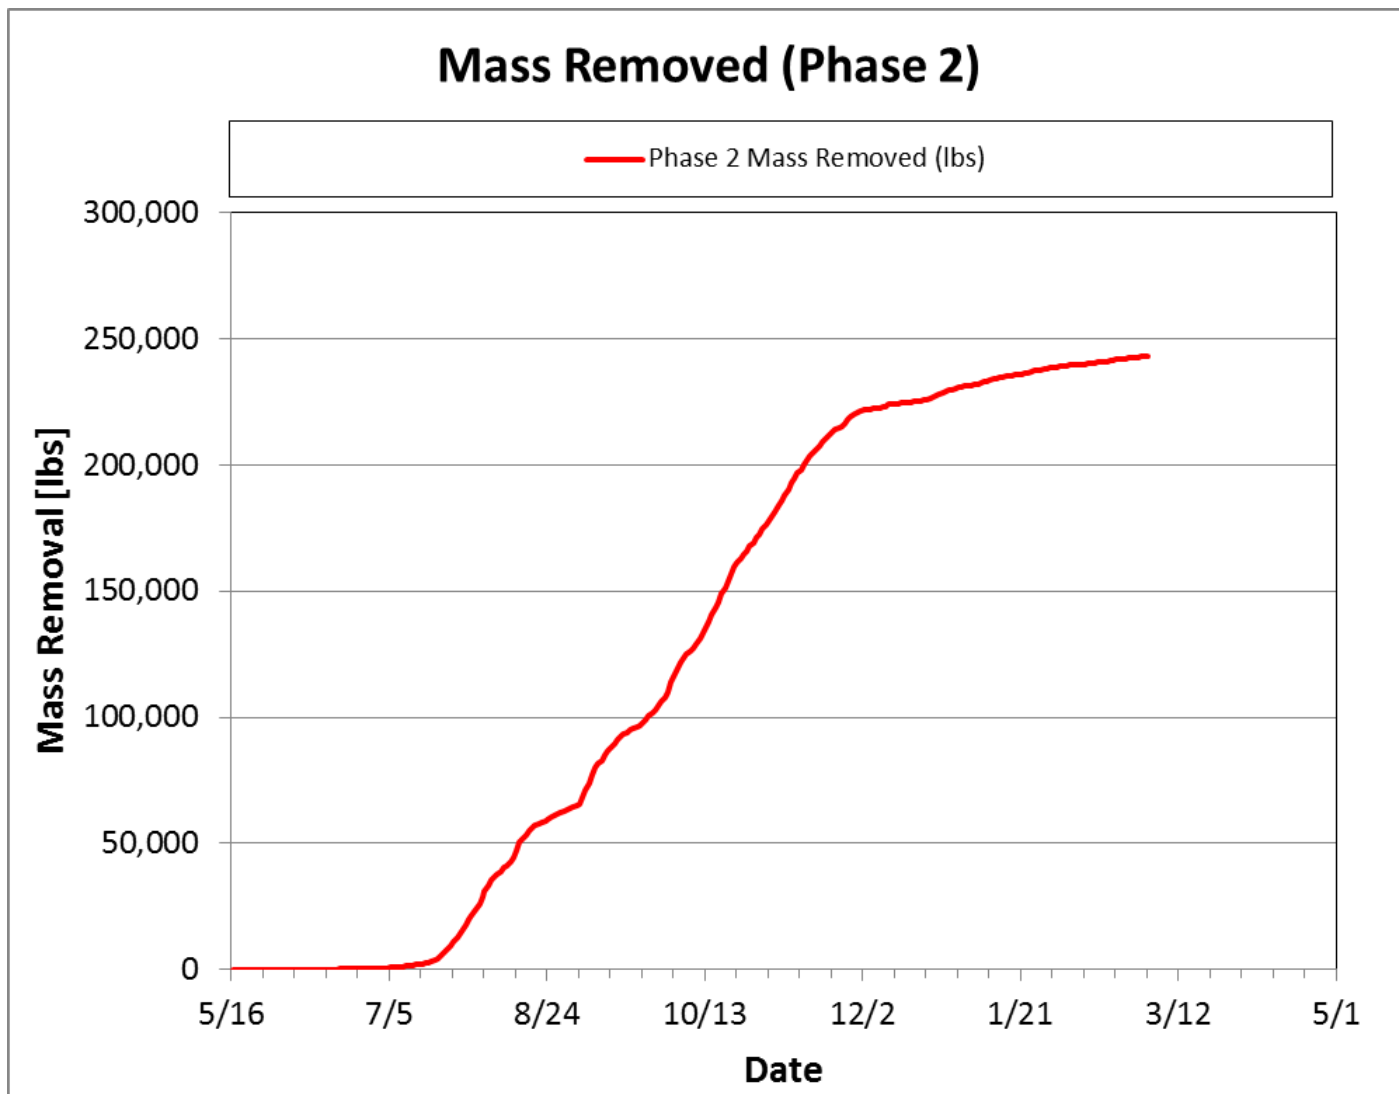
Figure 6- Phase 2 mass removed through February 20, 2015

Phase 2 total: 243,400 lbs

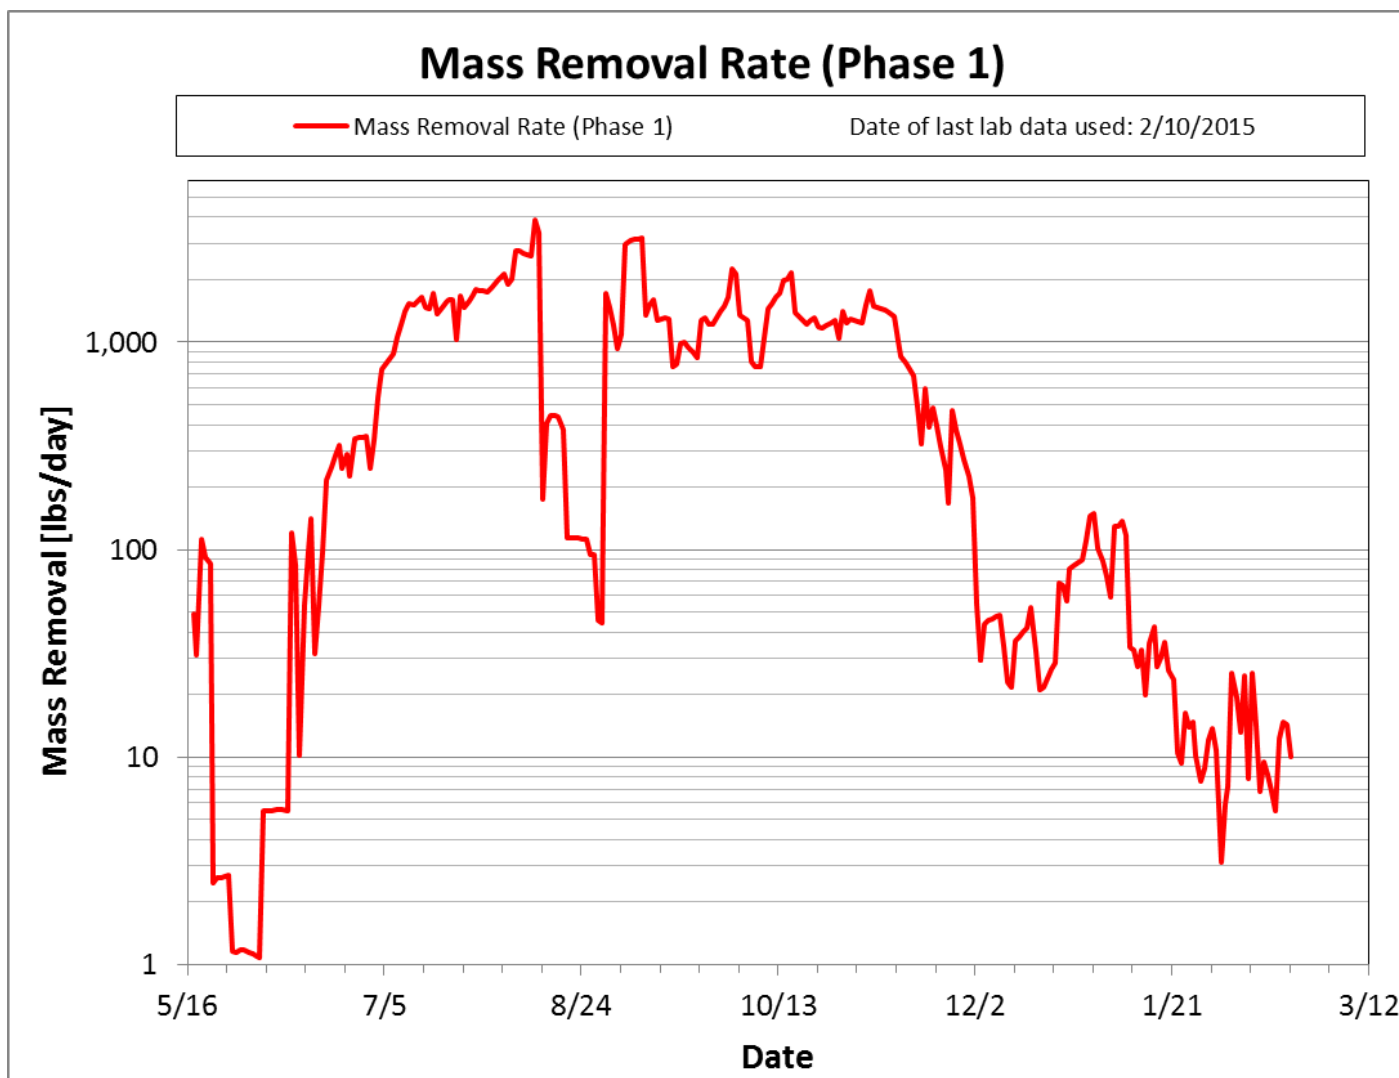
Figure 8 - Phase 1 mass removal rate (assumes all TO-15 reported compounds)

Average removal rate (13-20 February): 10 lbs/day

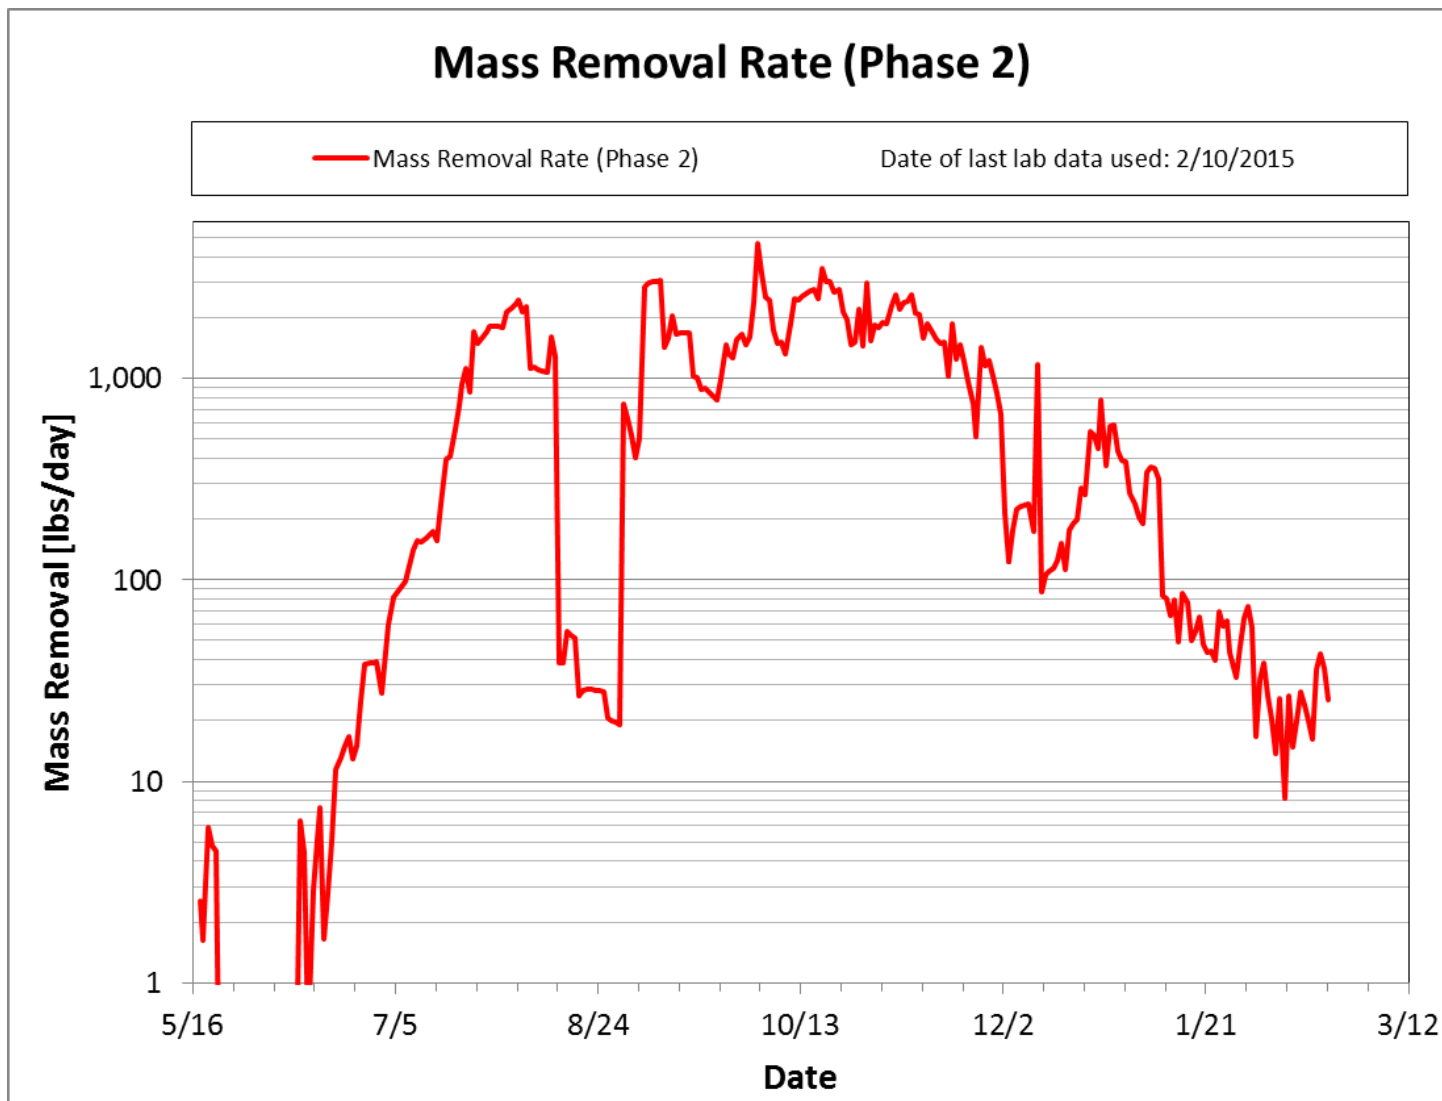
Figure 9 - Phase 2 mass removal rate (assumes all TO-15 reported compounds)

Average removal rate (13-20 February): 29 lbs/day

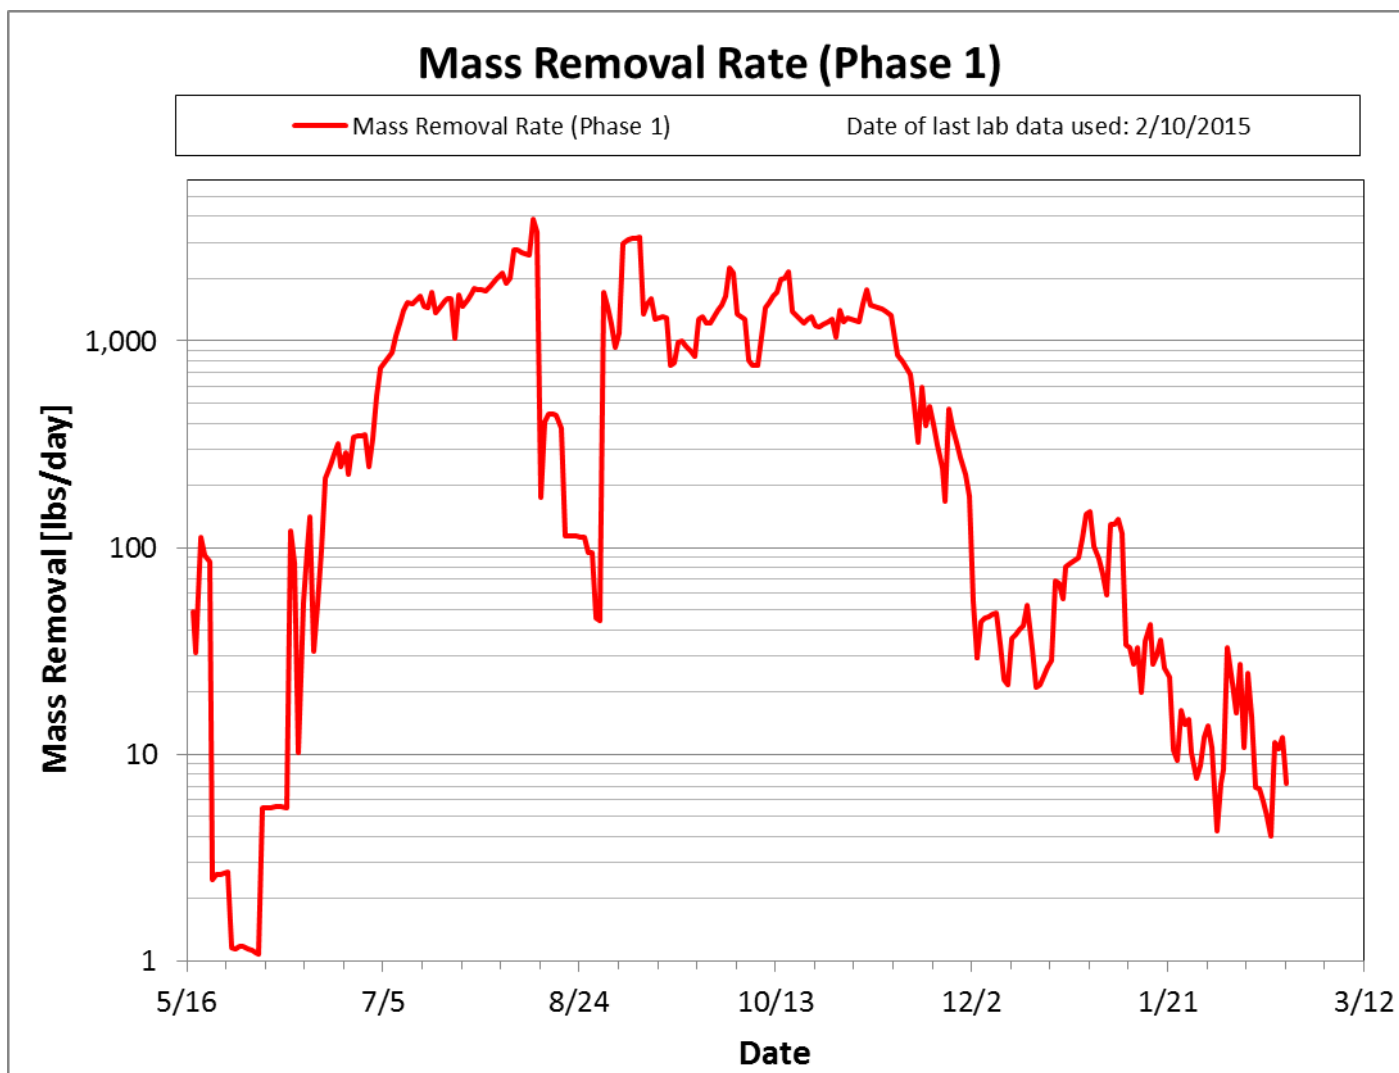
Figure 10 - Phase 1 mass removal rate (TO-15 reported compounds minus acetone and 2-butanone)

Average removal rate (13-20 February): 8.1 lbs/day

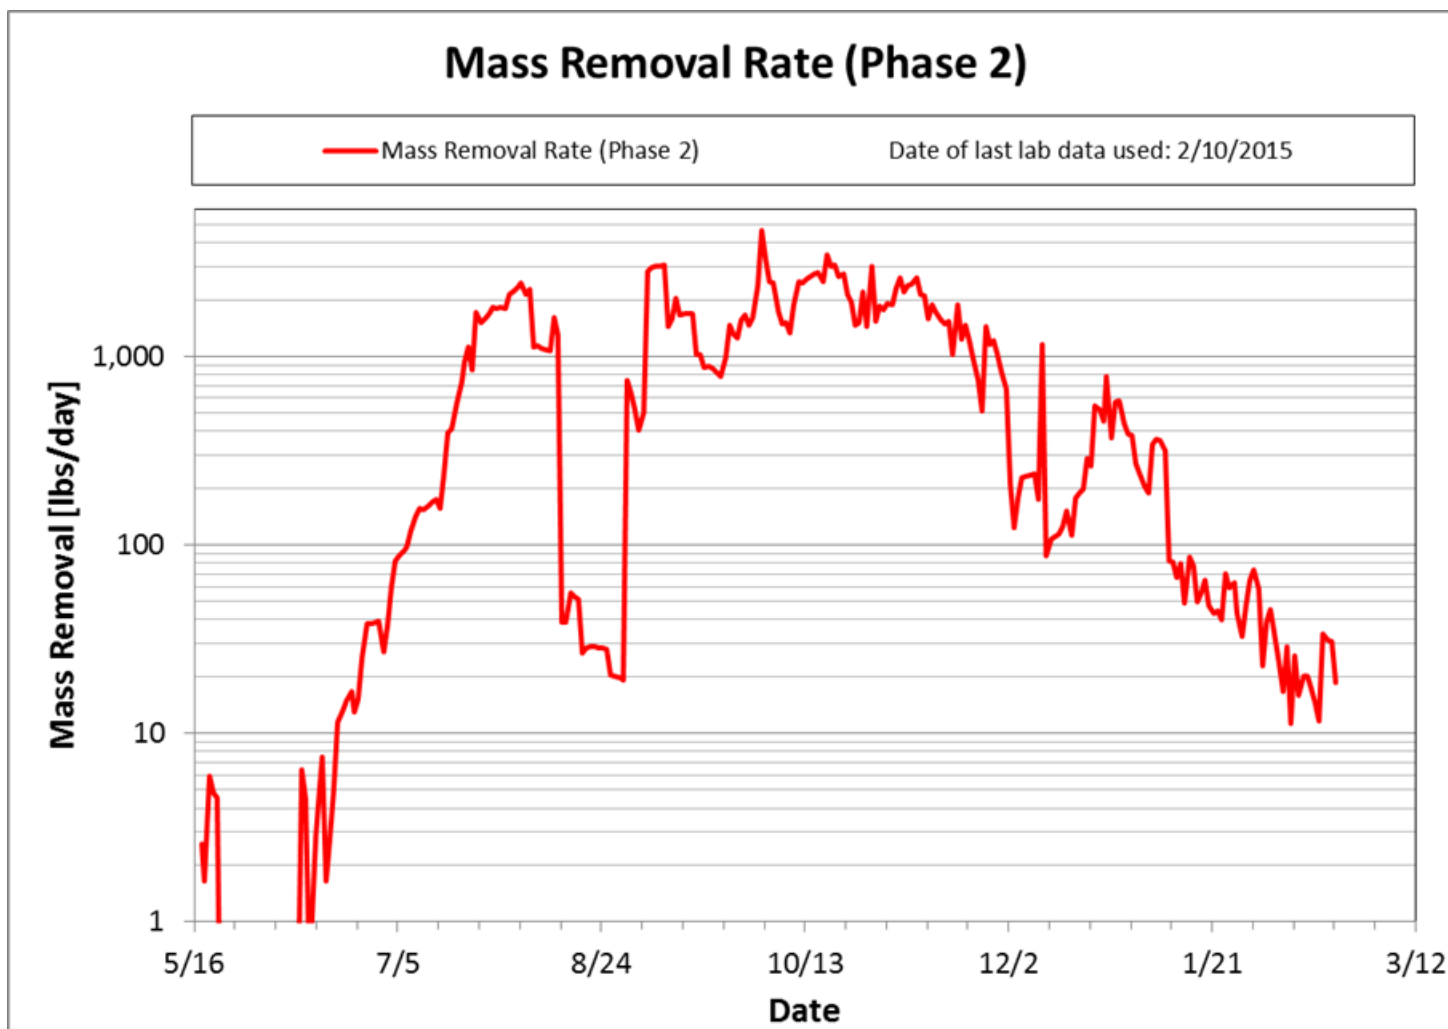
Figure 11 - Phase 2 mass removal rate (TO-15 reported compounds minus acetone and 2-butanone)

Average removal rate (13-20 February): 21.8 lbs/day

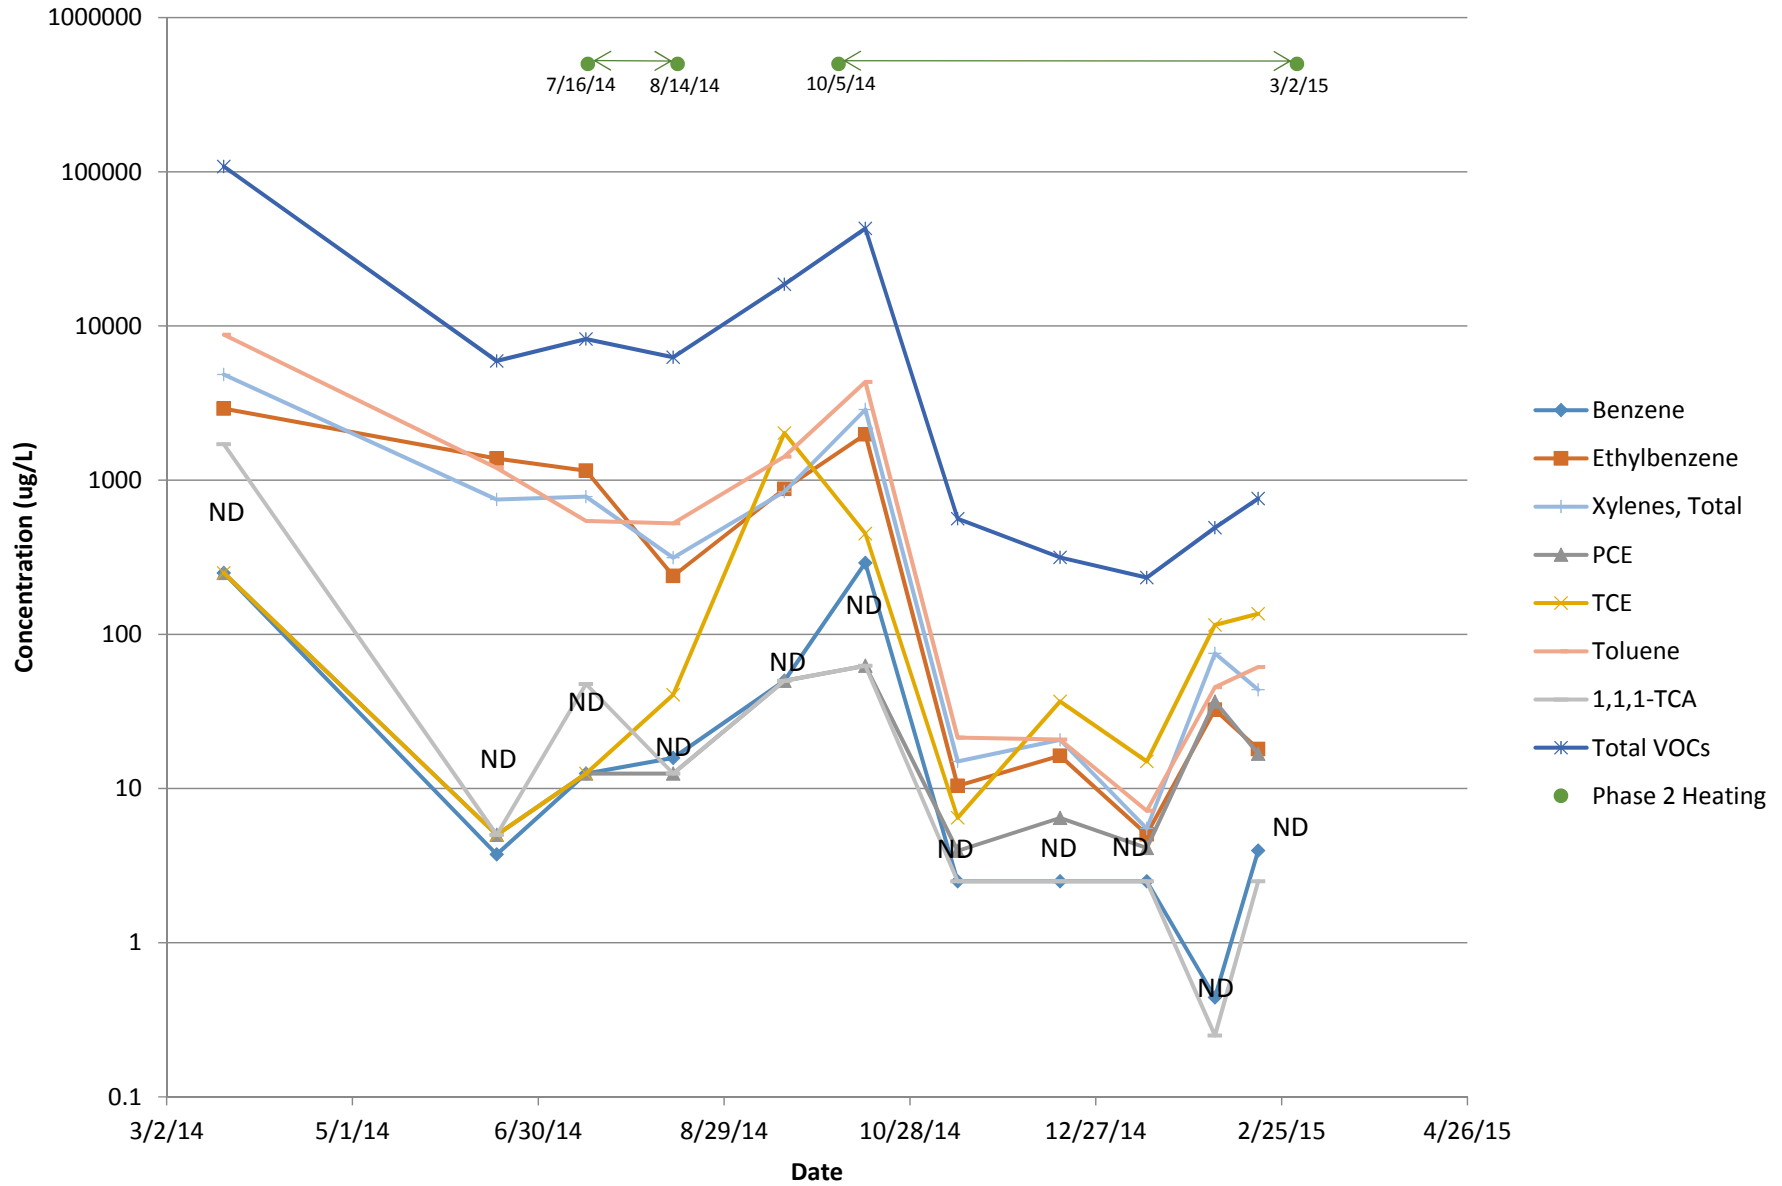
## ISTR-6 (Phase 2 Area)

NDs = 1/2 RL

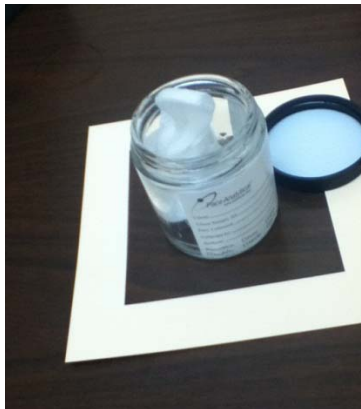
Wipe sampling follows the procedures in the US EPA's PCB spill cleanup guidance.<sup>1</sup> The lab will provide a 4 oz. soil jar with 5 mL of hexane inside the jar along with the 1" x 1" gauze. They will also provide one 10 cm x 10 cm wipe cardboard template (applicable for flat surfaces to show a 100 cm<sup>2</sup> area).

1. While wearing a new/clean pair of Nitrile (or other suitable) gloves, remove the cap from the sampling vial.
2. Remove the gauze from the sampling vial (the gauze will be pre-soaked with hexane).
3. Immediately begin applying the gauze using a gloved hand and, applying pressure, wipe the marked area completely twice, from left to right and then from top to bottom.
4. Let the gauze air dry.

5. Fold the dry gauze (sampled side inward) and return it to the sample vial.
6. Cap the sample vial.
7. Remove and discard the gloves.
8. Label the vial and fill out sampling details on the sampling forms.
9. Fill out chain of custody forms and prepare the sample for storage and shipping. Samples should be stored on ice until picked up by the laboratory courier or shipped on ice overnight to the laboratory for analysis.
