Case Study

LCP Chemicals Site

Phytoremediation Pilot Project

EPA Region 4

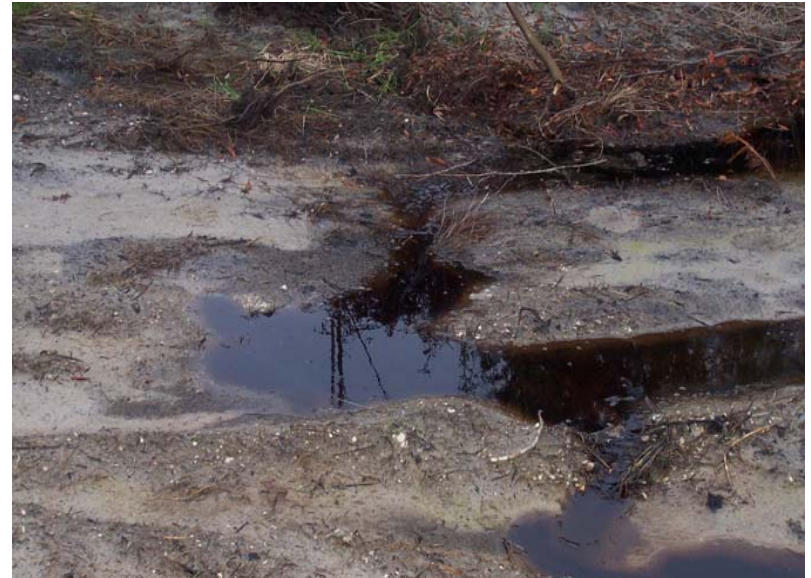
- During conditions of high water table, seepage of groundwater occurs along portions of the shoreline that separates the upland soils from the tidal marsh
- Dark brown color
- Some COCs present at elevated levels (74 ppb Hg and 60 ppb Pb)

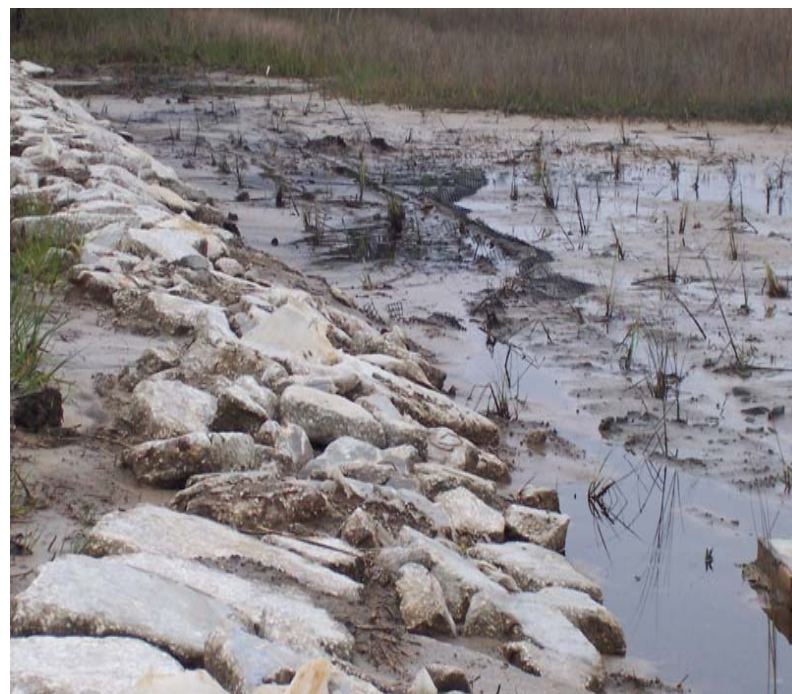
- **Installed a rip-rap border between the upland areas and the newly dredged zone using concrete pieces from on-site stockpiles**

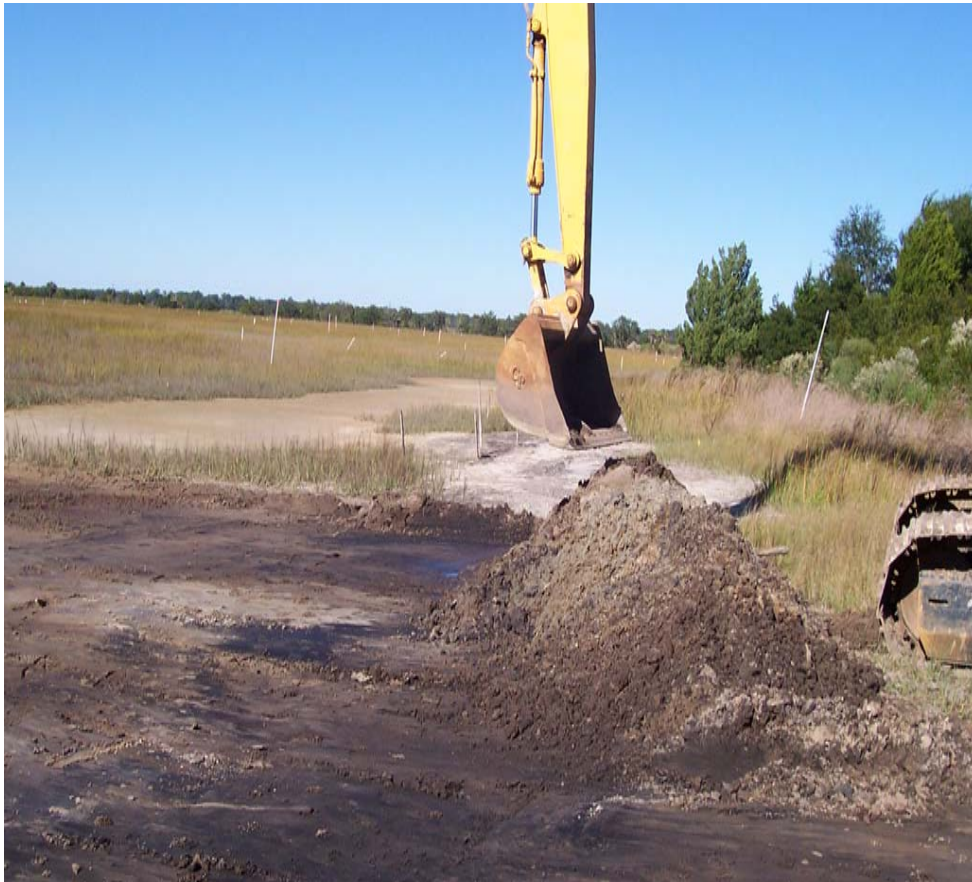
- **Excavated and stockpiled approximately 1,160 CY of marsh sediments**

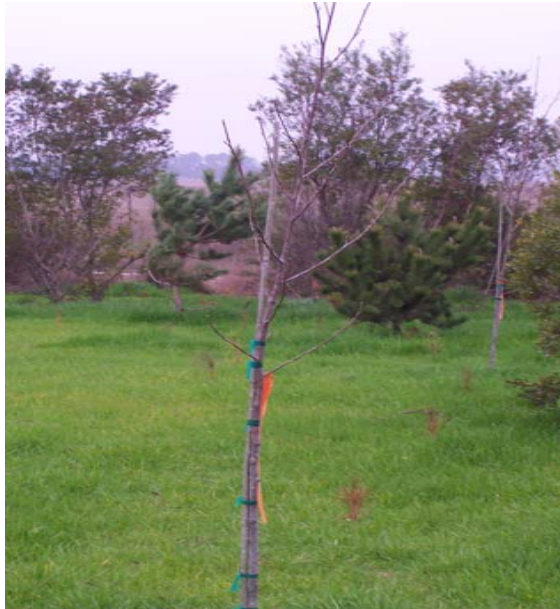
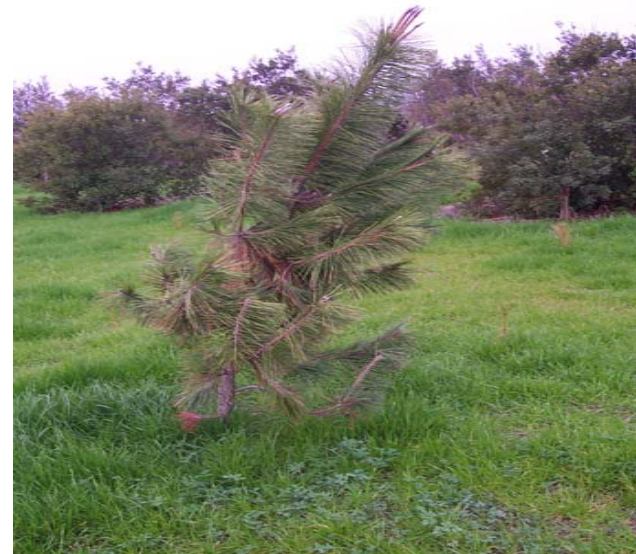
- **Planted trees, shrubs, and grasses within the specified area**
