# Phytoremediation Success and Experience at a Site in Southern New Jersey

# Edward Sears Property Site

## New Gretna, New Jersey

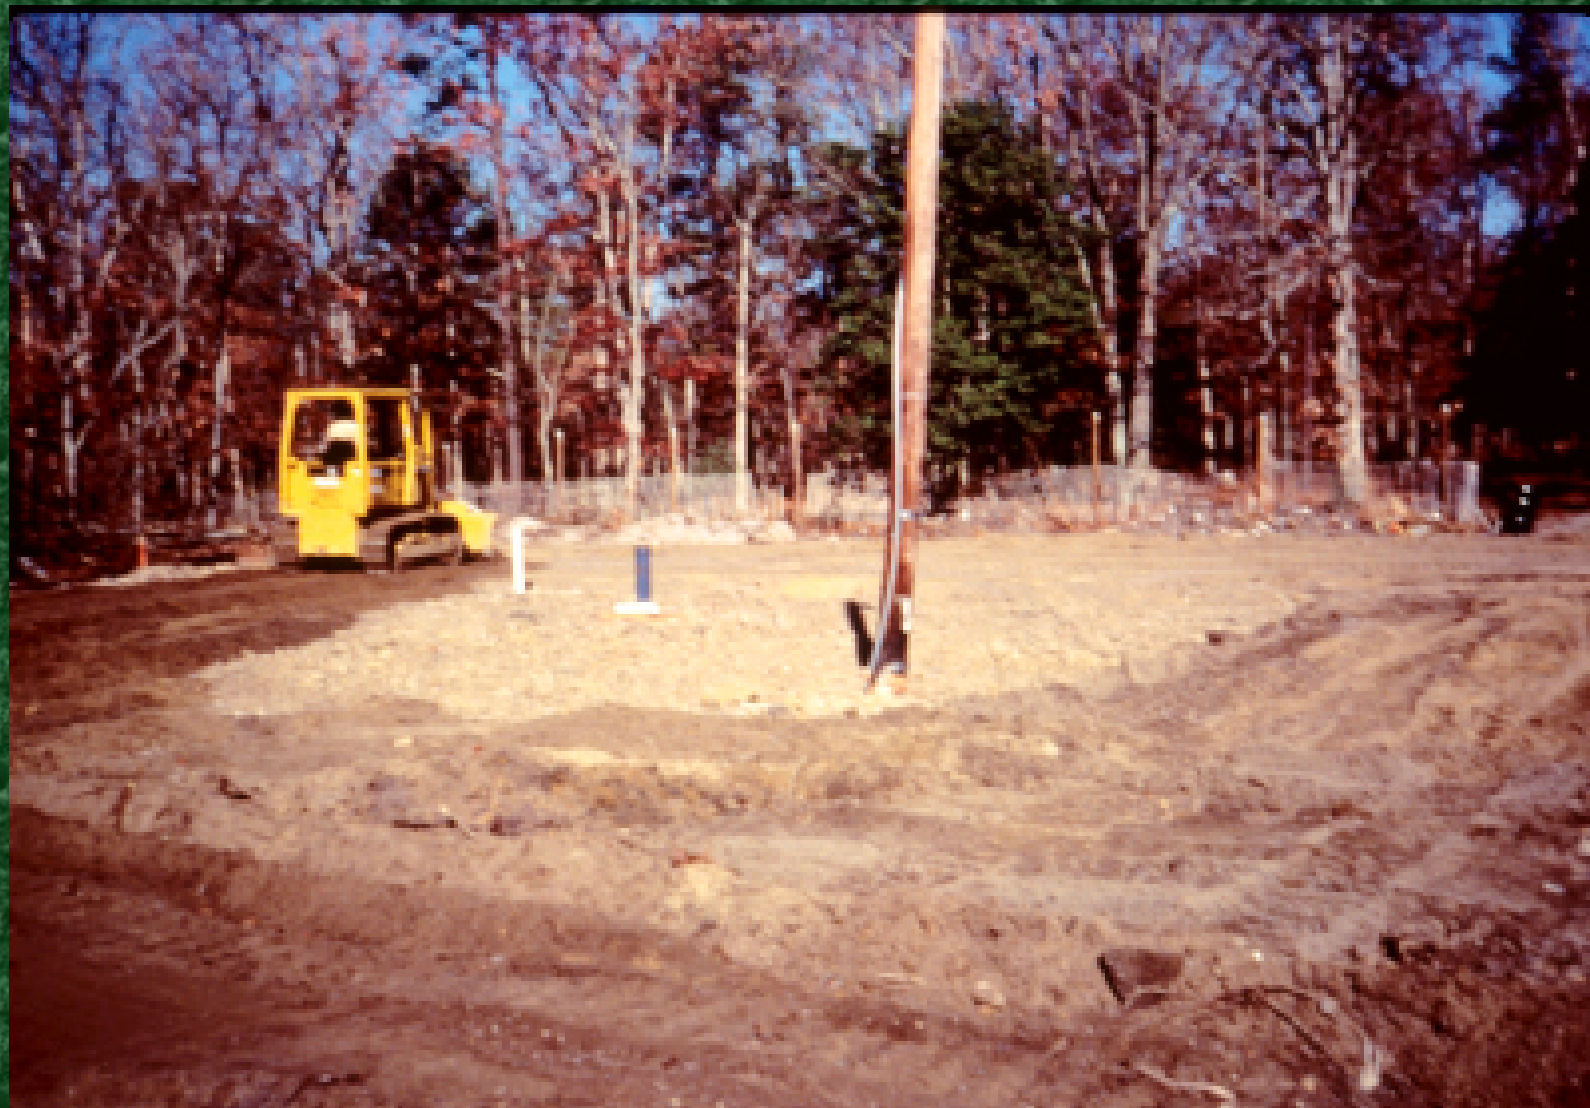
- Trees planted in December of 1996.
- Trees averaged 14 feet in length.
- Holes dug with a 12-inch width auger, 15-feet deep.
- A 4-foot sonotube was placed in the upper portion of the hole, from 1 to 5 feet bgs.
- A plastic barrier placed on top, around the tree trunk.
- Trees planted down about 9 feet bgs.
- Amended soil and nutrients placed in the hole.

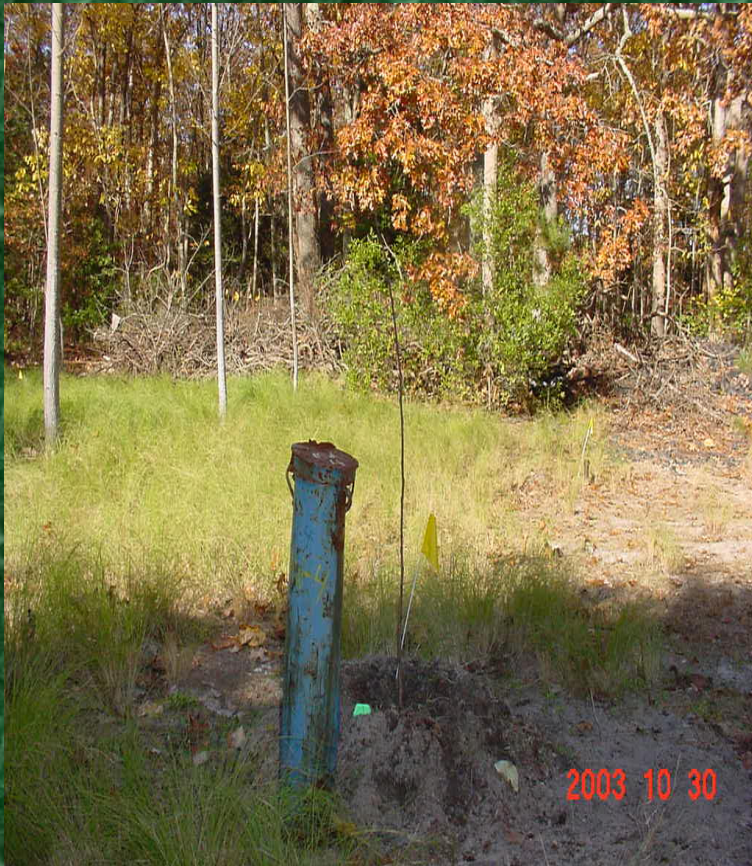
# Ground Water Sampling

- Occurs at least once per year (late August)
- **VOCs within the plot have dropped considerably!**
- VOCs outside the plot remain high.

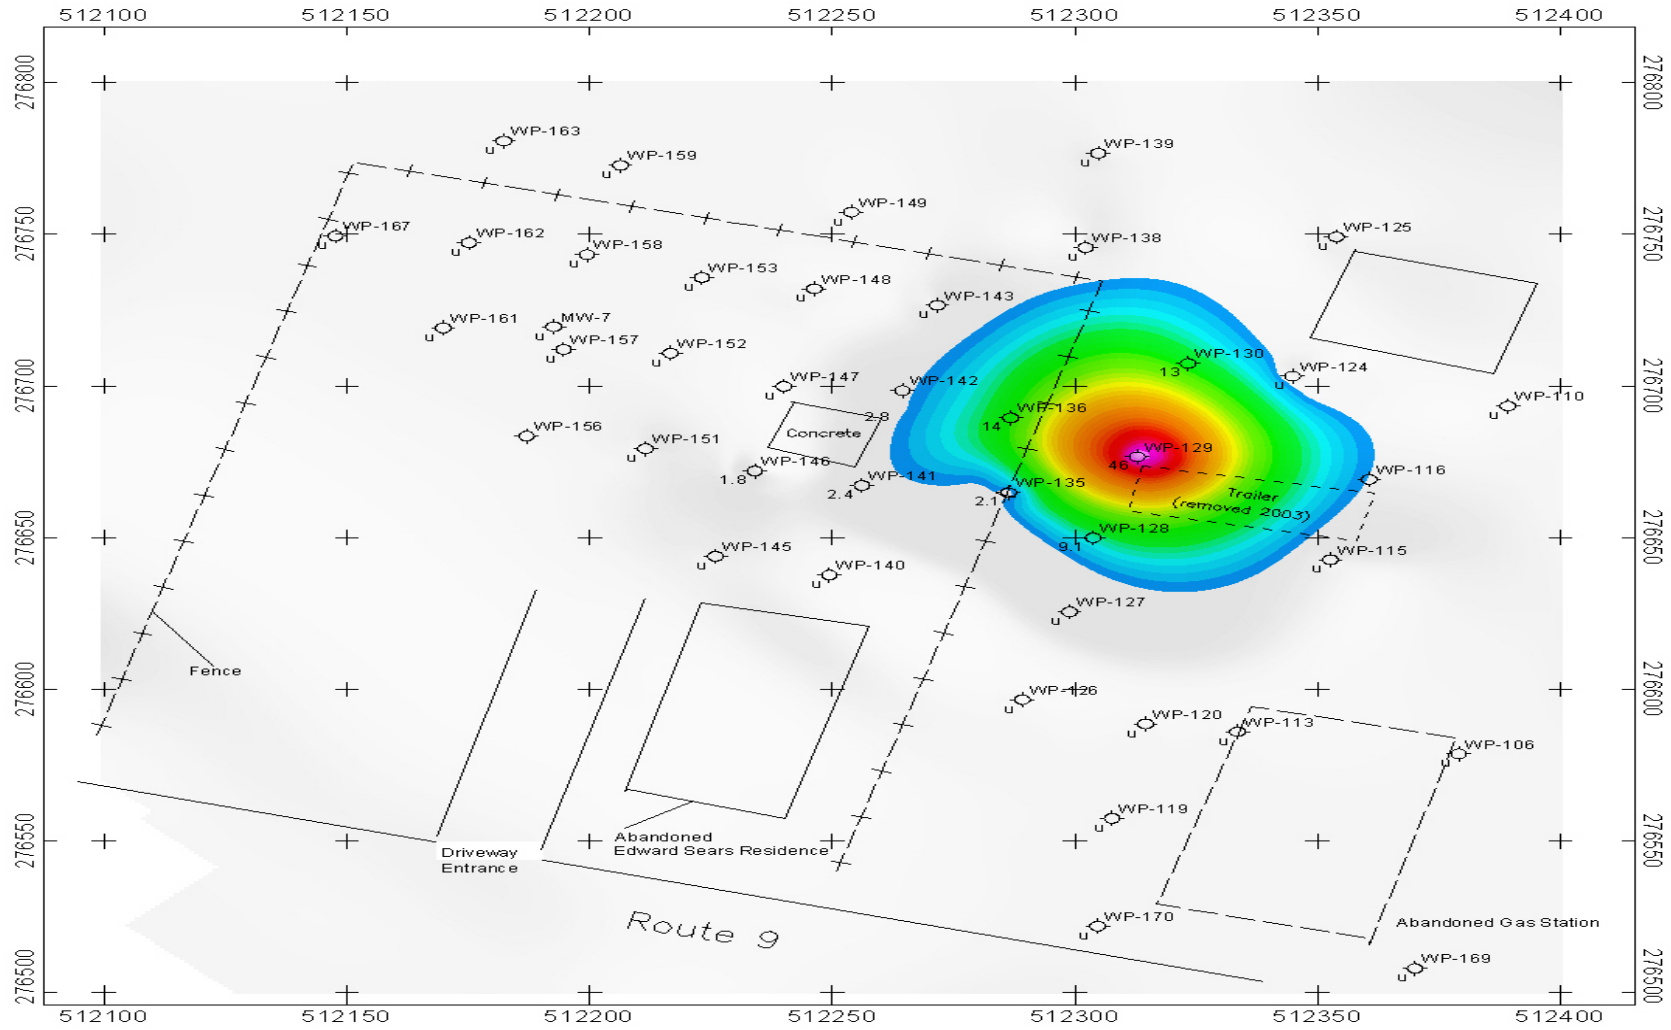
Figure 4. TCE Concentrations in Groundwater  
 Edward Sears Property  
 New Gretna, New Jersey  
 March 2005

WP-000 — Well ID  
 Sample Point  
 Trichloroethane (TCE) Concentration in Groundwater  
 (u = undetected, Data from August 2004)  
 ug/L = micrograms per liter

## Considerable Reduction of VOCs in Ground Water

- Trimethylbenzene (total) reduced from 1,890  $\mu\text{g/L}$  to 19.1  $\mu\text{g/L}$  .
- Xylenes (total) reduced from 545  $\mu\text{g/L}$  to nondetectable.
- All VOC contamination plumes have shrunk in size.
- No VOC reductions in an untreated, positive control area.

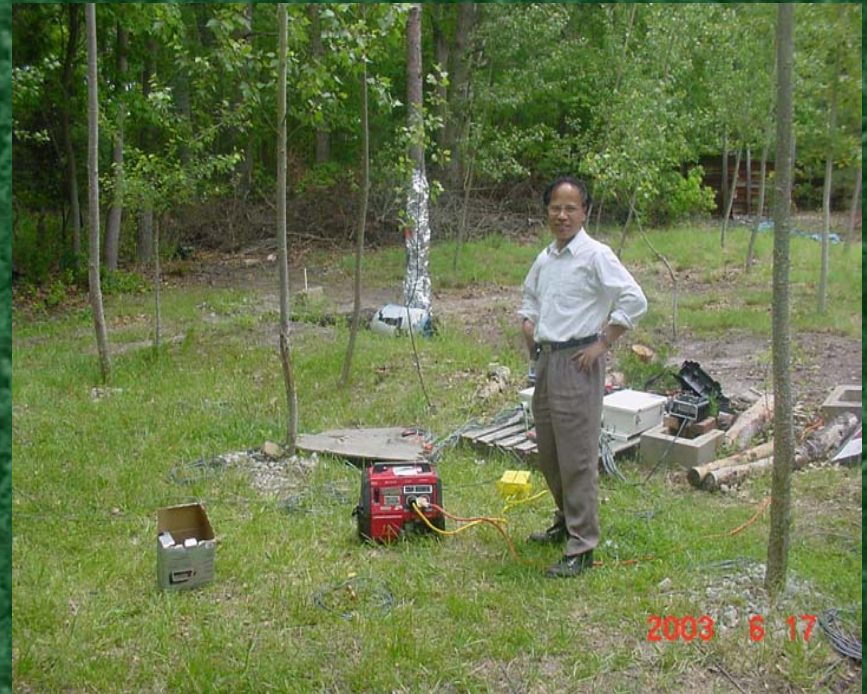
# Sap Flow Rates

- Measure ground water removal by the trees.
- Varies with season, weather, size, location, and health of the trees.
- Allows comparison of the native trees with the hybrid poplars.

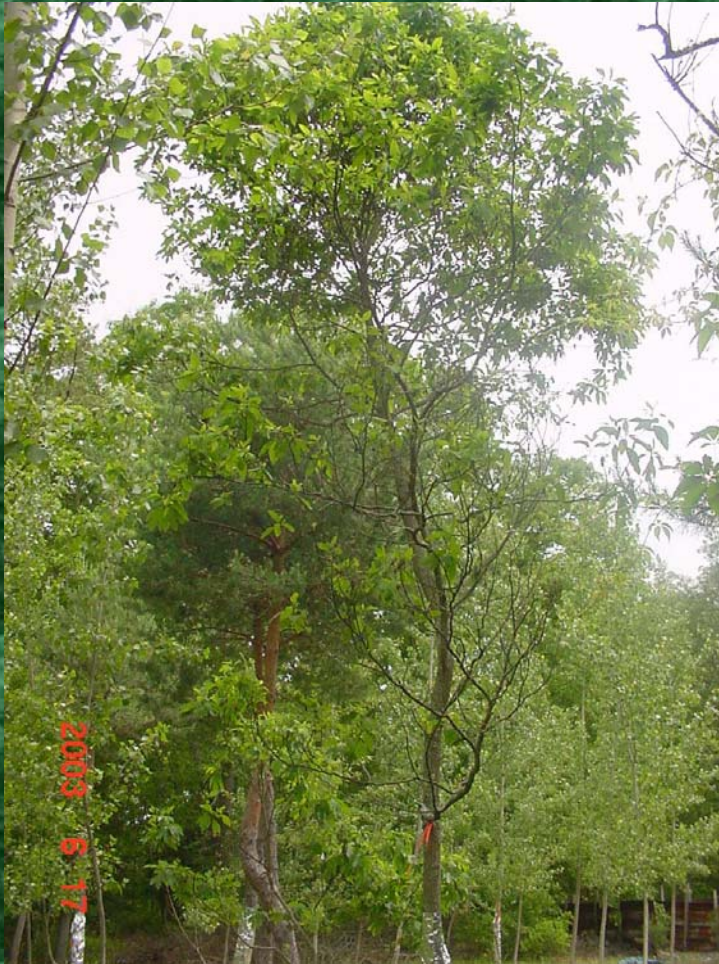
# August 2004 Average Sap Flow Rates of Selected Trees (Gallons per Day)

- Poplar No. 67= 9.62
- Poplar No. 92= 20.76
- Poplar No. 94= 7.58
- Pine= 5.54
- Red Cedar= 1.94
- Spruce= 10.51
- Sassafras= 16.54
- Oak= 2.08
- Poplar (avg.)= 9.64

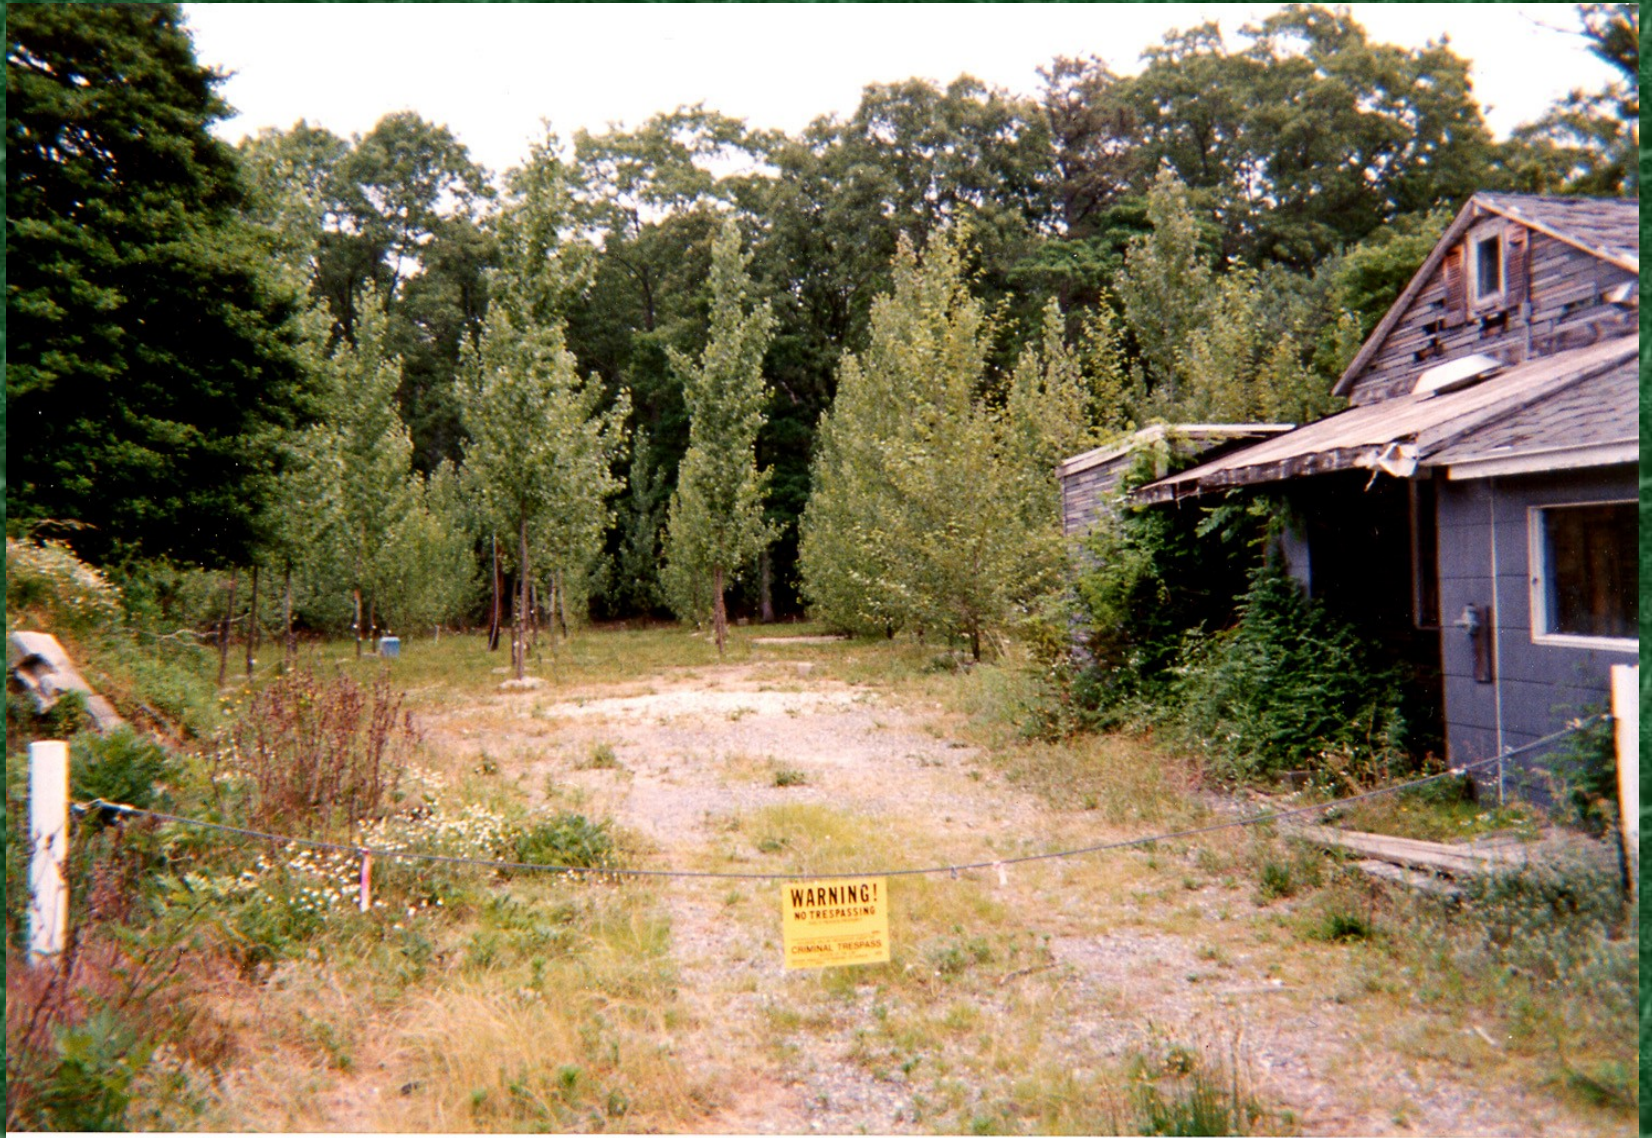
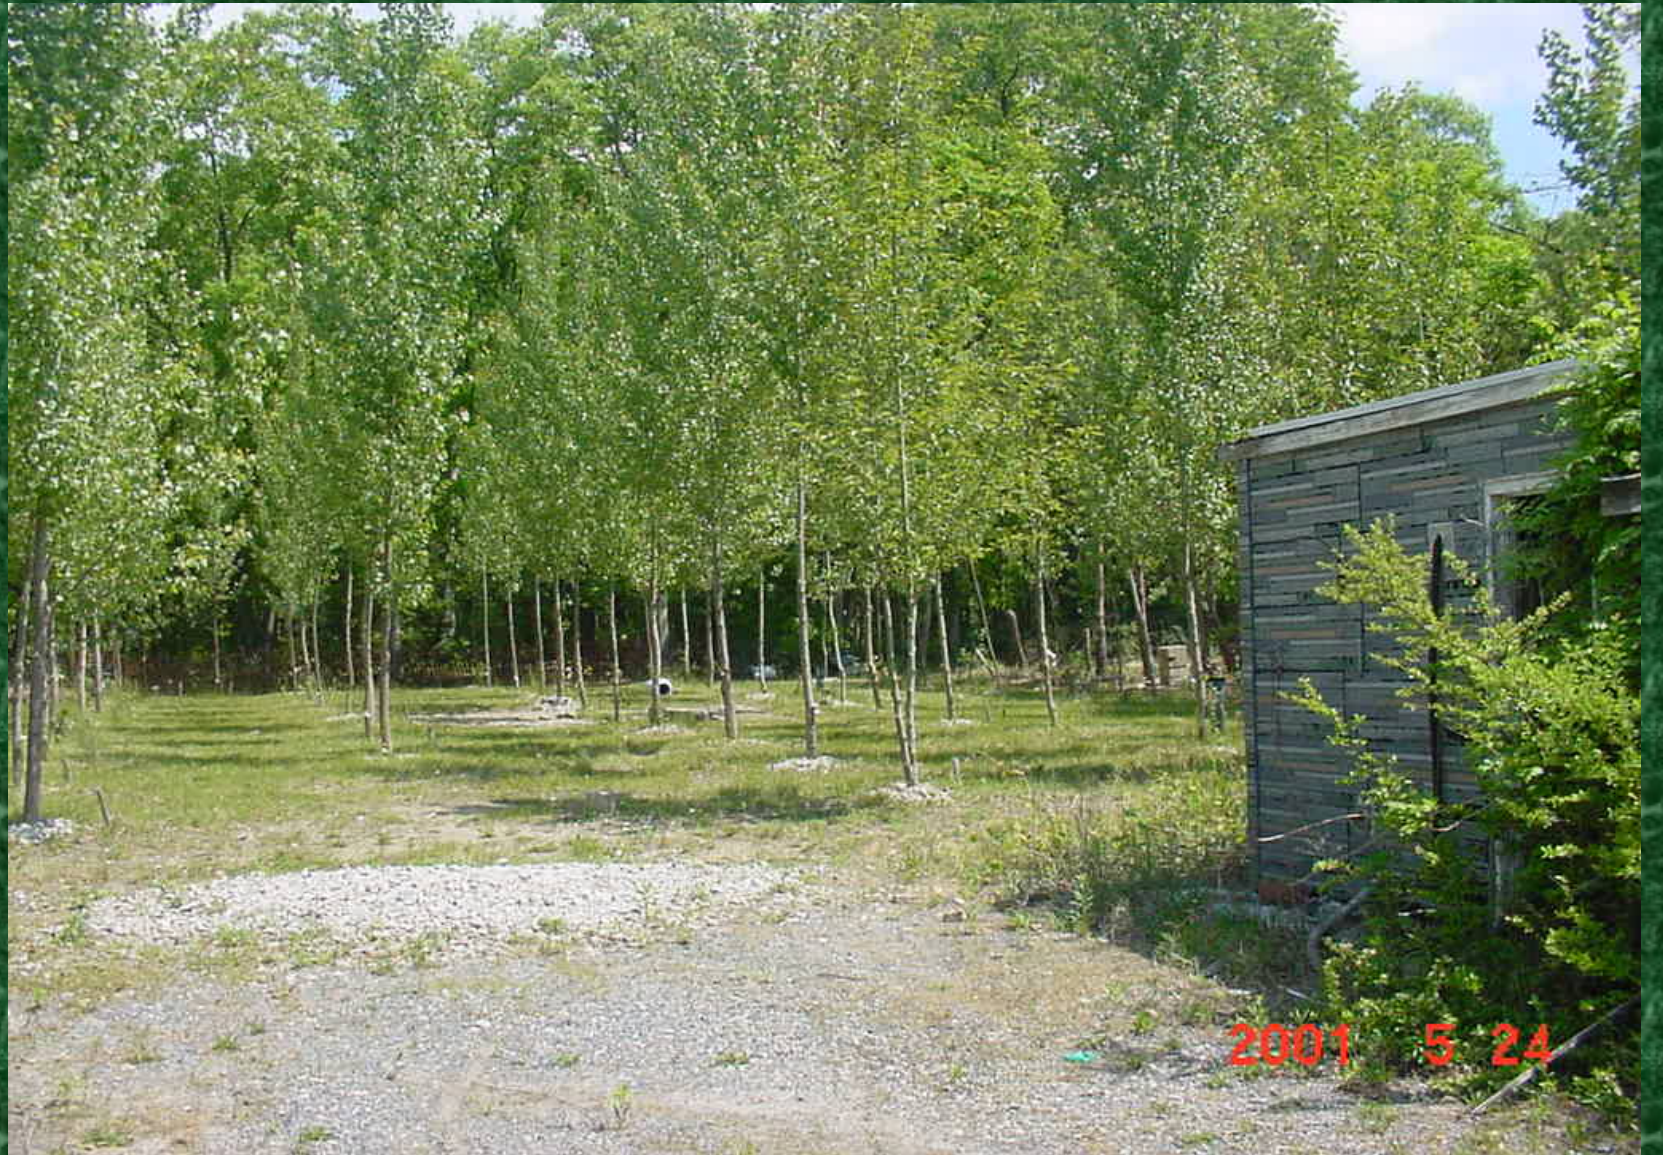
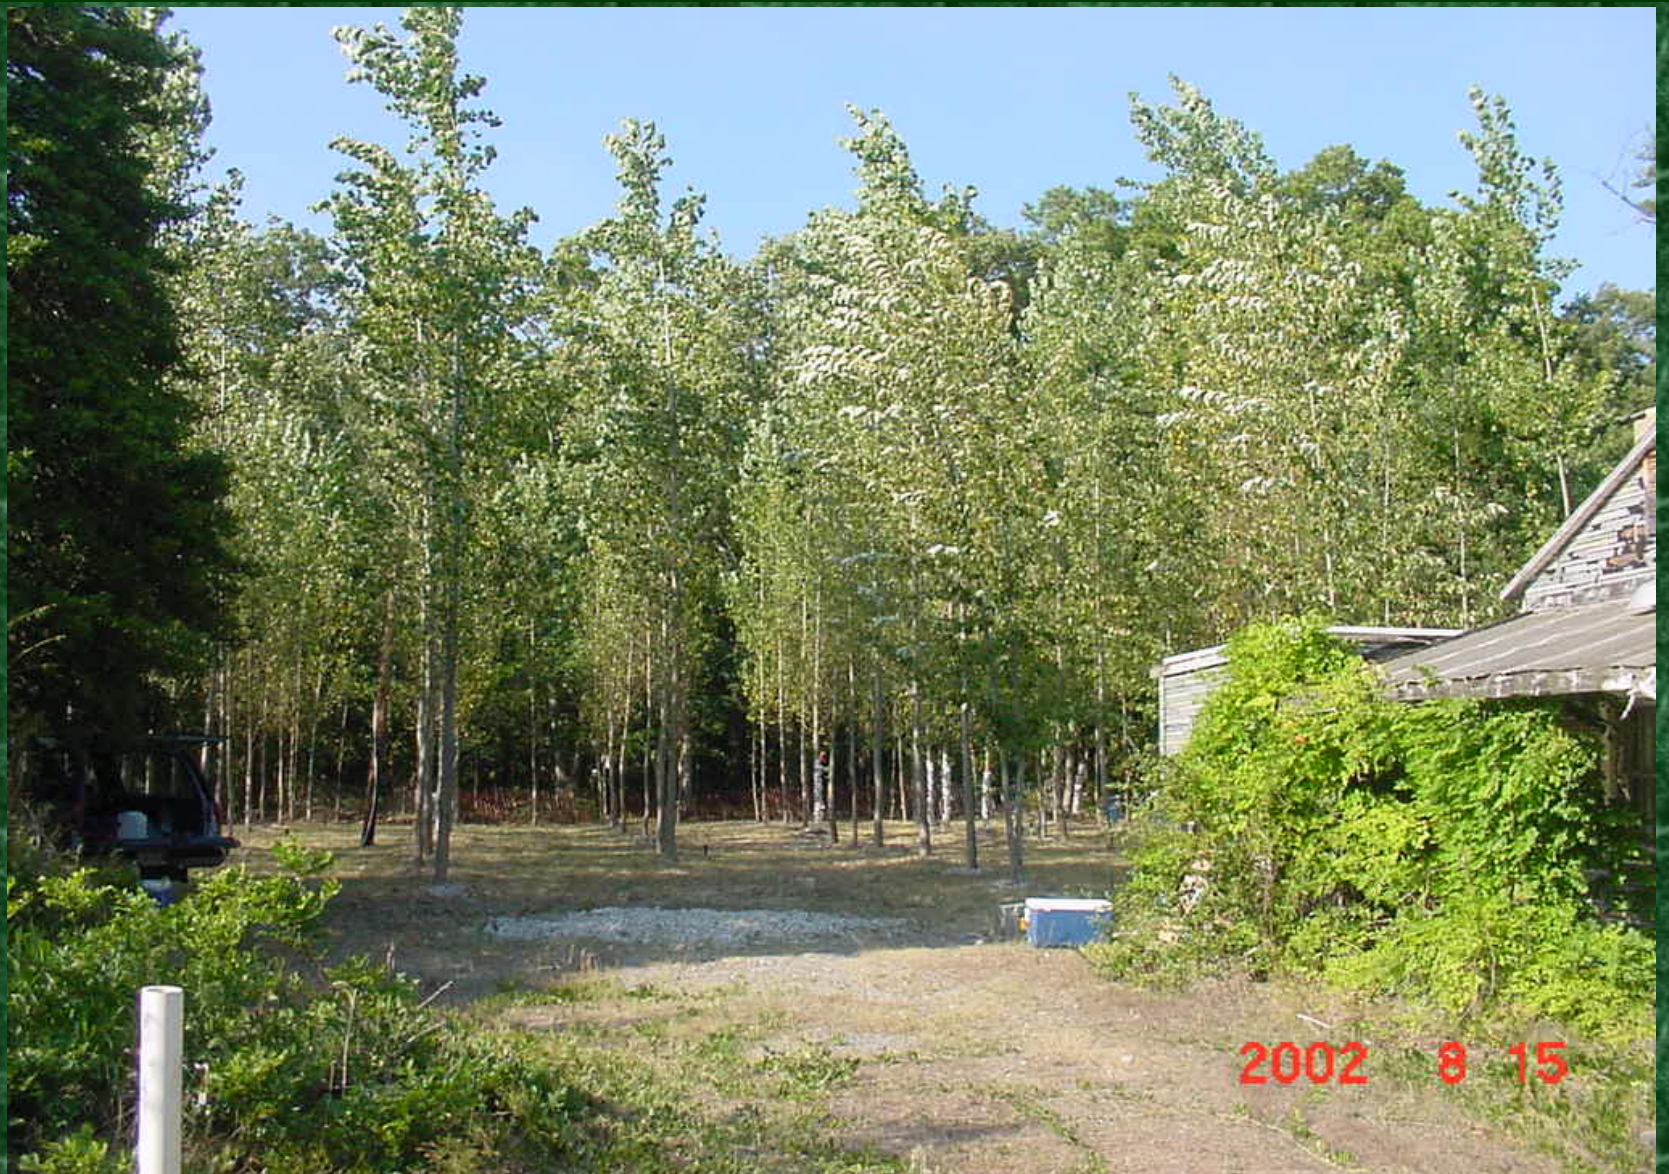
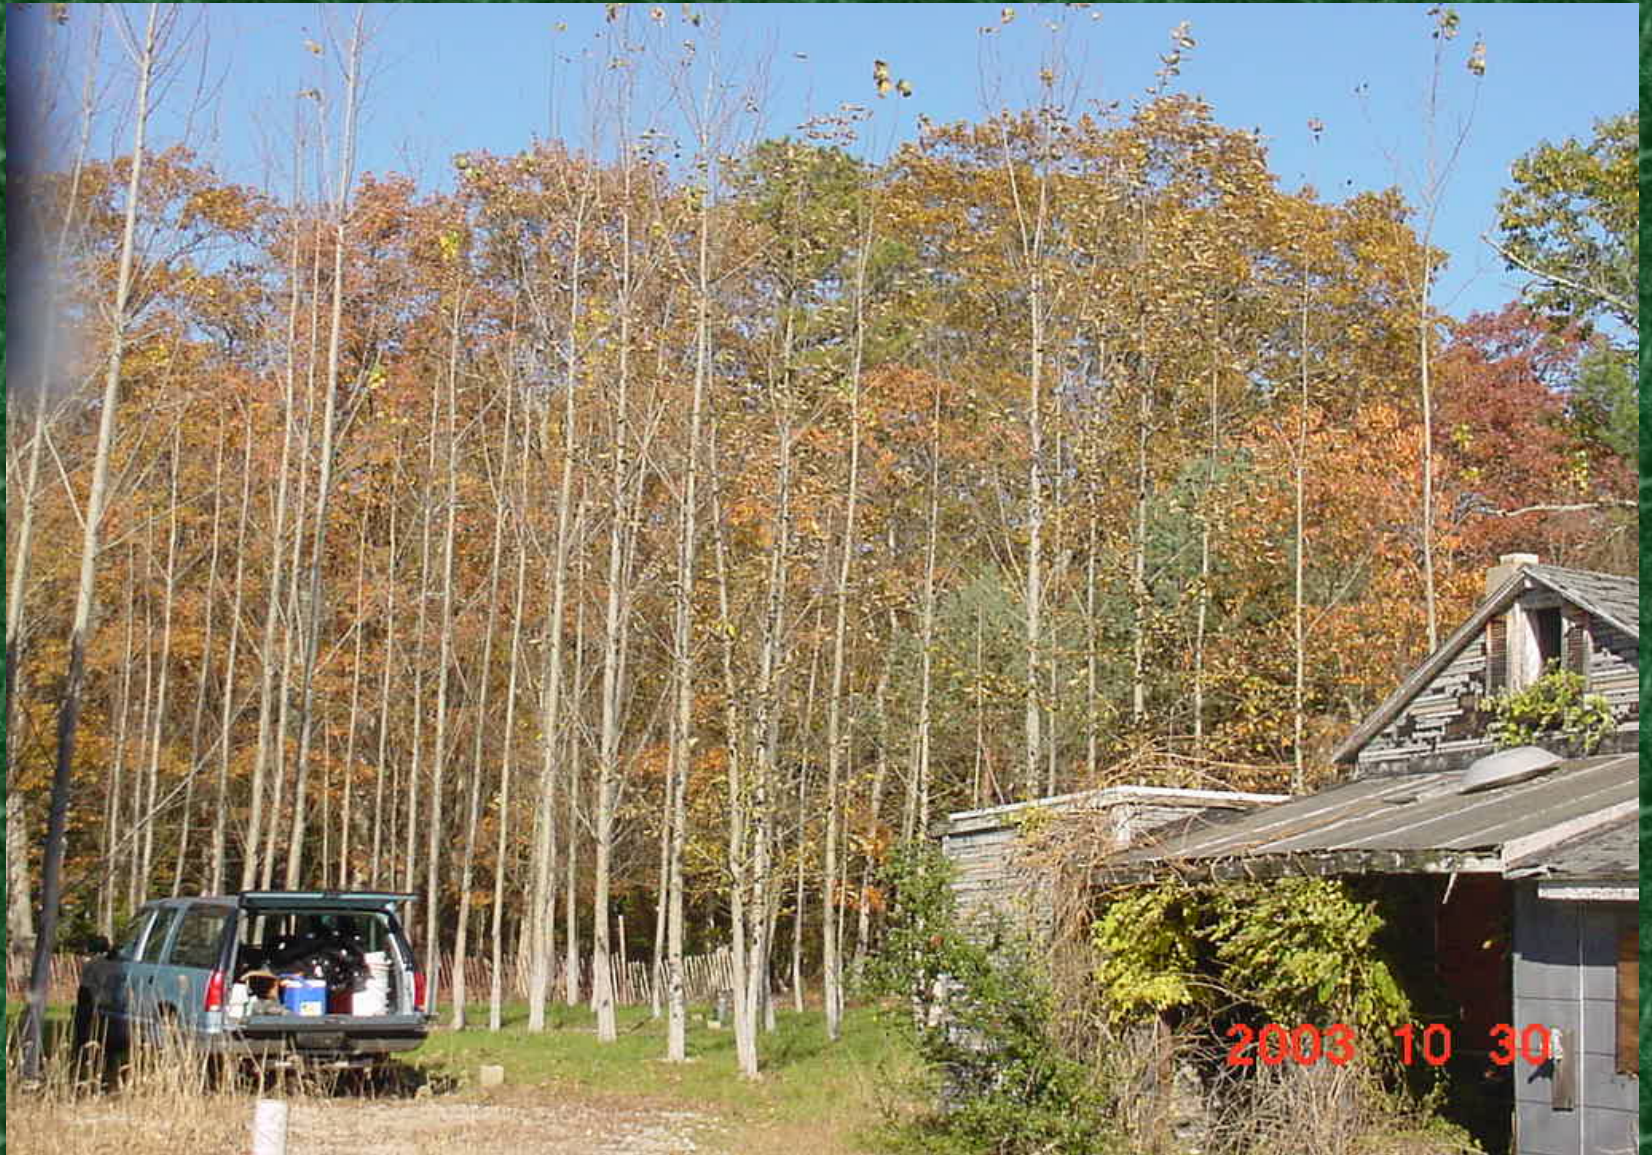
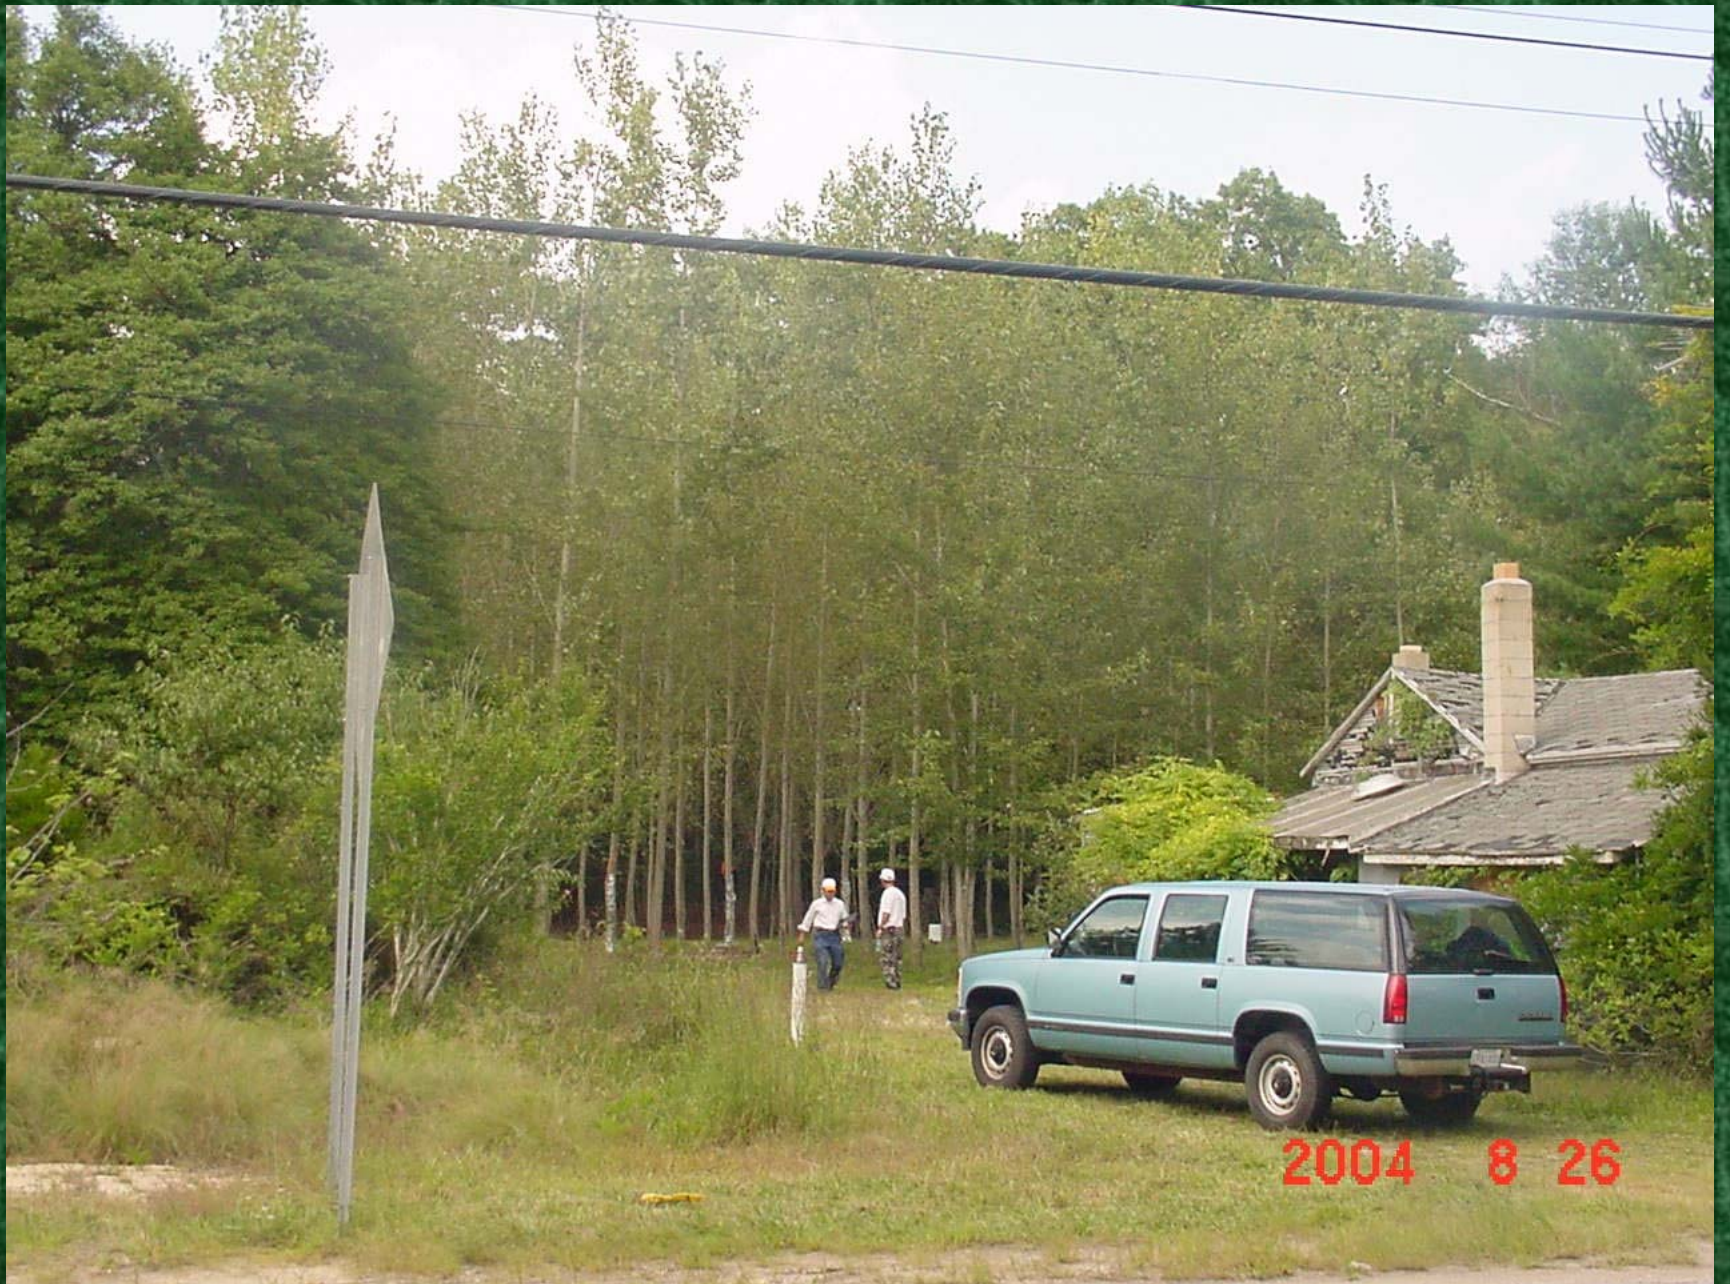
# Tree Growth Monitoring

After eight growing seasons (1997-2004):

- Average diameter of all the trees at breast height (dbh= 4.5 feet above ground surface) was 3.79 inches (9.62 cm).
- Largest diameter was 7.83 inches (19.86 cm).
- Average tree height was 43.77 feet (13.34m).
- Tallest tree was 59.27 feet tall (18.06 m).

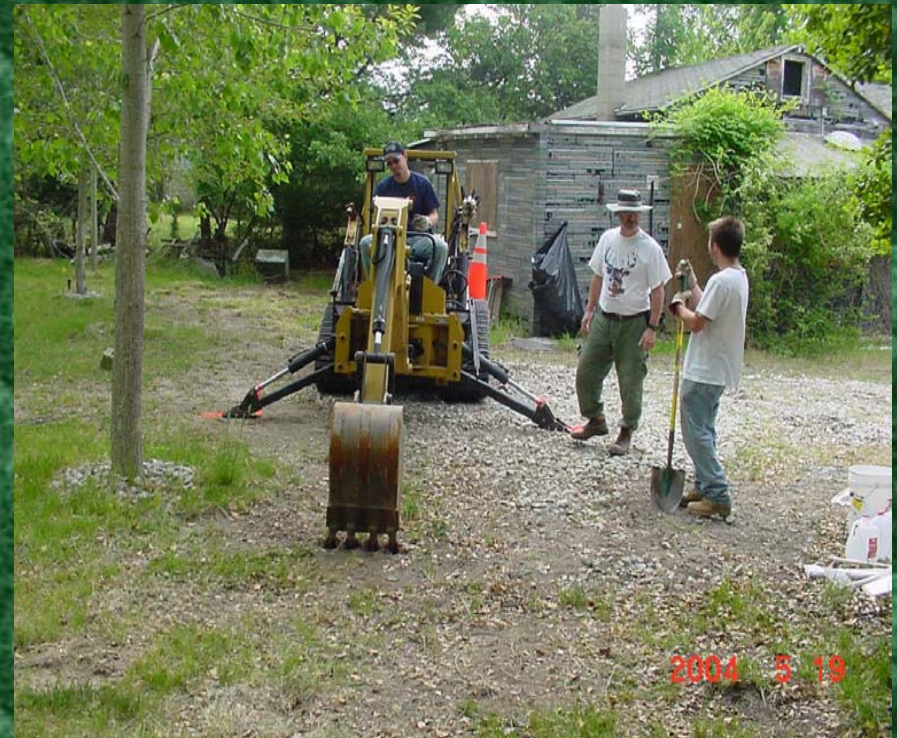
- Poplar No. 55 examined May 2004.
- A small backhoe was used to dig along one side of the tree.
- Surface roots continue more than 12 feet (4 meters) from the tree base.

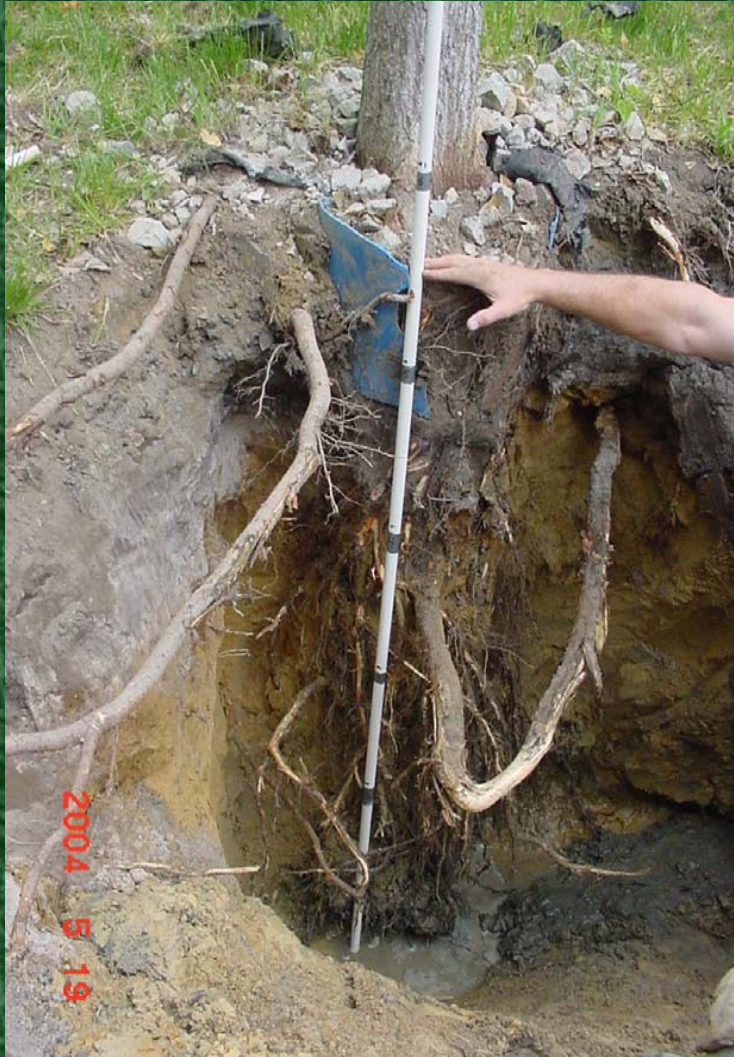
# Down They Go!

- Plastic surface barrier still intact and filled with gnarled roots.
- The sonotube was almost gone, but the root distribution showed evidence of it's former presence.
- Roots were still present at 7 feet (2.1 meters) bgs, becoming increasingly sparse and finer with depth.
