Phytotechnology Studies for Passive Groundwater Management at a Closed Waterfront Landfill: Lessons Learned

Steven Rose,
Malroz Engineering Inc.

Third international Phytotechnologies Conference
Atlanta, Georgia
April 20-22, 2005

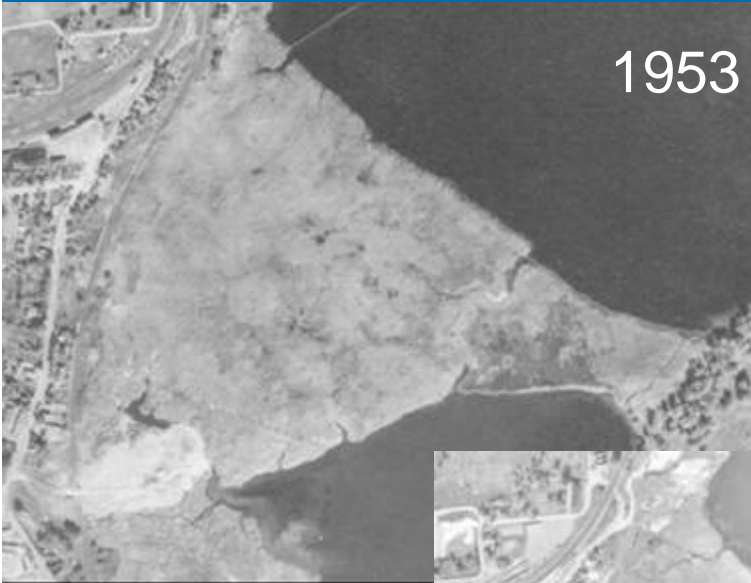
1953

Landfill Development

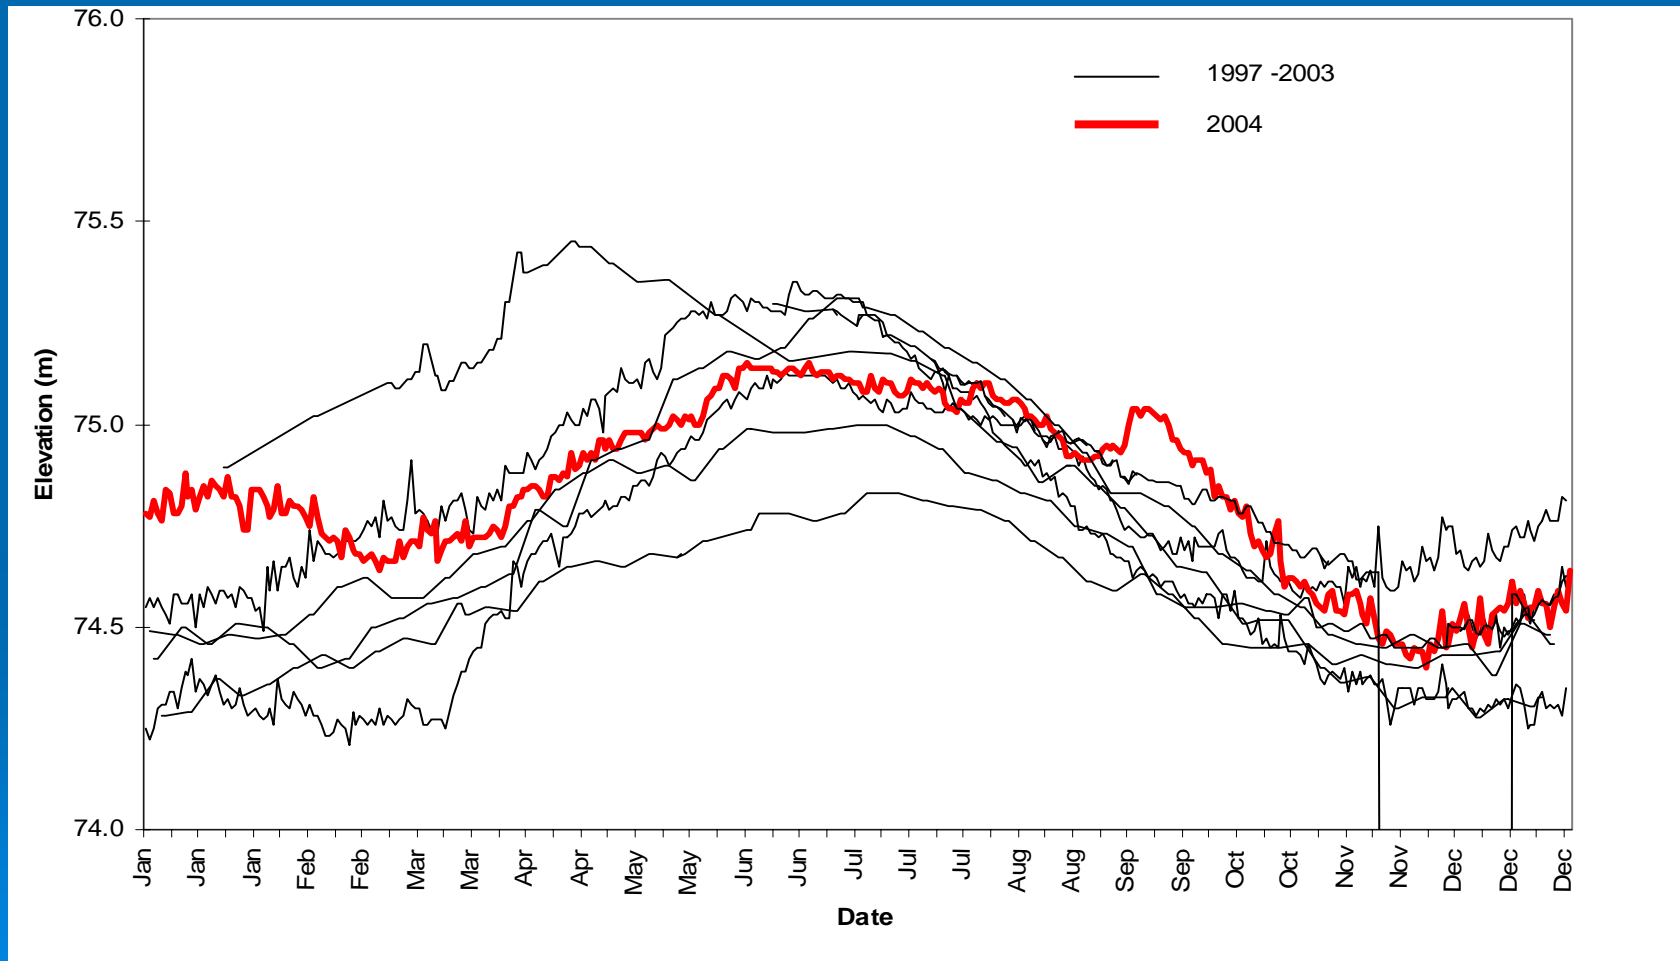
River Elevations (masl)

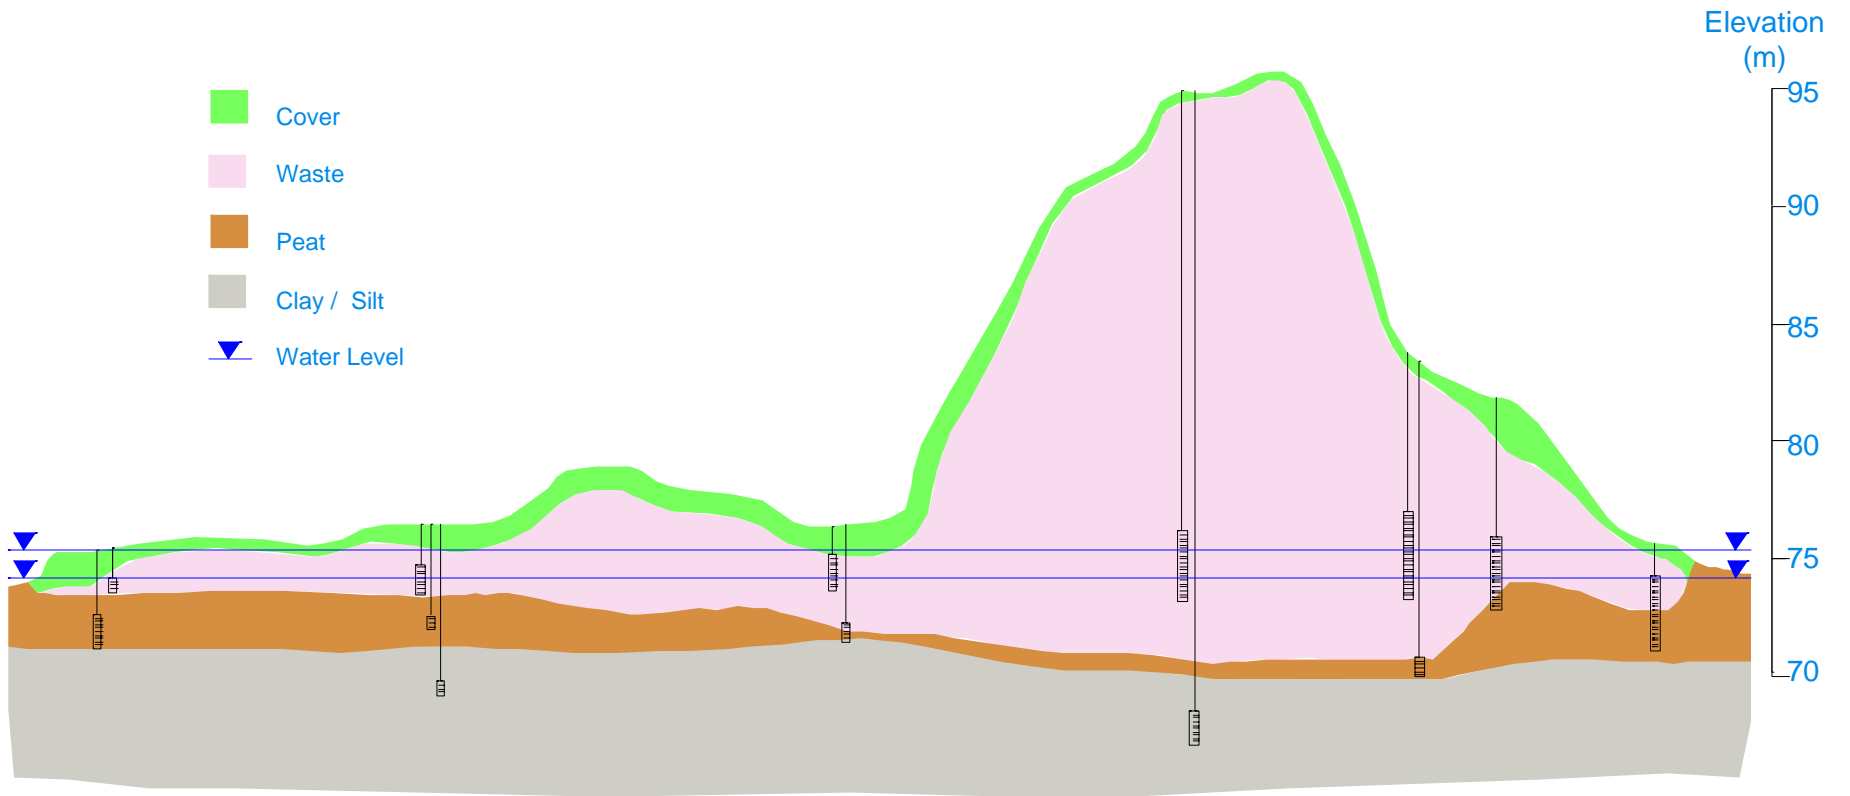
Site Characterization

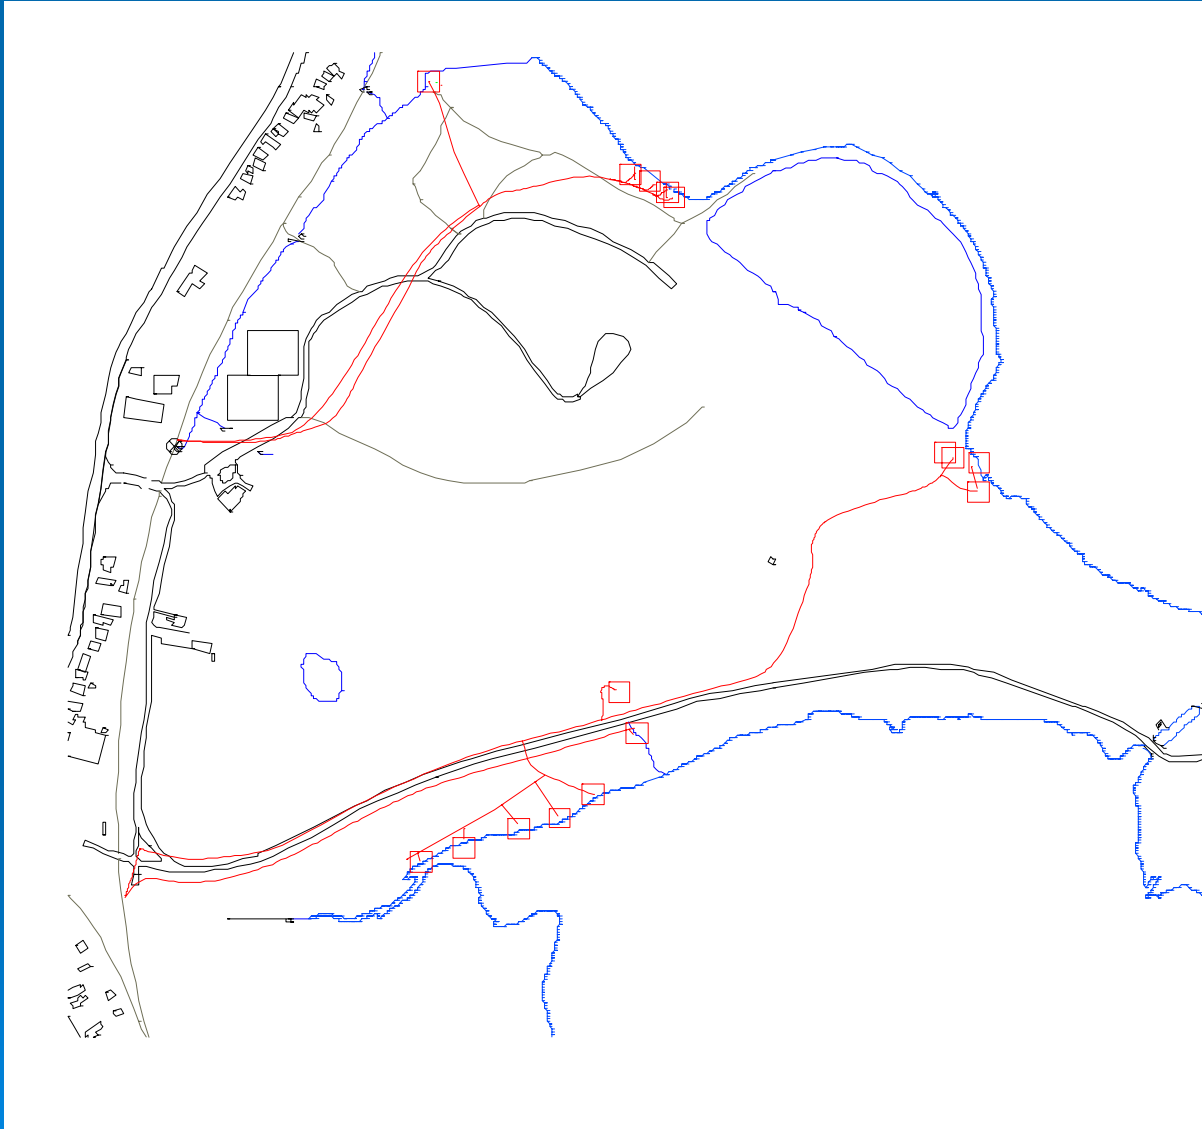
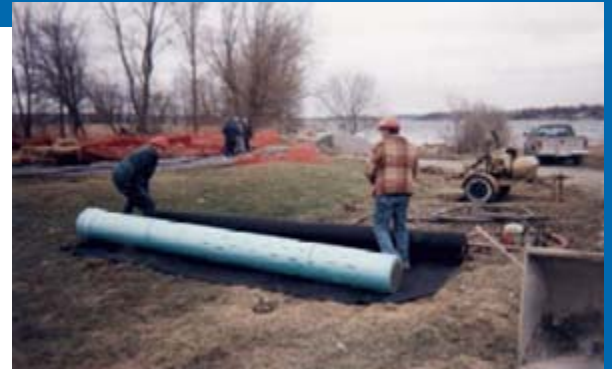
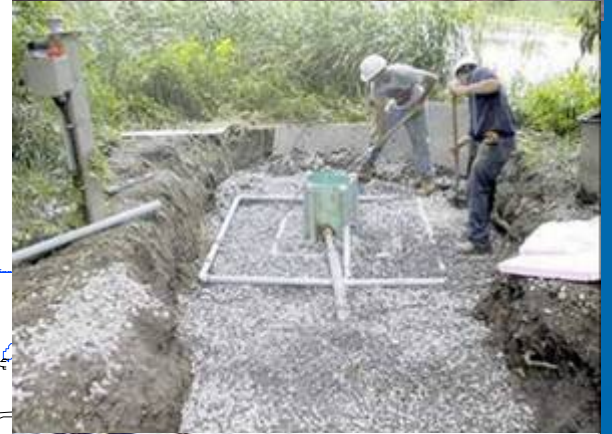
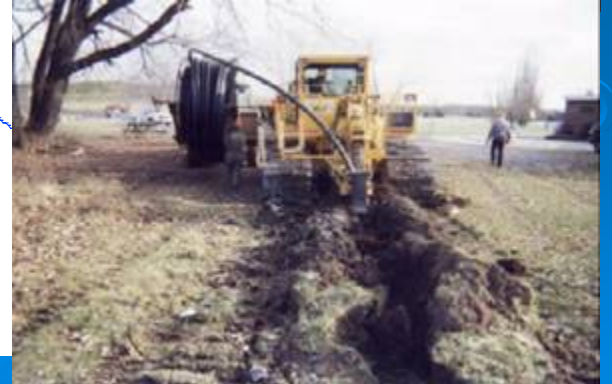
Groundwater Pumping

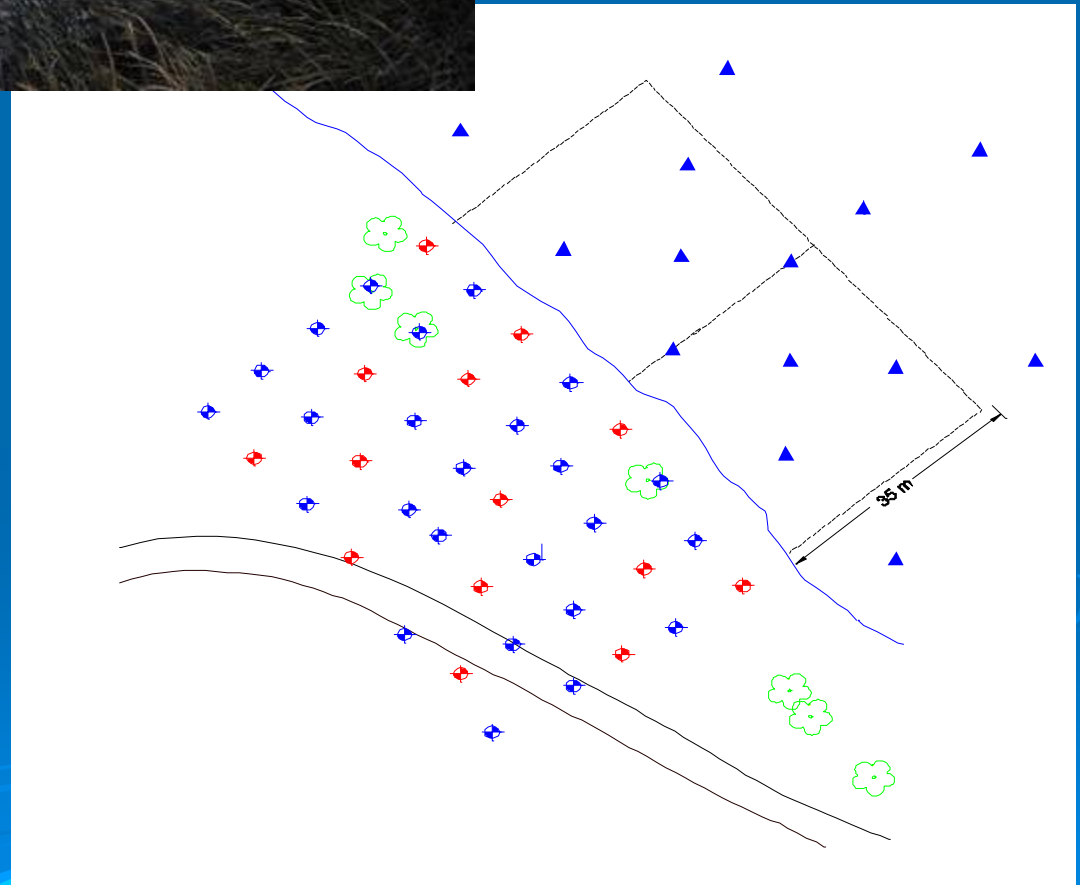
- shallow fringe wetland
- in-water construction
- 2 - 35 m x 35 m cells
- cattails vegetation

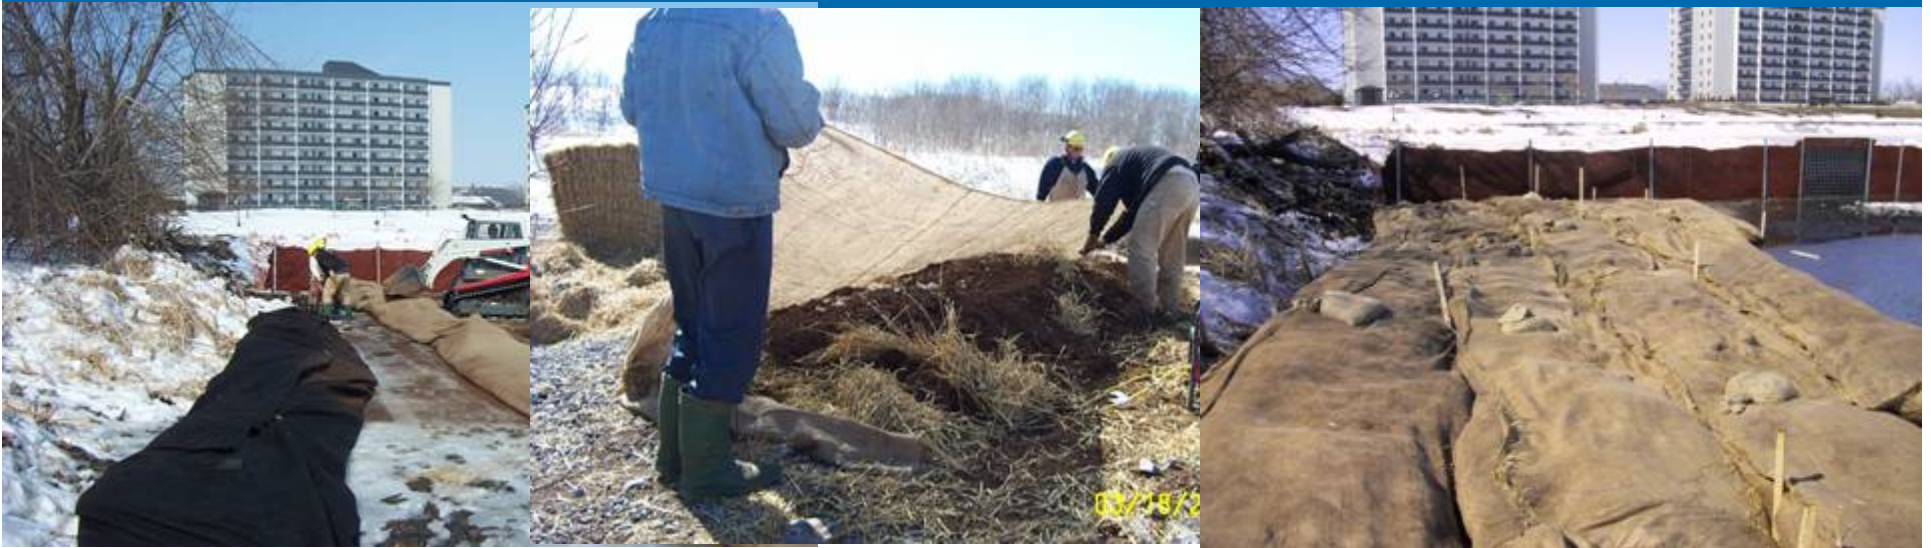
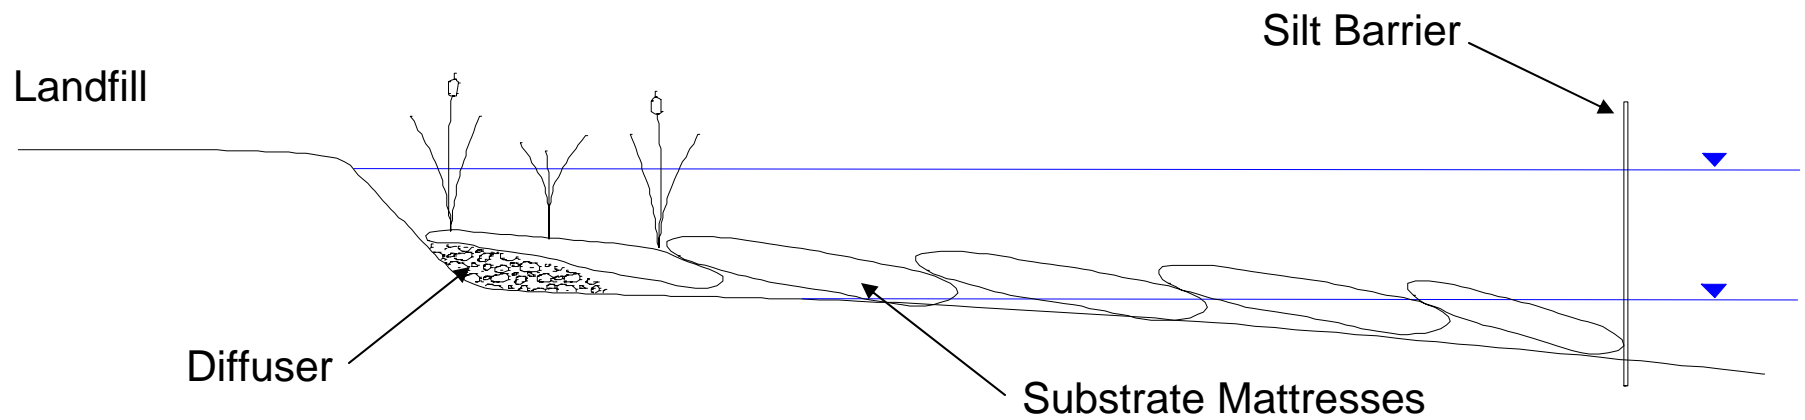
Constructed Wetland – Schematic Section

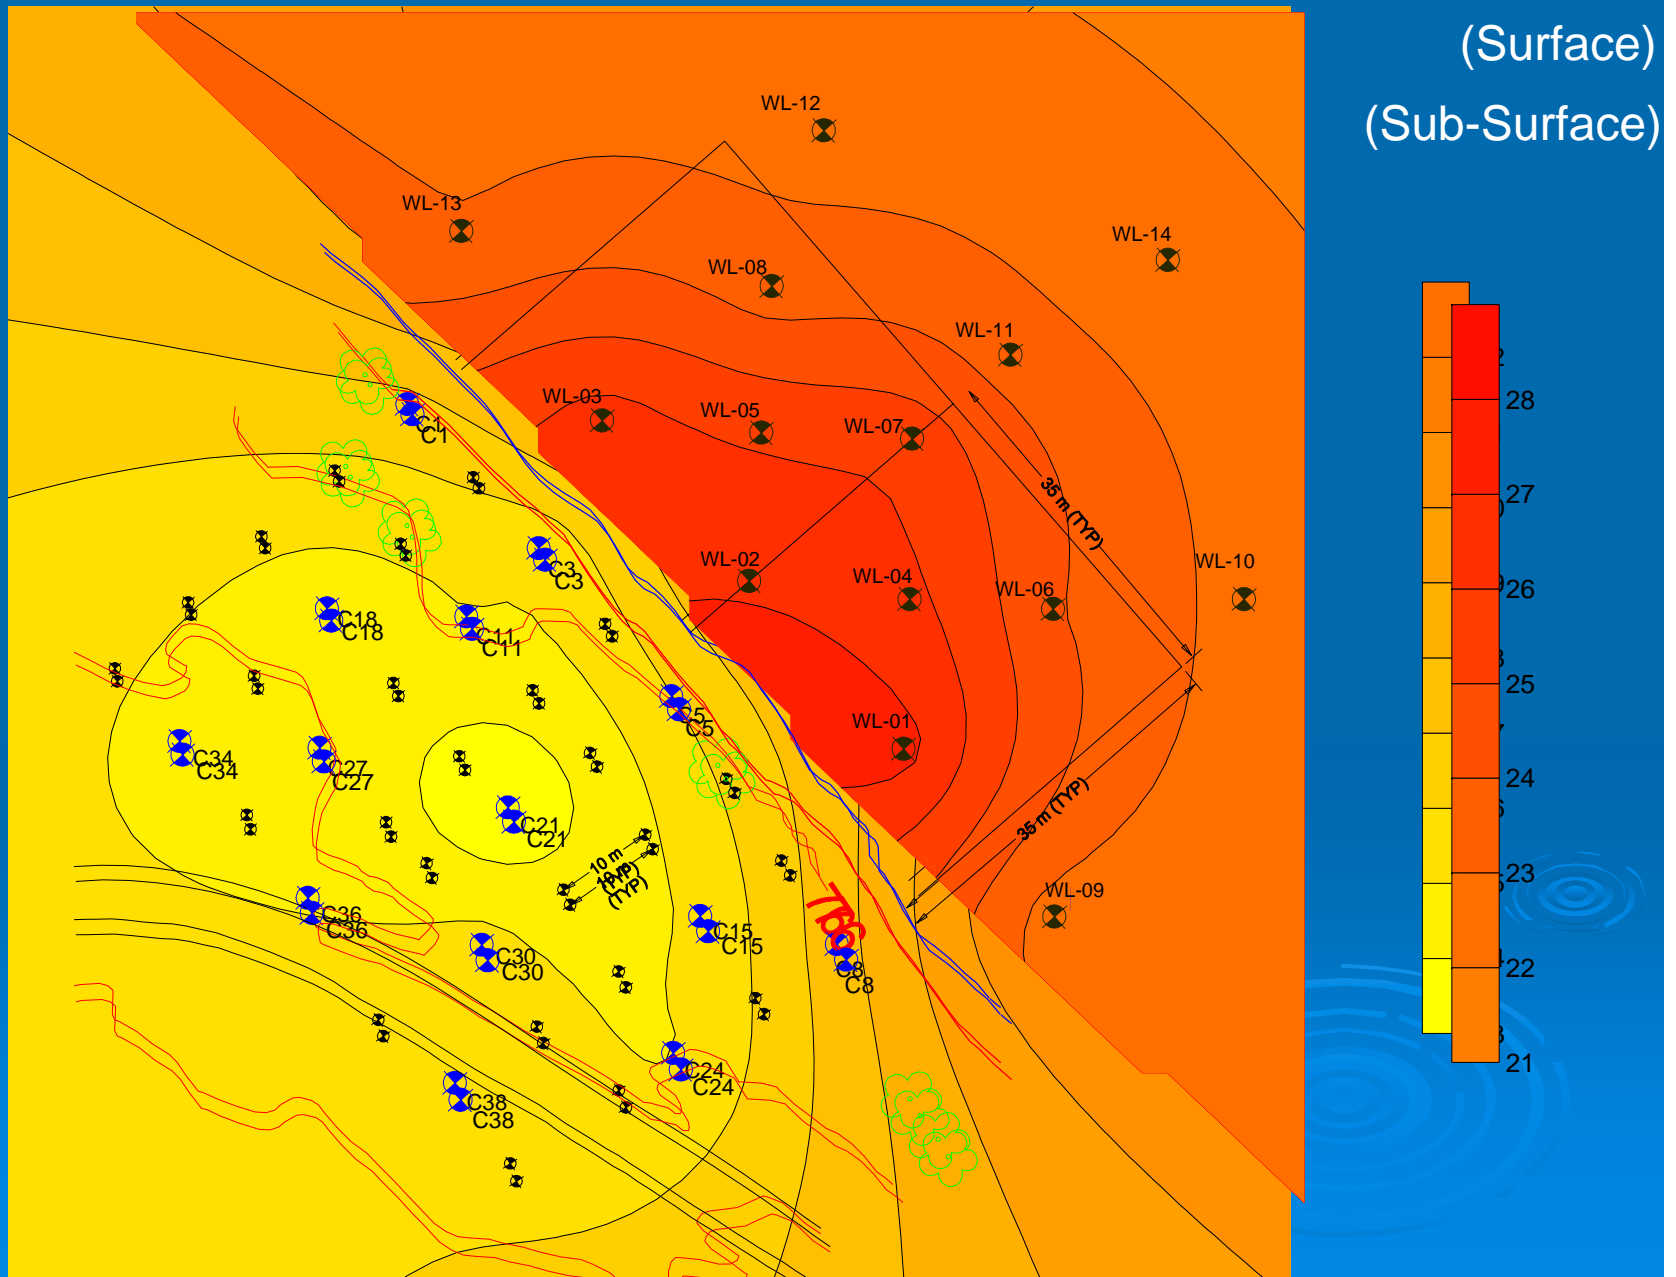
Temperature: Aug., 2004 (° C)

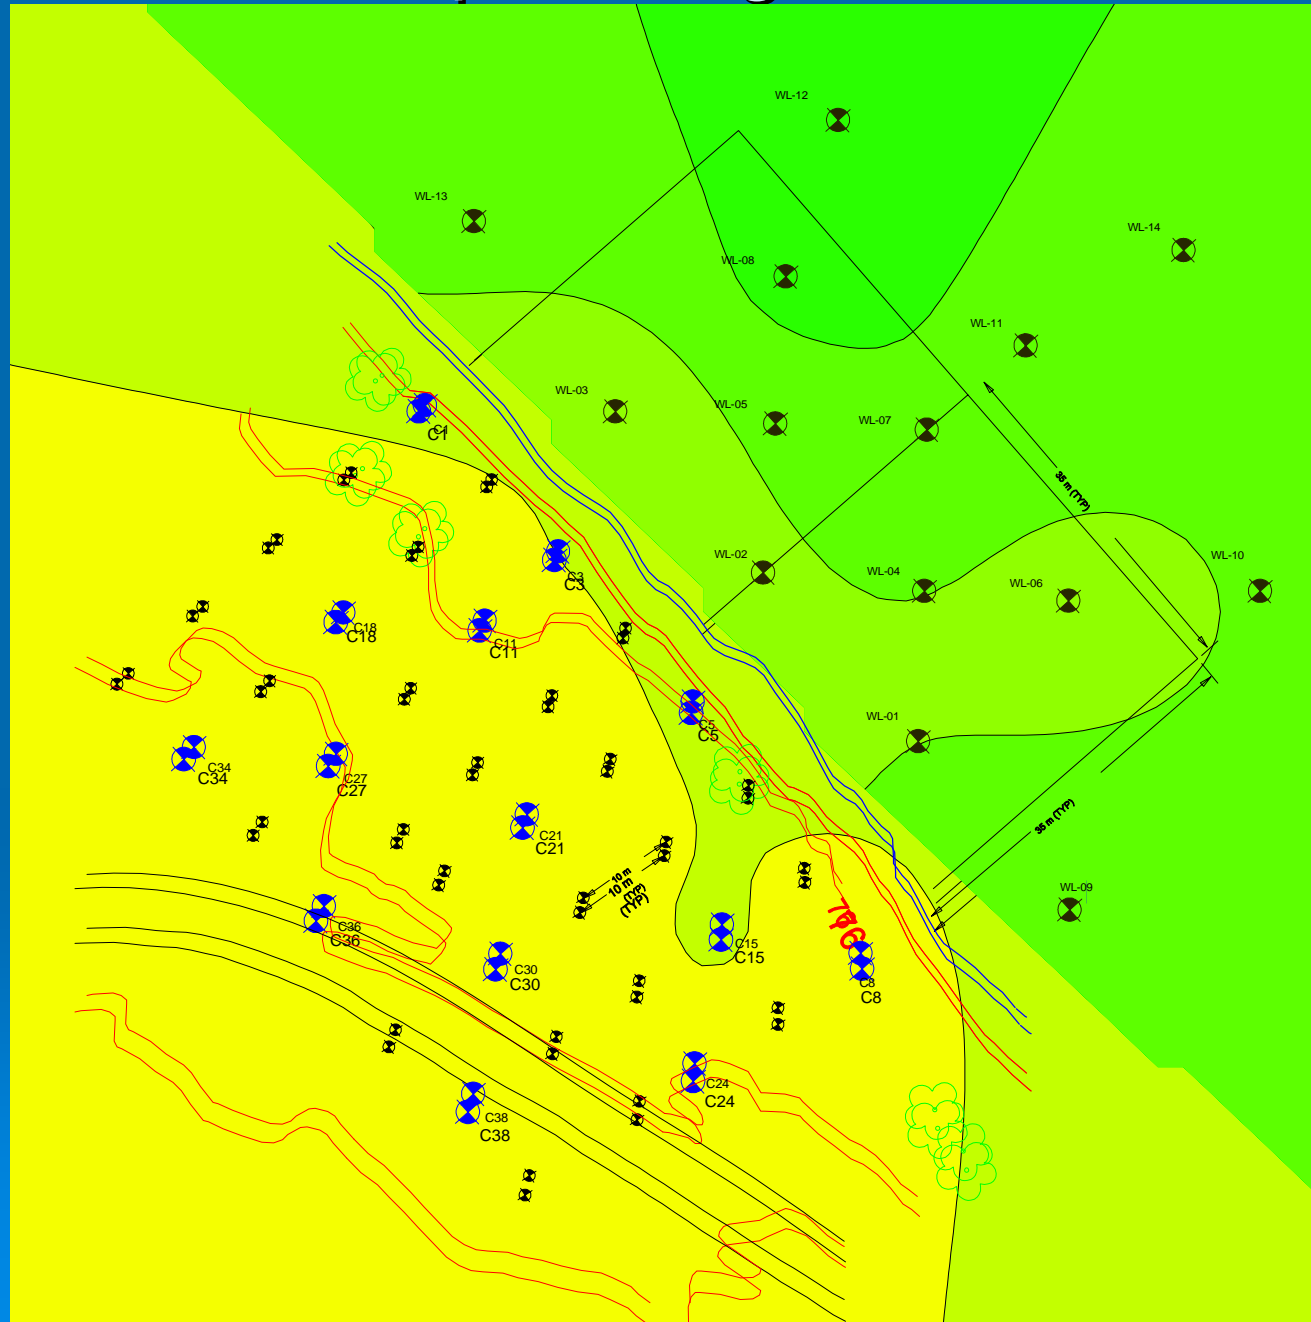
pH: Aug., 2004

(Surface)
(Sub-Surface)

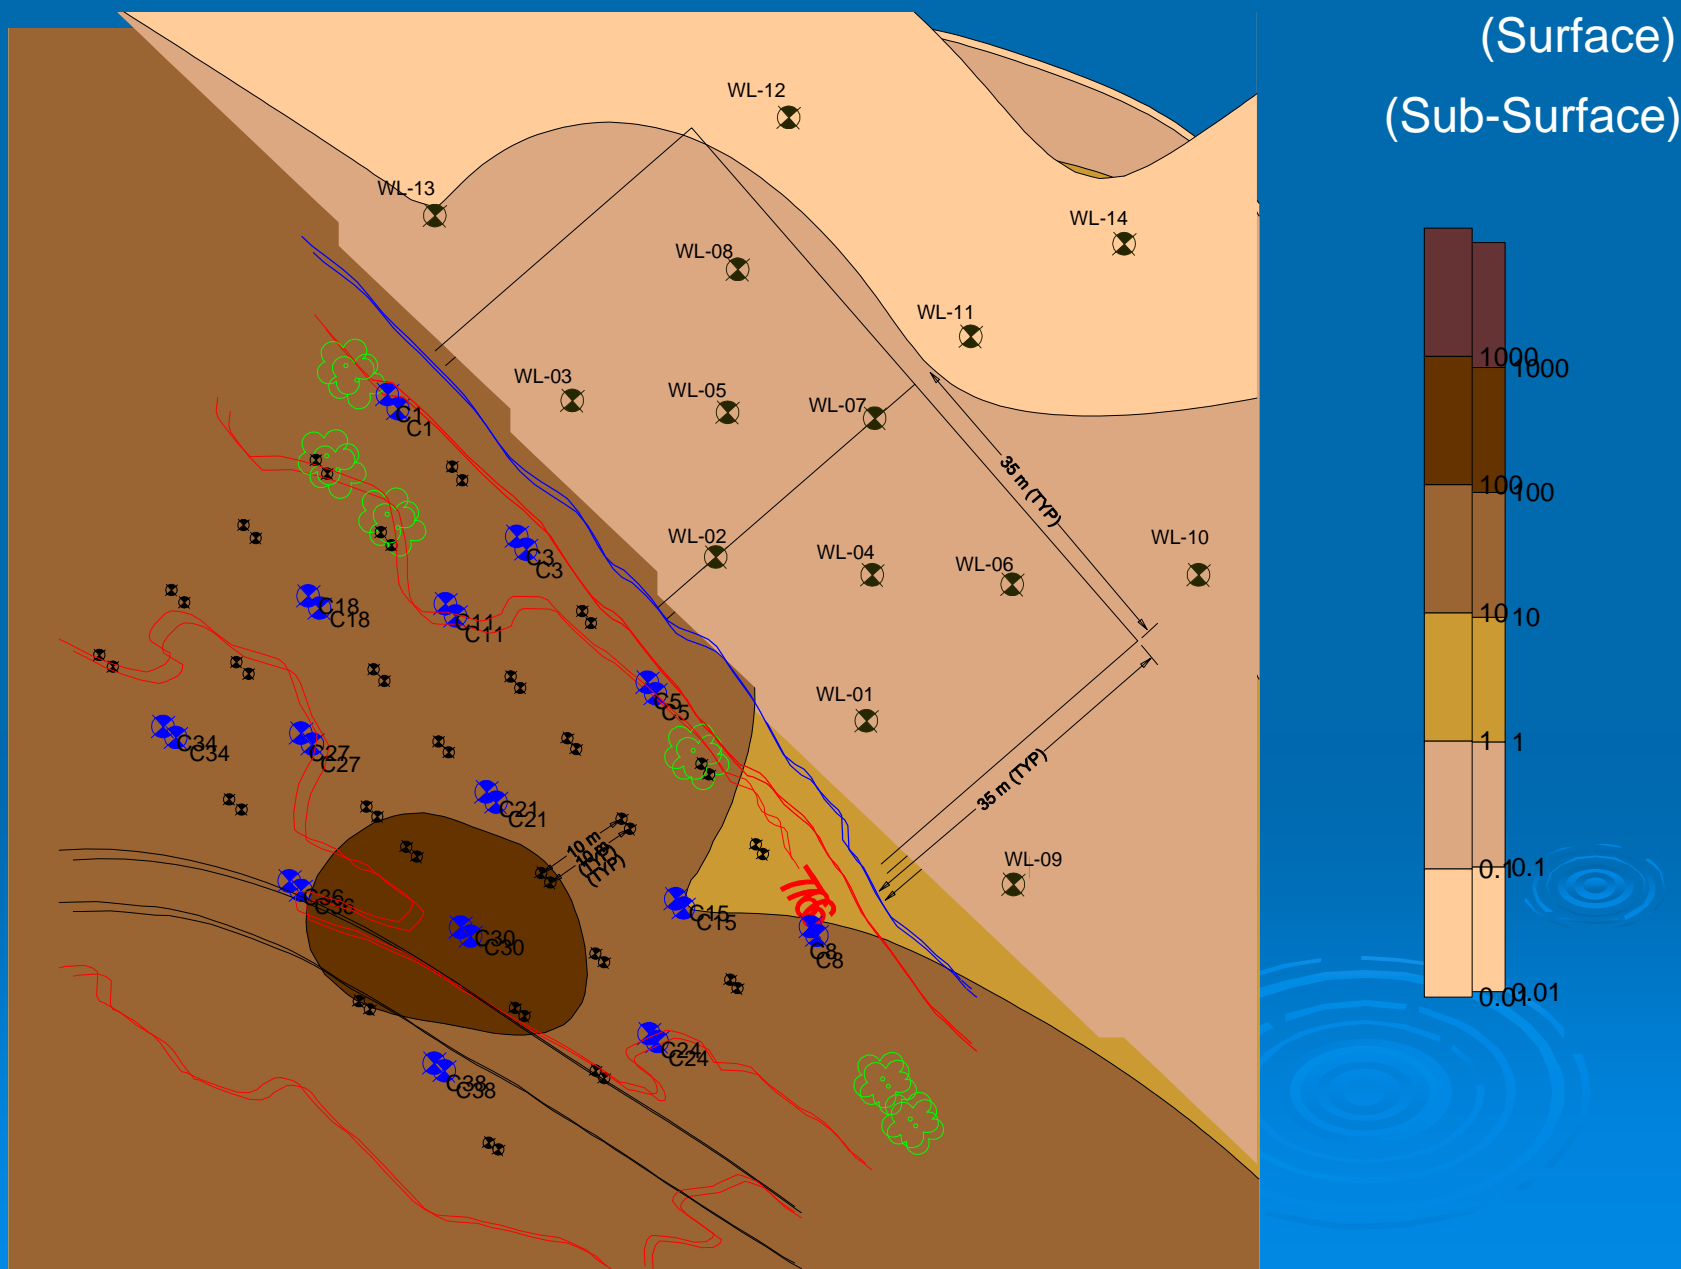
Iron: Aug., 2004 (mg/L)

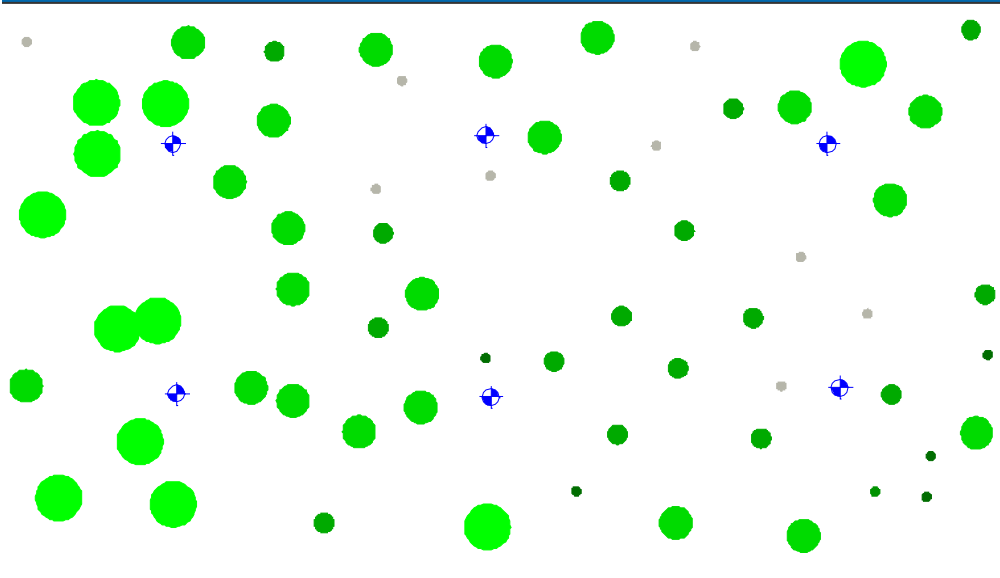
Tree Heights: Oct., 2004

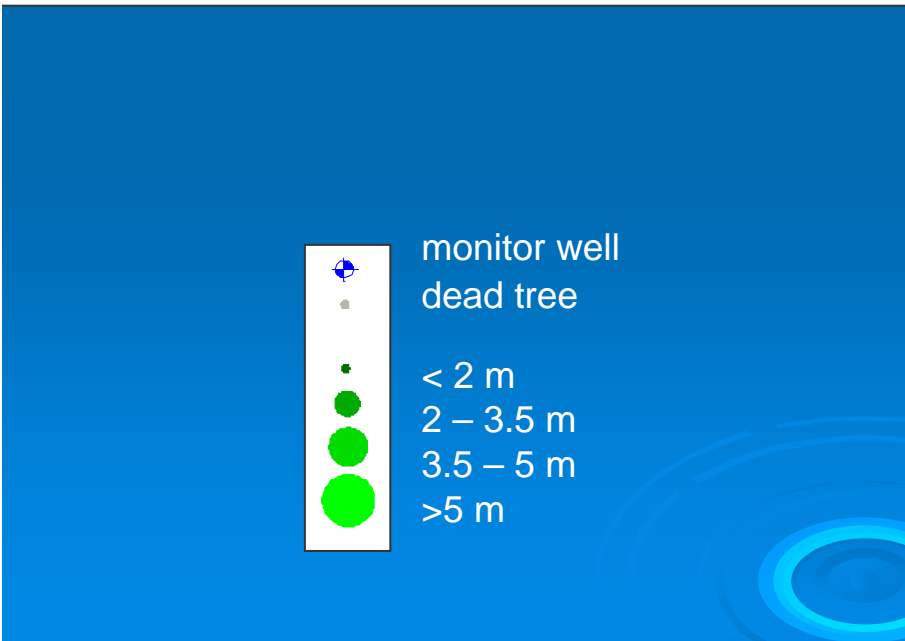
Willows

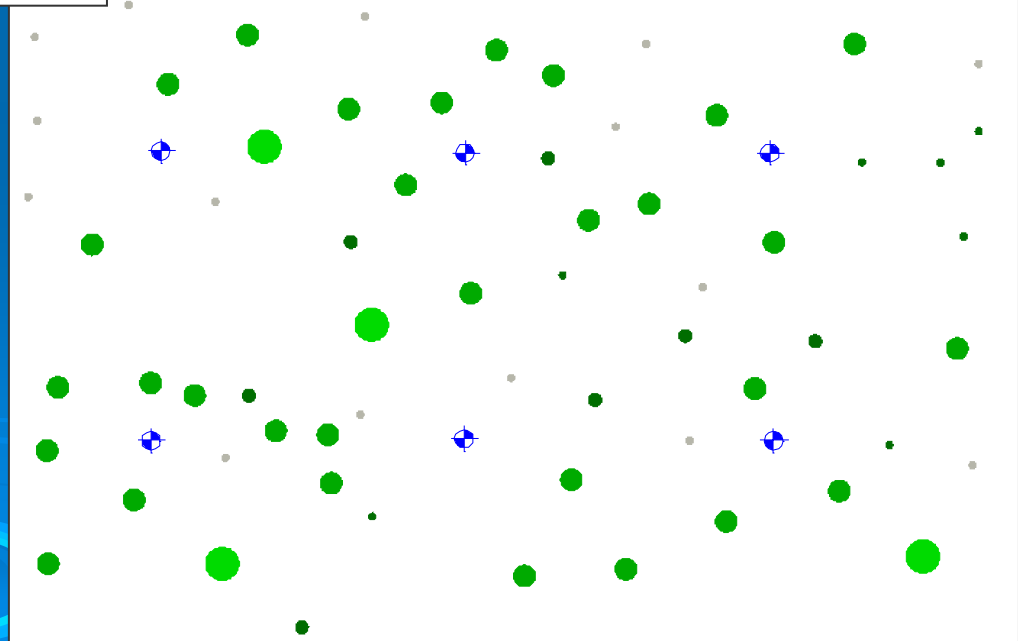
Poplars

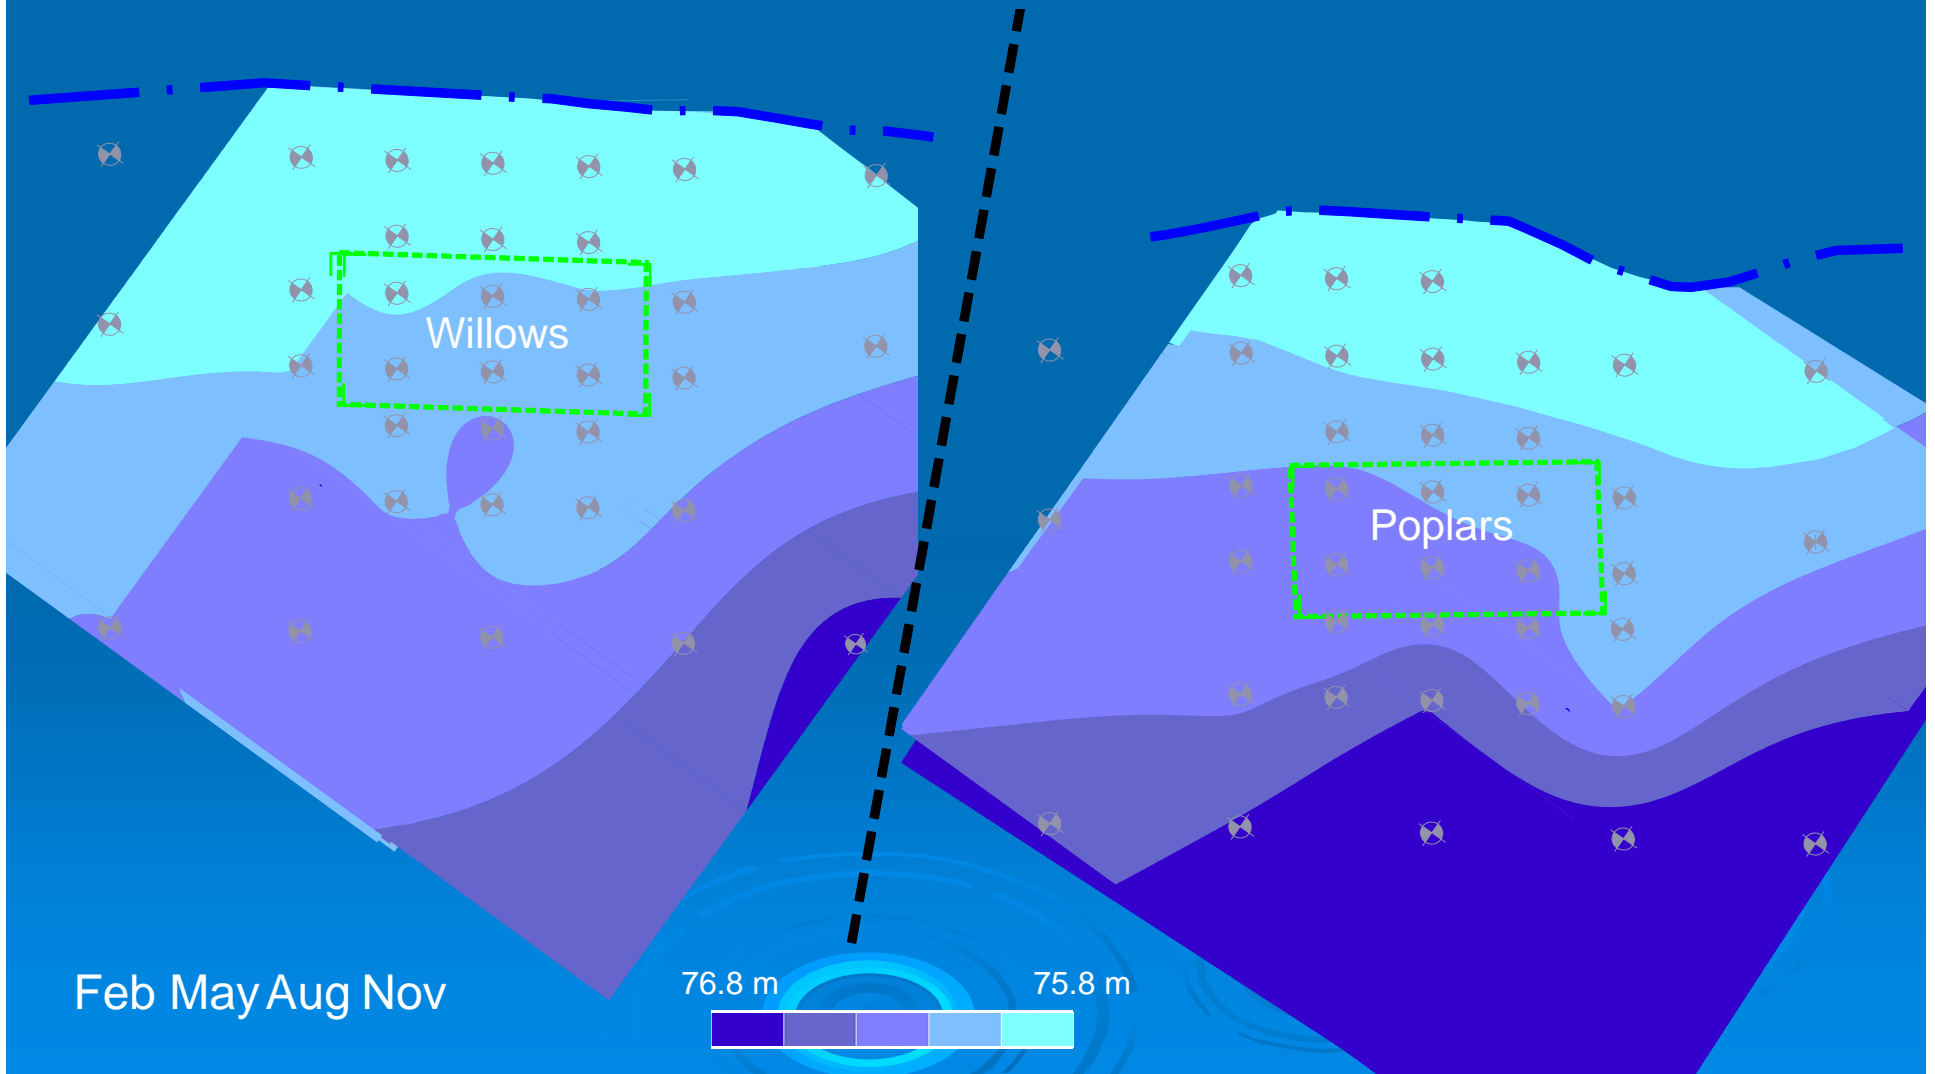
Groundwater Elevations: 2004

(contours = 0.2 m)

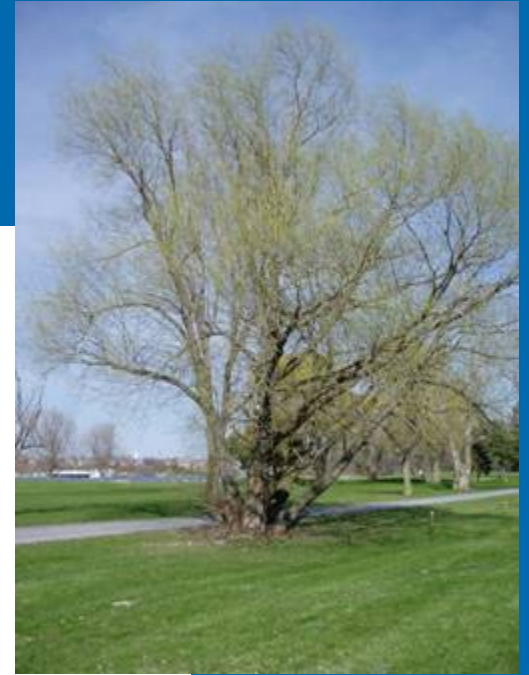
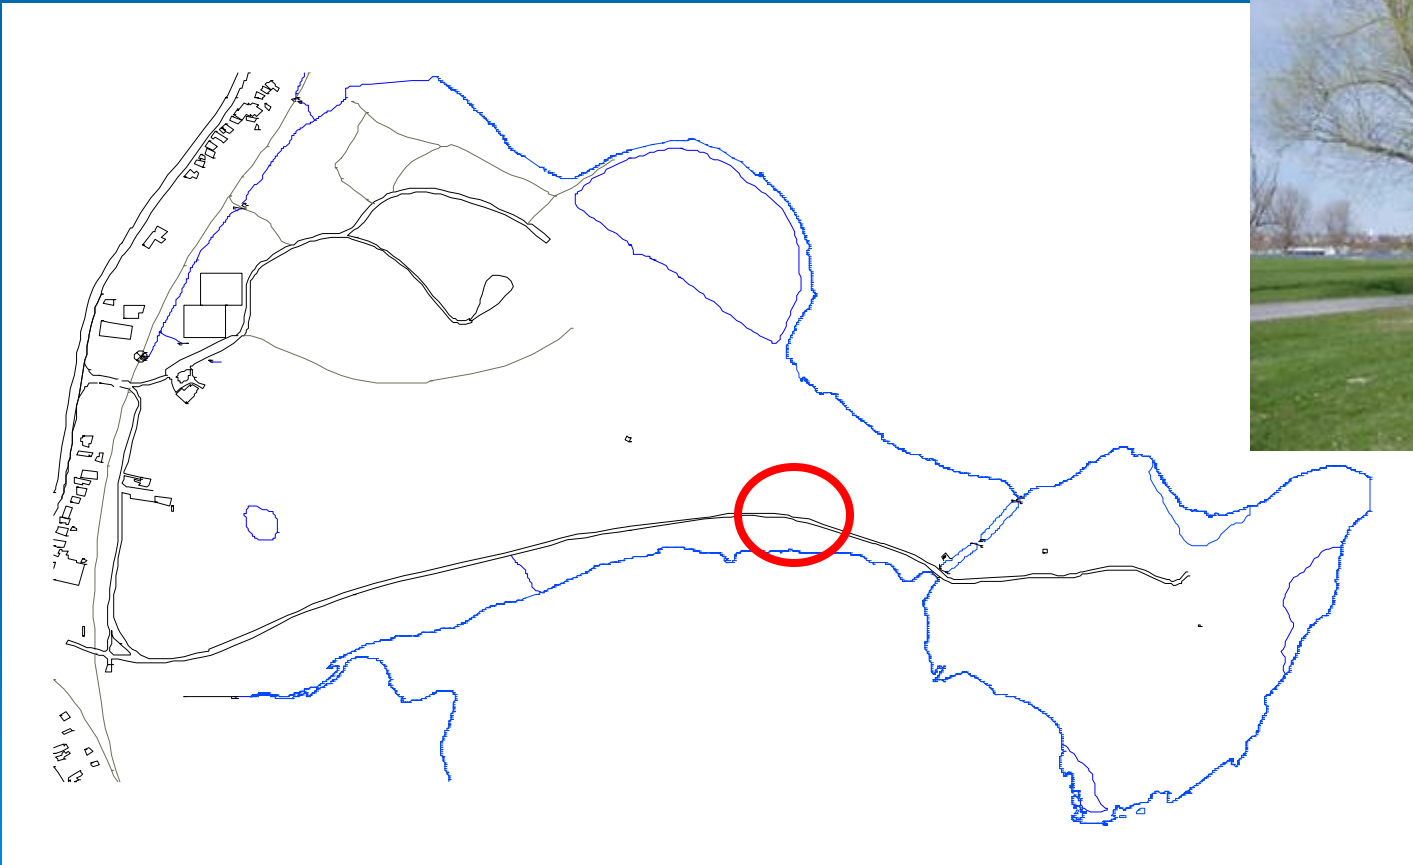
Instrumentation of 2 mature willows

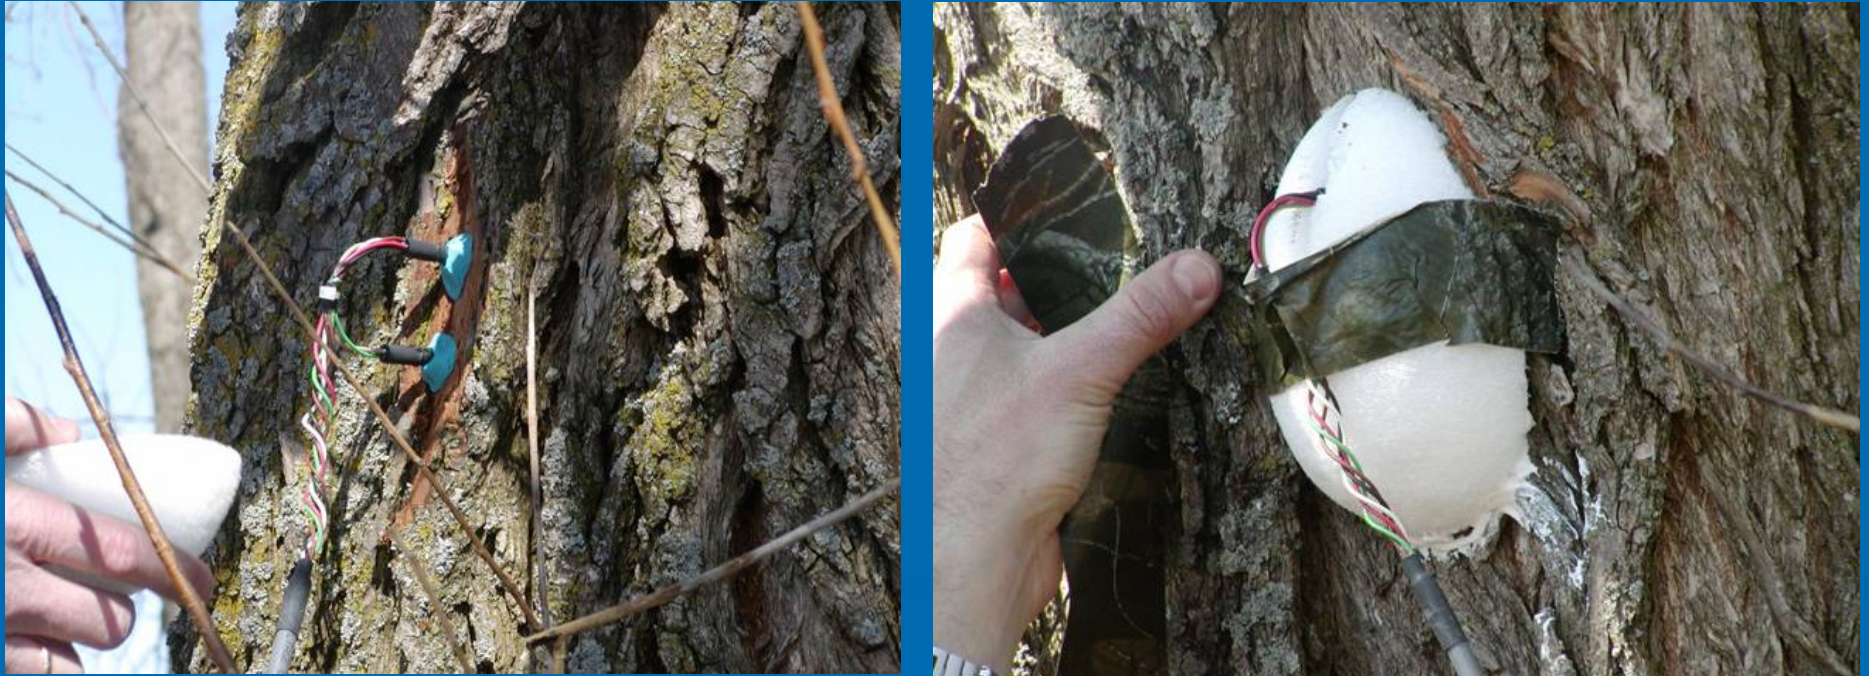
Sap Flow Probes

Based on correlation between sap flow and rate of heat dissipation in sapwood

➤ Sap Flow:

- diurnal patterns
- ~ 1,200 to 3,000 L/day (May)

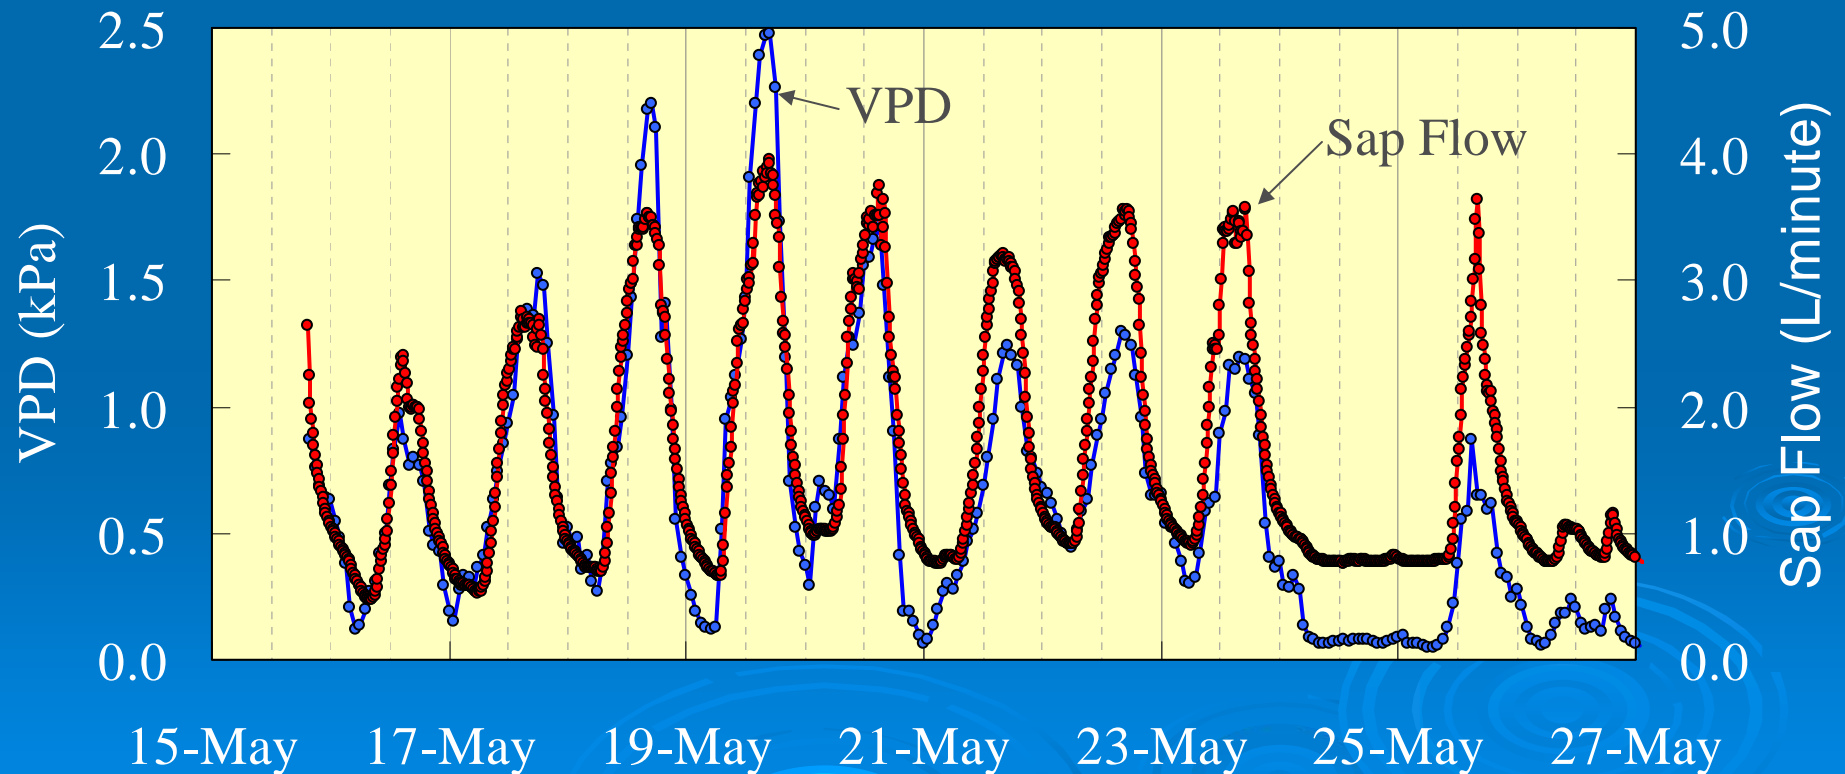
Sap Flow & Vapour Pressure Deficit

Vapour pressure deficit (VPD)

= difference between current amt of moisture in air & amt at saturation
